Sharifi, Shayan and Johnstone, Cameron and Stack, Margaret M. (2015) Tribological challenges of scaling up tidal turbine blades. In: 11th European Wave and Tidal Energy Conference (EWTEC2015), 2015-09-06 - 2015-09-11, Cité des Congrès de Nantes. ,

Tribological Challenges of Scaling Up Tidal Turbine Blades

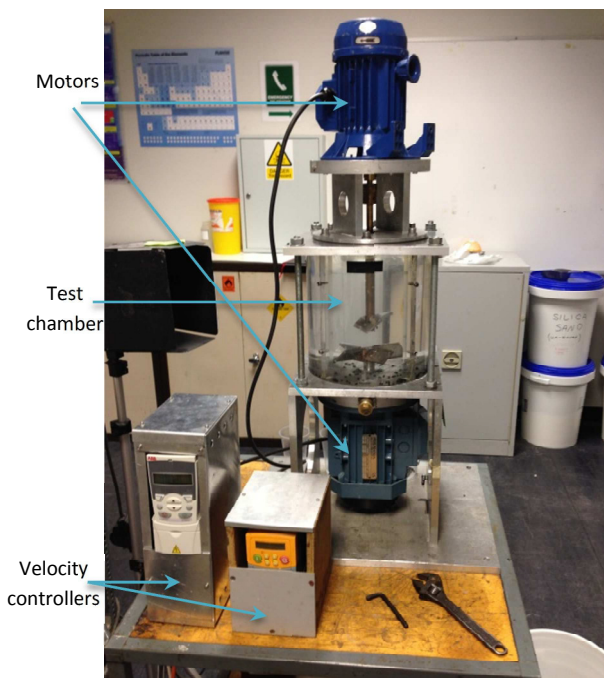
Figure 1 – Test apparatus

The test rig used for this set of experiments was a modified slurry pot tester. The rig consisted of a test chamber and two motors at the top and the bottom of the rig that provide the rotational motion of two propellers which functioned as a miniature turbine and a stirrer respectively. Figure 1 is an image of the test rig in a stationary mode and Figure 2 illustrates the test chamber showing the inserted test samples and the direction of the flow motion. The slurry pot tester investigates the erosion resistance of different materials rapidly and inexpensively.

role of the baffles in the test chamber were to prevent unwanted swirling of the flow due to the rotation of the samples and while the bottom propeller stirred the solution and provided the longitudinal flow and a good mixing of the slurry [6]. The propellers were rotating in opposite directions to avoid random motion of the particles, turbulence of the flow and error in the calculation of the impact velocity [5]. The blades of the bottom four bladed propeller (stirrer) were pitched at 45° which is the optimal degree to provide a better particle distribution. Also, down-pumping (which was used in the tests) has been found to supply a more uniform suspension and distribution of the particles [7]. The rotational velocities of the propellers were controlled using the controllers shown in Figure 1.

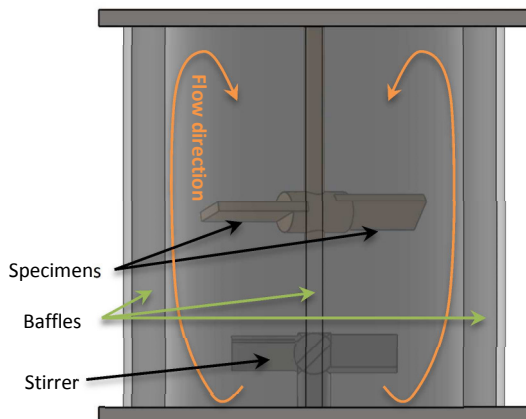
Figure 2 – Test chamber

The test samples which functioned as the turbine blades were inserted in different angled slots on a sample holder which acted as the hub of the turbine. A number of hubs were manufactured to test the samples in different impact angles. The slots on the hubs were spaced by 15° from 0 – 90°. The

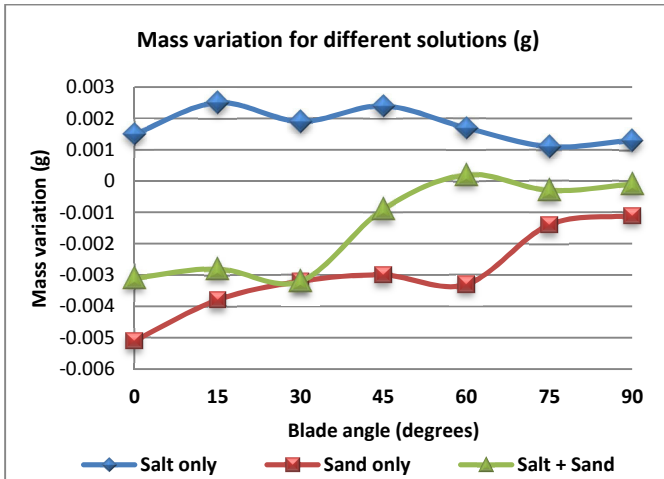
Figure 3 – Weight variation of the specimens

The weight of the specimens were measured with the accuracy of 10^{-4} g and it was found that the specimens from the tests with salt only solutions have gained weight whereas a weight loss was observed for almost all of the tests performed in the other solutions. The weight variations of the samples at different impact angles are plotted in Figure 3.

The results in Figures 3 and 4 indicate that the erosion rates are higher at the lower impact angles. This is a behaviour that normally observed in ductile materials. According to the literature, the erosion rates of ductile materials typically peaks at a particle impact angle of 30–50 due to occurrence of micro-cutting. The erosion at 90 degrees is caused by deformation wear and Hutchings has suggested that the material loss is observed when a critical fracture strain is reached. It is also stated that the formation and fracture of platelets controls the erosion rate [10], [12]. The peaks of the erosion rate in the current work are observed in the impact angles below 30 degrees which does not completely describe ductile material behaviour (although it should be acknowledged that these impact angles at which the erosion rate peaks can shift depending on the particle characteristics [14]).

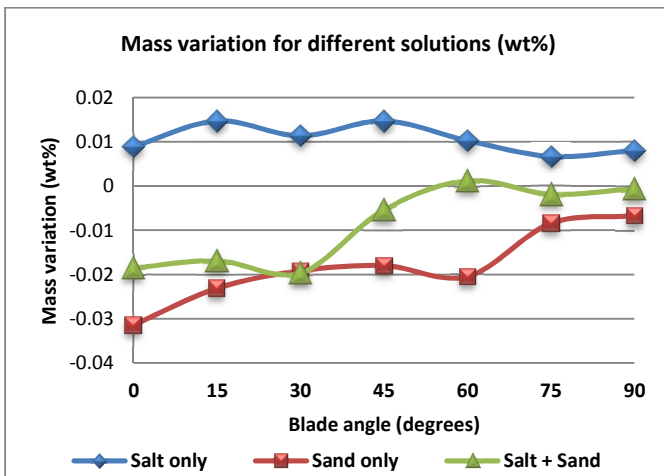
Figure 4 – Wt% variation

Although the initial weight of the samples were very close to each other, in order to normalise the results and compare the effects of the different impact angles on the mass variation, the results are plotted in wt% in Figure 4. The results indicate that lower impact angle have shown more interaction with the solutions and the solid particles. Higher weight gain and weight loss have taken place in the lower impact angles and this is similar for all of the solutions. It should be noted that although the results show a higher mass loss for the sand only solution, the weight gain due to the presence of the salt in the sand + salt solution should be taken into consideration. This is discussed in detail in the next section.

Another factor which is observed from the results is the effects of the dissolved salt in the water on the wear performance of the G10 composite. Referring to Figure 4, the amplitude of the deviations of the weight gain due to the presence of salt in the water in the salt only tests is rather small comparing to the other tests. On average, each sample has gained 0.011% of its initial weight after the tests. By deducting this value from the final weight of the tests with salt + sand, pure erosion can be calculated. Pure erosion in such

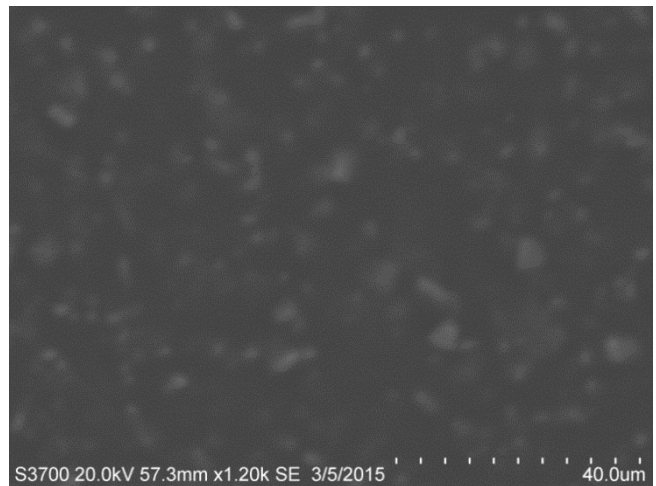
Figure 5 – A close view of a fresh surface

Following the weight measurement, the specimens were taken to scanning electron microscopy (SEM) to inspect the surface of specimens. The images were taken using a S3700 (Hitachi, Japan) Tungsten Filament Scanning Electron Microscope. As the samples were non-conductive, the inspection surfaces were gold coated prior to the analysis to increase the clarity of the images. Figure 5 is a close view of a fresh sample before the test. The faded brighter areas can be trapped micro-bubbles under the glossy surface or the residual dust from the side surface finishing as the surfaces were wiped very gently afterwards. It should be noted that as the samples were purchased from a commercial supplier, some tiny dents and superficial scratches were observed which can be due to the transportation. Extra care was taken to use the samples for the tests with a surface finish close to perfect.

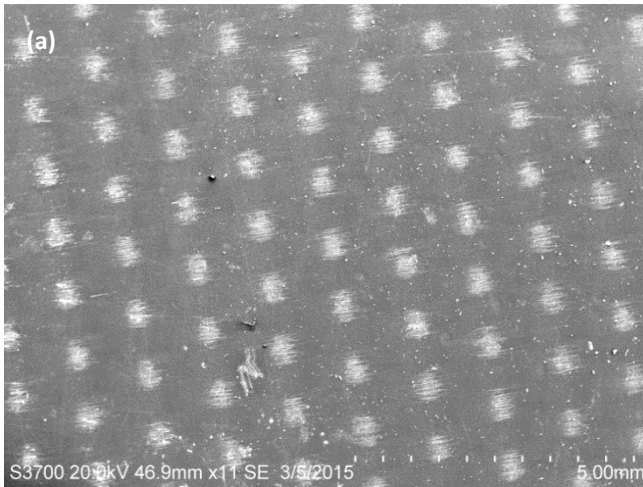
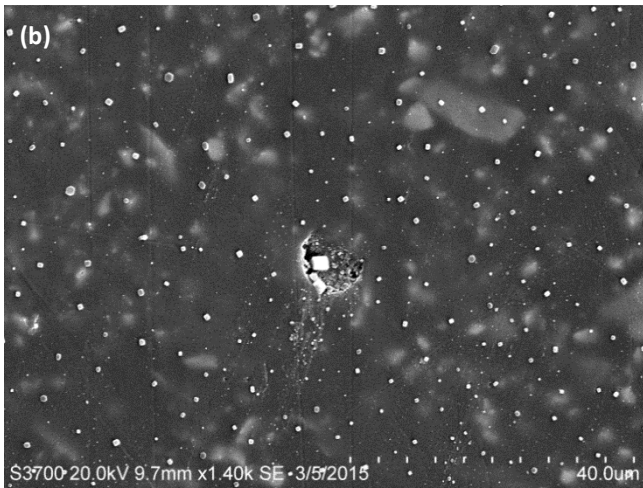
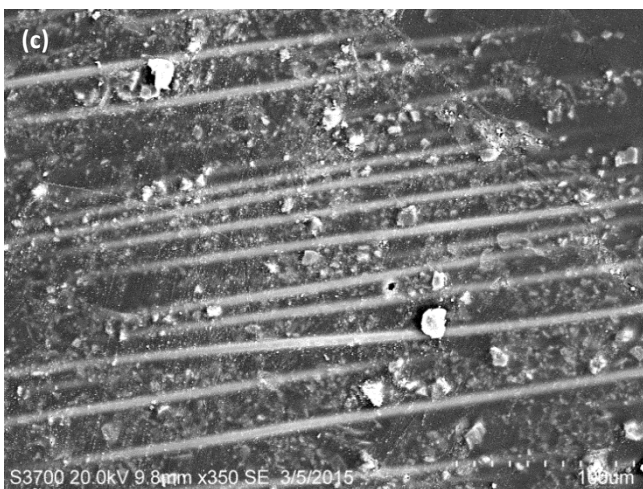
Figure 6 – sample after a test in salt only solution at 60° impact angle (a) site 1, (b) site 2 and (c) site 3

Figure 6 exhibits three different sites of the specimen used in the salt solution with the 60° of impact angle. Figure 6(a) shows a wider view of the surface after the tests and shows the salt crystals dried on the surface. In a closer view it can be

seen that any defects on the surface can increase the amount of the accumulated salt on the surface (Figure 6(b)). As the glass cloth fibres were woven in 0 and 90° directions, the last layer of the glass fibres in one direction was closer to the surface and caused some imperfection on the surface.

As it can be observed in Figure 6(c), these areas absorb more salt crystals as they can be accumulated better in those areas. This phenomenon was observed on the other samples tested in the salt only solution.

It is observed in the SEM that the salt crystals are mainly absorbed and accumulated where the fibres are closer to the surface. Also, as it is demonstrated in the work and is documented in the literature, the exposure of fibres can be very problematic and increases the susceptibility of the material to be eroded or result in failure due to the lack support from the protectant material. Therefore, using surface coating or gel coats for such materials can enhance the quality of performance and the life span of such materials. Further work will involve assessing the performance of different gel coats, reinforcements lay-outs and reinforcements volume fractions in order to optimize the composite for exposure to the operating environment.

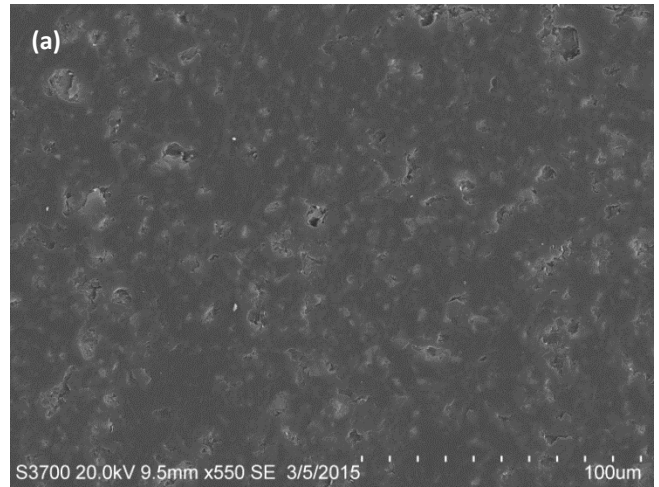
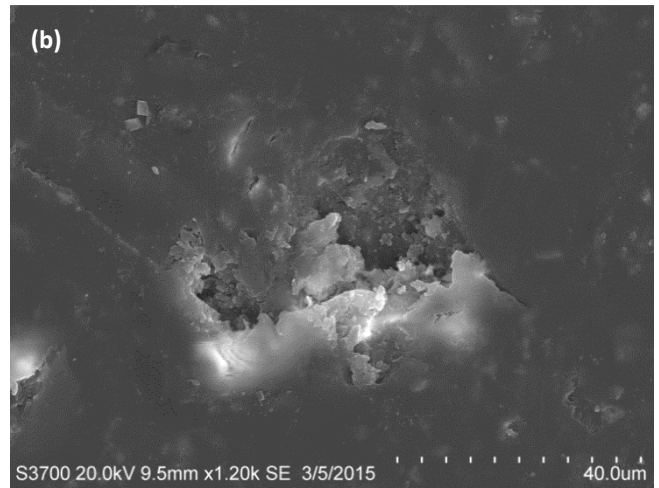
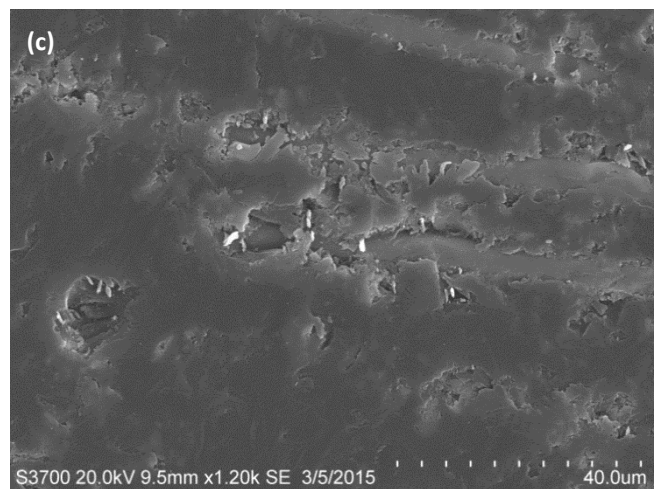
Figure 7 – Sample after a test in sand + salt solution at 15° impact angle (a) site 1, (b) site 2 and (c) site 3

Figure 7 shows three different sites of a sample after a test in sand + salt solution at 15° impact angle. In the wider view (Figure 7(a)), the indentations due to impact of the solid particles can be observed on the specimen surface. In the higher magnification images (Figures 7(b) and 7(c)) the typical effects of erosion on the surface, i.e. platelet formation, can be seen [9]. The platelet formation in the composite materials was observed as flaking due the glossy nature of the surface. It also can be seen that in the areas where the fibres were closer to the surface, the susceptibility to erosion was increased as the fibres are almost exposed. In the real devices, this can be very problematic due to the structural loads on the blades and may result in the breakage of the reinforcement [4].

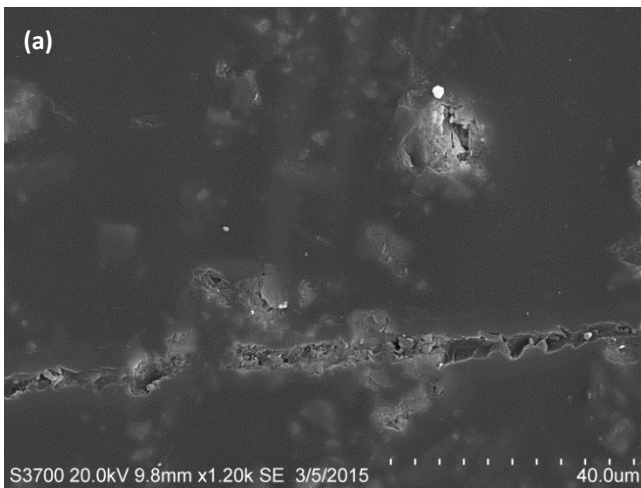
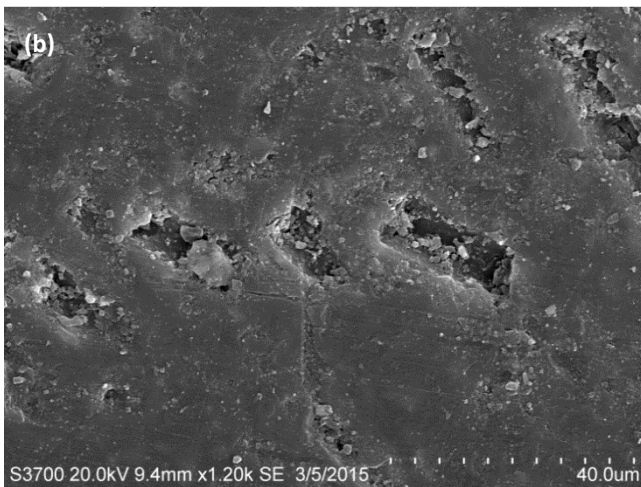
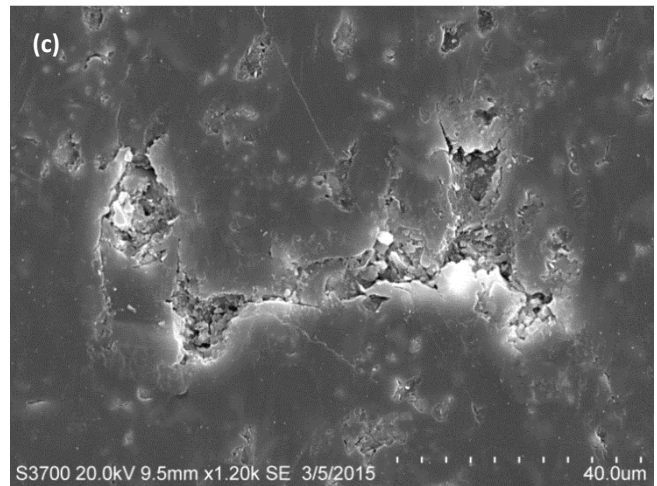
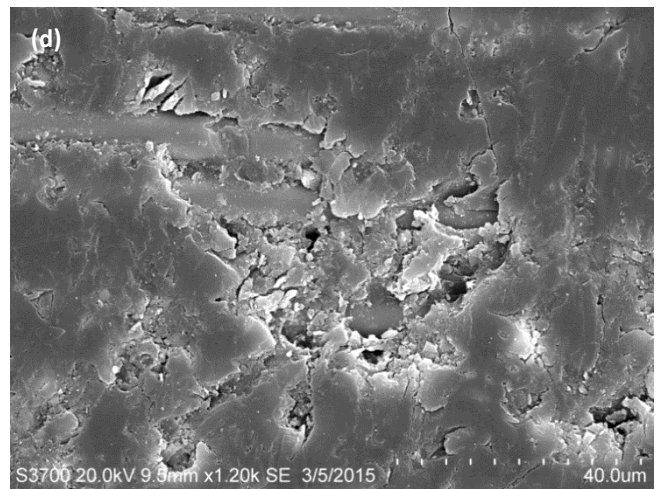
Figure 8 – (a) Different shapes of erosion (b) Sample after a test in sand + salt solution at 15° impact angle (a) site 1, (b) site 2 and (c) site 3

These phenomena were similarly observed on the other samples tested in the presence of the sand particles. Different shapes of erosion were identified on the specimen surfaces. They could be in the shape of indentation marks or scratches as shown in figure 8(a). An interesting observation was the detrimental effects of erosion before and after the crack propagations on the surfaces. There can be a number of indentation sites or pit like structures formed within a close distance due to the impact of particles colliding the surface (Figure 8(b)). These erosion pits became deeper due to the collision of more particles to the dents without causing significant material loss. However, if the pits were in a close distance of each other, once the outer layer of the surface is cracked and the cracks are propagated towards the adjacent dents, the material loss rate accelerated and a significant amount of material will be removed from the surface. This is clearly shown in the images below. Although the images in Figures 8(b), 8(c) and 8(d) are not taken from the same site, this process was repetitively observed on different samples.

For the material tested in this work, and as it was mentioned in the previous section, the mechanism of erosion is rather different and a steady state cannot be identified. The impact of the erosive particles causes the formation of platelets and flakes and once the material removal takes place, further impacts result in deepening the erosion pits or micro-cutting. Subsequent impacts in the adjacent surface also take place [18]. This is similar to the behaviour of metals. However, this changes as the resin surfaces is glossy and brittle. The pits within a close distance of each other start to join as the outer layer of the surface begins to crack and propagate. The connections formed between the dents through the cracks accelerate the material removal and the mass loss becomes significant.

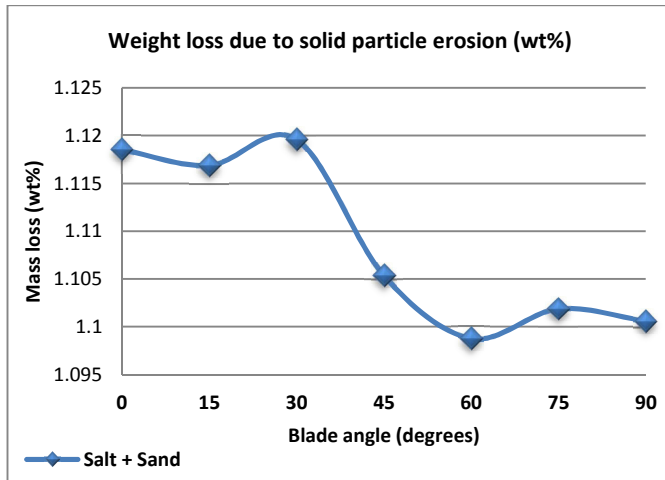
Figure 9 - Weight loss due to solid particle erosion in the Sand + salt solution (wt%)

conditions has been plotted in the Figure 9. The curve in Figure above follows the same trend as the pure erosion results with higher mass loss in smaller blade angles.

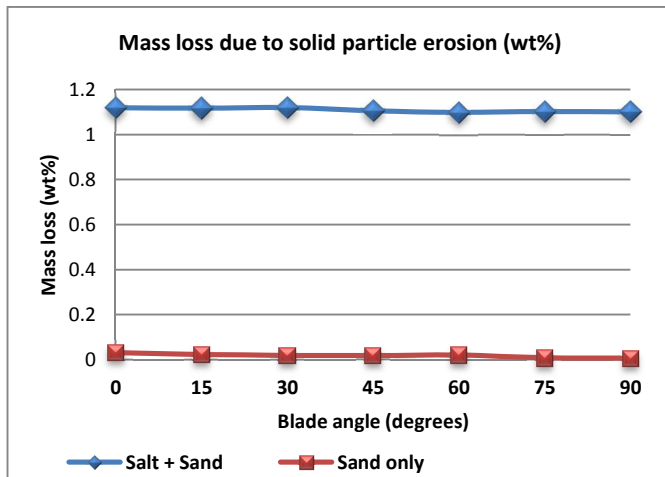
Figure 10 – Weight loss comparison due to erosion in Sand only and Sand + Salt solutions

If the results for the pure erosion in the sand only solution and the pure erosion from the sand + salt are plotted in a same graph, it indicates that the presence of salt has significantly increased the amount of erosion (See Figure 10). The curve plotting the erosion in the sand + salt solution has clearly shifted upwards. This emphasises the deteriorating effects of salt on tribological performance of materials and the importance of synergistic effects of salt and sand. Hence, using methods to avoid the absorption of salt seems to be necessary in order to optimize material performance.
