Rescue of a saturation diver, unconscious due to an explosion underwater

Key words: saturation diving, oxy-arc cutting, underwater explosion, hypothermia

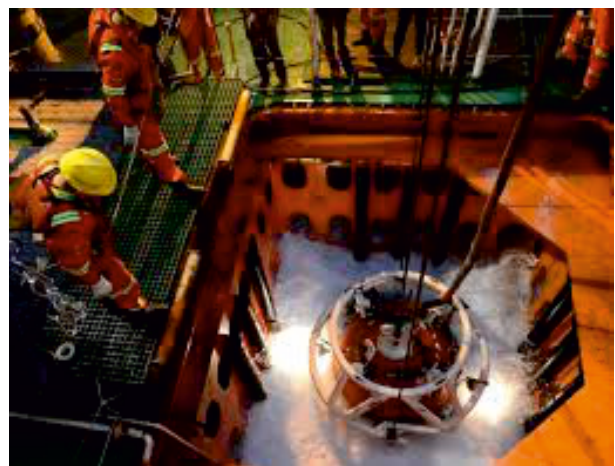
0.4 bars. Temperature is maintained around 26-28°C with a humidity of 70%. Carbon dioxide generated is removed chemically using scrubbers similar to closed circuit anaesthesia machine. These vessels have a built-in open to sea area inside the hull called “moon pool” through which the bell is lowered in water (Fig. 1). They descend down into the sea in a diving bell for carrying out necessary tasks. Divers

Figure 1. Diving bell being lowered from Monopole
