Successful conservative treatment of right common femoral artery dissection after closure with an Angio-Seal™ device

Artur Chmiel¹, Janusz Bieńkowski¹, Grzegorz Kołoczek¹, Wojciech Kreis¹, Katarzyna Mizia-Stec²

¹Department of Cardiology Provincial Hospital, Rybnik, Poland

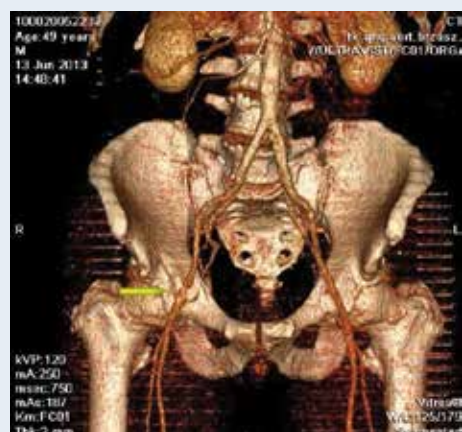
Figure 1. Angio-CT of the abdomen, aorta, iliac and femoral arteries. Localisation of the stenosis

the discharge, the patient noticed symptoms of intermittent claudication at a distance of 50–100 m. The patient was admitted to the vascular surgery ward where angio-computed tomography (CT) confirmed the right common femoral artery stenosis (Fig. 1). An ultrasound examination of the right femoral artery revealed severe stenosis of the vessel with the dissection of posterior wall that was caused by the bioabsorbable anchor of the closure device (Figs. 2, 3). Because of the recent multiple coronary stent implantations and dual antiplatelet therapy, the patient was discharged without surgery. Treatment of enoxaparin sodium in therapeutic doses was introduced.

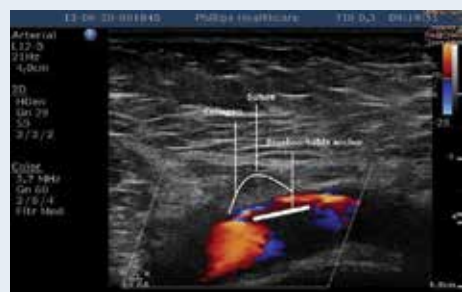
Figure 2. Colour Doppler ultrasound of the right common femoral artery stenosis. Components of the Angio-Seal™ device and posterior wall dissection are visible: anchor: bioabsorbable co-polymer anchor placed against the inside of the vessel wall; collagen: placed on top of the arteriotomy in the tissue tract; suture: clinches the anchor and collagen together to form a secure seal

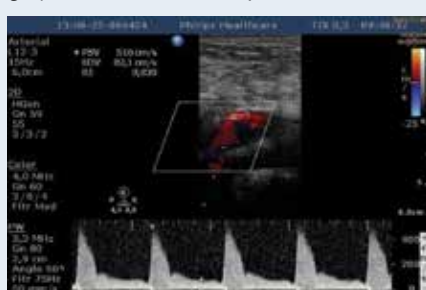
Figure 3. Pulse wave Doppler ultrasound of the right common femoral artery stenosis. Peak systolic velocity 510 cm/s, end diastolic velocity 82 cm/s

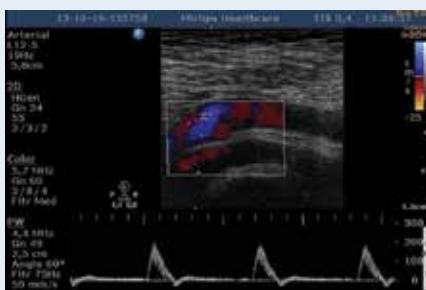
Figure 4. Pulse wave Doppler ultrasound of the right common femoral artery — flow normalisation after 4 months

Over the next 4 months, the distance of intermittent claudication gradually increased. In subsequent ultrasound examinations, the grade of the stenosis was smaller, and after 4 months, the flow was normalised and the symptoms had spontaneously completely resolved (Fig. 4) According to the manufacturer, all of the components of the device (suture, collagen and anchor) are bioabsorbed within 60 to 90 days. Management of such complications is not well established. Surgical arteriotomy, endarterectomy and thrombectomy in the case of concomitant thrombus and reconstructions are being performed. This case shows that conservative treatment with watchful observation might be an option.
