## ENGINEERING MEASURES FOR SOIL EROSION CONTROL ON AGRICULTURAL LAND IN THE PODOLENII DE SUS AREA, COZMESTI COMMUNE, IASI COUNTY

Simina-Mirela RĂILEANU<sup>1</sup>, Maria CIOBĂNIȚA<sup>1</sup>, Cristian TOTOLEA<sup>1</sup>, Daniel BUCUR<sup>1</sup>

### Abstract

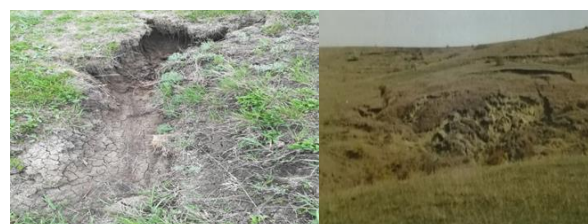
Figure 1 Pasture degraded by slope processes

depth erosion. At the same time, 26.08 ha of non-agricultural land will be reintroduced into the productive agricultural circuit, and fertility will be increased to the corresponding parameters of the agricultural lands currently strongly and very strongly degraded, which will lead to the restoration, their production for agricultural crops (*figure 1*).

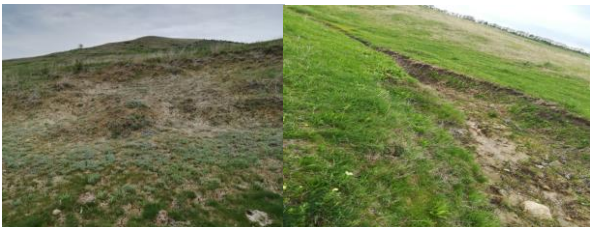
Figure 2 Formation of deep erosion and removed from the agricultural land

The arrangement of the slopes affected by surface erosion, deep erosion and landslides, with hydrotechnical works for leakage control and consolidation, the establishment of meadows and the improvement of degraded lands, contributes to the stabilization and creation of the conditions of evolution of soils, vegetation, biocenoses. ground. These can be transformed into new, balanced and stable biotypes, able to edify ecosystems with their own flora and vegetation, only if the arrangements made in accordance with all the existing ecological conditions and factors, will be maintained permanently and periodically supplemented with specific works (figure 2).
