Slope Assessment Systems: A Review and Evaluation of Current Techniques Used for Cut Slopes in the Mountainous Terrain of West Malaysia

ABSTRACT

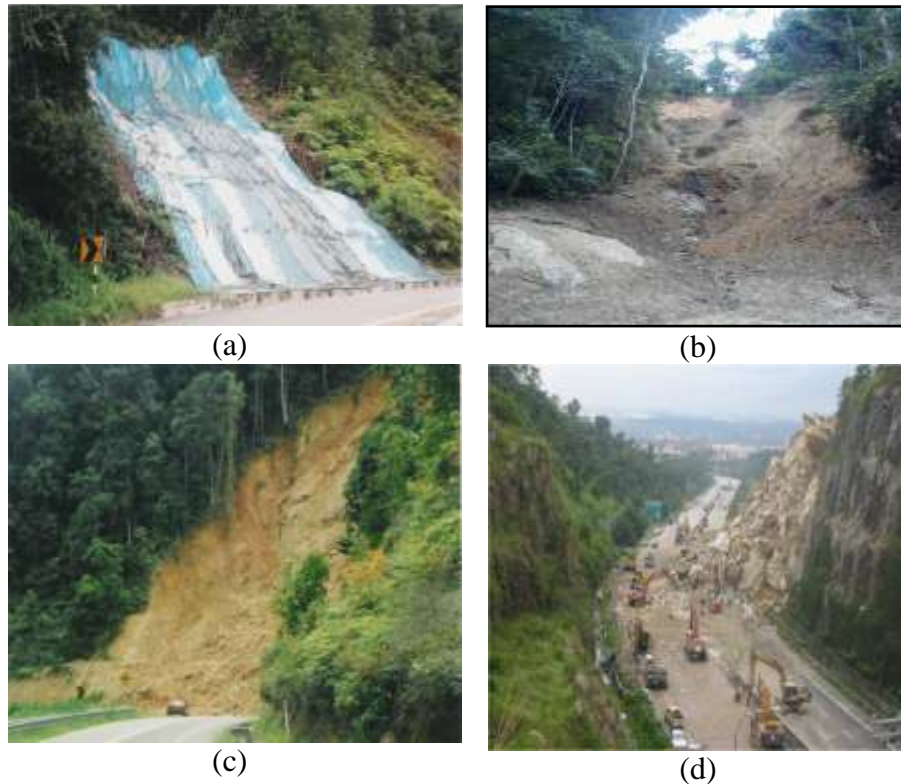
The most common type of landslides in Malaysia is the shallow slide where the slide surface is usually less than 4 m deep and occurs during or immediately after intense rainfall (Ali Jawaaid, 2000). These slides commonly occur in the residual soils mantles of grade V and grade VI according to the commonly used classification systems of Little (1969). Other types of landslides found are deep-seated slides, debris flow and geologically controlled failures such as wedge failures and rock fall. A slide is defined as the downward displacement or soil (or rock) sliding along one or more failure surfaces, rotational for the case of few units; translational for the case of many units (Varnes, 1978). Flows consist of the movement of slurry of soil and loose rocks down slope in a manner analogous to a viscous fluid. Falls are incidence of masses of rocks detaching from a steep slope and descending by free fall, rolling or bouncing. Figure 1 depicts some common landslide types found in Malaysia.

Figure 1: Some common types of landslides in Malaysia (a) Shallow slide, (b) Debris flow, (c) Deep seated slide (d) Rock fall.
