*Published in:*  
Proceedings of EuroCorr 2014

# Contamination profile of Printed Circuit Board Assemblies in relation to soldering types and conformal coating

*Hélène Conseil, Morten S. Jellesen, Rajan Ambat  
Materials and Surface Engineering, Department of Mechanical Engineering,  
Technical University of Denmark, Hélène Conseil  
Building 425, Kongens Lyngby, Denmark, helco@mek.dtu.dk*

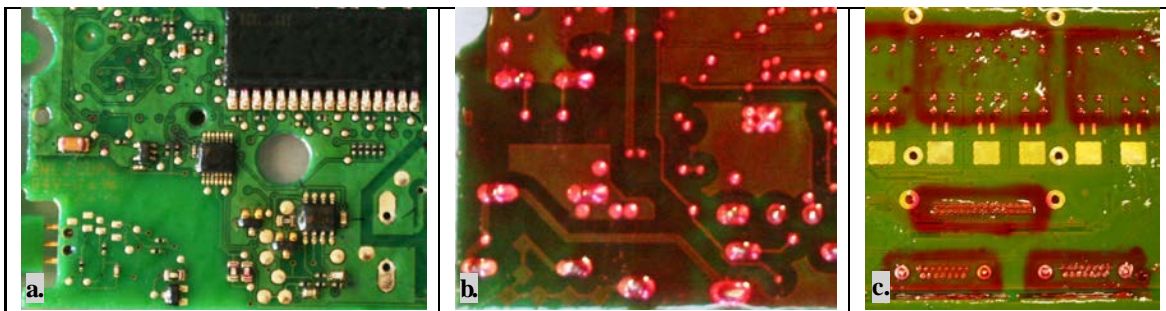
As shown in Fig. 1a, reflow soldered PCBAs in general did not show any red coloration indicative of the absence of residues. On the other hand, PCBAs that have undergone wave and selective soldering process have shown intense colour change including clear indication of the mark of pallet used in the case of selective soldering (Fig. 1b and 1c). The red coloration in both cases indicates the presence of high levels of flux residue.

**Figure 1:** Residues RAT gel test on a) reflow, b) wave and c) selective wave soldered PCBs

Figure 1 shows partial images of typical PCBAs tested with Residue RAT, revealing the localized contaminations on the PCBA surface as a function of involved soldering process. The patented Residues RAT gel makes use of pH change due to the presence of acid in the flux residue to reveal the colour change in an optimized manner [7].

While red coloration was seen all over the surface of the wave soldered PCBAs (Fig. 1b) (although only part of it is shown), selective soldered PCBAs showed residues only over a selected area depending on the application procedure (Fig. 1c).

The observation can be explained by the type of flux application in different soldering process.

For reflow soldering process, the use of flux in the form of paste and screen printing process limit the location of residues only to the localized areas, for example very close to or under the components.

Although only few PCBAs are shown in Figure 1, the results shown here represent typical levels of residues found based on the test carried out on a large number of PCBAs with various designs and three soldering process. Therefore the results are applicable as a relative comparison between the cleanliness levels of various soldering process using no-clean flux systems.

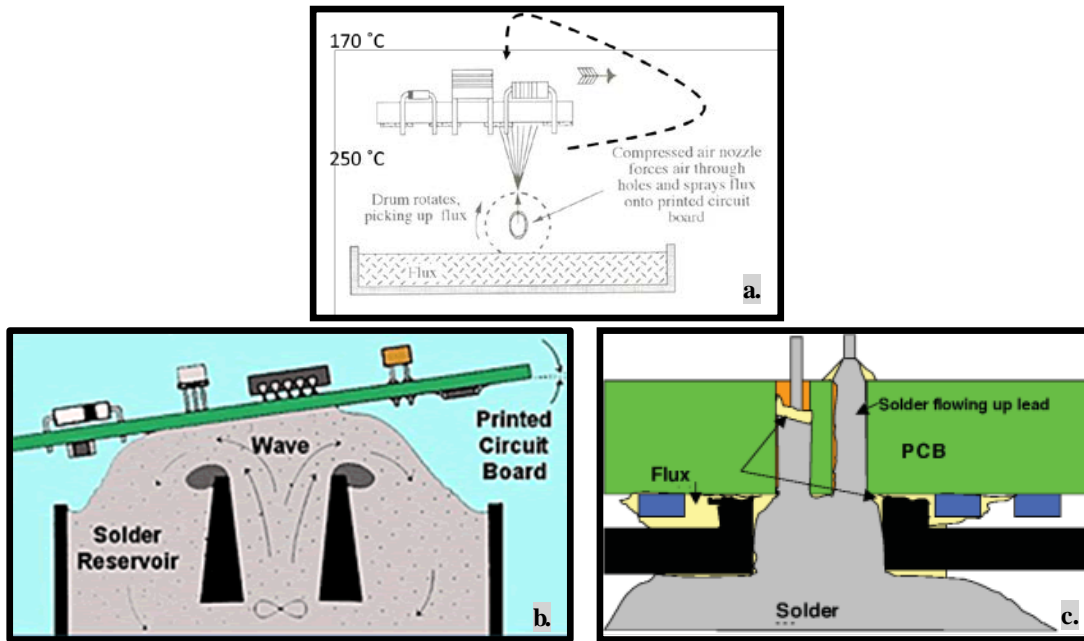
**Figure 2** : Schematics of a) flux spraying at the bottom of the PCB to remove oxide on the through hole component leads and solder pad [10], b) through hole assembled PCB passing through the molten solder wave [11] and c) selective wave soldering process using a pallet [12]

In wave and selective soldering process, the flux is sprayed onto the bottom side of the PCBA, therefore resulting in wider distribution of flux on the surface. A large number of droplets can be left on the top of the PCBA, through via-holes, and the difference in the temperature of the top and bottom parts of the PCBA during soldering could introduce higher amounts of residue on the top part, where the temperature reaches only up to 170 °C (Figure 3 a and b).

In the case of selective wave soldering process, flux can be sweep under the pallet, and these trapped residues are not exposed to a sufficient temperature to be degraded (Figure 3 c).

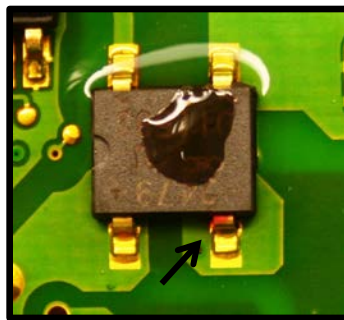
Reflow soldering flux residue can be concealed initially due to the presence of the binder and the resin part of the flux, and WOA may not be immediately released [10]. Fig. 3 shows the residue RAT gel test of the reflowed PCB after five cycles of water spraying following by slow drying under an UV light in order to open up the residues. It can be seen that after this treatment a small red spot appears under the component, showing the release of WOA. The residues were found to be concealed initially and require heavy exposure to humidity for opening up [13].

**Figure 3**: Residues RAT gel test on reflow soldered PCBA after severe humidity exposure

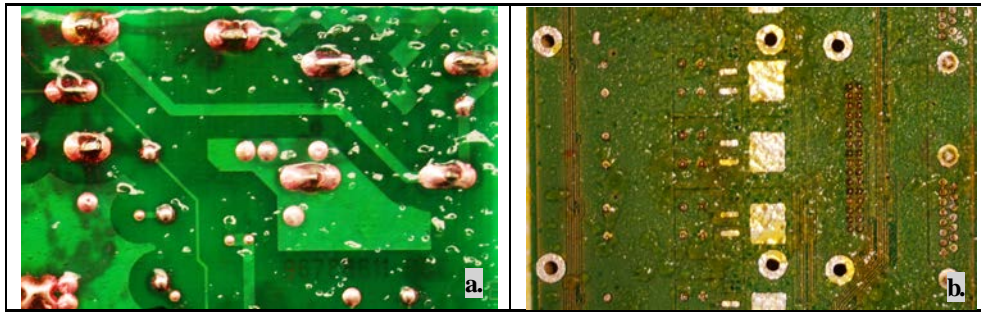
Fig. 3 shows images of Residue RAT gel test, of a typical wave and selective soldered PCBAs similar to the ones shown above in Figures 1b and 1c, however, after a simple cleaning process, by rinsing with a solution of Isopropyl alcohol and Millipore water at 3:1 ratio and scrubbing with a soft tissue, and rinsed again with the same solution to avoid any additional contaminations from the tissue. It is clearly showed that the acid residues are decreased, however little residues were found at some localized regions.

**Figure 4:** Residues RAT gel test on cleaned a) wave soldered PCBAs and b) selective wave soldered PCBAs

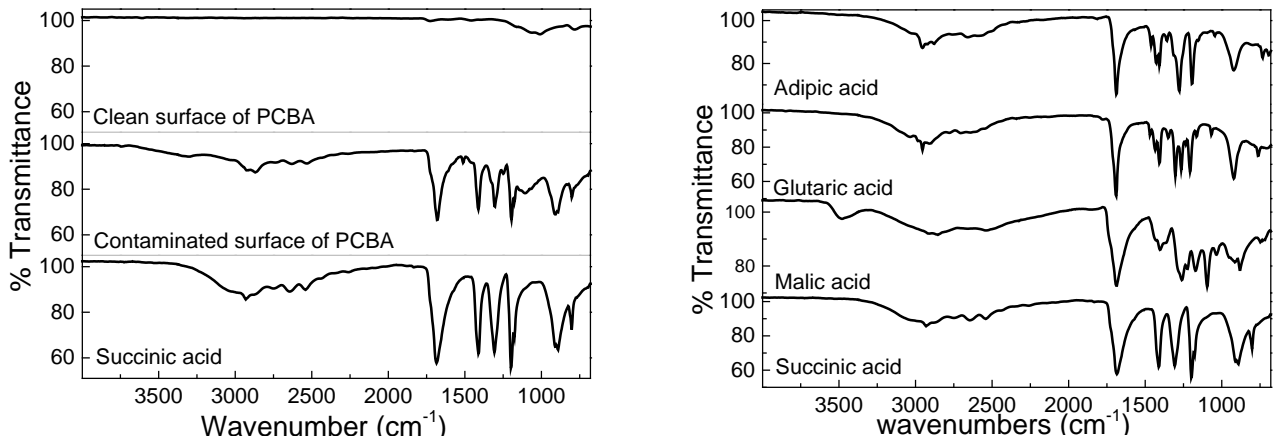
In order to confirm that the contamination revealed by the residue RAT gel corresponds to flux residue, FTIR analysis were performed directly at the contaminated area on the PCBA surface, using a microscopic IR spectrophotometer with ATR. Typical spectra shown in Fig. 5a, clearly show that the chemistry of the contaminated area of the PCBA of the Fig. 3. a. corresponds to weak organic acid (succinic acid in this case), the active part of the flux systems. Similar evaluations of PCBAs showed such acids (Fig.5b).

**Figure 5:** FTIR spectra on the surface a) of wave soldered PCBA and b) of typical contamination found on the surfaces of WOAs

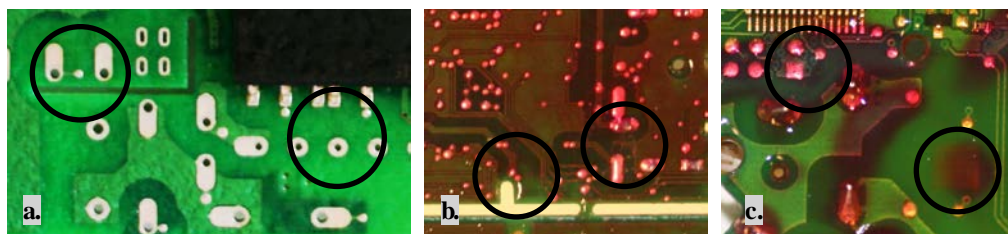
**Figure 6:** Selected areas for optical microscope pictures, of a) reflow b) wave and c) selective wave soldered and coated PCBs

Performance of the conformal coating on the contaminated PCBAs were evaluated by exposure to  $40 \text{ }^\circ\text{C}$  and 98% RH for 3 weeks, and by observing the change in morphology of the coating due to blister formation. Only typical results before and after exposure to humidity are shown in Fig. 7-9, and for comparison of the initial level of contamination, Figure 6 consists of Residue RAT tested surface of same PCBAs with circles showing examined area for blisters. Fig. 8 and 9 also show the results for cleaned PCBAs which are conformal coated and tested.

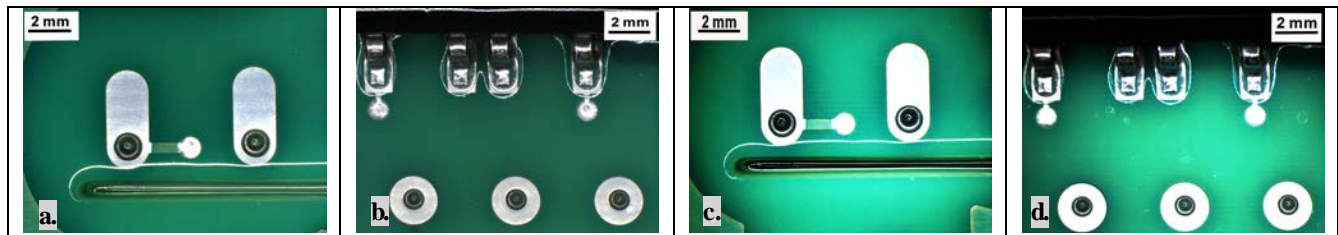
**Figure 7:** Optical microscope pictures of reflow soldered and coated PCB, a) b) before and c) d) after 3 weeks exposure to saturated humid

Results show that the conformal coating on reflow soldered PCBA remained unaffected during the three weeks of exposure (Fig. 7) (no blisters were found on the surface). But on wave and selective soldered PCBAs (Fig. 8 and 9), the conformal coating showed signs of deterioration and the majority of the blisters appeared at the same areas where a high level of contaminations were found by the Residue Rat testing. It clearly indicated that the excessive levels of contamination could introduce problems for conformal coating under humid conditions. This is expected, as the ionic contaminants under the coating will influence the water transport through the coating due to osmotic pressure, while the adhesion of the coating is affected by the contamination at the interface [14-16].

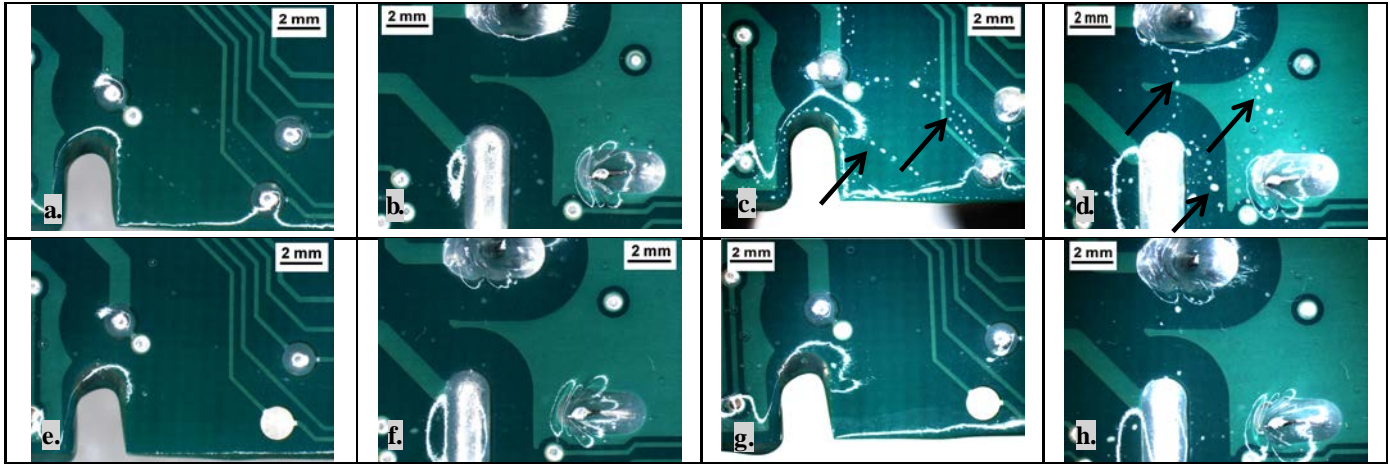
**Figure 8:** Optical microscope pictures of as received wave soldered and coated PCB, a) b) before and c) d) after 3 weeks exposure to saturated humid, and cleaned wave soldered and coated PCB, e) f) before and g) h) after 3 weeks exposure to saturated humid

However, in both cases, cleaning of the PCBA has enhanced the performance of the conformal coating, indicating a direct relation between the contamination and the blister formation.

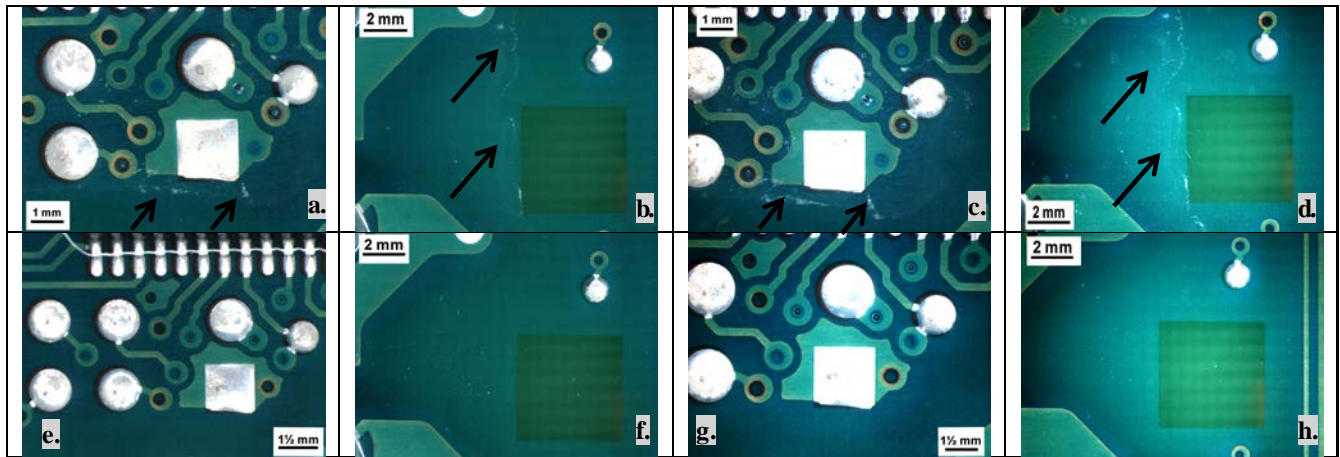
**Figure 9:** Optical microscope pictures of as received selective wave soldered and coated PCB a) b) before and c) d) after 3 weeks exposure to saturated humid, and cleaned selective wave soldered and coated PCB, e) f) before and g) h) after 3 weeks exposure to saturated humid
