Impacts of Landfill Disposal of Construction and Demolition Waste (CDW)

Abstract Growing population, industrialization and infrastructure development have resulted in enormous waste generation over the past decades. The disposal of vast amounts of waste remains a major challenge. However, in the globalized world recycling has become a main option for managing wastes while in other parts of the globe, landfilling is resorted to because of waste handling difficulties. South Africa is one of many countries where landfilling activities is high, as roughly 75 % of daily generated solid waste is disposed in landfills. This includes massive amounts of construction and demolition wastes (CDW) from reconstruction and development activities. South Africa depends on landfilling as a system of waste management which in the foreseeable future would linger on till feasible recycling options are initiated. Consequentially, the generation and seepage of leachate into soil, ground and surface water reserves is probable in such dump sites due to exposure of the waste bodies to rain and run-off water. A bespoke device was used in the study to investigate the impacts of disposing CDW in open dumps wi

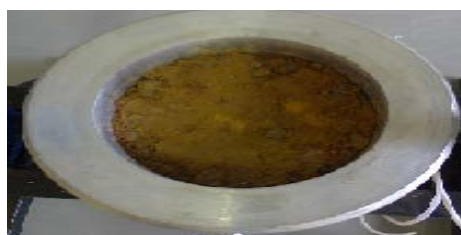
Figure 3 Thin soil layer overlying the CDW fitted in the bucket section as used in the study

The sizeable CDW with fragmented CCA treated material was fit into the bucket underlying a 20 mm thin layer of lightly rammed clayey soil. The layer of soil prevented a rapid flush out of the influent during the testing process and allowed lasting interaction between the CDW and seeping water to form leachate. The experimental arrangement for the bucket holding the CDW containing fragments of CCA treated materials overlain by the thin layer of soil is shown in Figure 3.

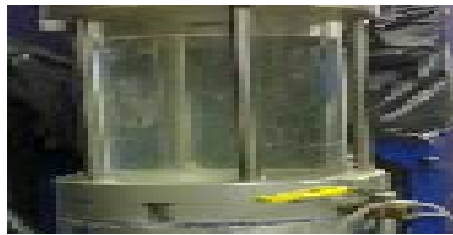
Figure 4 Upper component of the device with de-ionized water in the reservoir as used in the study

ii. the upper component joined to the bucket section called the reservoir; held de-ionized water as influent slowing draining into the waste body (in the bucket section) till leachate was generated, collected as effluent and the concentration of the collected effluent was tested periodically to examine the changes in the targeted toxic contents. The upper component of the assembled device as used in the study is seen in Figure 4.

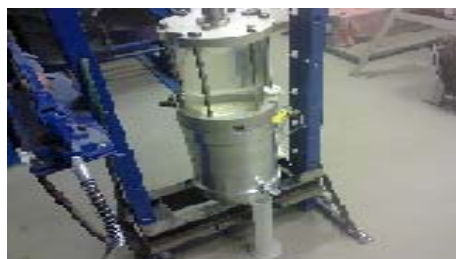
Figure 5 Assemblage testing on CDW using de-ionized water as permeant to generate leachate tested in the study

Considering that CDW would continually be dumped in landfills, studying this scenario will contribute to the interest in waste management by offering a closer understanding of the impacts of disposing these waste types on the environment and the implication on human health. To that effect, two main tests were conducted and recorded herein. Test-X represented the experimental scenario simulating CDW with fragmented CCA treated materials in a landfill whereas Test-Y represented the control scenario with selected CDW with no CCA content. Figure 5 shows the complete assemblage studied herein in room temperature with the testing duration lasting up to 10 days. On the formation and flow-out of leachate, a 50 ml cylinder was used to constantly collect the effluent. Only the pH from the general water quality parameters i.e., dissolved oxygen (DO), conductivity, temperature and oxidation-reduction potential (ORP) was reported in the study since other parameters require more standardized measurements and validation. The measurements in the study were done using a Portable Multi-flex Beckman Century pH/mV/FT/DO-915A-1202-TM SS-1 Meter Model. The laboratory formed leachate were collected as effluents and stored in plastic containers at a temperature of 2°C to prevent microbial and chemical activities. Samples of the effluents were analyzed by full spectral method according [8] and then compared to the South African standard of drinking water.
