Comparative imaging of European eels (*Anguilla anguilla*) for the evaluation of swimbladder nematode (*Anguillicoloides crassus*) infestation

Frisch, K, Davie, A, Schwarz, T & Turnbull, J 2016, 'Comparative imaging of European eels (*Anguilla anguilla*) for the evaluation of swimbladder nematode (*Anguillicoloides crassus*) infestation' *Journal of Fish Diseases*, vol. 38, pp. 635-647. DOI: 10.1111/jfd.12383

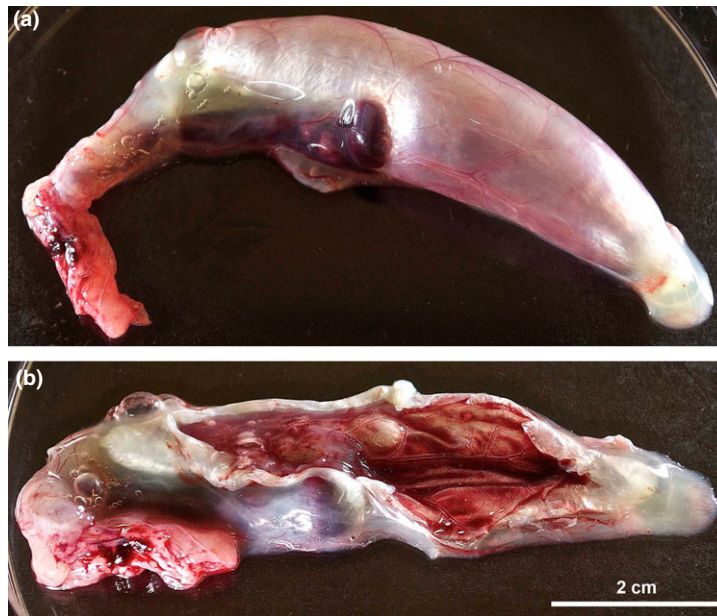
Figure 3 *Anguilla anguilla*, no. 5. (a) Unopened and (b) opened swimbladders dissected from eel in Fig. 1. Wall is transparent and thin walled, and lumen is worm free.

was transparent and thin walled (wall thickness < 1 mm) (Fig. 3).

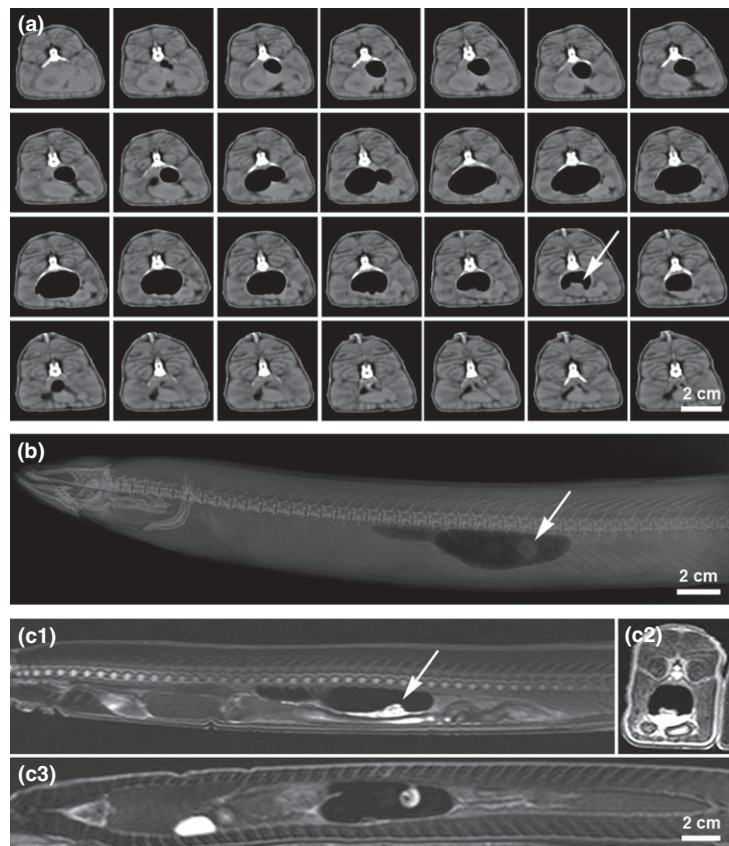
Figure 4 *Anguilla anguilla*, no. 1. (a) Computed tomography showing a clearly discernible swimbladder of a moderately infected eel; segment 20 contains a distinctly visible specimen of *Anguillicoloides crassus* (arrow). (b) Lateral radiograph of the cranial half of the same eel with a distinct radiographic shadow of a coiled worm (arrow). (c1) Lateral, (c2) transverse and (c3) dorsal T2 MRI of the same eel showing a clearly discernible swimbladder containing at least one adult worm in all three views (arrow) and fluid in the lumen.

One of the moderately infected eels (fish no. 1) had a swimbladder that showed contours of worms, a thickened wall and rounded shape of the whole organ on CT (Fig. 4a) and radiographic (Fig. 4b) examination. The MRI images had the

same findings, but also showed fluid in the lumen and the caudal end of the swimbladder to be collapsed and fibrotic (Fig. 4c). The high-end and low-end ultrasound examinations showed no observable anomalies (Fig. 5). On post-mortem examination, the swimbladder wall was slightly thickened (1 mm thickness) in the gas-filled

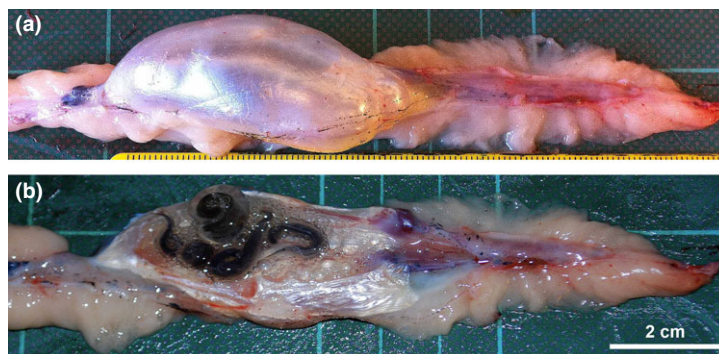
Figure 6 *Anguilla anguilla*, no. 1. (a) Unopened and (b) opened swimbladders dissected from eel in Fig. 4. Wall is opaque and thickened, the caudal end is atrophied (right image side), and the lumen is filled with worms (arrow) and some exudate.
