CLIC Note 680

### A HIGH-GRADIENT TEST OF A 30 GHz MOLYBDENUM-IRIS STRUCTURE

Presented at  
EPAC'06, Edinburgh, UK,  
June 26-30, 2006

# A HIGH-GRADIENT TEST OF A 30 GHZ MOLYBDENUM-IRIS STRUCTURE

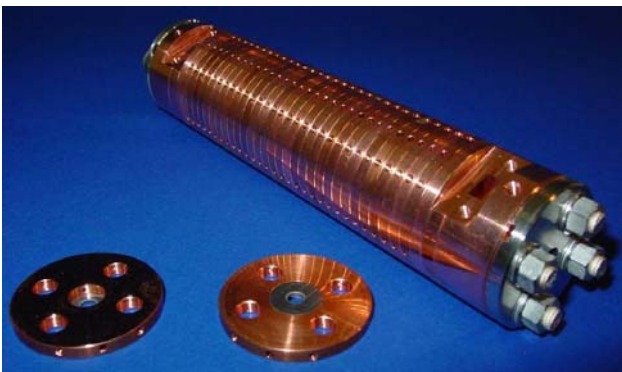
Figure 1: 30 GHz Molybdenum-iris structure.

The CLIC study has been investigating a number of different materials through both rf and dc-spark tests as part of an effort to determine if alternative material to copper can be found which will allow higher accelerating gradients [1, 2]. An initial part of this study was to test a series of identical-geometry 30 GHz structures with Cu, W and Mo irises in CTF2, but limited to 16 ns pulse length [1], and identical-geometry but scaled 11 GHz structures with W and Mo irises at NLCTA [4]. The 30 GHz Mo-iris test has now been repeated with a new but identical structure in the new test stand at CTF3 [3], which has allowed testing to pulse lengths up to and beyond the current CLIC pulse length of 70 ns. Details of the Mo test structure (fig. 1), its design, rf parameters and fabrication method can be found in [1].

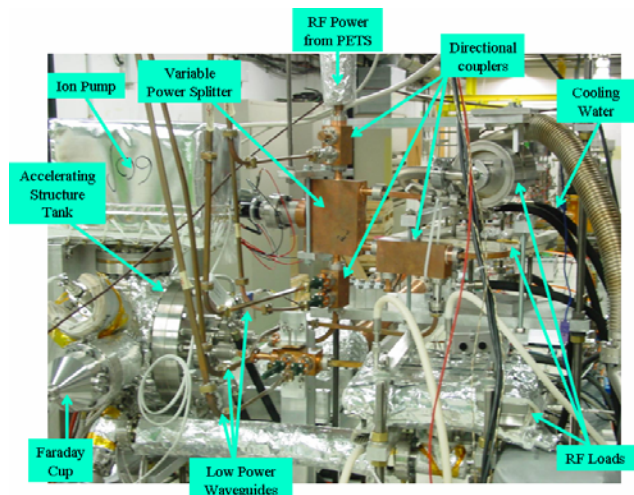
Fig. 2 shows a picture of the test stand including the most relevant diagnostics elements. The rf power coming from the PETS is feed to the accelerating structure after going through a first measurement directional coupler, a variable power splitter and a second directional coupler. The power transmitted through the structure is dissipated in a water cooled load after going through a third directional coupler.

Figure 2: Structure test stand.

Signals picked up by these couplers are down-mixed and digitized. The first coupler is used to measure the power available to test the structure. The percentage of the available power used to test the structure is changed by moving the stepper motor that controls the variable power splitter and it is measured using the second coupler. This coupler is also used to measure the reflected power from the structure while the third is used to measure the transmitted power.

The other important diagnostic elements of the test stand are the Faraday cups located up and down stream of the molybdenum-iris structure. These Faraday cups collect the electron current that makes it through the irises of the structure when a breakdown occurs. That current together with the measured reflected power and the transmitted power (or lack of transmitted power) was used to determine whether or not the structure was able to hold the gradient produced by the rf pulse.

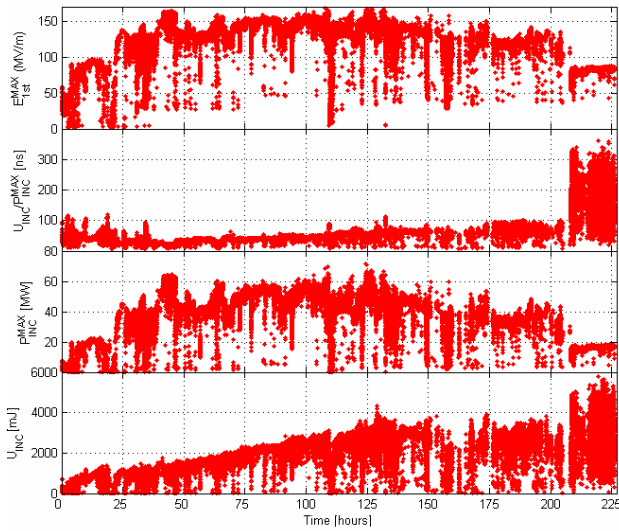
The conditioning history of the structure is shown in fig. 3. The data is plotted as a function of time rather than the number of rf pulses to include periods when rf pulsing was interrupted to allow the system to pump back down after a breakdown. This is an important distinction especially in the early stages of conditioning molybdenum when a significant amount of gas is released during breakdown. Dead times caused by external factors like maintenance and shutdowns of CTF3 have been removed from the data. The structure was conditioned with an rf repetition rate of 10 Hz.

Figure 3: Conditioning history of the structure. From top to bottom are: peak accelerating gradient in the first cell, pulse length (computed as the pulse energy divided by the incident peak power), peak incident power and pulse energy.

The conditioning data shows that the energy of the pulses that the structure was able to hold increased steadily during the first 125-150 hours of conditioning, during which the pulse lengths were kept shorter than 100 ns. The structure conditioning was only interlocked on vacuum level, otherwise it was allowed to break down repeatedly. Despite this rather aggressive conditioning strategy, Mo was again observed to condition very slowly [2, 4].

70 ns pulse length. As a consequence the value is lower than the peak gradient which is plotted in fig. 3.

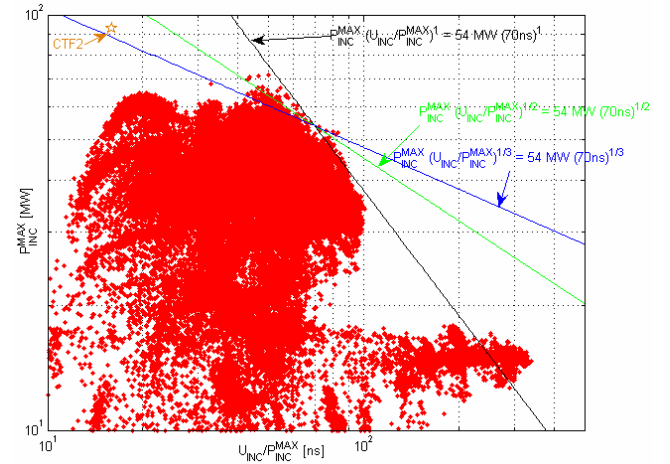
The input power versus pulse length for the entirety of stable rf pulses observed during the conditioning process is plotted in fig. 4. The best point reached in CTF2 with the Mo structure is shown as an orange star, 93 MW and 16 ns. The three lines show plausible pulse length dependencies: constant pulse energy, constant peak power times square root pulse length and constant peak power times cube root pulse length. All three dependencies show that the most recent test achieved as high or higher performance than that performed in CTF2 [1].

Figure 4: Peak power vs. pulse length. The red points were reached with the structure. The available power limited the achievable gradient for short pulses (<60 ns). Breakdowns in the PETS and the transmission line limited the achievable pulse length for low gradient. The region where the limit in achievable gradient was due to the molybdenum structure itself was between 60 and 100 ns.

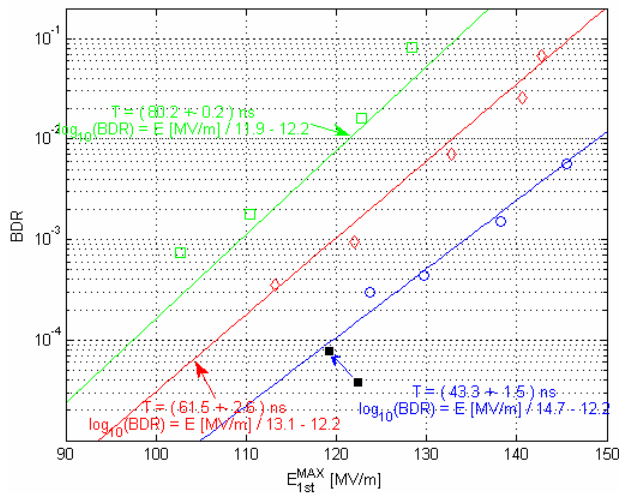
breakdown probability as a function of gradient for different pulse lengths has been measured near the end of the conditioning process, and the data is shown in fig. 5.

Figure 5: Breakdown probability for different pulse lengths.

The data has been fitted with lines that give constant pulse dependence for all breakdown probabilities – which means that the slopes are inversely proportional to the gradient at a fixed breakdown probability. This same inverse proportionality fits well with data of the X-band Mo-iris structure [4].

The data show that a back-off of about 40% is needed to go from the conditioning gradient to the gradient which gives a breakdown rate of the order of  $10^{-6}$ . The breakdown rate slope appears to be lower by a factor of two than for copper NLC structures [5]. Some possible causes for the lower slope, and consequently larger required back-off, have been identified: the slope is material dependent, the slope is material purity or preparation dependent, the low slope of the Mo iris structure is a consequence of assembly by clamping, or the slope is a consequence of the rather extreme surface state created during conditioning (discussed in the next section). A clear priority for the CLIC high gradient testing program is to determine the origin of this lower slope. A consequence may be that although higher conditioning gradients can be achieved with Mo than with Cu, at low breakdown rates the advantage from Mo may be small or non-existent.

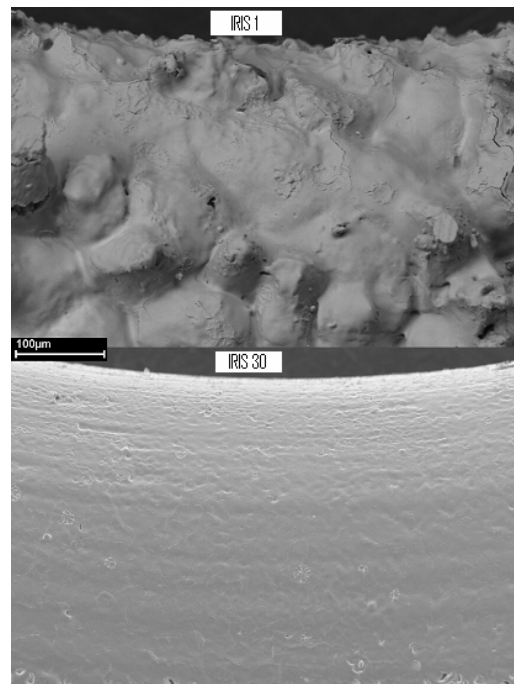
The irises and cells were systematically inspected at the end of the experiment and scanning electron microscope (SEM) images of the first and last irises of the structure are shown in fig. 6. SEM images of previously tested Mo

irises can be found in [4]. The first iris shows dramatic re-melting and a modified surface while the last iris shows re-melting but with little change to its shape.

Figure 6: SEM picture of the first and last iris.

It is not known when during the tests the surfaces were modified. The surface modification may be due to an excessively aggressive conditioning strategy (which was adopted to speed the slow conditioning of Mo), it may have occurred only during the period when the structure was conditioned and the gradient did not improve or it may only have occurred at the longest pulse lengths. These questions will be addressed in the future tests.
