# OPERATIONAL EXPERIENCE WITH FIRST CIRCULATING BEAM IN THE LHC

Mike Lamont, Reyes Alemany-Fernandez, Roger Bailey, Paul Collier, Brennan Goddard, Verena Kain, Alick Macpherson, Laurette Ponce, Stefano Redaelli, Walter Venturini Delsolaro, Jorg Wenninger CERN, Geneva, Switzerland – on behalf of the LHC beam commissioning team

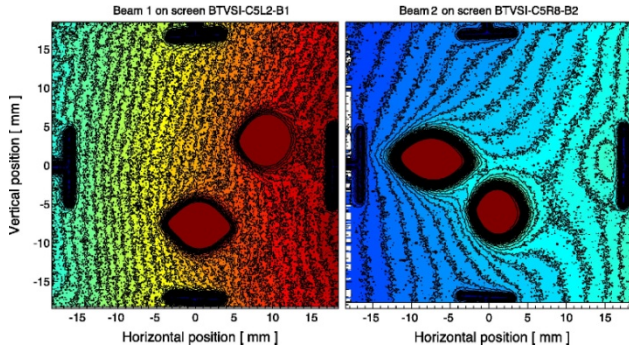
The BTV screen images of the first turns achieved for B1 (left) and B2 (right) are shown in Fig. 1. These acquisitions were taken at 10:26 and 15:00 of Sep. 10th,

respectively. The aluminium screens of the injection region were left into the beam during the beam threading and, after all the collimators were opened, they recorded the image of the injected beam and of the same beam after 1 turn, i.e. after 89  $\mu$ s. It was possible to record up to 4 turns on these screens. The screens were then removed from the beam path to proceed with the establishment of circulating beam, which relied of the measurements from the BPM and BLM systems.

Figure 1: Beam screen (BTV) acquisitions that illustrate the very first turn of B1 (left) and B2 (right).

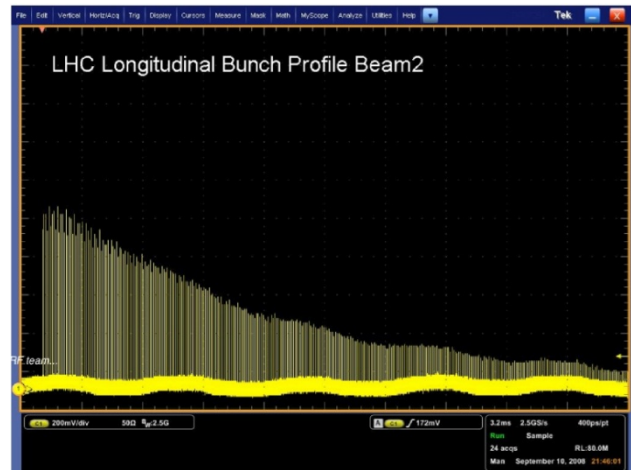
Figure 2: Longitudinal beam profile of the circulating, un-captured B2. Each vertical line represent one turn. Courtesy of RF team.

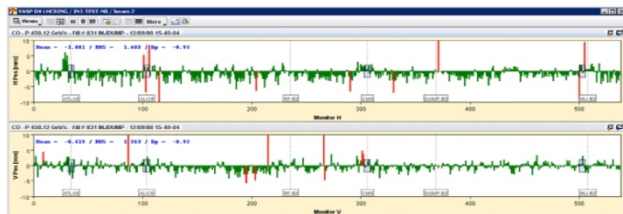
The best reference closed-orbit, established after beam capture, is shown in Fig. 3. The horizontal RMS orbit was 1.6 mm and the vertical was 1.3 mm. These were achieved by using a limited number of correctors. The analysis of the residual orbit suggests that by using more correctors one could easily improve the RMS errors by a factor 3-5 [6].

Figure 3: Best B2 closed-orbit as established on Friday 12th. Faulty monitors (red) are disregarded for the RMS calculation.

Note that the horizontal offset for the captured beam has an offset of about -1.2 mm due to the energy mismatch discussed below.
