IOP Conf. Series: Earth and Environmental Science 789 (2021) 012021 doi:10.1088/1755-1315/789/1/012021

Getting into hot water: Water quality in tropical lakes in relation to their utilisation

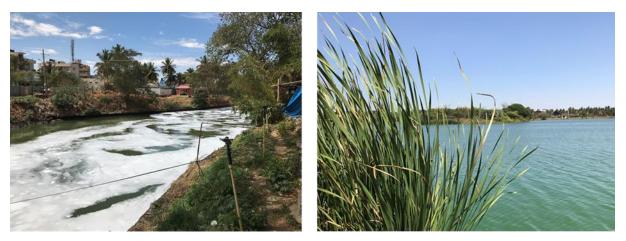
Figure 4. Bellandur Lake (left) and Jakkur Lake (right)

Bellandur Lake is the largest lake in Bangalore and was constructed, about 130 years ago, in a relatively undeveloped part of what is now Bangalore city. Originally, its waters were clear and it was full of wildlife [43]. However, as the city expanded, it became surrounded by urban development and its natural water supply was disrupted [43]. Although originally covering about 329 ha., weed growth and siltation have reduced its area to about 154 ha. [42] and its volume to about 6,786 x 10^3 m³. It has a water retention time of 30 days. Although Bellandur Lake still receives some runoff from rain (859 mm y⁻¹) falling over its 148 km² catchment, its main hydrological input comes from approximately 300 Megalitres per day [MLD] of waste water (mainly sewage) that is discharged into it from Bangalore city. As a result, the lake is heavily polluted – a problem that led to foam on the surface of the lake catching fire and burning for several hours in May 2015 [43].

Jakkur Lake is situated in north-eastern Bangalore. It covers an area of 55 ha. and has an estimated volume of 894 x 10^3 m³ and a water retention time of about 90 days. The lake has three inlets and two outlets, and there is a waste water treatment plant close to its main inlet. This feeds into an algal pond (5 ha.), fringed with macrophytes, through which secondarily treated (15 MLD) and untreated (0.01 MLD) wastewaters enter the lake [44].

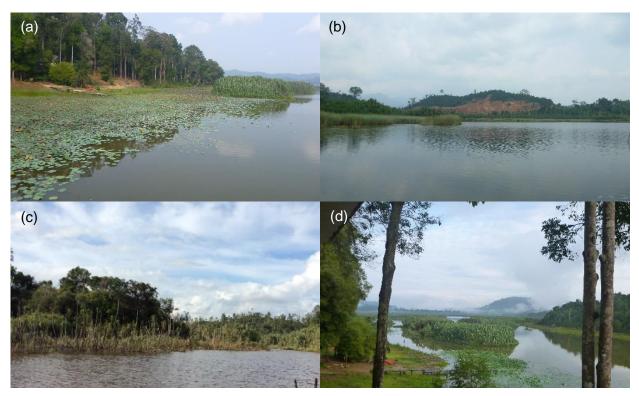
Figure 6. Tasik Chini, Malaysia, showing (a) Hydrosere of secondary dipterocarp forest, sedge at the lake margins, and floating vegetation, (b) evidence of local mining activity (c) marginal vegetation and (d) overview of Tasik Chini from the tourist hotel.

2.5.1. Background. Tasik Chini is a rare example of a flood pulse wetland in Malaysia. It comprises many different types of wetland habitat (Figure 6) and lies within an area that has a humid tropical climate and an average rainfall of 2,500 mm y⁻¹ [77]. The lake, itself, comprises about 2 km² of open water that has a maximum depth of 2.7 m and is surrounded by 7 km² of freshwater swamp and swamp forest. The catchment of Tasik Chini covers an area of about 50 km² that comprises low hills and undulating land with a maximum elevation 641 m.a.s.l. This includes the Tasik Chini State Park Forest Reserve, which consists mainly of tropical rainforest.
