Loaxahatchee Impoundment Landscape Assessment (LILA): Tree Island Experiments and Management; May 1, 2005 to September 4, 2009: Final Report

Final Report Contract RS-050962-A02

**Loaxahatchee Impoundment Landscape Assessment (LILA):
Tree Island Experiments and Management
May 1, 2005 to September 4, 2009**

Leonard J. Scinto, René Price, and Mike Ross.
Southeast Environmental Research Center and Department of Earth and Environment
Florida International University, Miami, FL 33199
(305)-348-1965 (ph), (305)-348-4096 (fax) scintol@fiu.edu

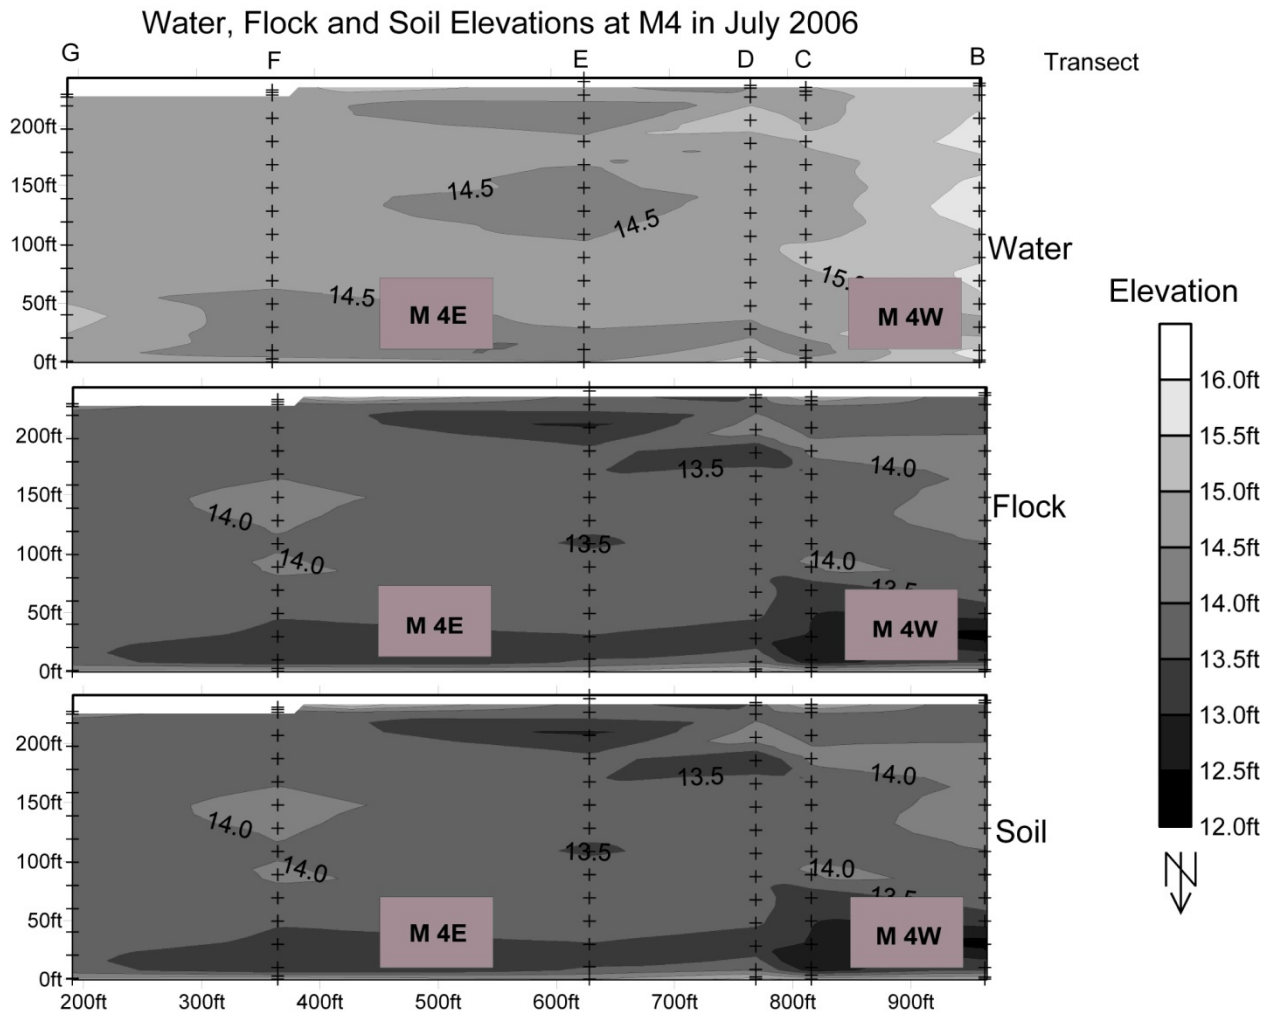
Figure 5.8. Elevations in feet of water level and top of flock and soil in M4 on July 2006.

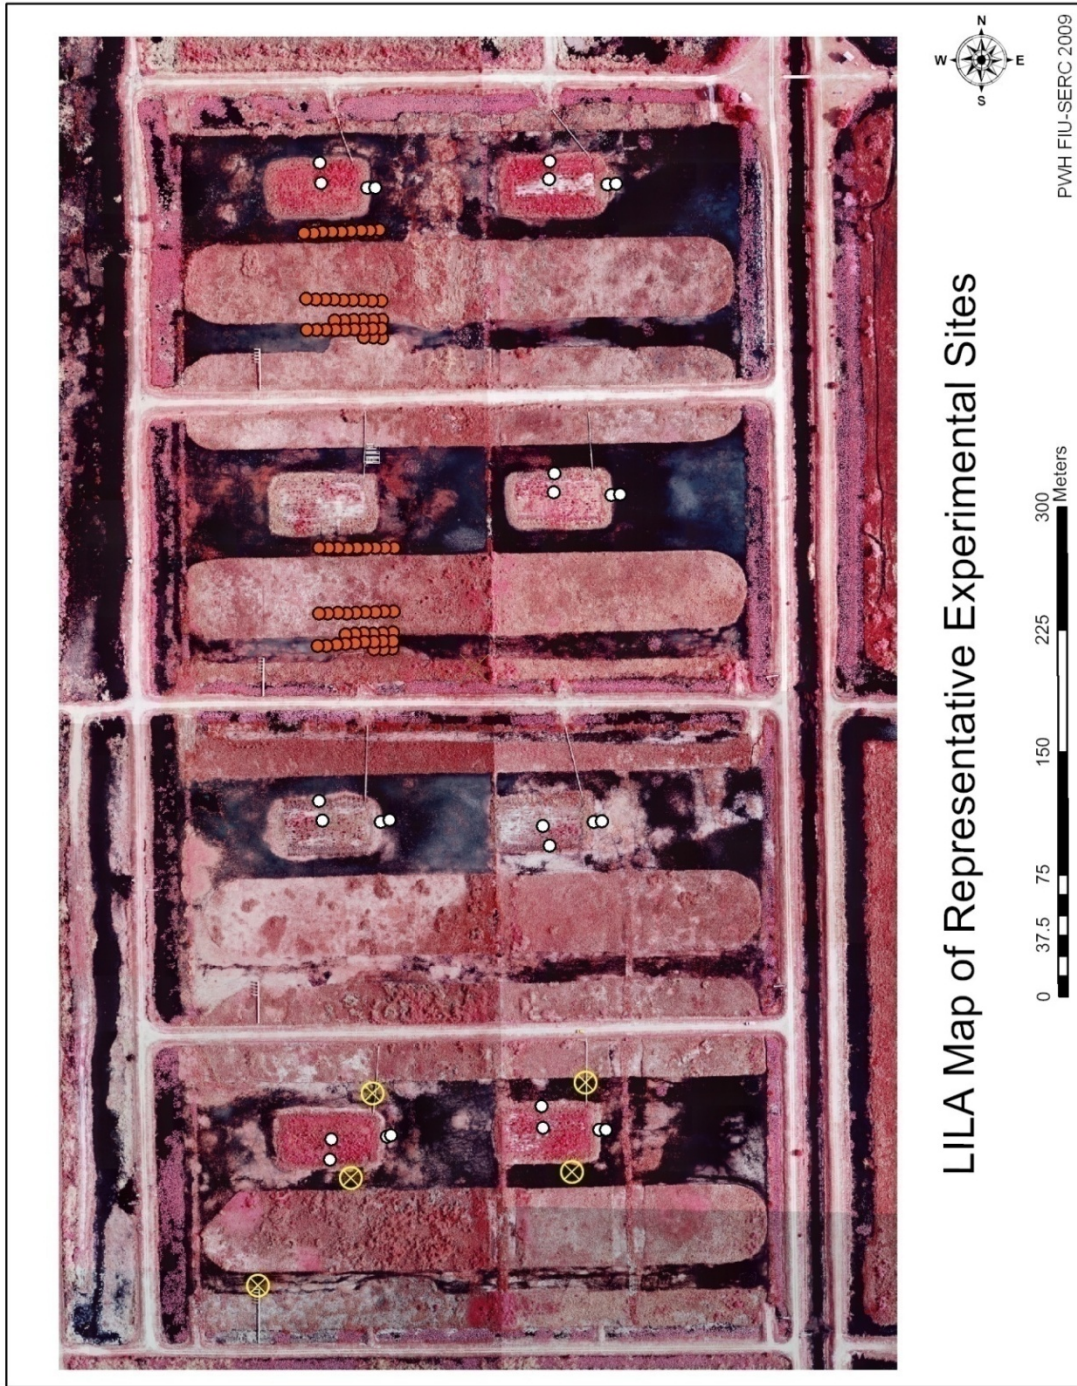
Figure 5.15. 2008 aerial photograph showing locations of the tree island SETs (white circles), the RAST plots (orange circles) and the locations of the 2008 M4 water velocity dye sampling points (yellow crossed circles).

The development of our GIS overlay database has made it possible to spatially locate field plots, major instrumentation, and other “sensitive” areas. This serves several purposes, including preventing others from walking on or otherwise degrading a research plot, identifying past manipulations e.g. transplanted vegetation plots, nutrient additions, to explain possible future anomalies, and ultimately to link data in a visual, spatial way. For instance, periodic measures of sedimentation and erosion table (SET) data can be linked as an attribute table allowing anyone to bring up past data by selecting the point on the GIS overlay. Figure 5.15 shows the 2008 aerial photograph with the spatial locations of three experiments; the tree island SETs (white circles), the RAST plots (orange circles) and the locations of the 2008 M4 water velocity dye sampling points (yellow crossed circles).

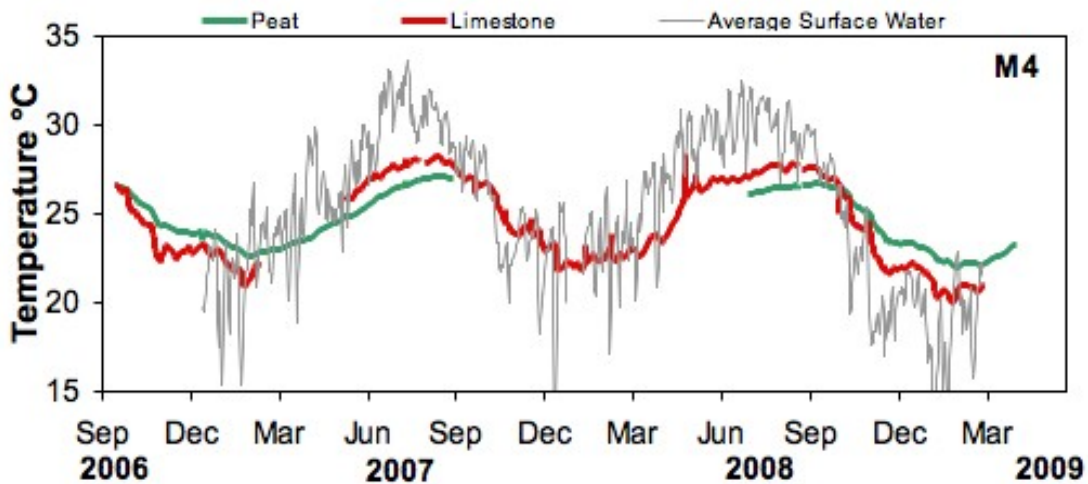
Figure 6.3.2.1.4. Daily average surface water temperature (gray) and hourly average groundwater temperature for the center of the peat (green) and limestone (red) based tree islands in macrocosm 4 from September 2006 to March 2009.

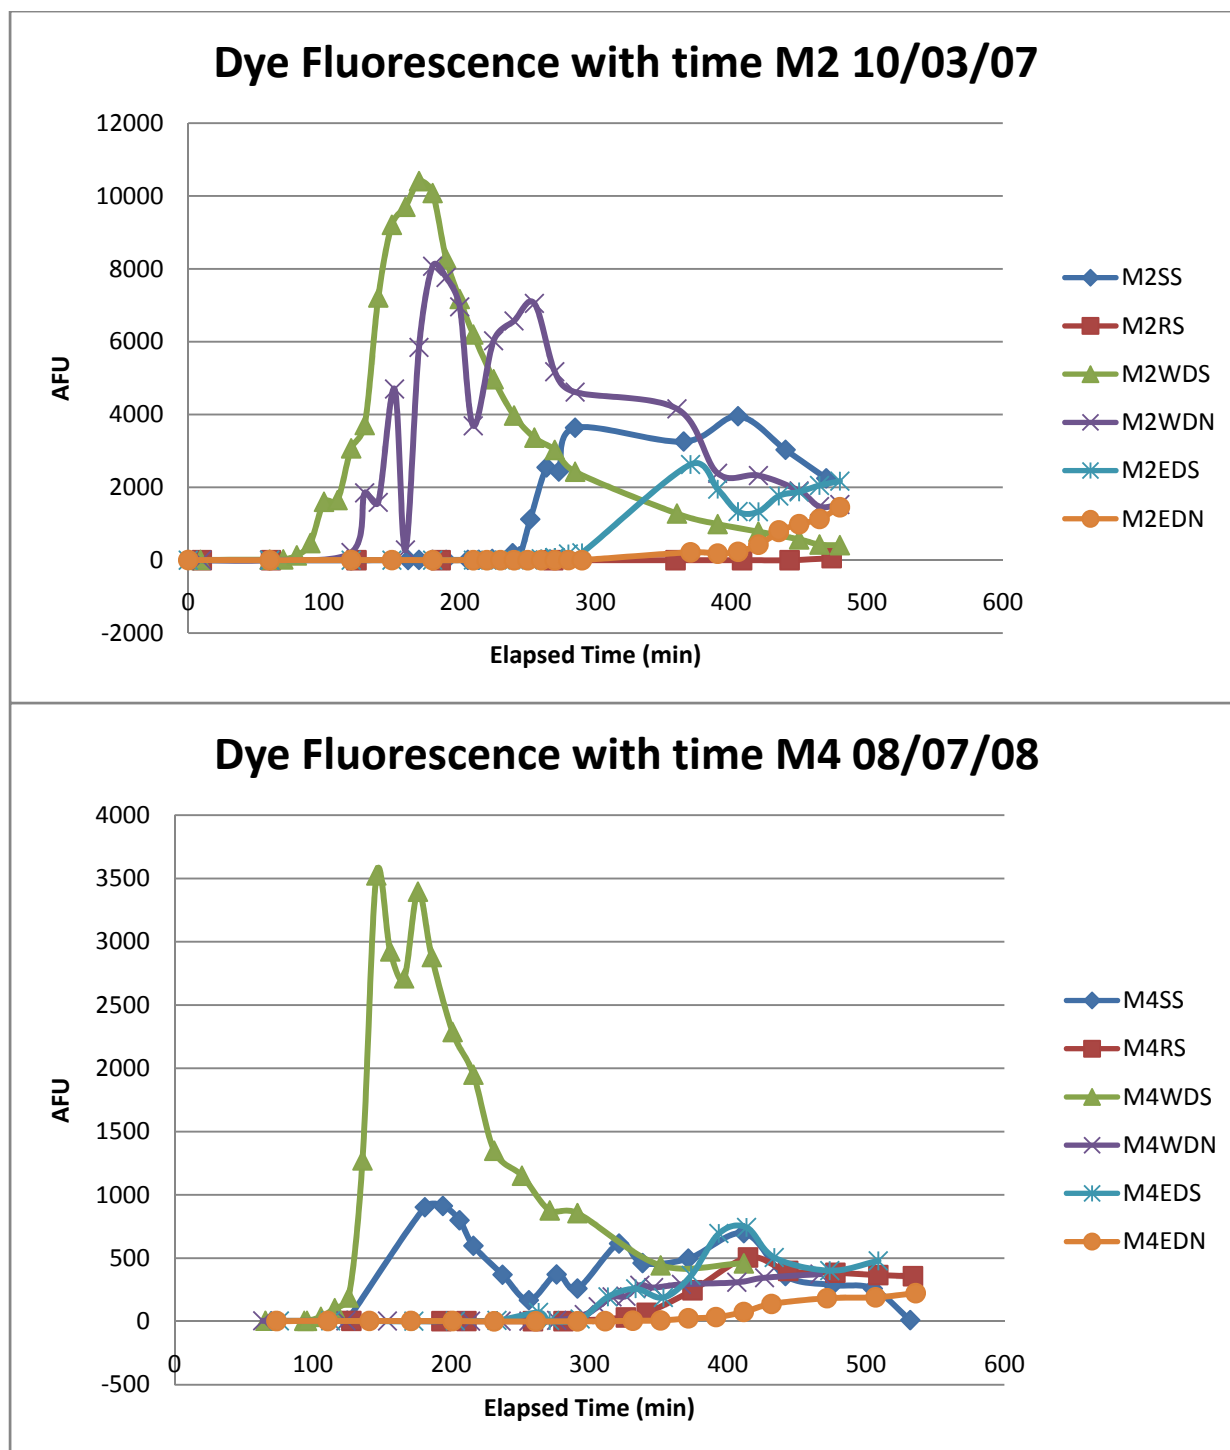
Figure 8.1. Analyzed fluorescence units (AFU) of Rhodamine dyes in dye tests of LILA mesocosms M2 and M4.

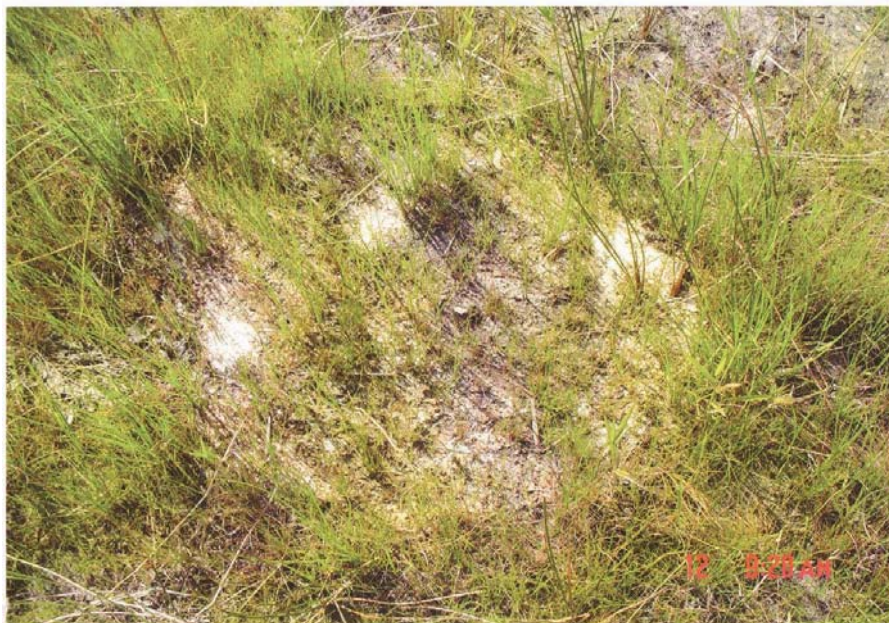
Figure 8.5. Degraded remains of a feldspar marker within a few months of placement. By six months these markers could not be located.
