THE EFFECT OF FULL-CONTOUR Y-TZP CERAMIC SURFACE ROUGHNESS ON
THE WEAR OF BOVINE ENAMEL AND SYNTHETIC HYDROXYAPATITE:
AN IN-VITRO STUDY

Submitted to the Graduate Faculty of the School of
Dentistry in partial fulfillment of the requirements
for the degree of Master of Science in Dentistry,
Indiana University School of Dentistry, December 2011.

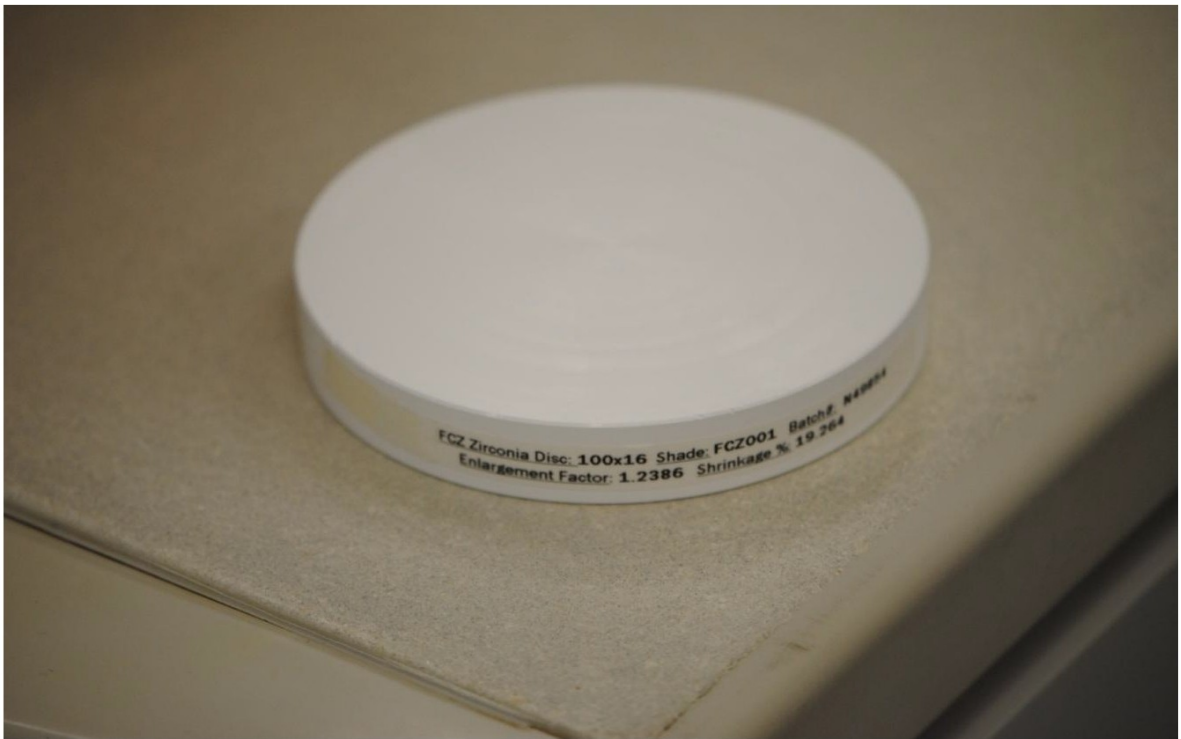
FIGURE 1. FCZ zirconia disk as provided by the manufacturer (Ardent Dental Inc., NY) to be cut into blocks for further milling with the CAD/CAM milling unit.

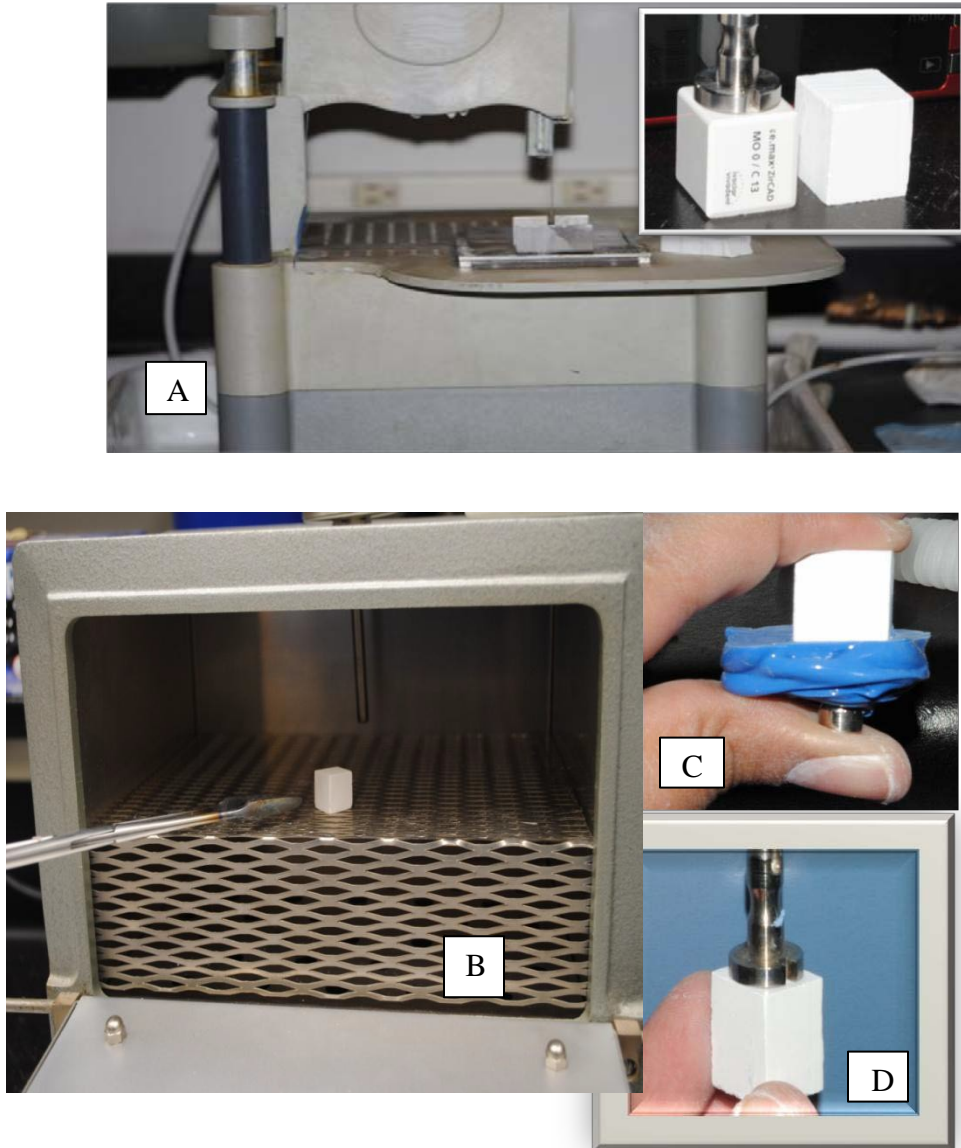
FIGURE 2. Zirconia blocks preparation steps for CAD/CAM milling. A) Cutting band saw used for zirconia block sectioning (inset represents the prepared block adjacent to a premade Zir-Cad sample from Ivoclar-Vivadent. B) Furnace used for moisture removal. C) Jig used to attach the CAD/CAM pin to the zirconia sample, and D) Specimen ready to be inserted in the CAD/CAM milling unit.

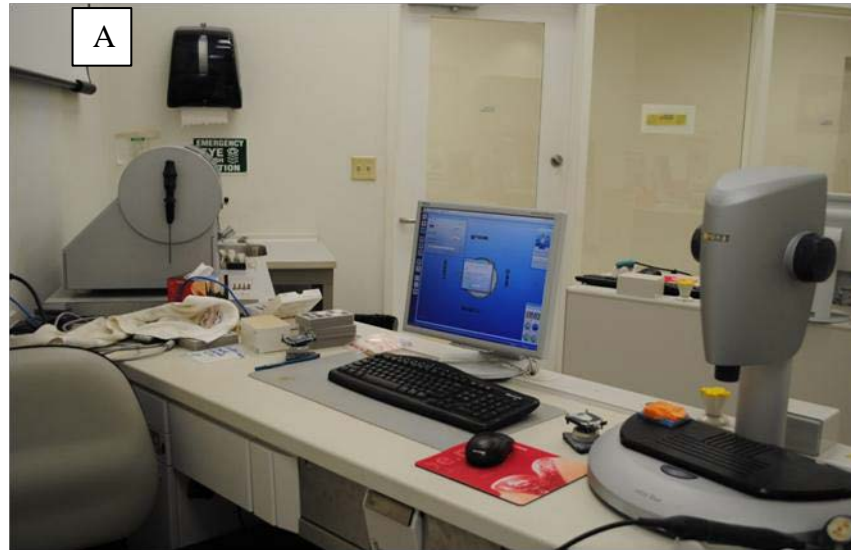
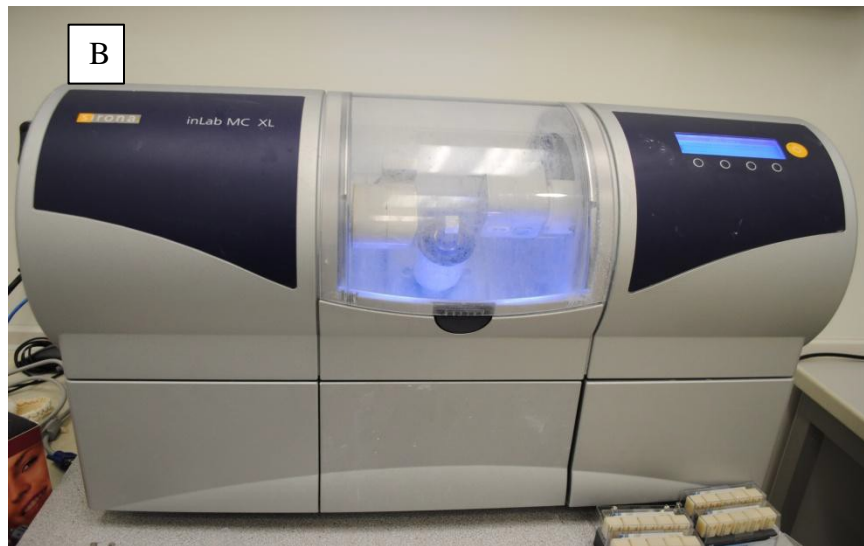
FIGURE 3. CAD/CAM milling facility at Ivoclar-Vivadent labs, Buffalo, NY. A) Computer, scanner, and software required for scanning and designing a restoration. B) The milling unit used for sample preparation according to the computer design.

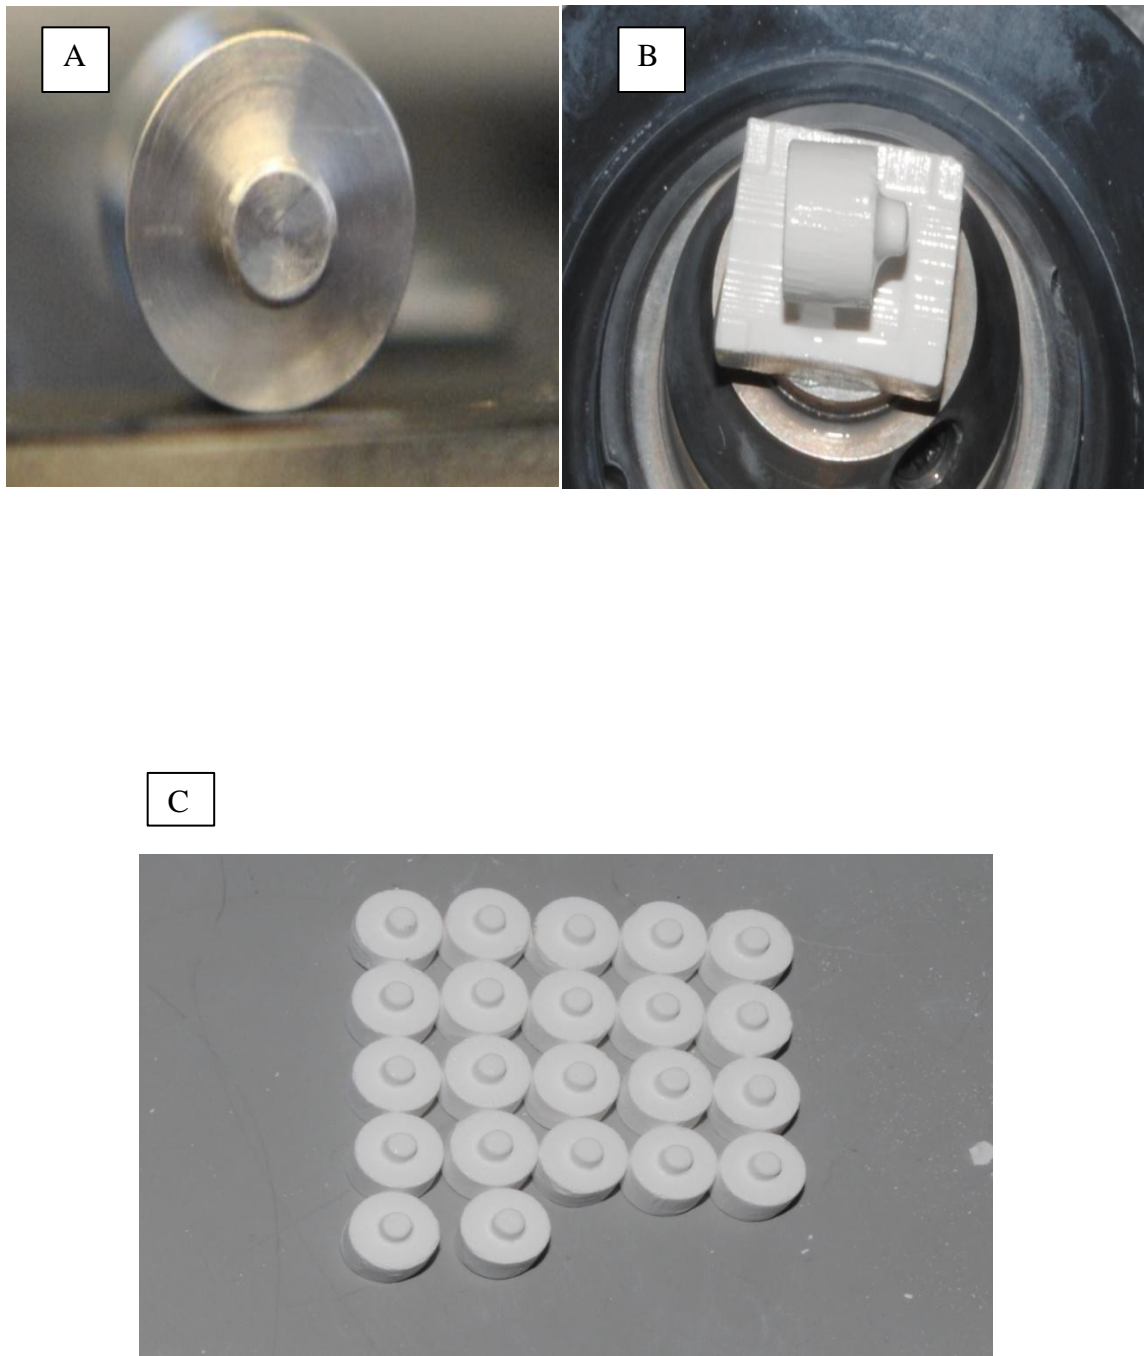
FIGURE 4. Zirconia sliders fabrication using CAD/CAM machine. A) Metal pattern prepared to be scanned by the CAD/CAM machine. B) The zirconia samples milled by the machine according to the scanned metal pattern. C) Zirconia specimens ready to be sintered.

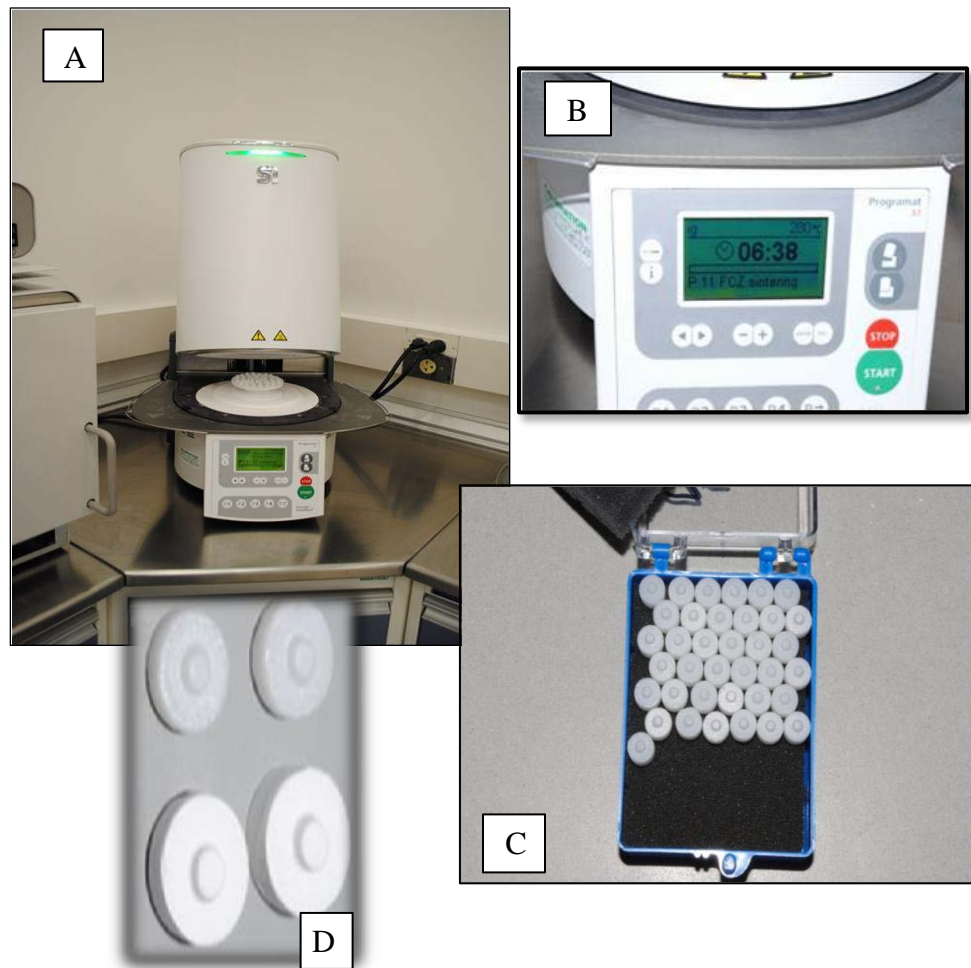
FIGURE 5. Sintering. A) Sintering furnace used. B) Sintering furnace screen showing sintering parameters. C) Fully sintered zirconia sliders. D) Zirconia shrinkage after sintering. The upper samples are fully sintered compared with the lower samples, which are not.

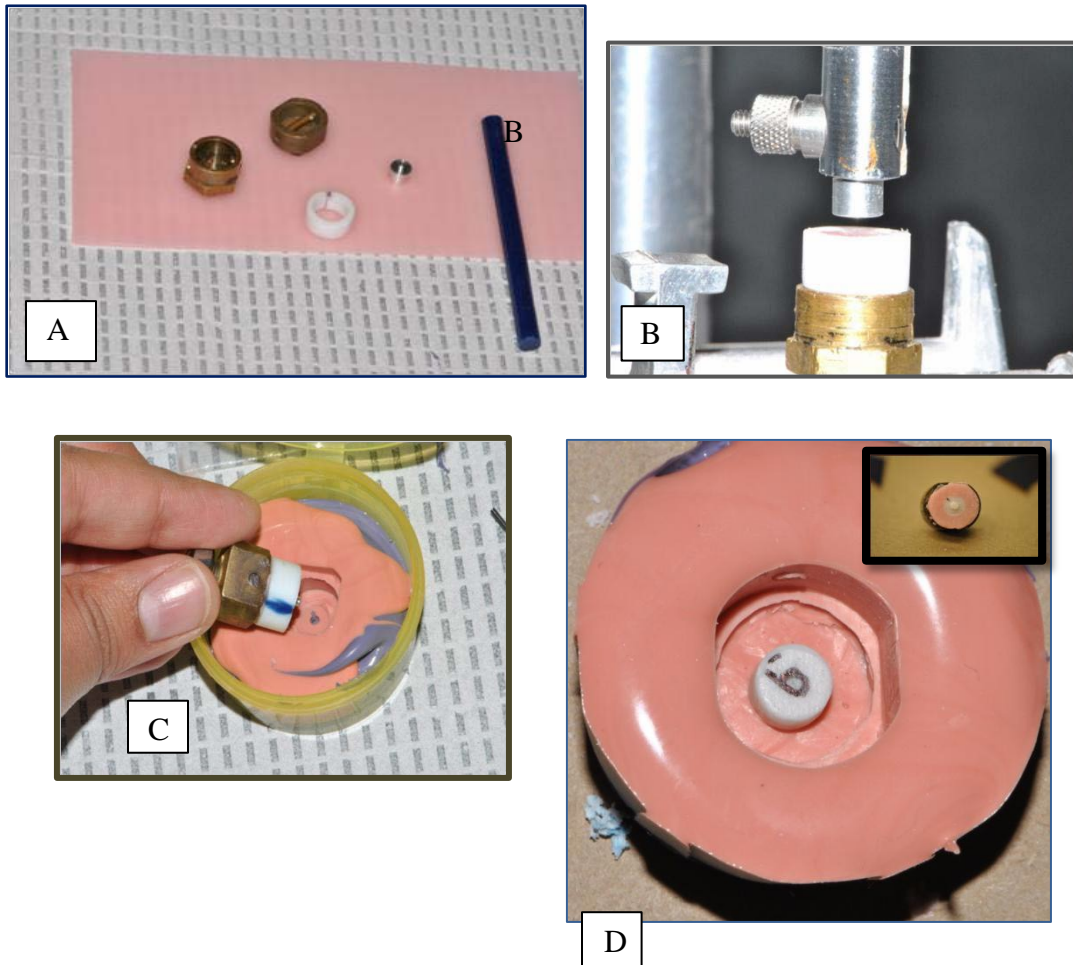
FIGURE 6. Zirconia mounting jig fabrication and mounting steps. A) The materials used for fabrication of the jig, (wax, metal specimen, plastic sleeve and brass holders.) B) A dental surveyor was used to mount the metal specimen inside the wax-filled cylinder; care was taken to make sure the tip of the slider specimen was parallel to the floor. C) The mounting jig was fabricated with silicone impression material. D) The zirconia slider in position in the jig ready for mounting (inset shows the final specimen after being embedded in acrylic resin).

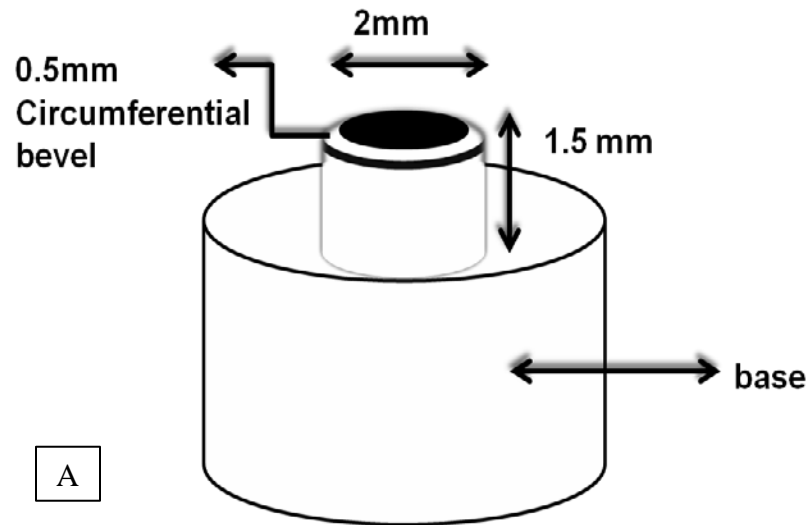
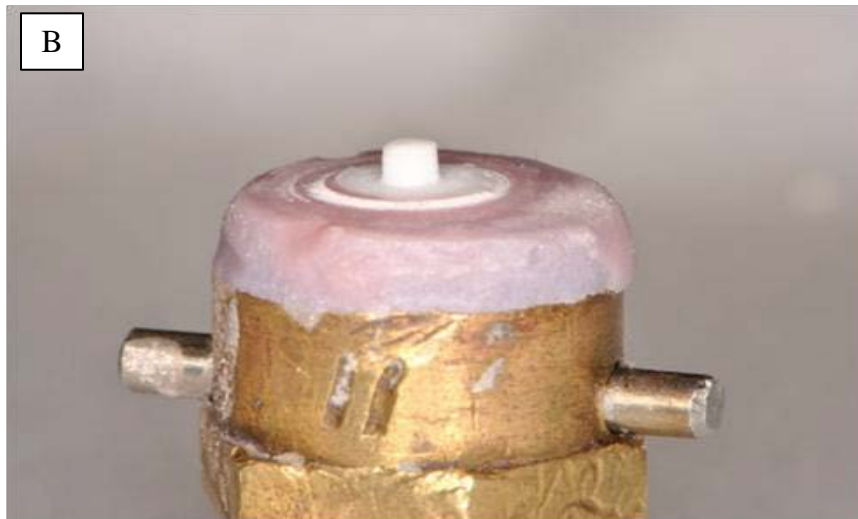
FIGURE 7. A) Schematic representation of zirconia slider showing the shape and dimensions of the slider. B) A mounted slider specimen with the slider tip extending above the mounting acrylic.

Forty-eight yttrium-stabilized full-contour zirconia (FCZ, Ardent Dental Inc., NY) ceramic specimens (hereafter named zirconia sliders) were manufactured using a CAD/CAM machine (Sirona, InLab MC XL). The zirconia material came from the manufacturer as a large disk-shaped block (Figure 1). Small cubic zirconia blocks (10 x 10 x 10 mm³) were prepared using a band saw. Next, the samples were placed in a furnace (Pyro oven, HD Justi Company, CA) at 275° F for 30 minutes to remove the moisture. Using a custom jig, each block was glued to a CAD/CAM fitting pin (Figure 2) in preparation for milling. To facilitate the CAD/CAM process a slider replica of the proper shape and size was machined from an aluminum rod and scanned by a digital scanner (Sirona, InLab MC XL) (Figure 3 and Figure 4). This information was sent to the CAD/CAM milling machine. The zirconia samples were then milled to the required shape and dimensions (Figure 4). The base of each sample measured 6 mm in diameter and 4 mm high. The slider portion of each sample was 2 mm in diameter and 1.5 mm high.

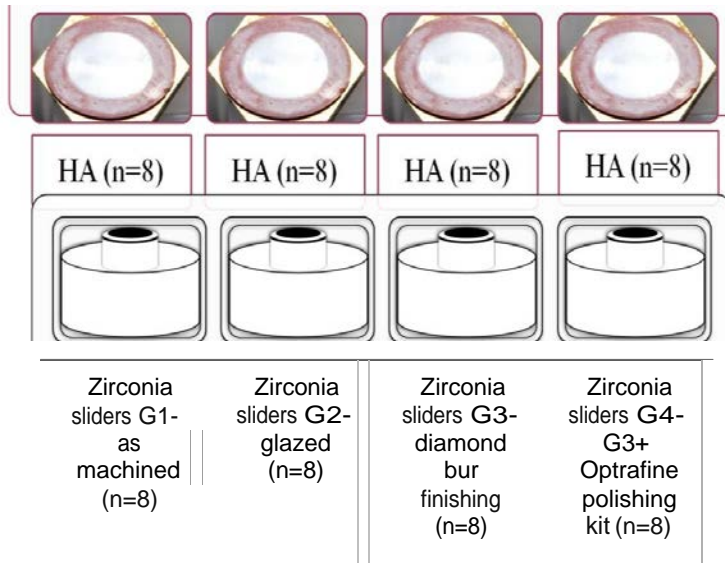
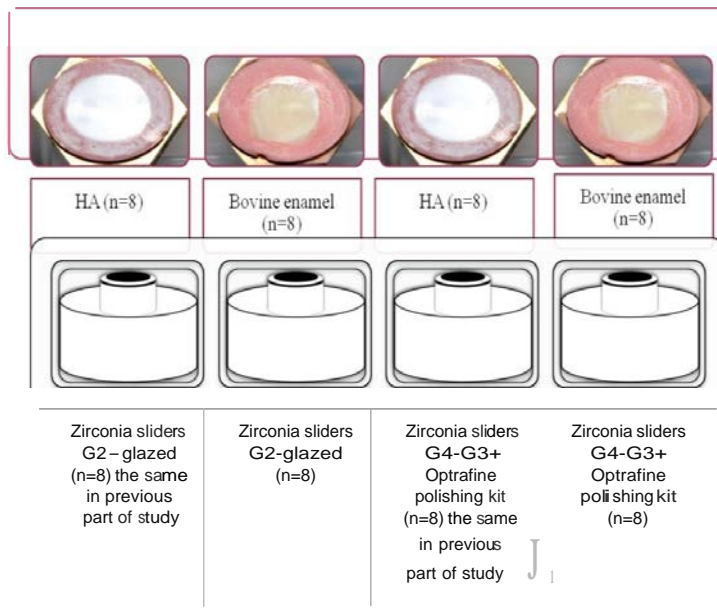
FIGURE 8. Schematic representation of the experimental groups tested.

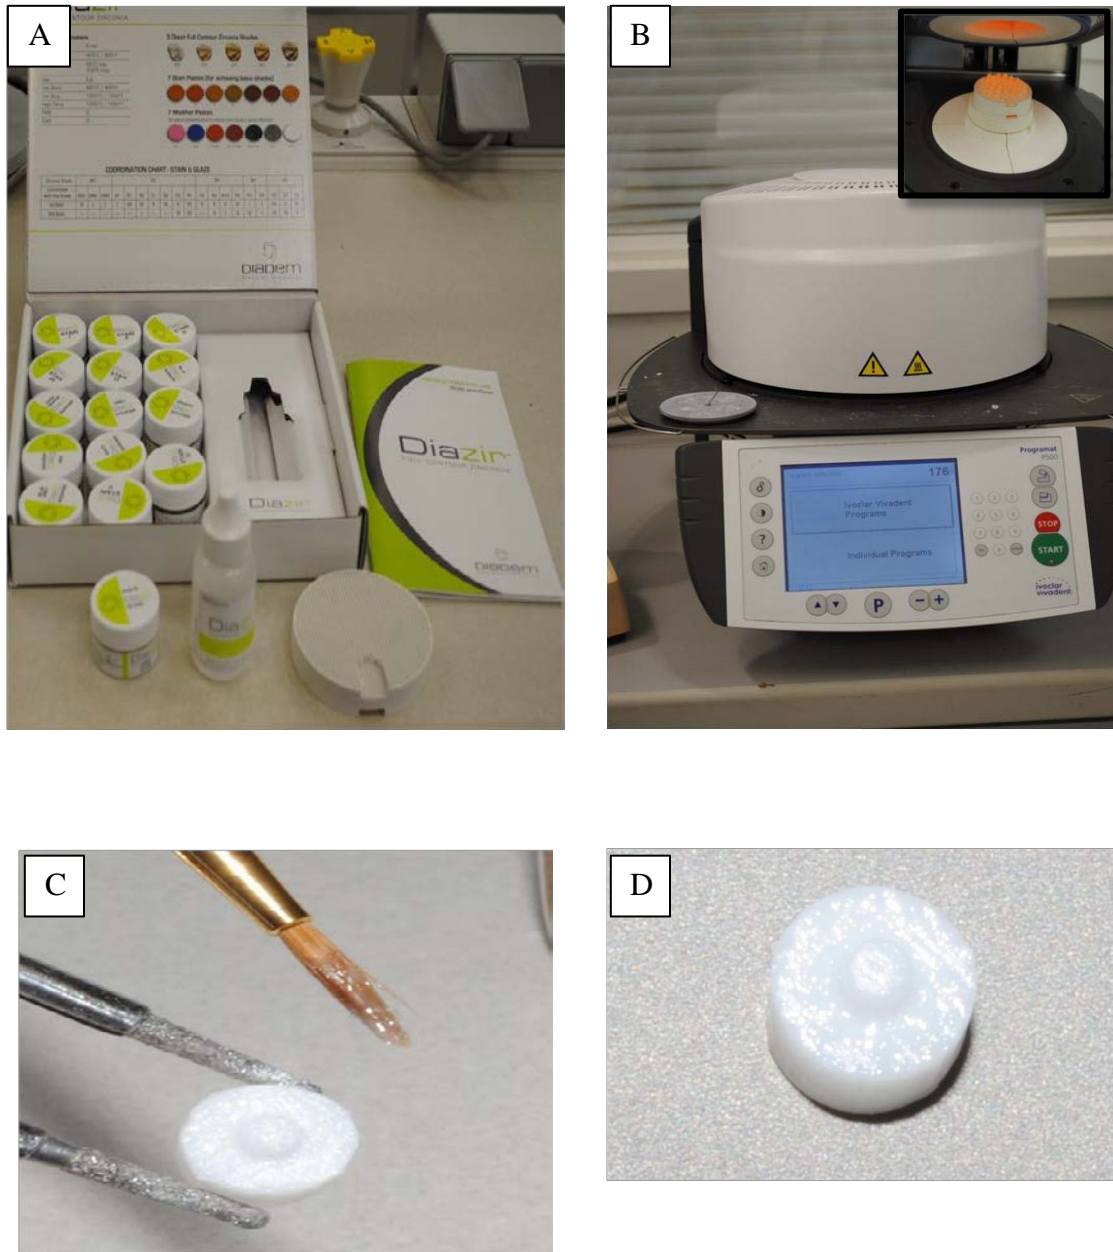
FIGURE 9. Glaze application to the zirconia sliders (Group 2). A) Diazir glaze. B) Glazing furnace (inset shows zirconia sliders after being placed in the furnace). C) Glaze application on the slider surface. D) Glazed slider.

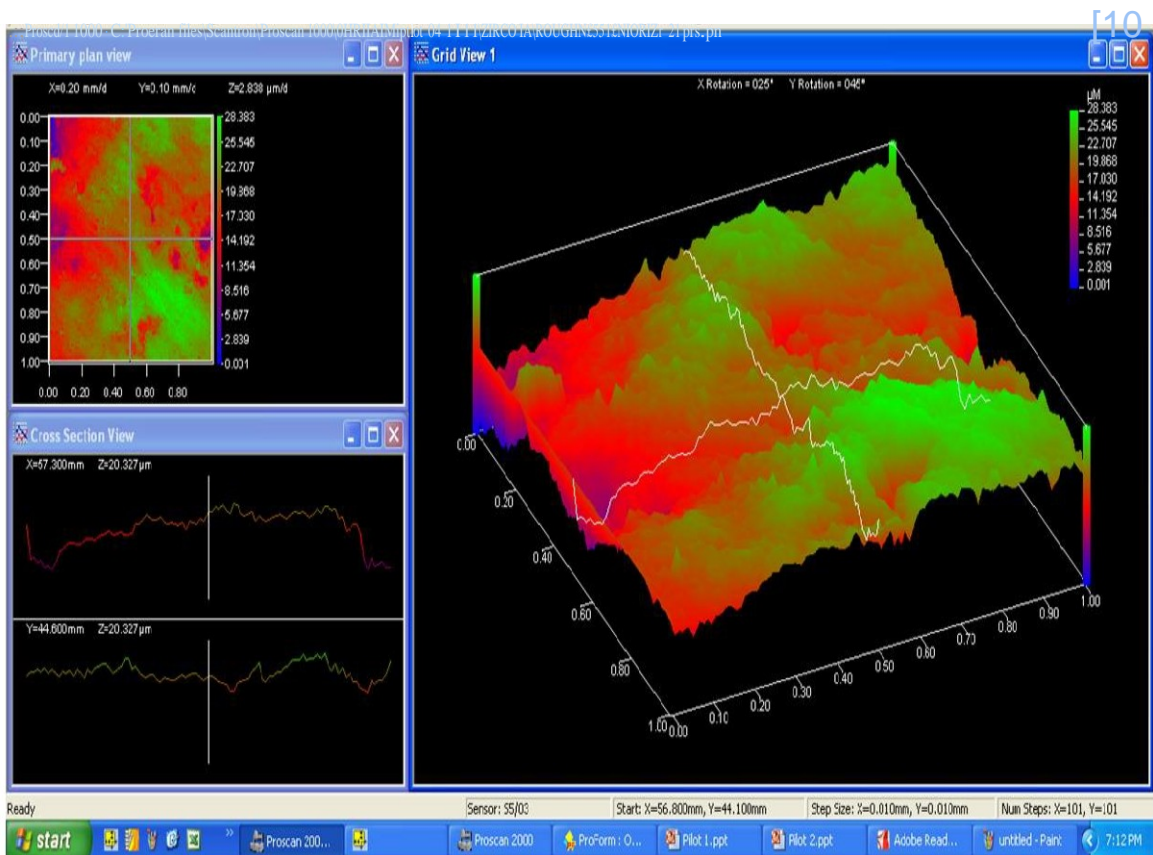
FIGURE 10. Original scan of Zirconia surface taken by Proscan 2000 profilometer using S5/03 sensor, with a step size of 0.01 for both x and y axis, frequency (Hz)= 100, and scanned area of 0.8 x 0.8 mm.

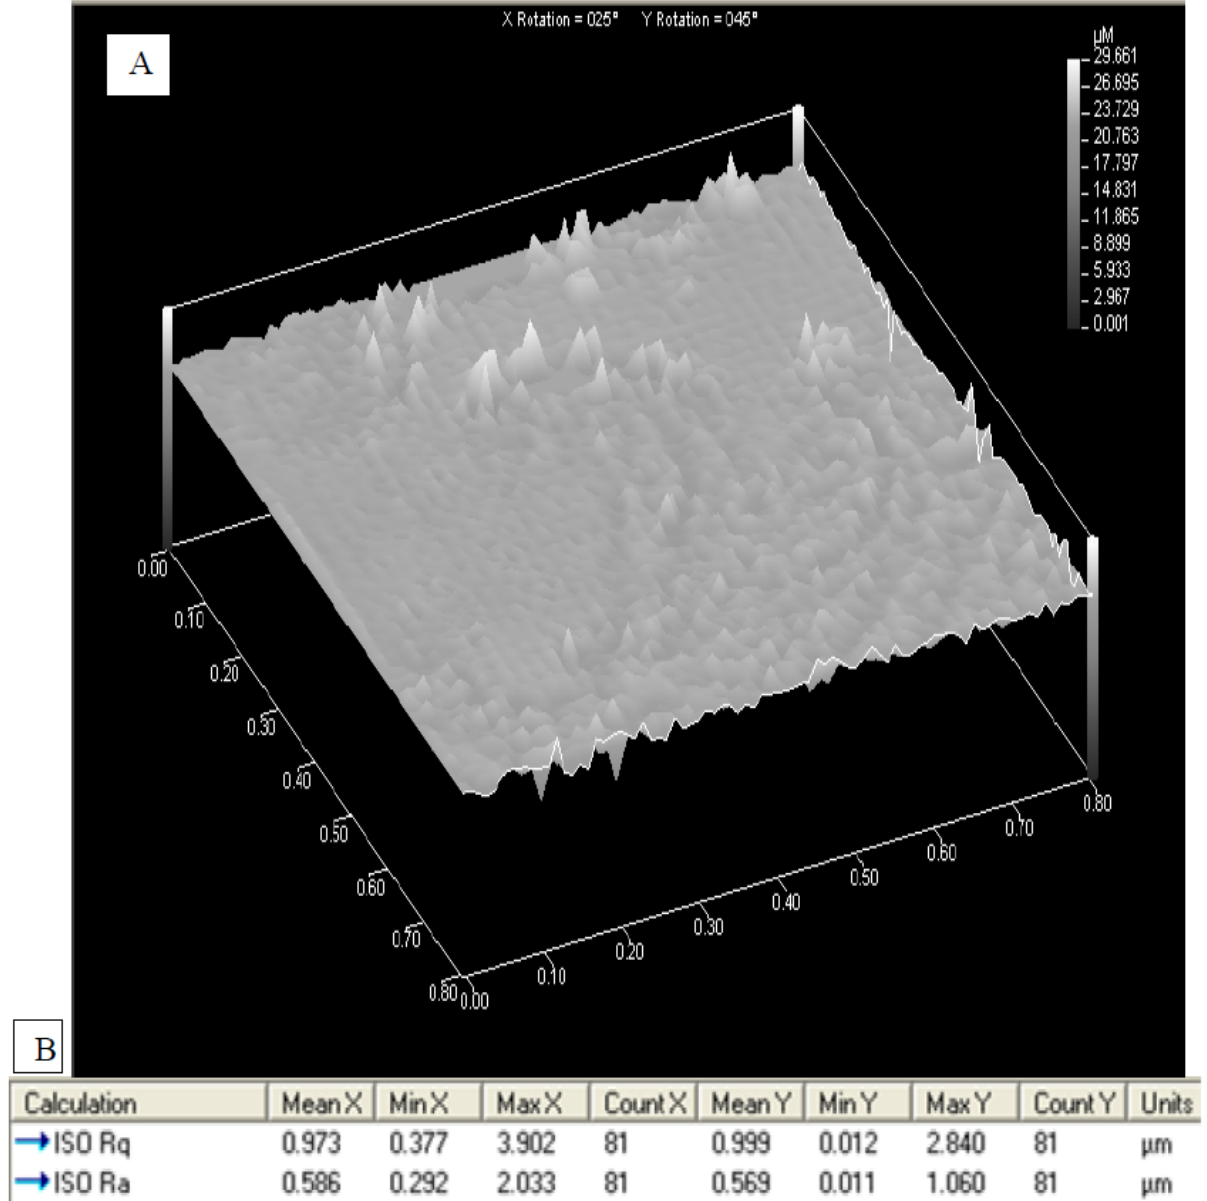
FIGURE 11. A) Zirconia surface scan after processing by the Proscan software; outlier points have been removed, and color scale has been changed to gray. B) Generated roughness measurements.

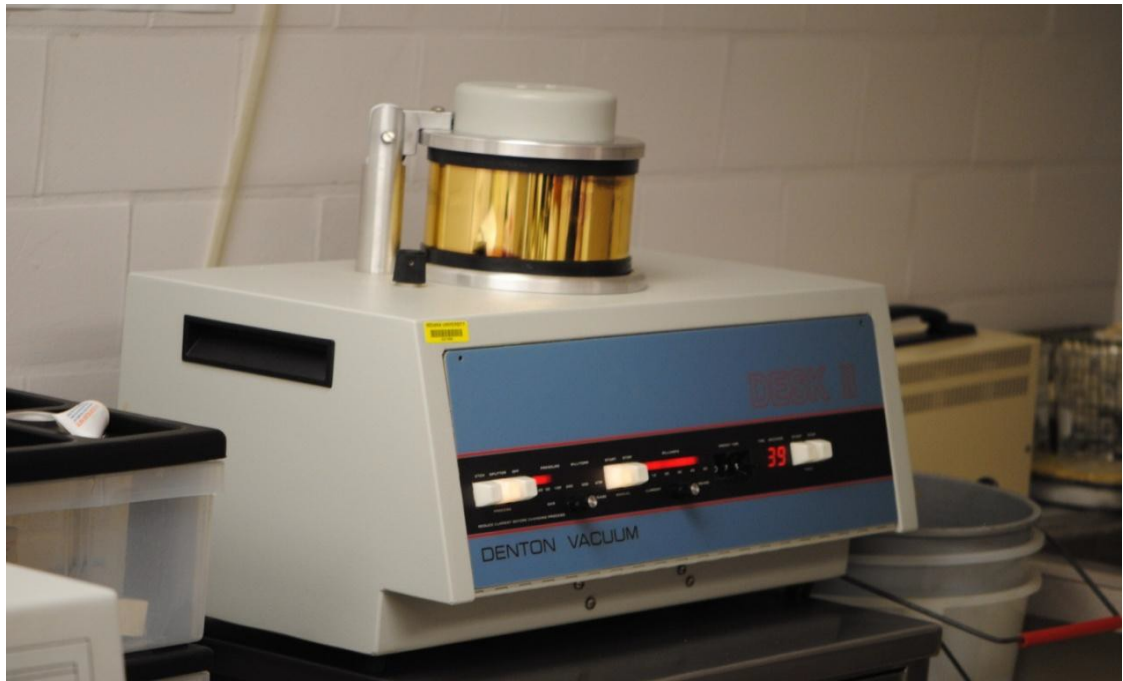
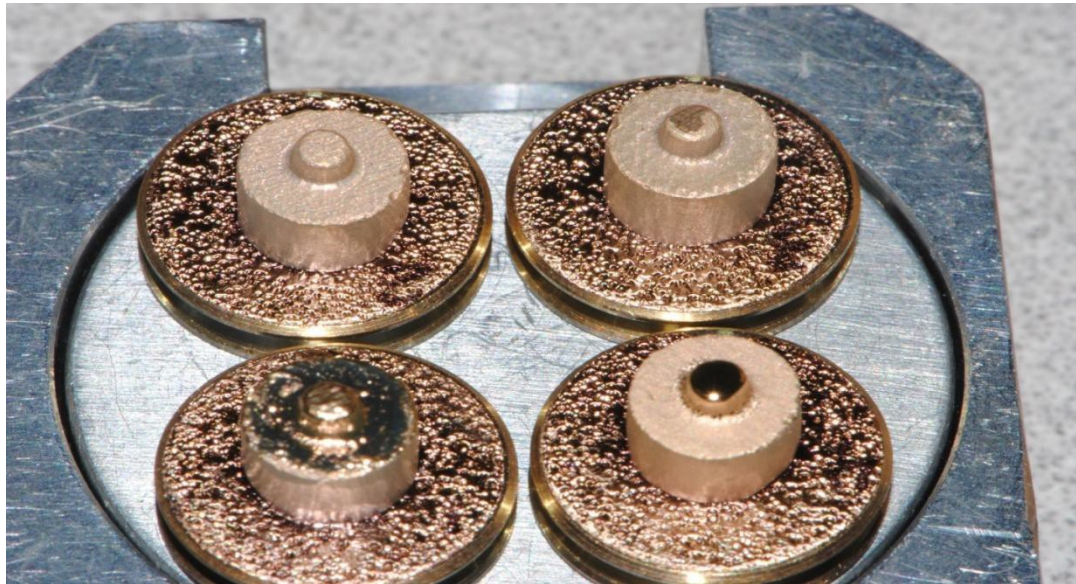
FIGURE 12 A) Sputter-coater (Denton Vacuum Desk II) and B) Zirconia samples sputter-coated with gold prior to SEM imaging.

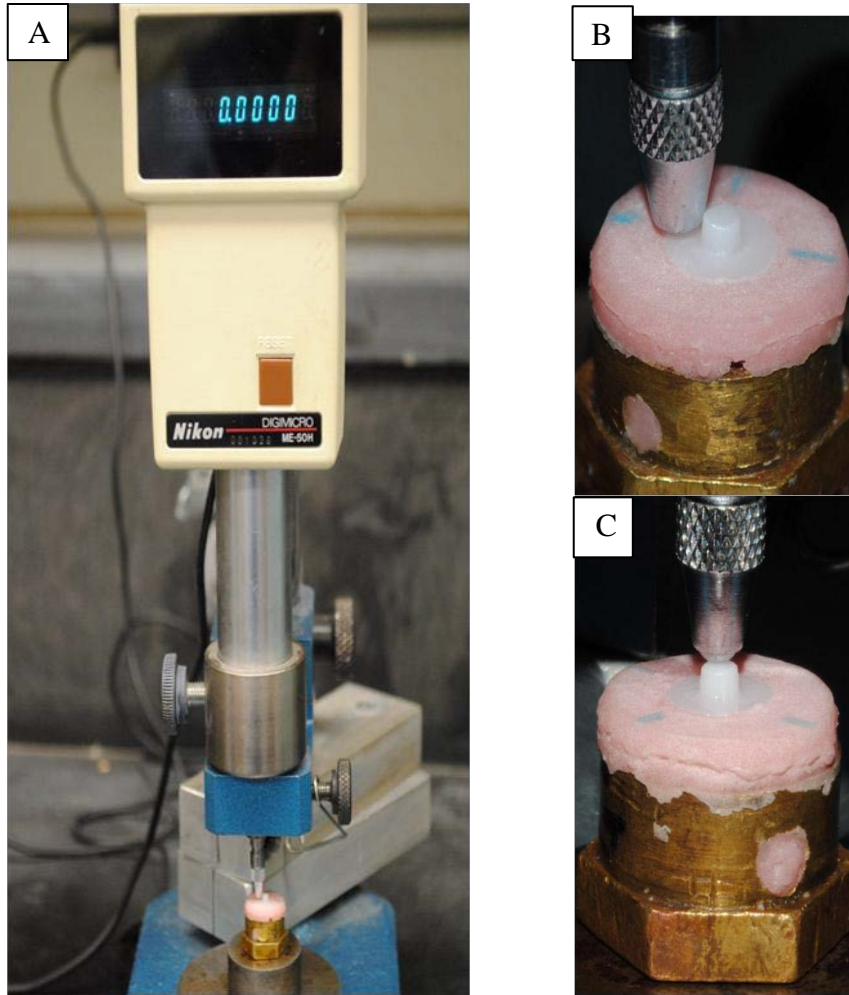
FIGURE 14. Baseline vertical height measurements for zirconia samples taken by digital micrometer. A) Nikon DigiMicro micrometer. B) Reference point selection; four reference points were placed on the surface of the slider base; after selecting the reference point, the micrometer reading was set to zero. C) After establishing a reference point, the tip of the micrometer was positioned over the slider tip to give a reading of the slider height.

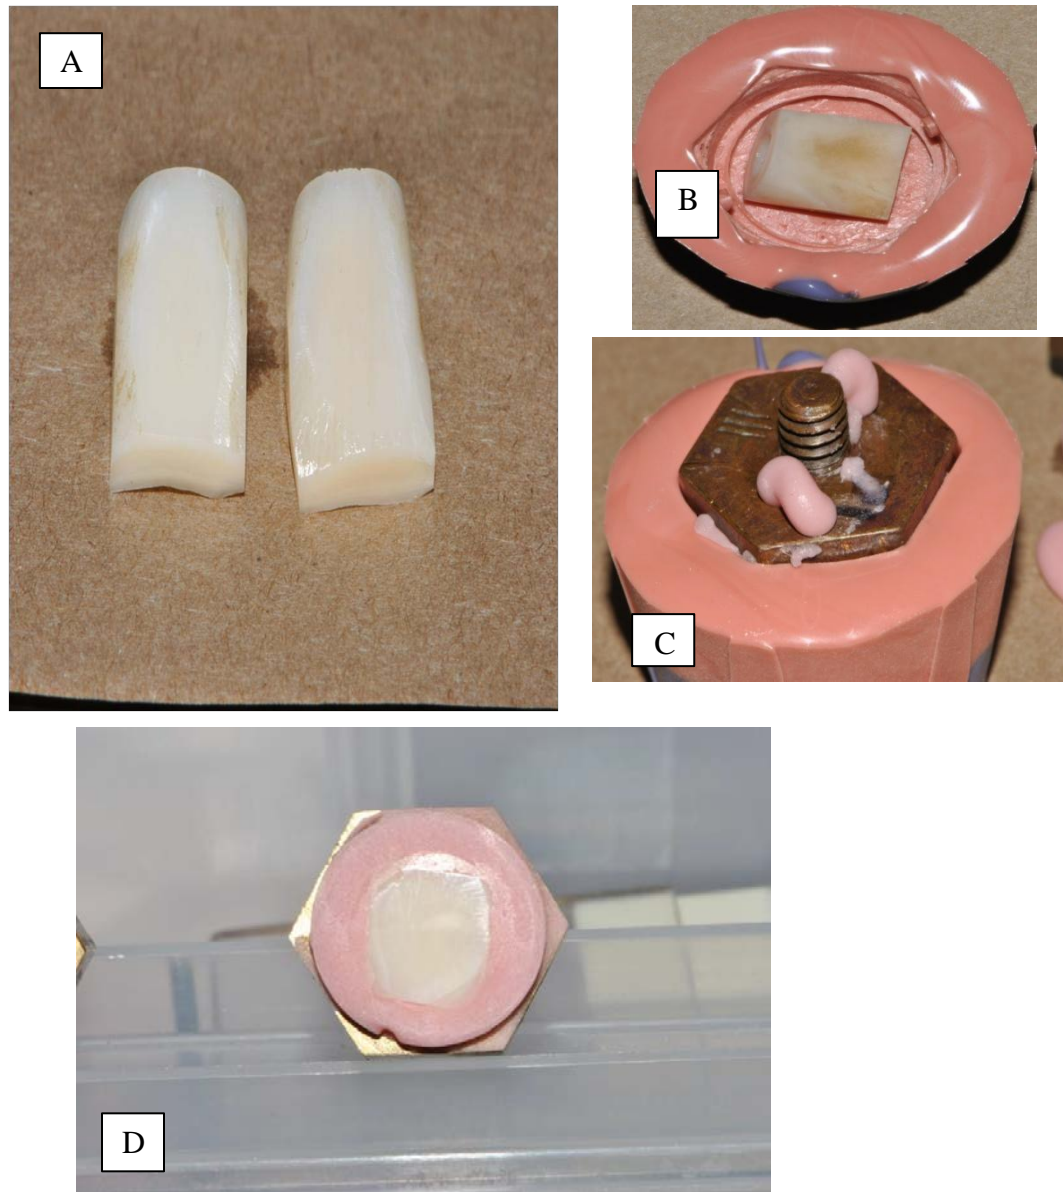
FIGURE 15. Bovine teeth preparation and mounting steps. A) Bovine incisors were prepared to have a square shaped facial surface. B) A bovine enamel sample was placed inside a custom made mold. C) Auto-cured acrylic resin was used to embed the bovine specimen inside the brass holder. D) Final specimen after polishing.

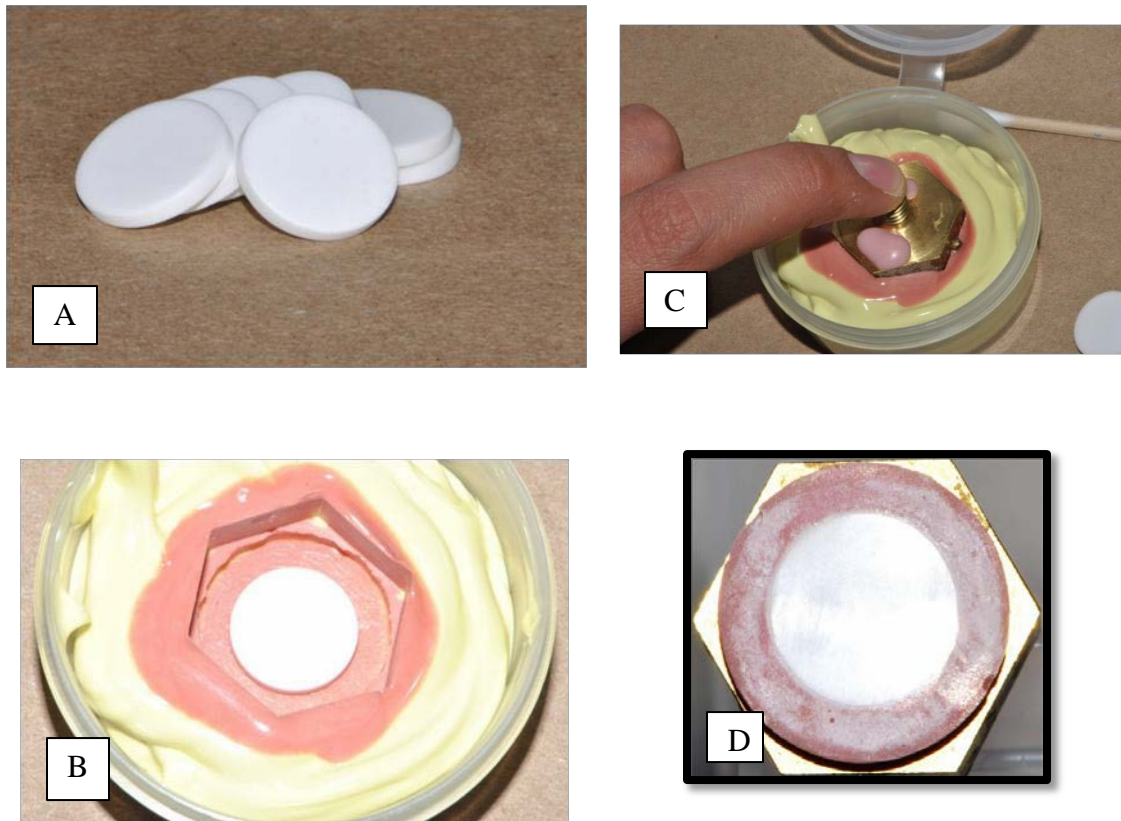
FIGURE 16. Hydroxyapatite mounting steps. A) HA disks. B) HA sample placed inside a custom made mold. C) Auto-cured acrylic resin was used to embed the HA specimen inside the brass holder. D) Final specimen after polishing.

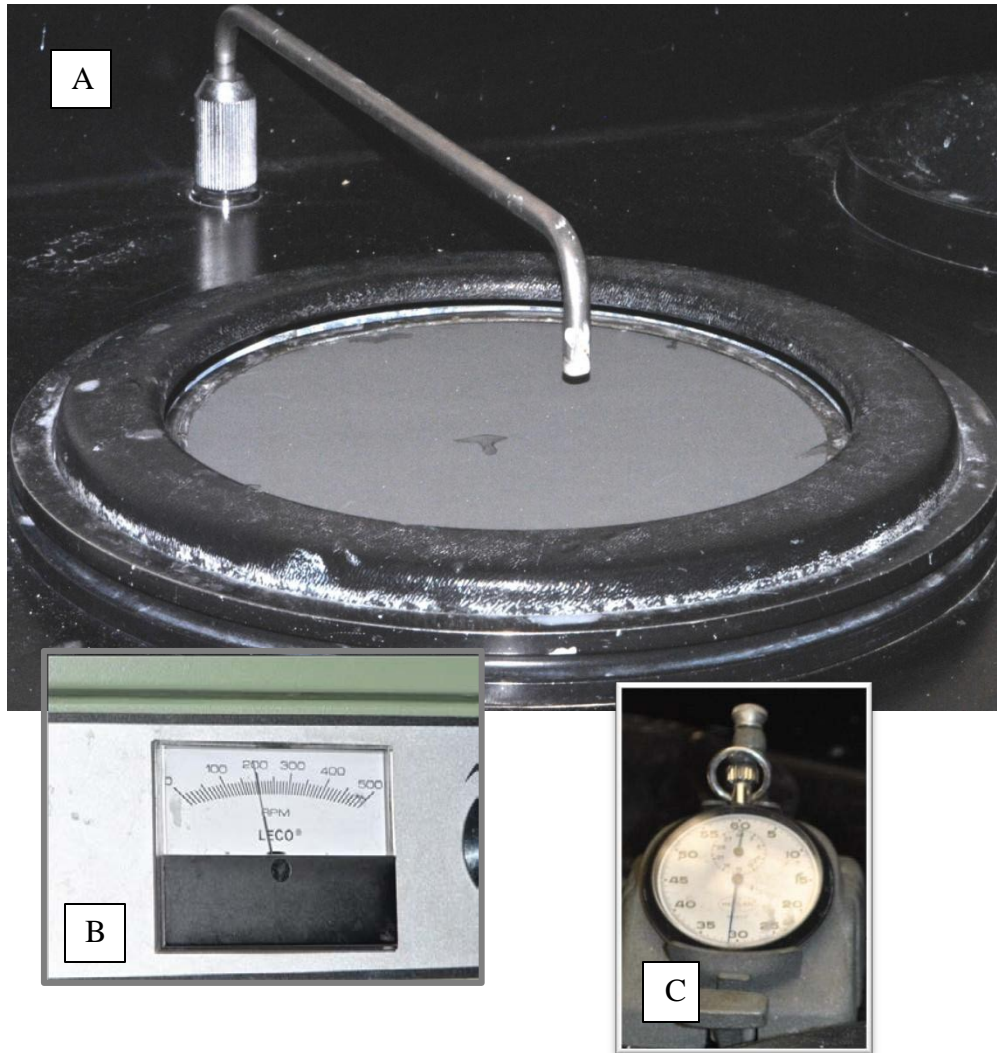
FIGURE 17. Polishing HA and bovine samples. A) Rotary polishing wheel used for polishing the samples. B) The speed of the wheel used as 200 RPM. C) Each polishing step was carried out for 30 s, and then samples were cleaned with ethanol and water. Three different grits of SiC papers were used (600, 800 and 1200).

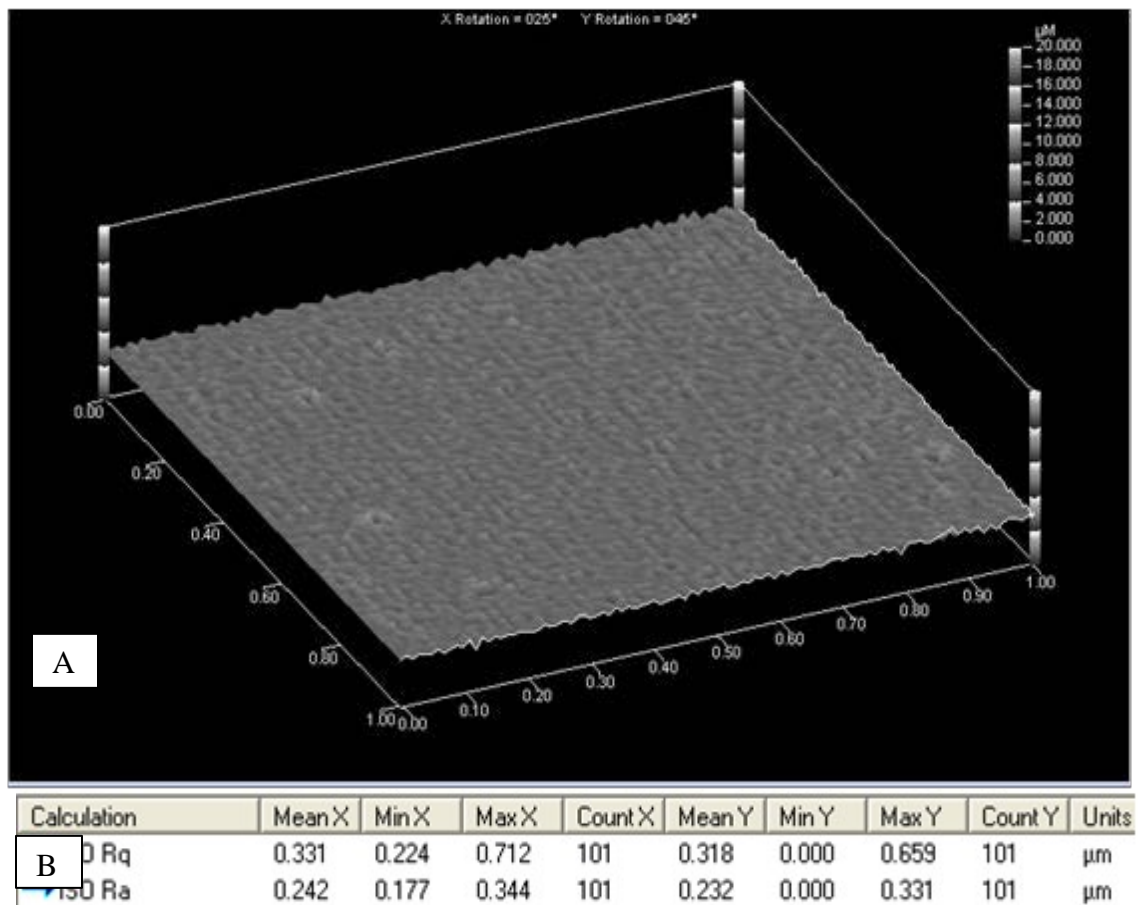
FIGURE 18. A) HA surface scan provided by the Proscan. B) Generated roughness measurements. Due to the large surface area of the specimen, three scans of three different areas were taken for each sample.

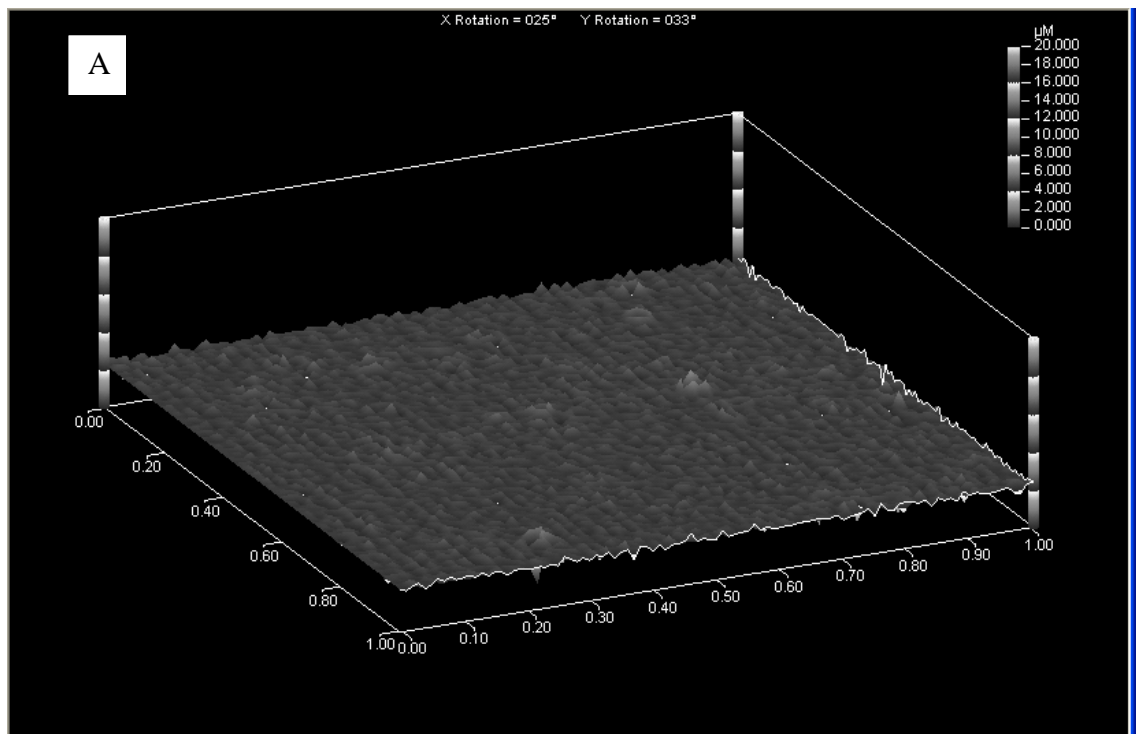
FIGURE 19. A) Bovine enamel surface scan provided by the Proscan. B) Generated roughness measurements due to the large surface area of the specimen; three scans of three different areas were taken for each sample.

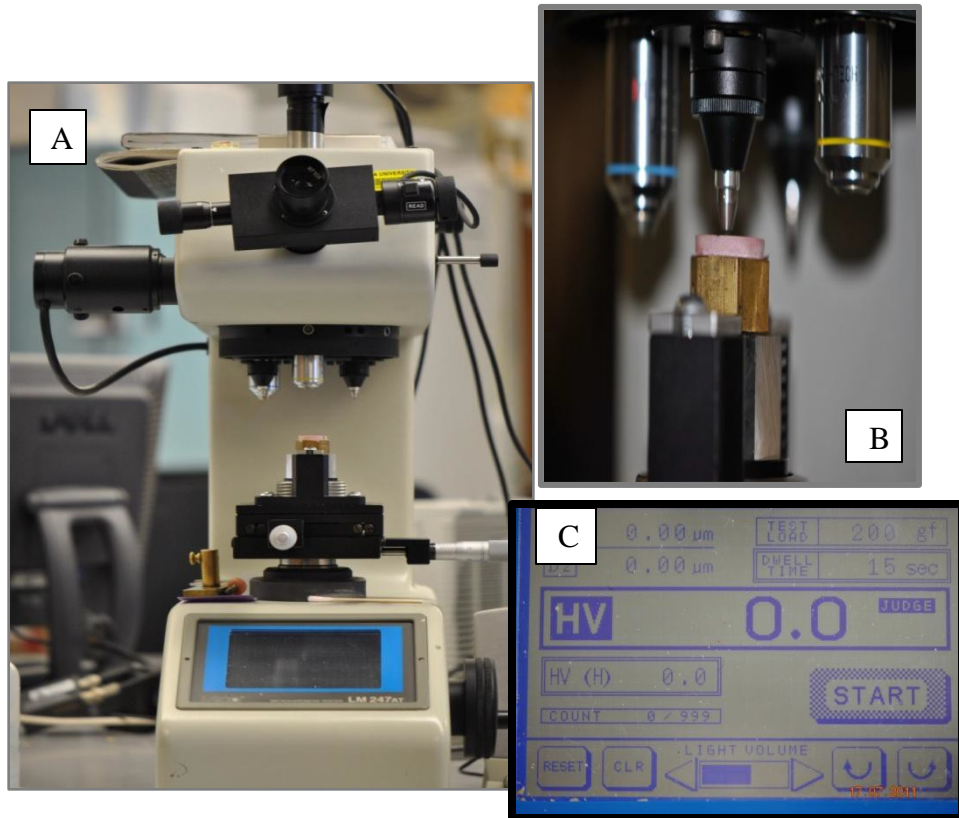
FIGURE 20. Hardness test and parameters. A) Vickers hardness testing machine. B) A closer picture for the specimen while placed inside the machine. C) Control screen of the hardness machine shows the parameter used. A load of 200 g for 15 s was applied, and then computer software was used to calculate the Vickers hardness. For HA specimens, hardness measurements were made at five points per sample and the average was considered the hardness for that sample. For bovine enamel, 15 points per sample were used for hardness measurements. An average Vickers hardness number below 270 resulted in sample exclusion from the study.

less than 270 were excluded. In cases of the presence of cracks or dentin exposure after polishing, the sample was also excluded. Hardness parameters are shown in Figure 20.

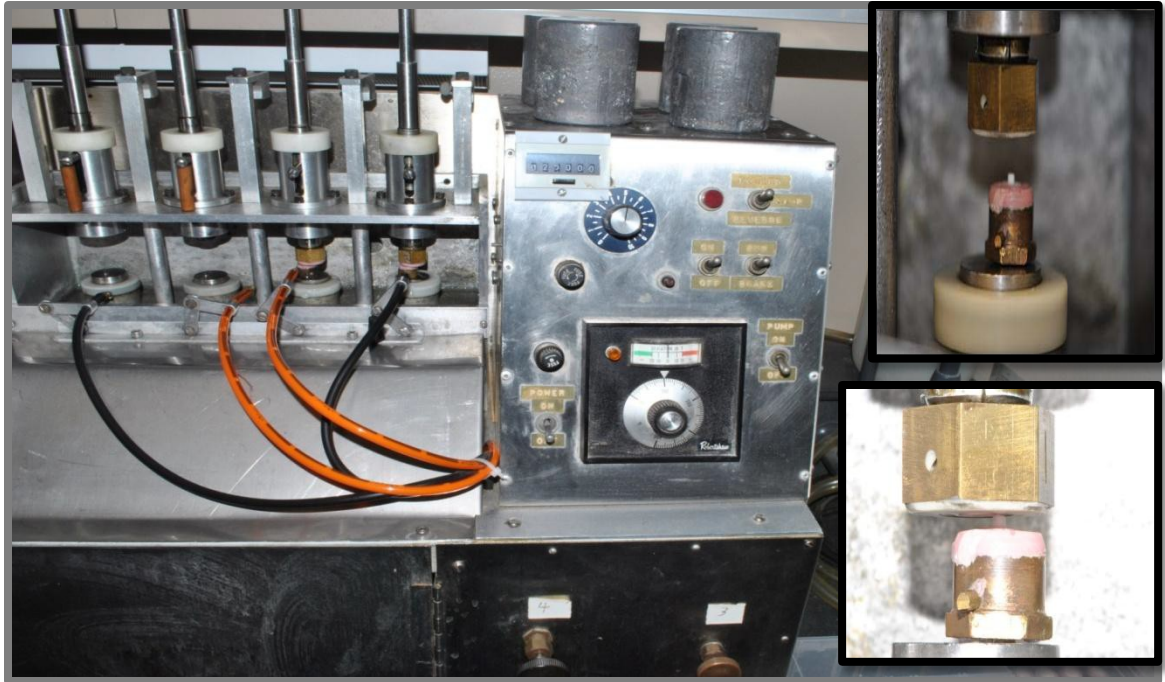
FIGURE 21. Two-body pin-on-disk machine, and wear testing parameters. Wear test was carried out for 25,000 cycles, at 1.2 Hz, using a weight of 49 N. Room temperature water was used continuously for lubrication purposes.
