THE EFFECT OF FULL-CONTOUR Y-TZP CERAMIC SURFACE ROUGHNESS ON
THE WEAR OF BOVINE ENAMEL AND SYNTHETIC HYDROXYAPATITE:
AN IN-VITRO STUDY

Submitted to the Graduate Faculty of the School of
Dentistry in partial fulfillment of the requirements
for the degree of Master of Science in Dentistry,
Indiana University School of Dentistry, December 2011.

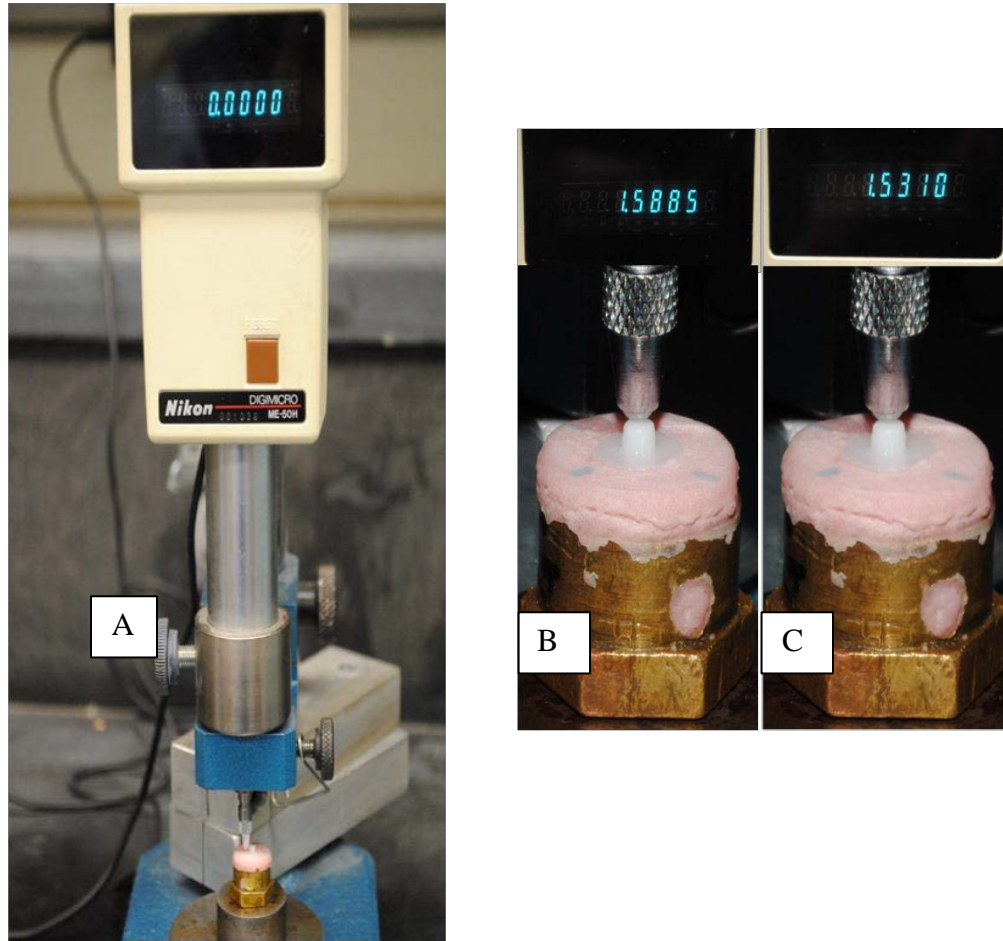
FIGURE 22. Zirconia vertical height loss measurements. A) Nikon DigiMicro micrometer. B) Baseline vertical height of zirconia samples before wear (inset shows an example of such measurement). C) After-wear vertical height measurements (inset shows the after-wear reading for the same sample). Reading given by micrometer is in millimeters. Vertical height loss was measured by subtracting the two values and then converting the result from mm to μm .

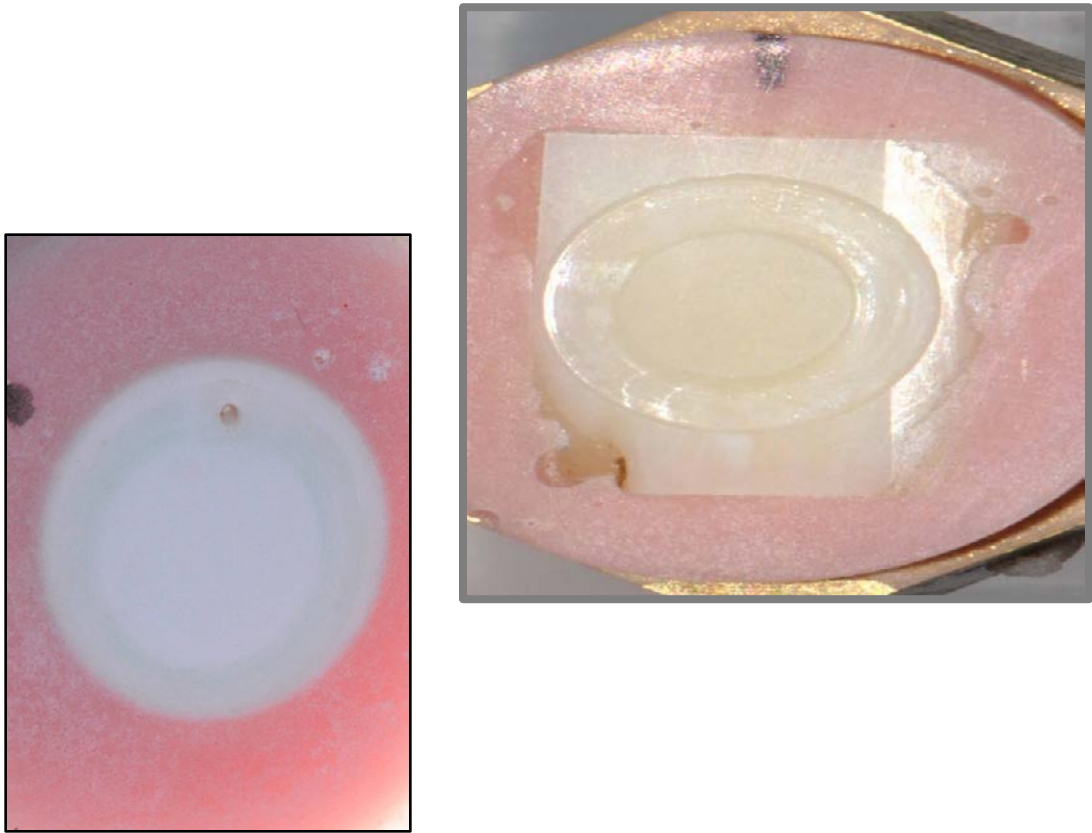
FIGURE 24. Wear track formed on HA (left) and bovine (right).

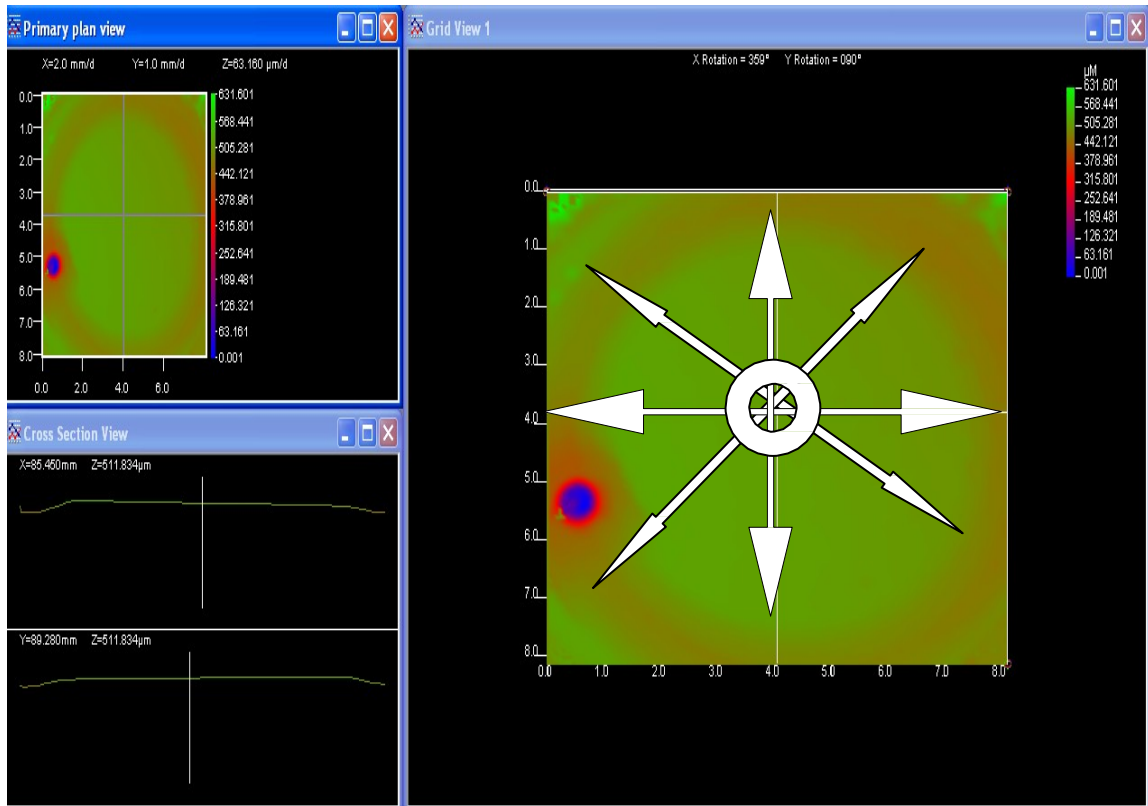
FIGURE 25. Vertical height loss measurements. Using Proscan software, antagonist (HA and bovine) specimen surfaces were scanned after wear testing. Then, for each specimen, the software computed the vertical height loss. Eight areas were selected and their vertical heights were compared with the vertical height of the central unworn area using two-point difference height function. The mean average of the eight vertical high differences was recorded as the vertical high loss for those specimens.

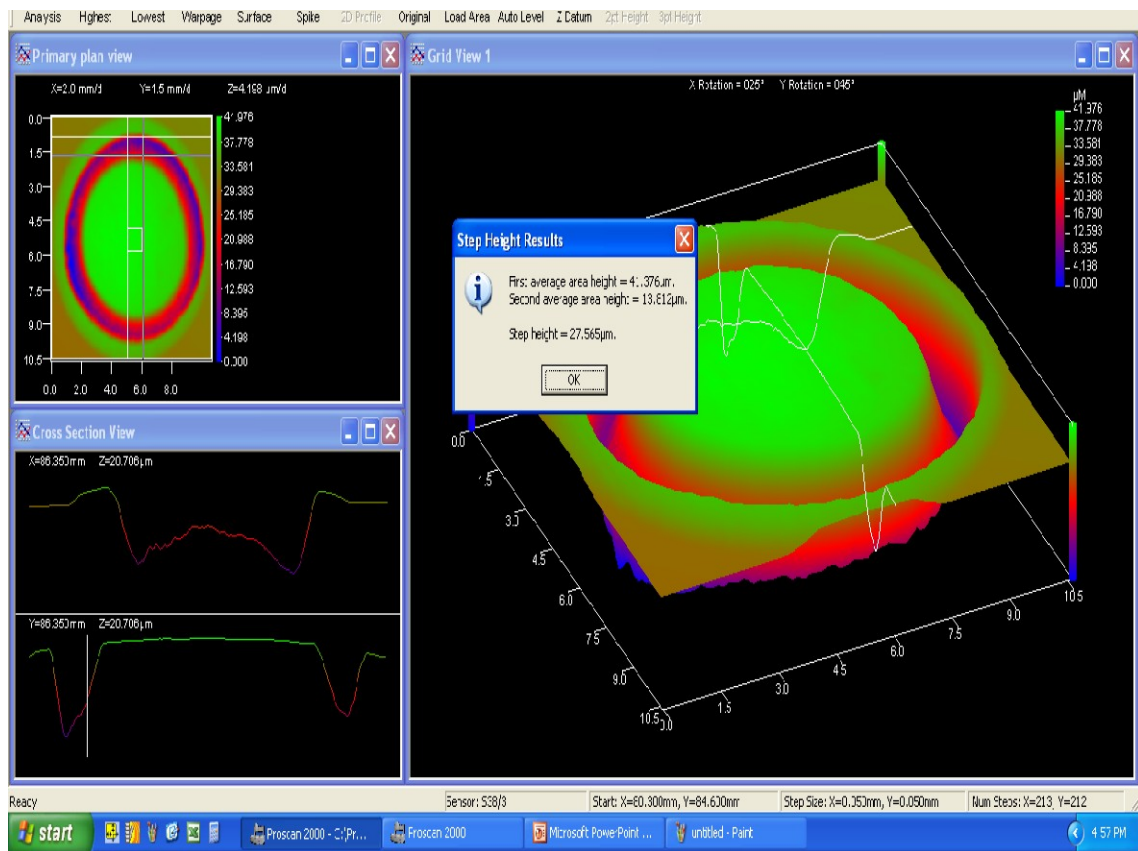
FIGURE 26. Example of vertical height loss.

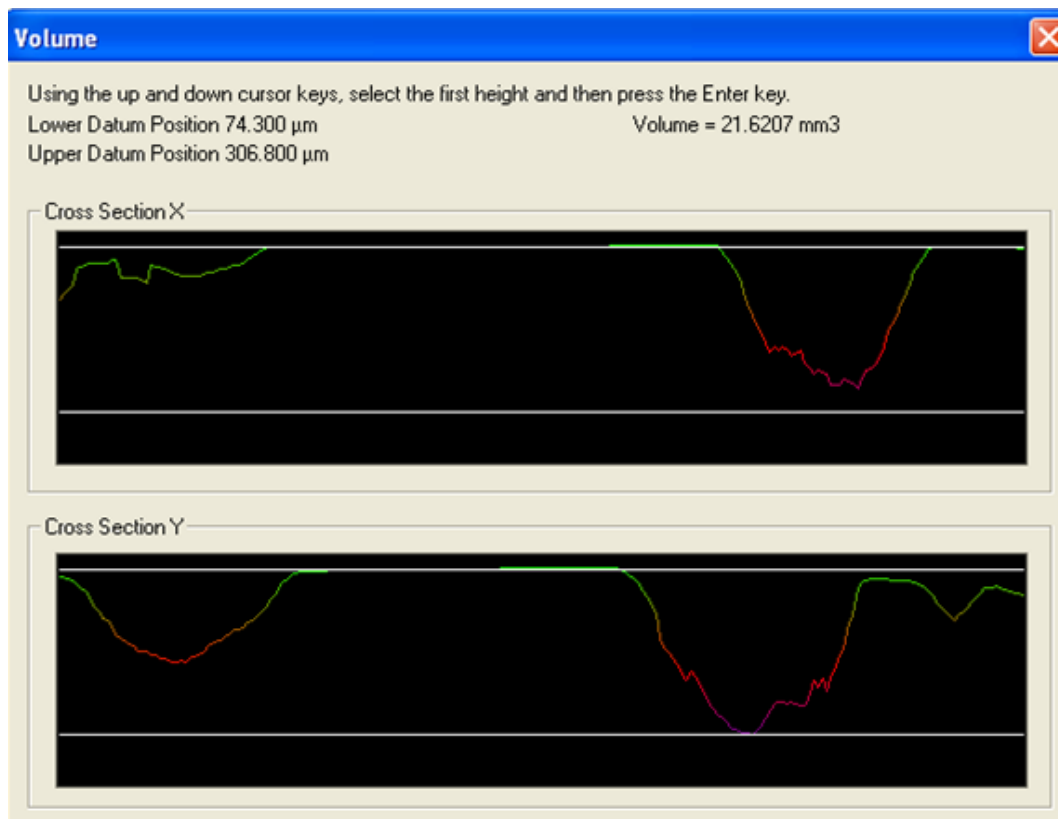
FIGURE 27. Volume loss measurement by Proscan software; using the same after-wear scan for each sample; volume loss was measured by the software. The volume loss represents the volume differences between central area (unworn area) and the deepest part on the wear track. Three different areas were chosen, and six readings were taken along x and y axes; then, the averages were taken.

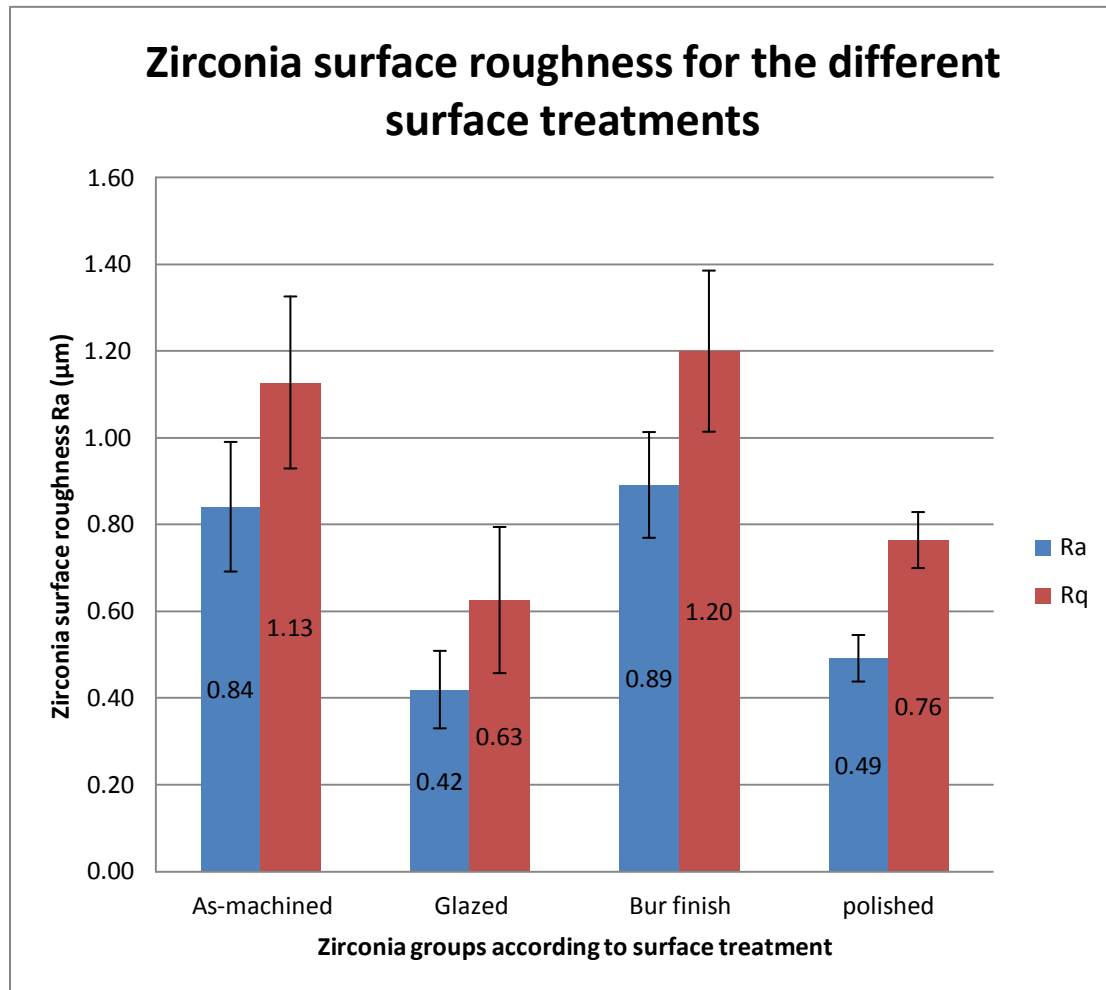
FIGURE 28. Zirconia surface roughness values (Ra and Rq in μm) before wear testing for the different groups along with standard deviation.

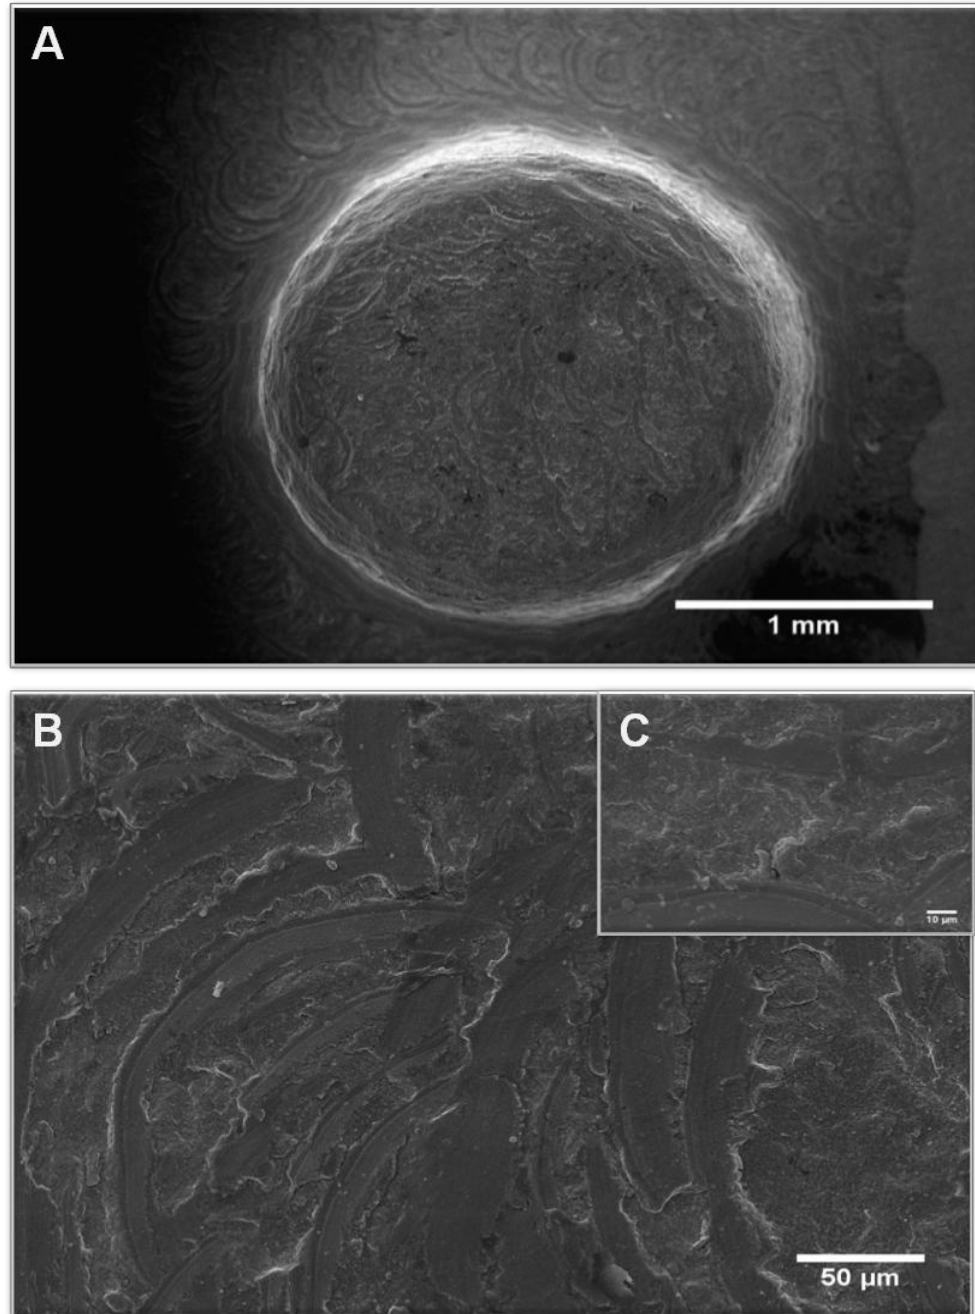
FIGURE 29. SEM micrographs at different magnifications (A) X50; (B) X500 and (C) X1500 for group 1 (as-machined zirconia sliders). The surface appears rough with circular irregularities due to bur movement during milling process.

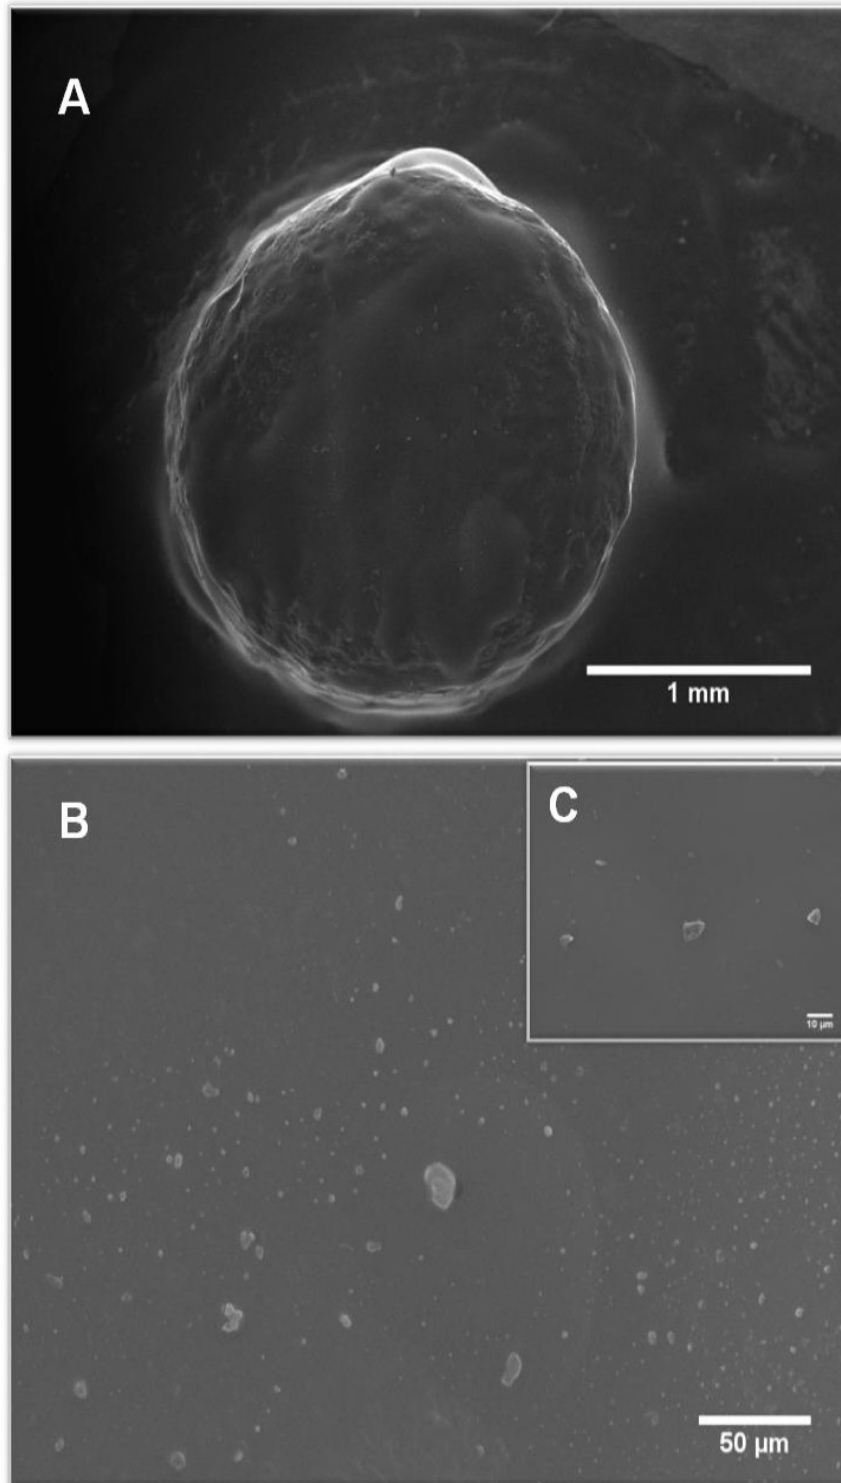
FIGURE 30. SEM micrographs at different magnifications (A) X50; (B) X500 and (C) X1500 for group 2 (glazed zirconia sliders). The surface looks smooth and shiny due to glaze layer.

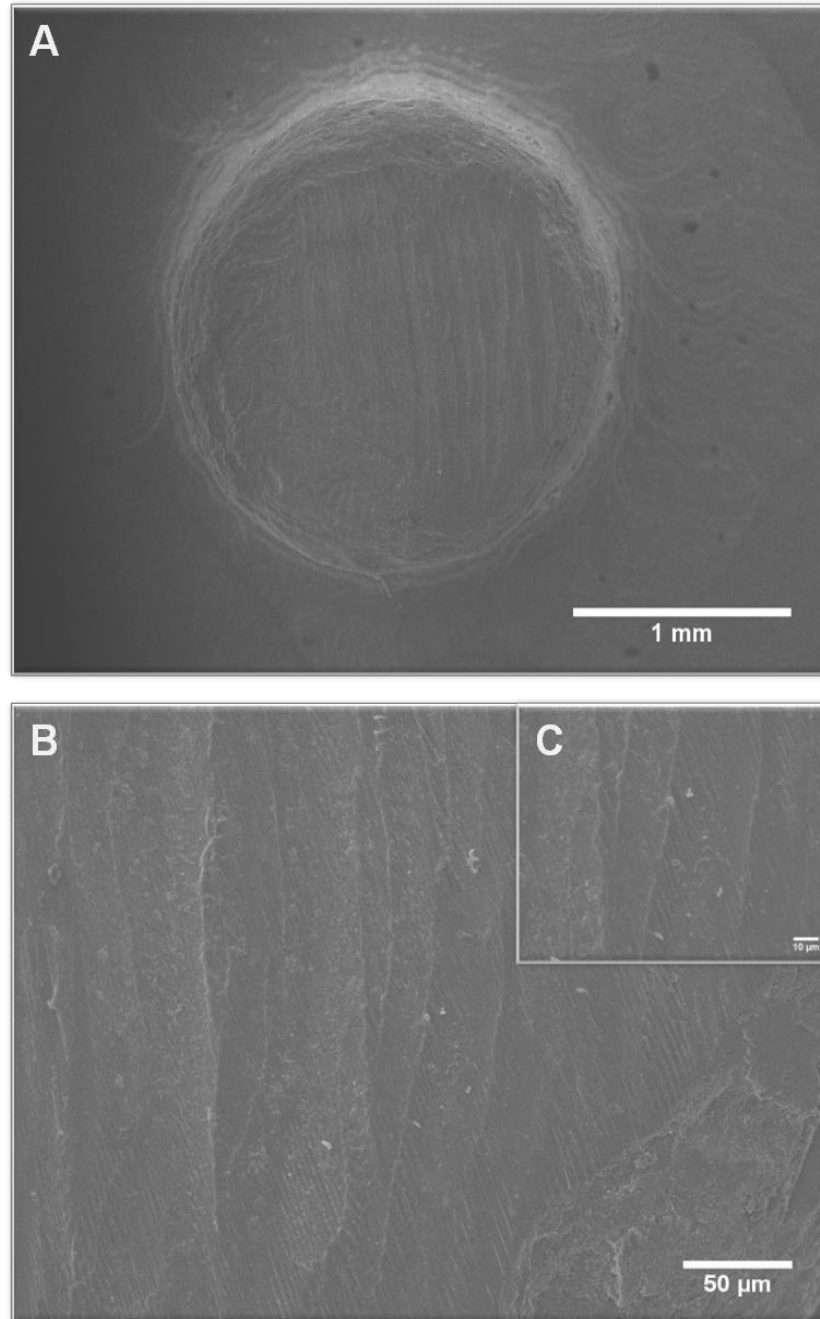
FIGURE 31. SEM micrographs at different magnifications (A) X50; (B) X500 and (C) X1500 for group 3 (bur-finished zirconia sliders). The surface appears rough with parallel irregularities representing the bur strokes.

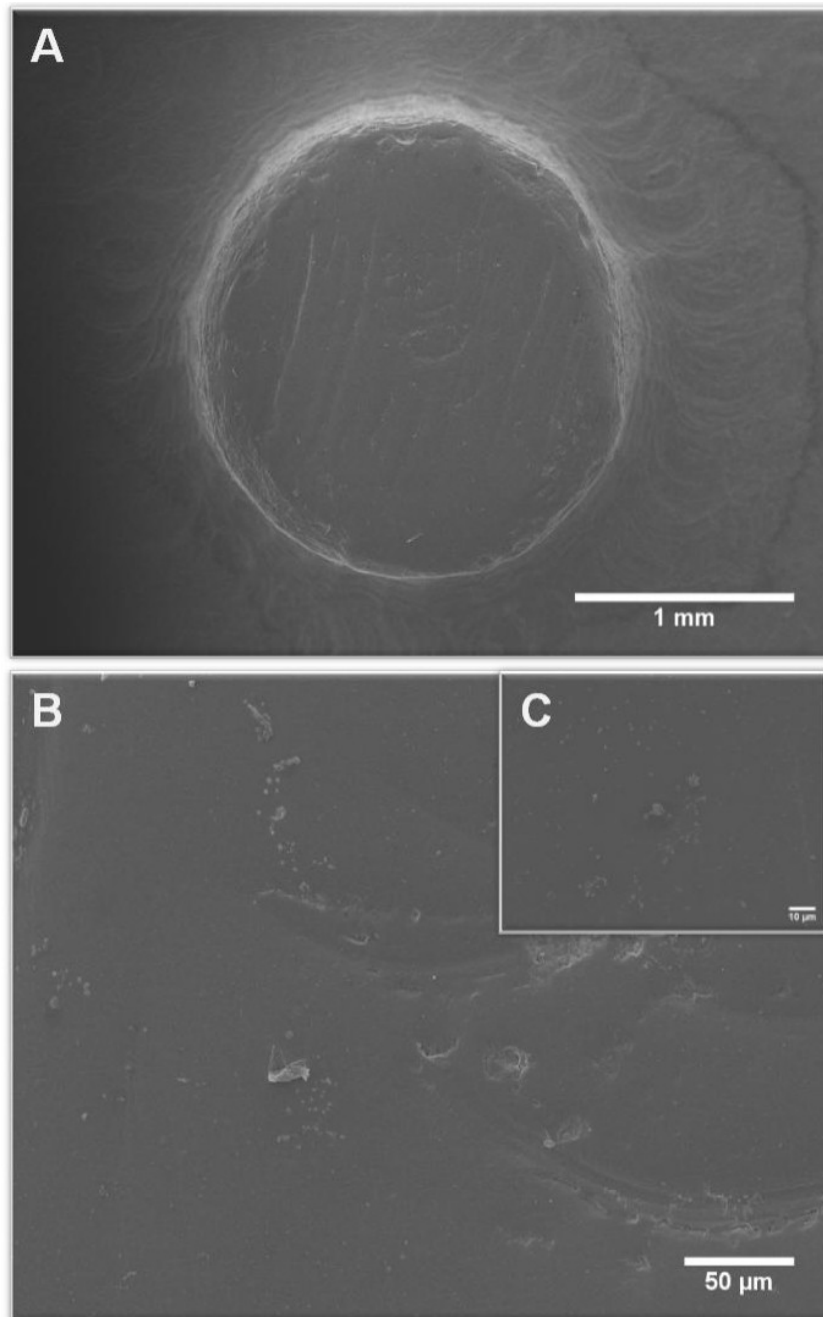
FIGURE 32. SEM micrographs at different magnifications (A) X50; (B) X500 and (C) X1500 for group 4 (bur-finished and polished zirconia sliders). Images revealed a smooth surface with small irregularities.

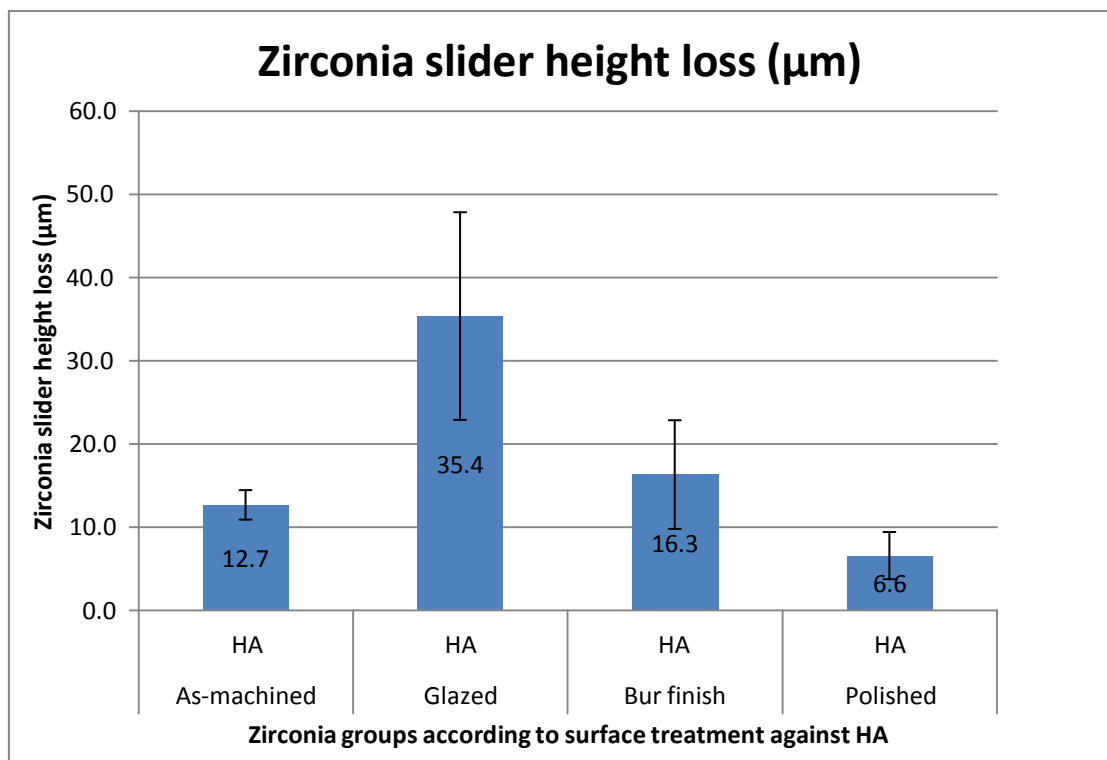
FIGURE 33. Zirconia slider height loss opposing HA antagonist.

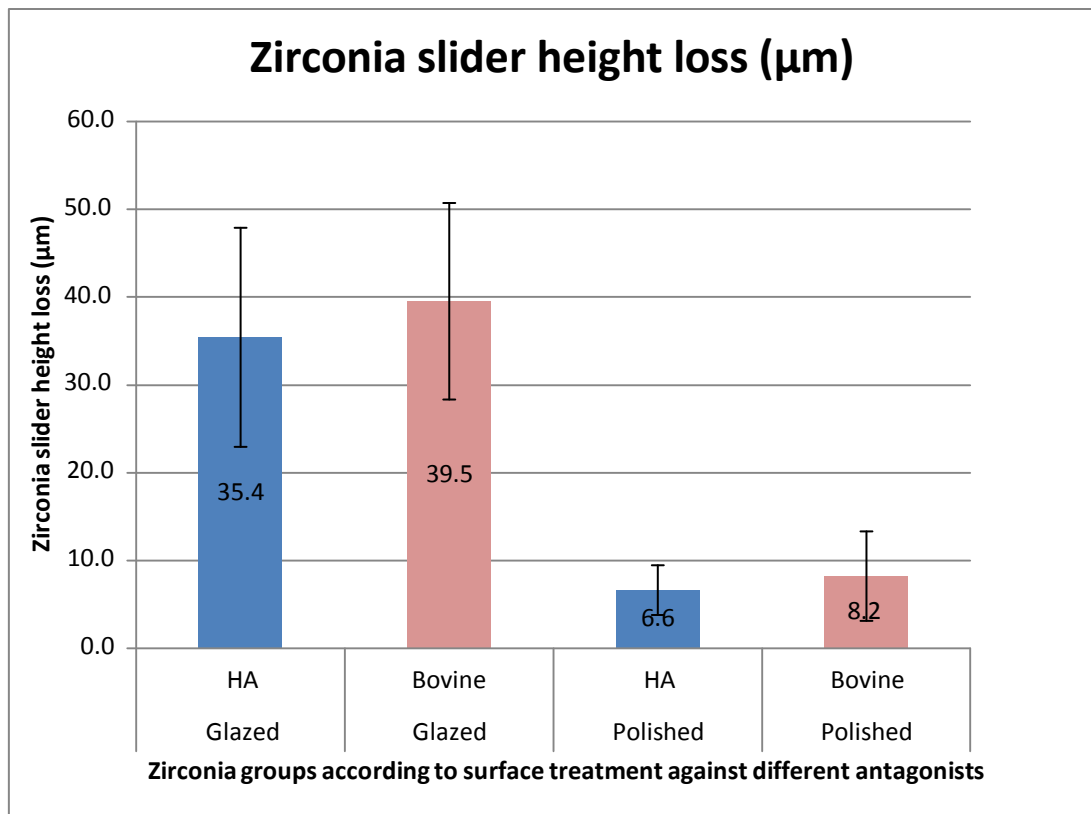
FIGURE 34. Zirconia slider height loss when opposing different antagonists.

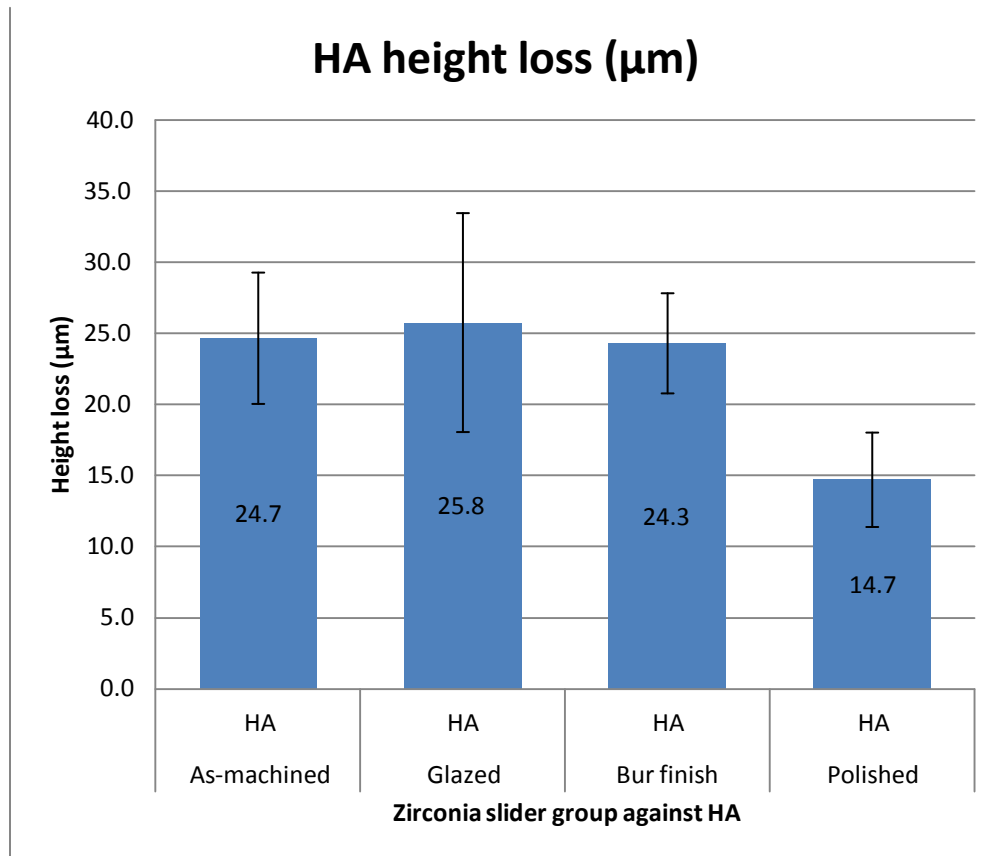
FIGURE 1. HA height loss against different zirconia groups.

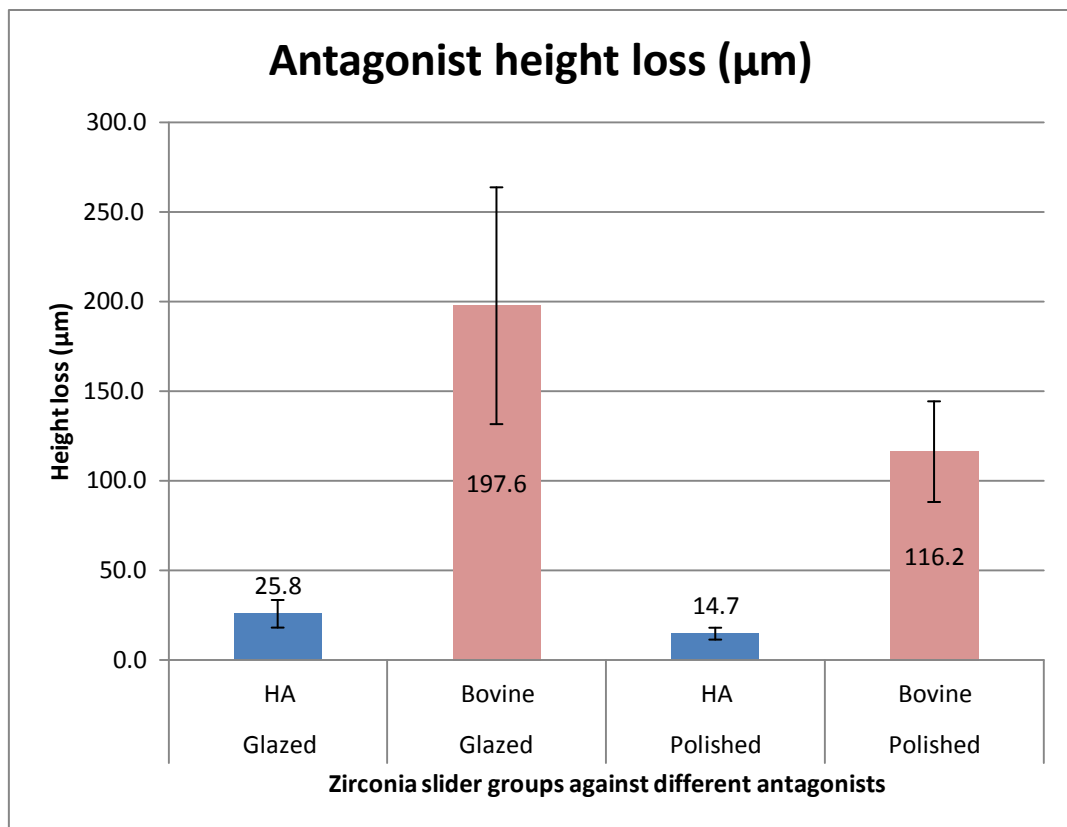
FIGURE 37. Different antagonists (HA, bovine) height loss against glazed/polished zirconia groups.

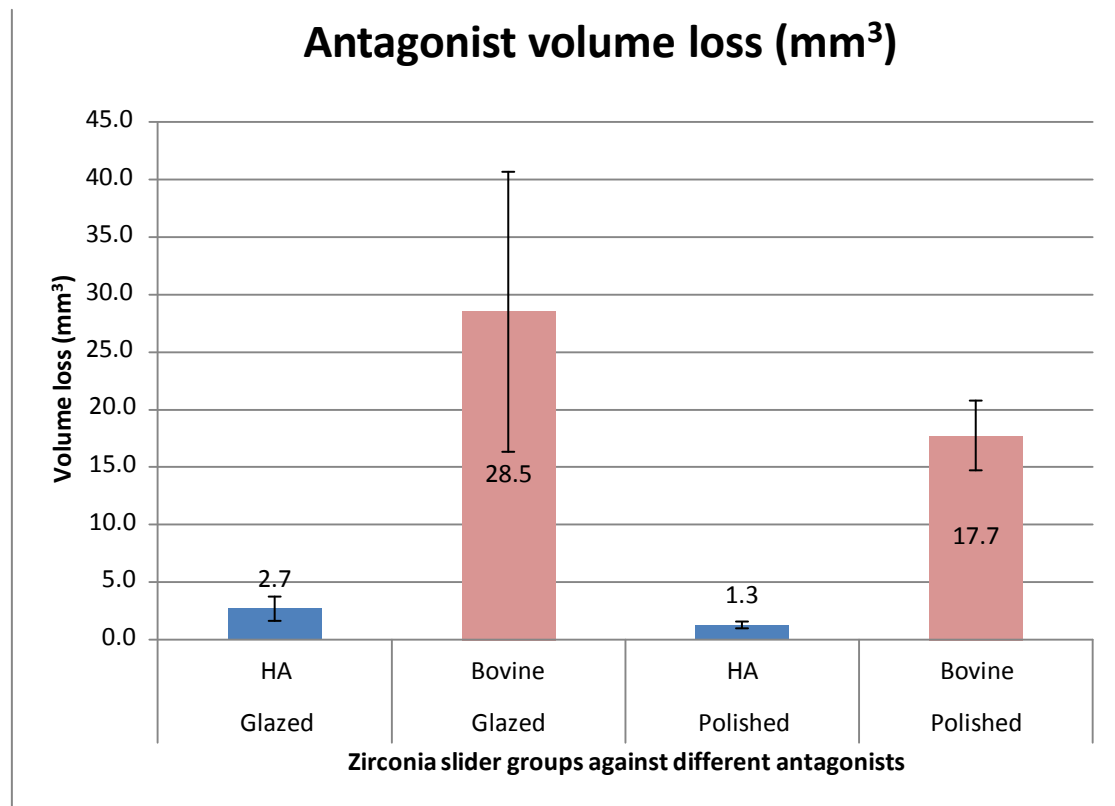
FIGURE 38. Different antagonists (HA, bovine) height loss against glazed/polished zirconia groups.

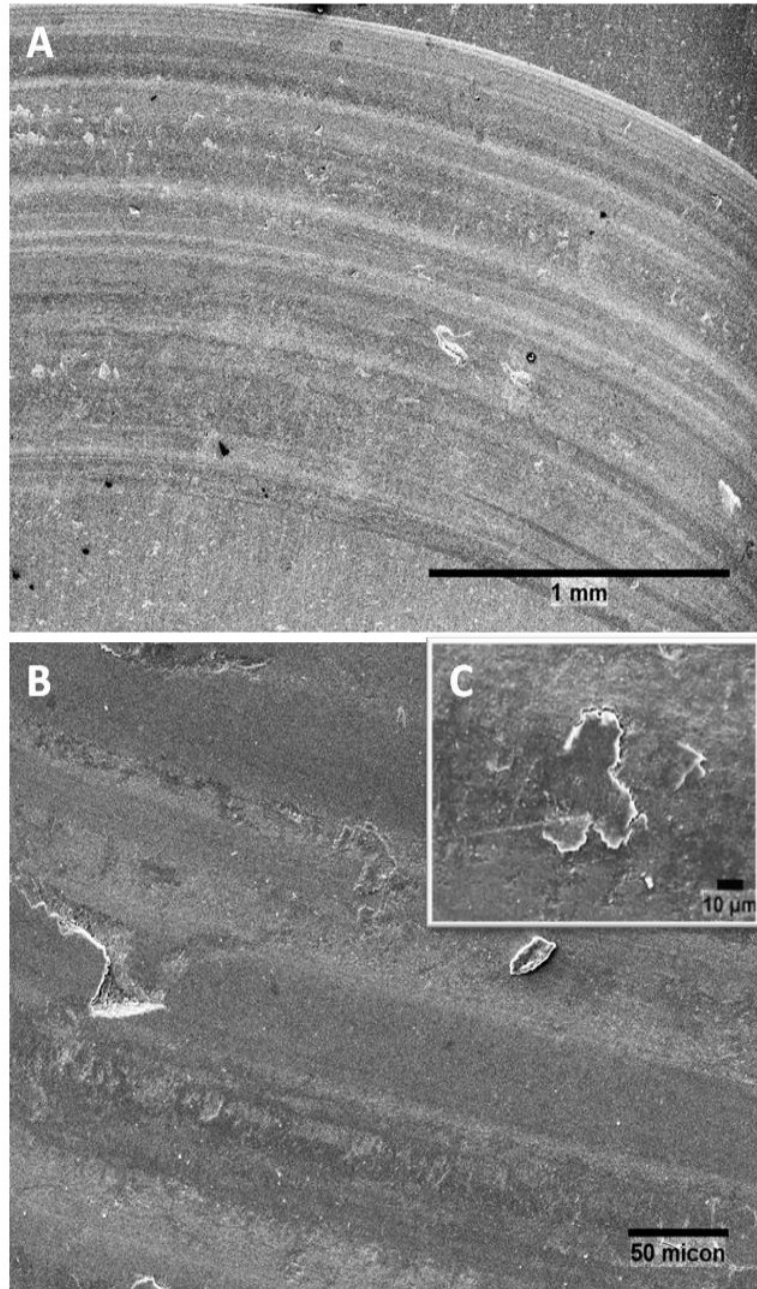
FIGURE39. SEM micrographs at different magnifications (A) X75; (B) X500 and (C) X1500 of the HA surface against group 1 (as-machined zirconia sliders). The surface looks rough with some irregularities and cracks.

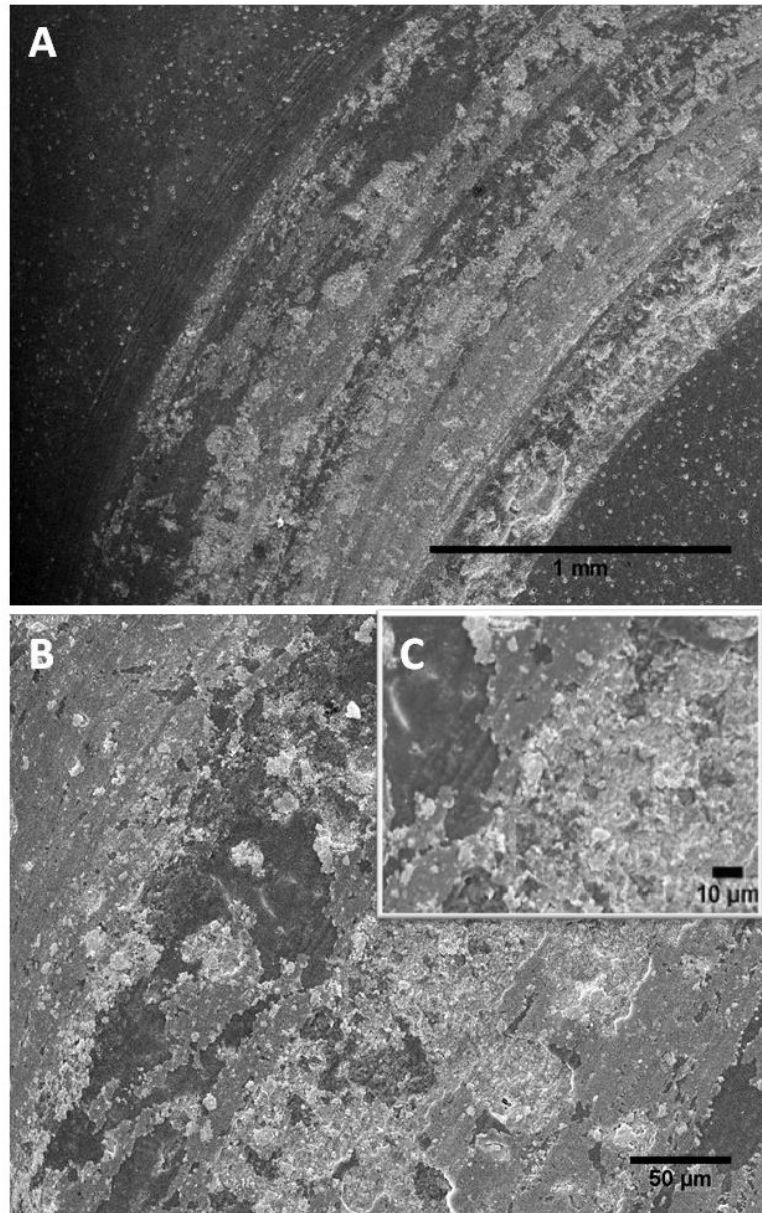
FIGURE 40. SEM micrographs at different magnifications (A) X75; (B) X500, and (C) X1500 of the HA surface against group 2 (glazed zirconia sliders). The surface looks rougher than group 1 with some adherence of glaze material to the HA surface.

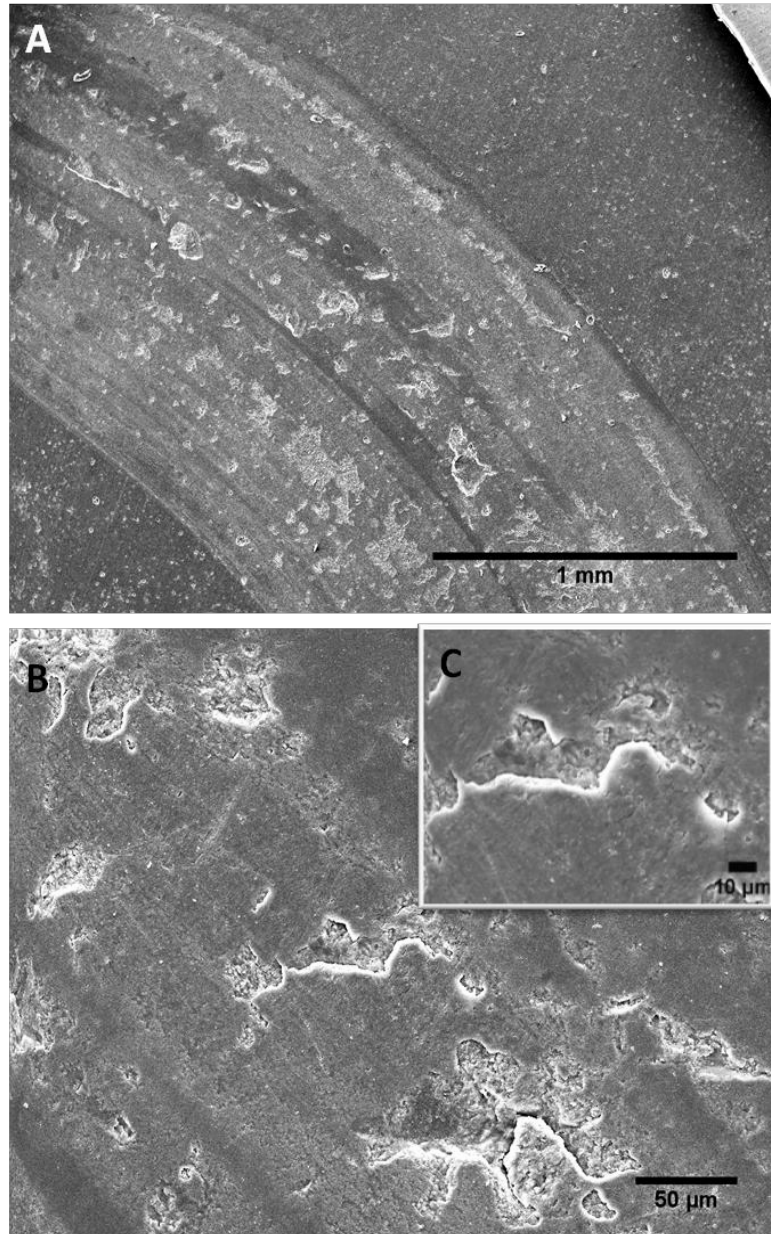
FIGURE 41. SEM micrographs at different magnifications (A) X75; (B) X500, and (C) X1500 of the HA surface against group 3 (bur-finished zirconia sliders). The surface looks rough with some irregularities, cracks, and loss of material.

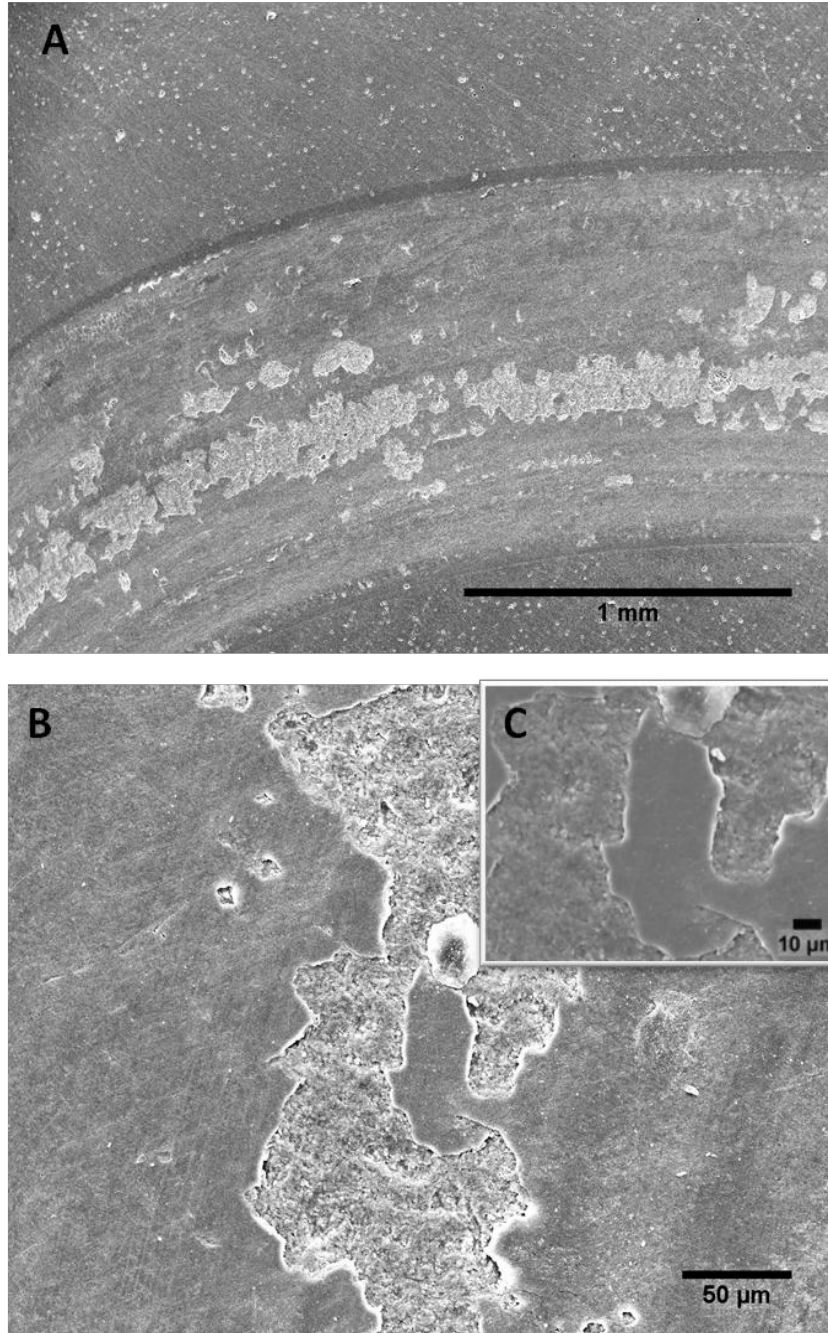
FIGURE 42. SEM micrographs at different magnifications (A) X75; (B) X500, and (C) X1500 of the HA surface against group 4 (bur-finished and polished zirconia sliders). The surface looks smooth with some loss of surface materials.
