Investigation of irradiation effects on highly integrated leading-edge electronic components of diagnostics and control systems for LHD deuterium operation

journal or publication title	Nuclear Fusion
volume	57
number	8
page range	086012
year	2017-06-14
URL	http://hdl.handle.net/10655/00012566

**Investigation of irradiation effects on highly integrated leading edge
electronic components of diagnostics and control systems for the LHD
deuterium operation**

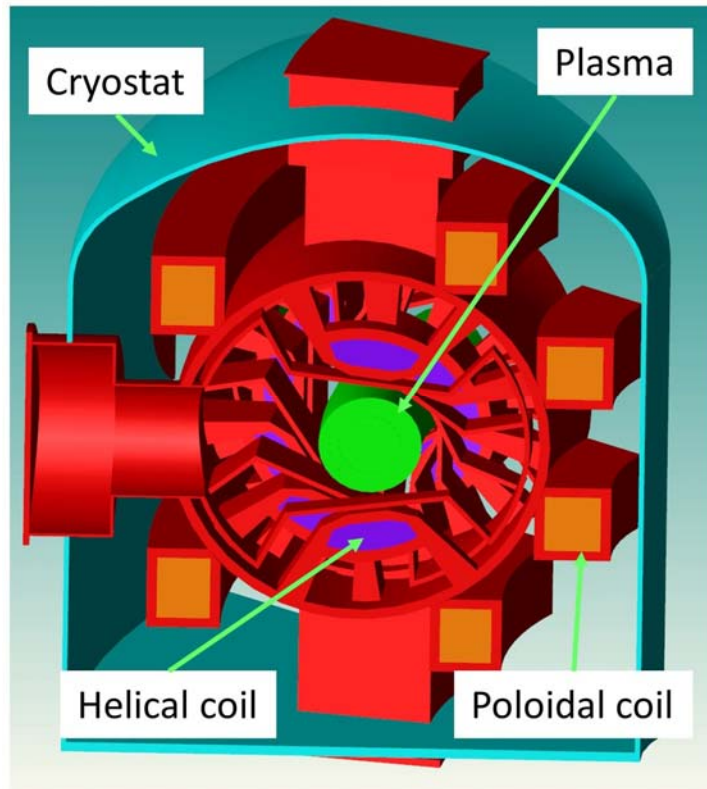
Fig. 1. MCNP Model of LHD. The figure is made with SuperMC [8, 9]

For precise estimation of the radiation field in the LHD torus hall, MCNP6 three-dimensional Monte-Carlo neutronics code [6] is used with the cross-section library of ENDF B-VI [7]. In the MCNP calculation geometry, the LHD components within the support structure are divided by small toroidal angle pitch, and the components are assumed to be toroidally symmetric in a toroidal pitch angle. The geometry in one toroidal pitch angle is modelled based on the CAD drawing with some simplification (Fig. 1). The neutron source is isotropic and homogeneous in the torus with the energy of 2.45 MeV. A three-dimensional map of the radiation field in the LHD torus hall has been obtained. Figure 2 a shows the neutron flux profile in the LHD torus hall and the profile in the basement level of the torus hall at the maximum neutron emission discharge (total neutron emission rate of $1.9 \times 10^{16} \text{ s}^{-1}$). It is found that the neutron flux in the torus hall, and the flux in the basement level are around $10^9 \text{ cm}^{-2}\text{s}^{-1}$ and around $10^6 \text{ cm}^{-2}\text{s}^{-1}$, respectively. Figure 2 b shows the profiles of the dose on silicon (Si),

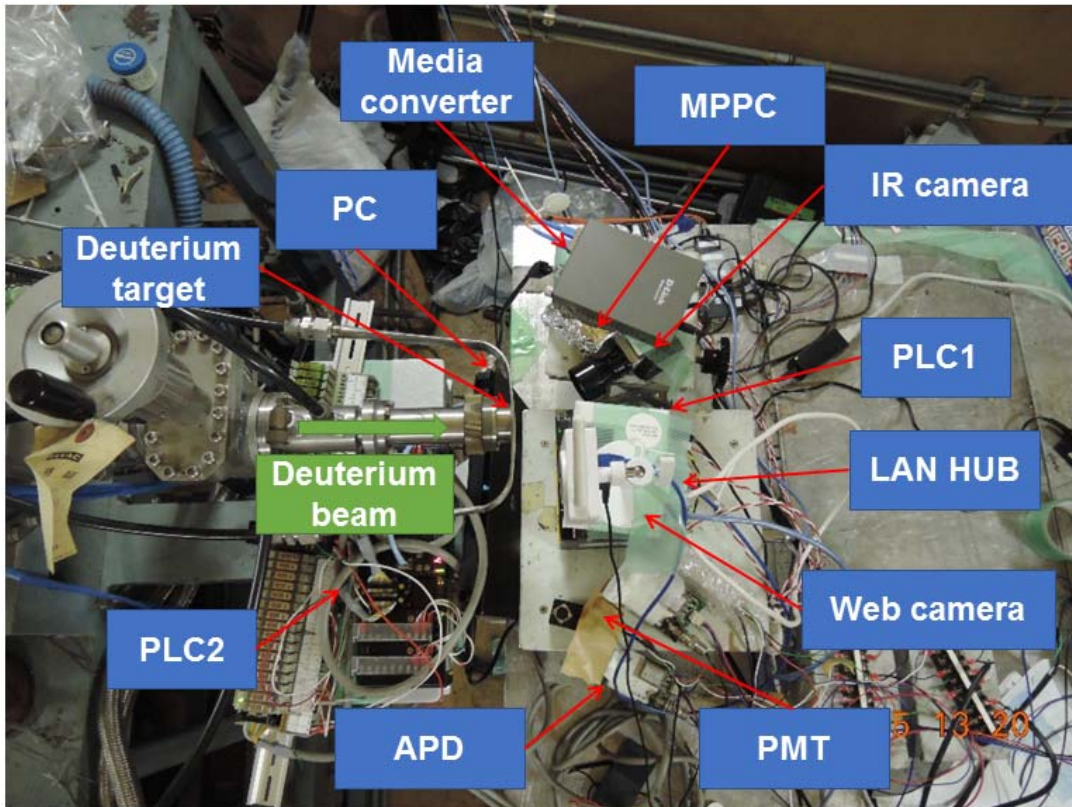
Fig.3 Arrangement of neutron irradiation test in OKTAVIAN.

To investigate the irradiation effect on electronic components used in the LHD torus hall, neutron irradiation tests are performed in the Fast Neutron Laboratory (FNL) at Tohoku University [10] and OKTAVIAN [11]. A PC, a media converter, an infrared (IR) camera, a multi-pixel photon counter (MPPC), a web camera, two avalanche photodiode (APDs), two photomultiplier tubes (PMTs), and PLCs are tested (Fig. 3). In the experiment performed in OKTAVIAN, the total neutron emission rate from the target is up to $9 \times 10^8 \text{ s}^{-1}$, therefore, the neutron flux at 5 cm away from the target, and the flux at 10 cm away from the target are up to $3 \times 10^6 \text{ cm}^{-2}\text{s}^{-1}$ and $7 \times 10^5 \text{ cm}^{-2}\text{s}^{-1}$, respectively. The neutron exposure has been performed for 11.5 hours. The neutron flux in this experiment is two or three orders smaller than the neutron flux in the LHD torus hall and in the same order as the neutron flux in the basement level of the torus hall. The status of all components is monitored remotely from the control room. The results of neutron exposure test are summarized in Table 1. Transient effects due to neutron irradiation are observed on a PC, an IR camera, a web camera, APDs, PMTs and a PLC. Disconnection of the network is observed on the PC at neutron flux of $3 \times 10^5 \text{ cm}^{-2}\text{s}^{-1}$. The frequency of this effect is once per 11 hours. If we assume that the frequency increases linearly with the neutron flux, the PC placed in the torus hall without any shield will experience a disconnection of the network up to once per four shots at the maximum neutron emission discharge of LHD. Here, we assume that the frequency increases linearly because the both ionisation and displacement damage due to radiation on the semiconductor materials increase linearly with the radiation fluence [12]. Note that we classify the effect as transient because the disconnection of the network recovers due to the reboot. Temporal dead pixels

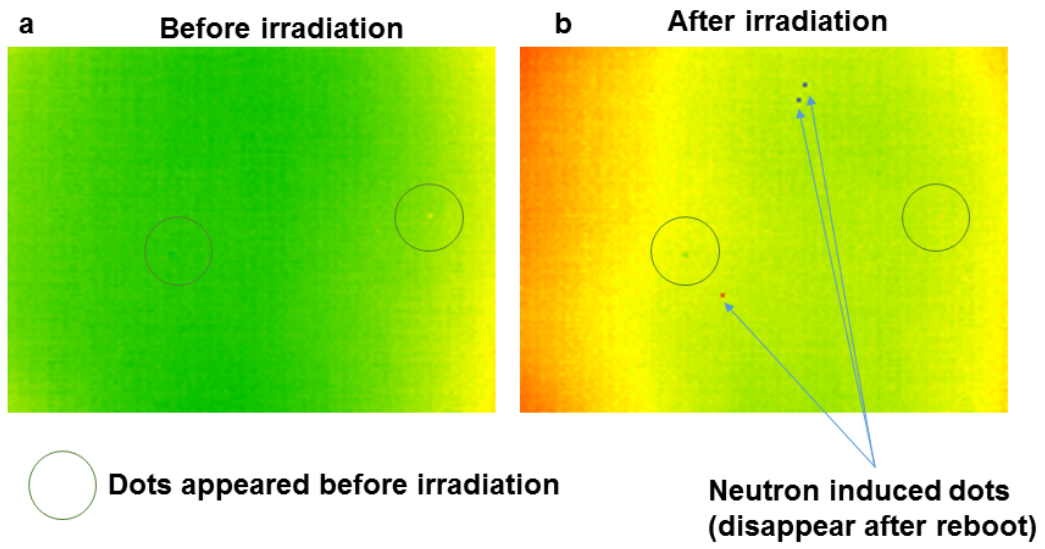
Fig.4 IR camera image taken (a) before neutron irradiation and (b) after neutron irradiation.

due to neutrons appear on the IR camera (Fig. 4). We observed four dots per 3 hours at neutron flux of $7 \times 10^5 \text{ cm}^{-2}\text{s}^{-1}$. Note that the temperature shown in dead pixels is always zero. The IR camera will be installed on the upper port of LHD where expected maximum neutron flux is $10^{10} \text{ cm}^{-2}\text{s}^{-1}$. If the number of dots linearly grows as neutron flux, the number of dead pixels due to neutrons will reach 2 dots per shot. Note that the effect is transient because the dead pixels due to neutrons recover due to reboot. The loss of the image is obtained on the web camera at the neutron flux of $3 \times 10^6 \text{ cm}^{-2}\text{s}^{-1}$ whereas on the neutron flux of less than $3 \times 10^5 \text{ cm}^{-2}\text{s}^{-1}$ the image transfer has no problem. At first, green on the web camera disappears (Fig. 5), therefore, the movie completely disappears even though the connection between the web camera and a PC is stable. The effect is observed once per 11.5 hours, and the expected failure rate in the LHD torus hall is once per forty shots. In PMTs and APDs, we observed neutron-induced pulse with frequency of 23 Hz and 1.5 Hz, respectively. If we put the PMTs and APDs near LHD, where the neutron flux will be $10^{10} \text{ cm}^{-2}\text{s}^{-1}$, we will obtain neutron induced pulse with frequency of 115 kHz and 7.5 kHz, respectively. We observed neutron-induced error at neutron flux of $3 \times 10^6 \text{ cm}^{-2}\text{s}^{-1}$ whereas at neutron flux of $3 \times 10^5 \text{ cm}^{-2}\text{s}^{-1}$ no error is observed on PLC modules. Neutron-induced errors occurred on the PLC three times per 9 hours (Fig. 6). The behaviour of the AC output module is different in each case. In the first case, the output voltage becomes zero when disconnection of the network occurs. However, the second time, the output voltage stays the same even though the network is disconnected. Moreover, the third time, the output voltage shows 10 V (maximum) when disconnection of the network occurs. Note that no permanent effect is observed in this experiment.

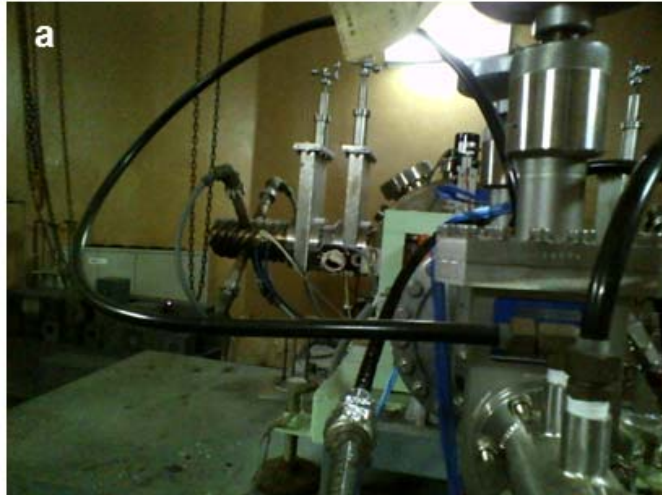
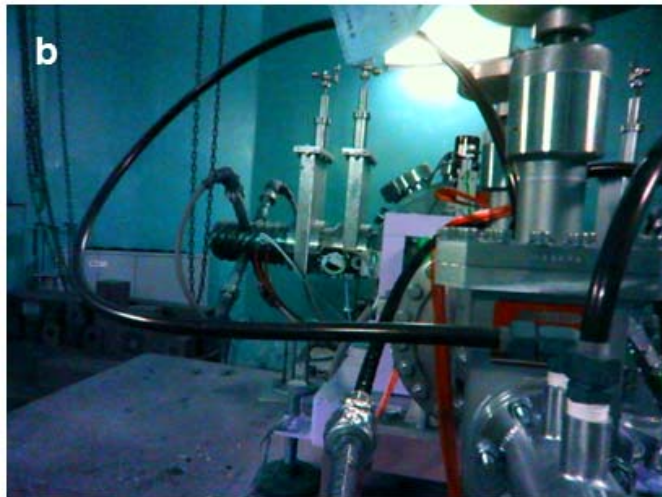
Fig. 5 (a) Normal web camera image. (b) Green on web camera disappears due to neutron irradiation.

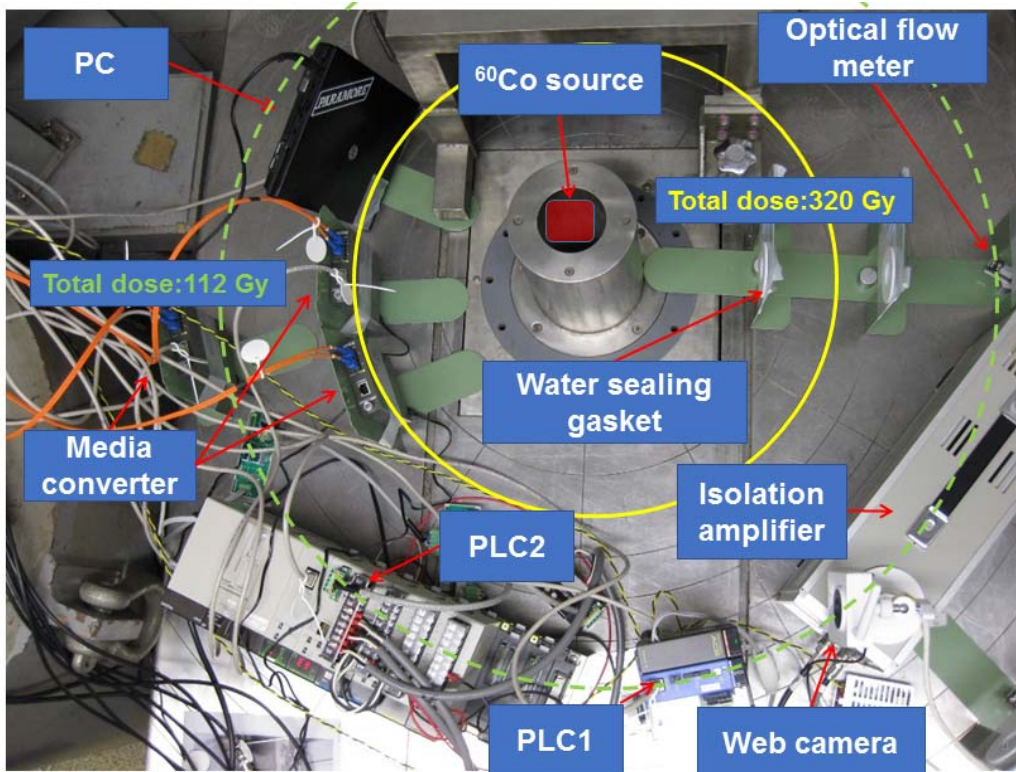
Fig. 7. Arrangement of gamma-ray irradiation test in Nagoya University Cobalt-60 irradiation facility

Gamma-ray irradiation tests are performed in the Nagoya University Cobalt-60 irradiation facility [13]. A PC, two media converters, two optical flow meters, two isolation amplifiers, a web camera, and two PLCs were irradiated (Fig. 7). The gamma-ray dose rate to the silicon (Si), which is a major ingredient of electronics components, evaluated by calculation on the day of the experiment (2015/7/14) is 190 Gy/h at 20 cm from the source, 86 Gy/h at 30 cm from the source, and 30 Gy/h at 50 cm from the source. The results of gamma-ray exposure are summarized in Table 2. No transient effect is seen except for the web camera and the analog terminal of the PLC at the dose rate of 38 Gy/h. The PC is broken at the integrated gamma-ray dose of 224 Gy. The connection of two media converters is stable after the integration dose of 320 Gy. The signal of two optical flow meters is unchanged after the integration dose of 240 Gy. The output signal from the isolation amplifier is stable after the integration dose of 112 Gy. The dot noise due to gamma-ray is observed on web camera. This effect is only observed during the gamma-ray exposure. The output signal from PLC1 and PLC2 is monitored by a PC through the network. The increase of the offset of the analog output is observed from the beginning of the analog output from analog output module (DA04-IN) of PLC1 (Fig. 8). The output signal disappears when the integrated dose reaches 86 Gy, because the connections between the PLC1 and the PC is broken. The mismatch of input and output signals is observed on analog output module (CS1W-DA08V) and Devicenet input module (CS1W-DRM21-V1) of PLC2 at 95 Gy (Fig. 9 a) whereas DA output and AD input signals are same (Fig. 9 b). Both signals disappear at 112 Gy because of CPU-module broke. We tried to reboot both PLCs by inserting and pulling out the power supply plug of the electric apparatus. However, there was no reaction from both PLCs. We found that modules of the PLC are broken around the dose of 100 Gy. This is comparable with the dose in the LHD torus hall over nine years, and the dose is one order smaller than the threshold of the

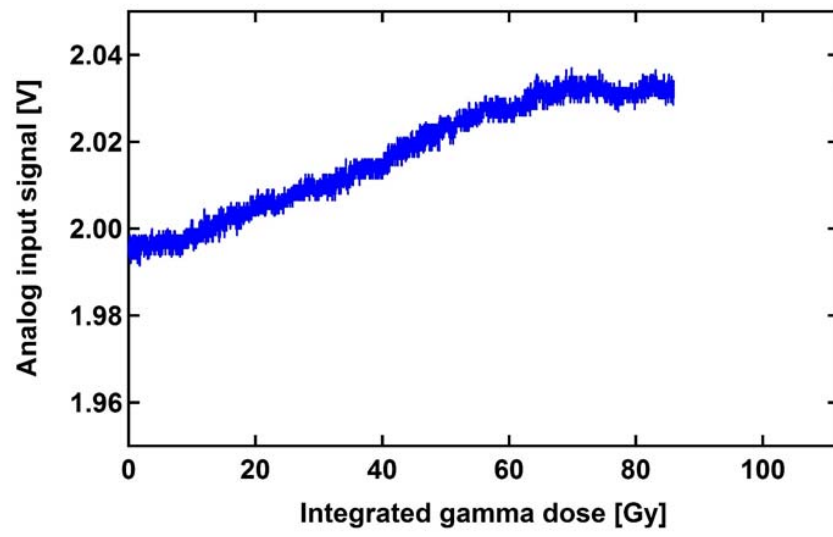
Fig. 8 Offset increase on analog output module due to gamma-ray irradiation.
