CULTURAL RESOURCES MONITORING OF THE SAN ANTONIO WATER SYSTEM PARLAND PLACE WATER AND SEWER MAIN INSTALLATION PROJECT, SAN ANTONIO, BEXAR COUNTY, TEXAS

FINAL REPORT (Redacted)

Cultural Resources Report No. 18-015 ASF18-014-00

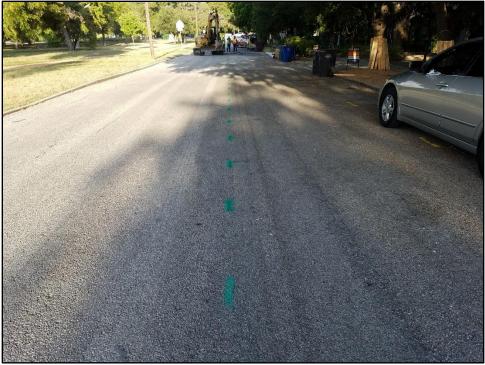
Figure 5-1. Overview of the APE with new sewer main marked in green, facing west.

The APE consisted of a city street flanked by residential housing to the north and a city park to the south (**Figure 5-1**). Topography along the western end of the APE was generally level, but increased in elevation by a 5-10 percent slope, roughly mid-way through the monitoring area. Monitoring investigations for the new sewer main installation were conducted from August 27–31, 2018, and investigations for the new water line were completed on October 22–25, 2018. All excavations were conducted by a backhoe, and all spoil matrix (with the exception of asphalt fragments) were deposited on the ground surface adjacent to the trench for use as backfill material.

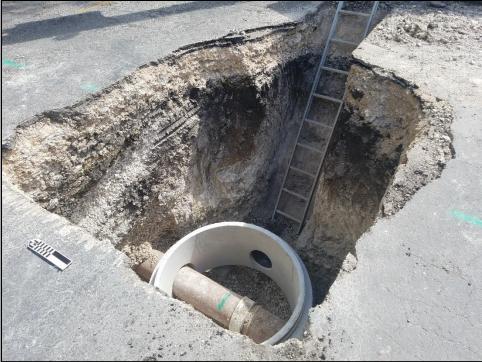
Figure 5-3. Installation of new sewer manhole at the junction of an existing SAWS sewer main, facing northeast.

Excavations began with the location of the existing sewer line and the installation of a new manhole at the western end of the APE (**Figure 5-2**). Excavations for the new manhole measured 5 feet by 5 feet (1.5 m by 1.5 m) and were excavated to 8 feet (2.4 m) deep in order to expose the existing SAWS sewer main (**Figure 5-3**). The existing main projected north to south and multiple existing manholes associated with the utility were observed within the immediately vicinity of the Project Area (see **Figure 5-2**). Disturbance from the existing utility was observed within the northern and southern profile walls of excavation box, but no cultural deposits or features were observed throughout the remaining profile.

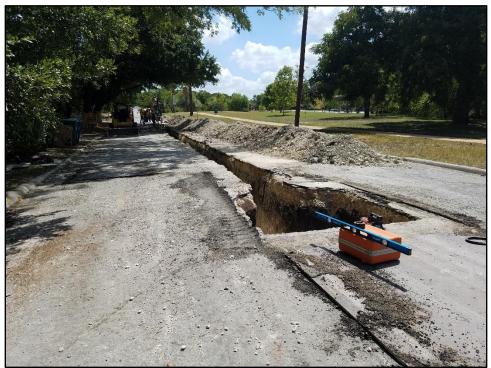
Figure 5-4. Overview of sewer main installation excavations within the APE, facing southeast.

Once the new manhole was installed, trenching excavations for the new sewer main projected east, toward Milton Street (**Figure 5-4**). Excavations measured 3 feet (1 m) wide and 8 feet (2.4 m) deep. The average soil profile for the western end of the APE consisted of (**Figure 5-5**):

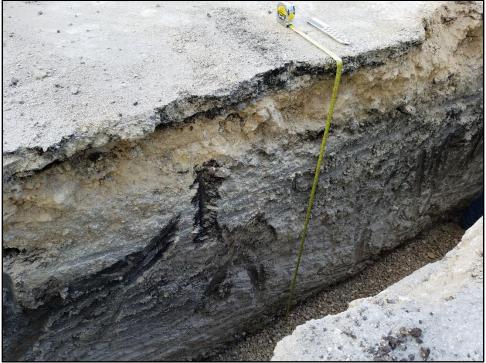
Figure 5-5. Average soil profile at the western end of the APE during sewer main installation excavations, facing southwest.

Soils appeared to be intact stratigraphic deposits, uniform throughout. As excavations continued east and neared the base of an upland slope, the soil profile transitioned into shallower deposits of eroding bedrock overlain with a layer of dark silty clays with chert grave inclusions (**Figure 5-6**):

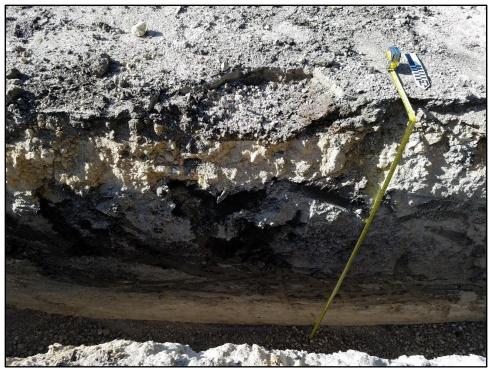
Figure 5-6. Average soil profile at the center of the APE during sewer main installation excavations, facing south.

- 0 to 4 inches (0 to 10 cmbs)–asphalt;
- 4 to 12 inches (10 to 30 cmbs)–gravel construction base;
- 12 to 39 inches (30 to 100 cmbs)–10YR 3/2 very dark grayish-brown silty clay with less than 2percent chert gravel inclusions;
- 39 to 63 inches (100 to 160 cmbs)–10YR 4/1 dark gray clay with 5-percent calcium carbonate nodules and 5 to 10-percent chert gravel inclusions;
- 63 to 67 inches (160 to 170 cmbs)–10YR 6/2 light brownish-gray clay with 60 to 70-percent eroding bedrock/marl;
- 67 inches to 91 inches (170 to 230 cmbs)–10YR 7/1 light gray eroding bedrock/marl, no friable limestone rock observed.

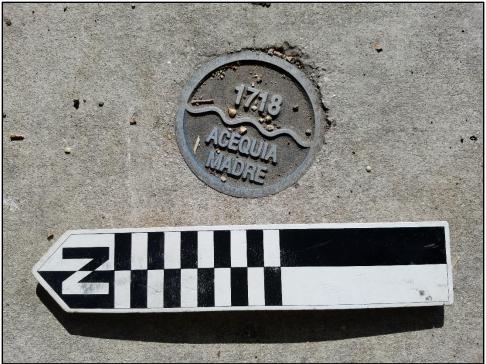
Figure 5-7. Acequia medallion set in the northern sidewalk of the Parland Place ROW.

As soils transitioned near the center of the APE, excavations approached the projected alignment of the *acequia*. Field documentation observed a metal medallion set into the sidewalk near the residential dwelling at 135 Parland Place (**Figure 5-7**). The medallion was engraved with "1718/*Acequia* Madre", with a water line symbol illustrated (**Figure 5-8**). The orientation of the water line (approximately a 220-degree orientation) appeared to correlate with the projection of the *acequia* as depicted on the COSA OHP *Acequia* Maps. However, sewer main excavations within the vicinity of the projection did not identify any evidence of the *Acequia* Madre *de Valero*.

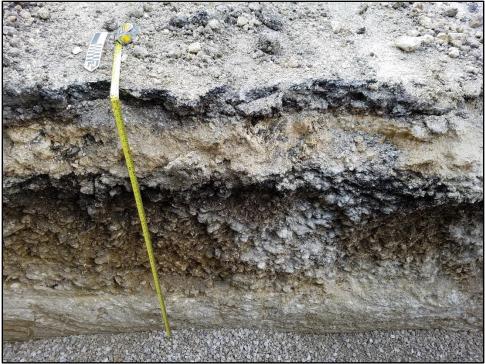
Figure 5-9. Average soil profile at the eastern end of the APE during sewer main installation excavations, facing south.

Monitoring investigations of the remaining western APE documented another soil transition as excavations ascended the gently sloping (5 to 10-percent slope) terrace. Chert gravel and cobble inclusions (5 to 10 cm in diameter) dramatically increased to 60 to 80-percent, with evidence of some sandy matrix observe near the lower levels of excavation. The average soil profile of the eastern APE consisted of (**Figure 5-9**):

- 0 to 4 inches (0 to 10 cmbs)-asphalt;
- 4 to 12 inches (10 to 30 cmbs)-yellow gravel construction base;

- 12 to 39 inches (30 to 100 cmbs)–10YR 3/2 very dark grayish-brown clay loam with less than 2percent calcium carbonate inclusions and 20 to 30 percent chert gravel/cobble inclusions;
- 39 to 51 inches (100 to 130 cmbs)–10YR 4/2 dark grayish-brown clay loam with less than 2-percent calcium carbonate inclusions and 40 to 50 percent chert gravel/cobble inclusions;
- 51 to 63 inches (130 to 160 cmbs)–10YR 3/4 dark yellowish-brown clay loam with 60 to 80 percent chert gravel/cobble inclusions;
- 63 to 65 inches (160 to 165 cmbs)–10YR 5/6 yellowish-brown sandy loam with 80 to 90 percent chert gravel/cobble inclusions;
- 65 to 91 inches (165 to 230 cmbs)–10YR 6/1 gray, 10YR 8/1 white, and 10YR 7/6 yellow mottled clay.

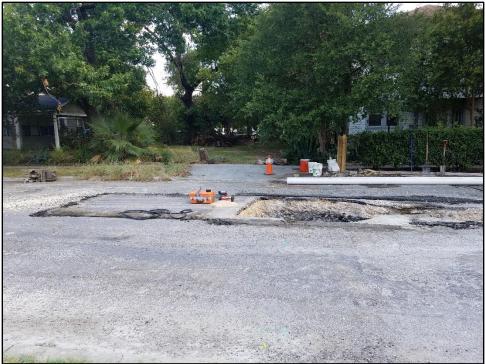
Figure 5-10. Overview of grassy ditch projection in relation to APE and new sewer main manhole installation, facing north.

Overall, no cultural deposits or features of any temporal affiliation were observed during the new sewer main installation. Furthermore, no subsurface evidence of the *Acequia Madre de Valero* was observed during trenching excavations. However, field observations of the general Project Area identified a grassy ditch to the northwest of the APE, within an empty residential lot (**Figure 5-10 and 5-11**). The ditch measured between 6.5 to 8 feet (2 and 2.5 m) wide, approximately 12 to 18 (30 to 46 cm) deep, and

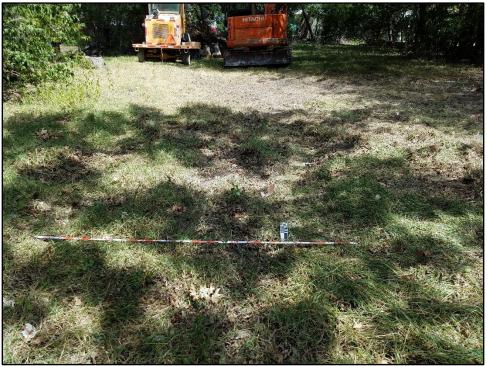
Figure 5-12. Overview of grassy ditch to the northwest of the APE, facing north.

projected at a 186-degree orientation (**Figure 5-12**). A single, small palm tree is located within the ditch at its intersection with the Parland Place ROW. No evidence of the ditch was observed south of the Project Area or within any of the residential lots along the Funstone Place ROW, south of the APE. Observation of the lot to the north of the grassy ditch, along Elmhurst Avenue, also showed evidence of the ditch; however, the northern lot appears to be been heavily modified from parking lot construction and building demolition. At the time of the sewer main investigations, it was unclear if the grassy ditch served as an atypical drainage ditch, or if it represented a remnant of the *Acequia Madre de Valero*.

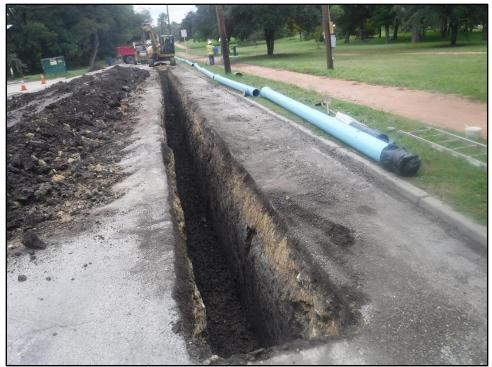
Figure 5-13. Overview of water main installation excavations along the southern boundary of the Parland Place ROW, facing east-southeast.

In order to determine if the ditch observed to the north of the Project Area was a remnant of the *Acequia Madre de Valero*, an additional 50-foot (15 m) section of water main excavations immediately west of the APE was also monitored for cultural resources. Water main excavations within the extended APE were monitored from October 22–26, 2018, beginning east of the Broadway Street–Parland Place intersection. Trenching was conducted south of the new sewer main alignment, along the southern Parland Place ROW, and measured 2 feet (61 cm) wide and 5 feet (1.5 m) deep (**Figure 5-13**).

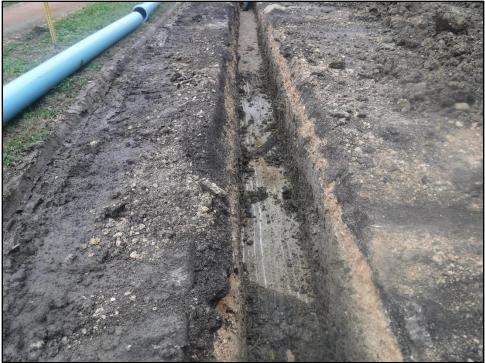
Figure 5-14. Modern concrete slab observed within the extended APE monitoring area, facing west.

Monitoring investigations observed heavily disturbed soils at the western end of the extended APE, associated with underground utility installations, including existing sewer, water, and storm drain easements. A 33 foot (10 m)-long concrete slab was also observed at 4.5 feet (1.4 m) below surface in the area where the grassy ditch projection would have intersected the new water main excavations (**Figure 5-14**). It is unclear if the concrete slab is the structural remains of a building that may have once occupied the area prior to the construction of the Parland Place ROW (circa 1912–1951), or is associated with an existing underground utility. The fine-grain, grey concrete construction matrix suggests a modern-construction and supports the theory of an existing underground utility.

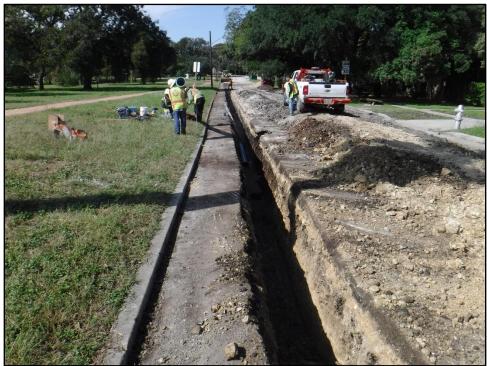
Figure 5-15. Overview of water main installations within the APE, facing west.

Continued monitoring investigations for the remaining APE observed the same soil stratigraphy as that was observed for the sewer main installation excavations (**Figure 5-15**). Overall, no cultural deposits or features of any temporal affiliation were observed during the new water main installation. Furthermore, no subsurface evidence of the *Acequia Madre de Valero* was observed.
