RESEARCH ARTICLE

Investigation of 9000 hours multi-stress aging effects on High-Temperature Vulcanized Silicone Rubber with silica (nano/micro) filler hybrid composite insulator

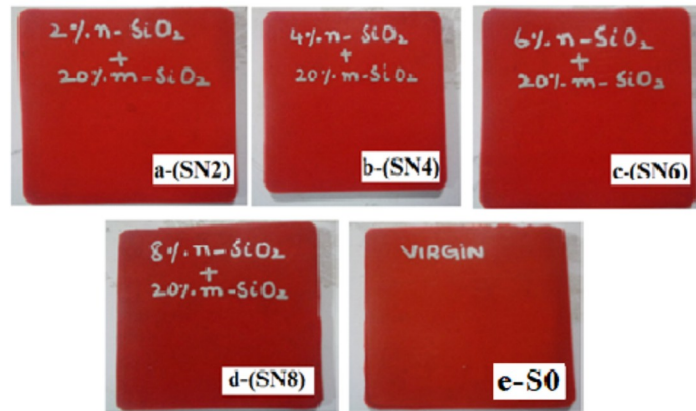
Fig 1. Original Samples, a- SN2, b-SN4, c-SN6, d-SN8 and e-S0.

Nano (size: 12 nm, density: 2.1 g/m^3) and micro (size: $5 \mu\text{m}$, density: 2.52 g/m^3) silica are acquired from Sigma Aldrich. All other chemicals used for the preparation process are of industrial grade. Methyl vinyl silicone rubber (colorless, molecular weight: 5800000, vinyl %:0.09, density: 2.54 g/cm^3) is procured from DOW Corning, USA. Mixing and compounding method is used for the preparation of the sample. First of all, the fillers are suspended in 0.1 liter of ethanol. The mixture is stirred for 20 minutes. For preparation of the homogeneous mixture of filler in ethanol, ultrasonification is applied on the sample for 30 minutes. Silicone rubber is added in this solution under the process of sonication. For the removal of ethanol, the mixture is heated for an hour at 100°C . Later, it is placed in the mixture at 150 revolutions per minute (rpm) for 20 minutes at 150°C . This mixture is placed in pre-heated molds to get the required shape and size. The samples are cured at 170°C for 30 minutes. SiO_2 nanoparticles with varying percentages of 2%, 4%, 6%, 8% are added in the HTV-SiR base material, keeping the percentage of micro silica constant (20%). A neat sample (S0) is also prepared along with the hybrid samples. The composition of all the samples is shown in Table 1. Fig 1 presents the photographs of all the samples.

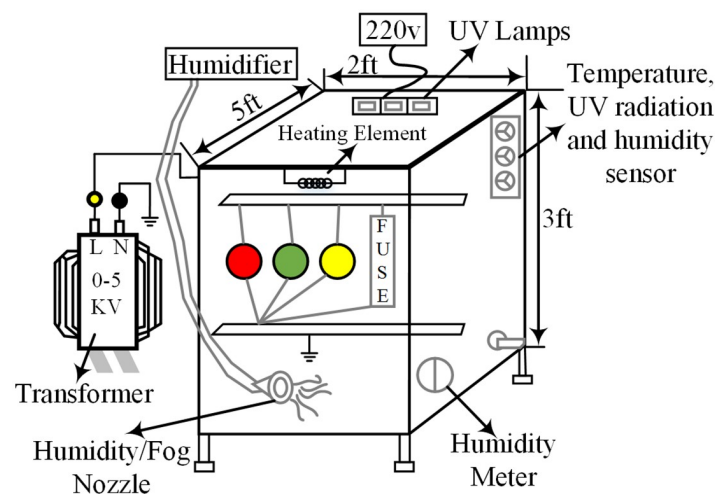
Fig 2. Aging chamber.

Depending upon the stresses applied on the sample, a chamber is fabricated to stimulate the aging environment. A $5\text{ft} \times 3\text{ft} \times 2\text{ft}$ plexiglass chamber is prepared as shown in Fig 2. The original picture of the aging chamber placed in the laboratory is shown in Fig 3. The samples are placed and stresses are applied simultaneously. A step up variac transformer of 220V/5kV is used to apply the electric stress. For the environmental stresses, UV radiations, heat, acid rain, fog, and humidity are applied. For UV radiation, three 20 watt UV lamps are installed in the chamber. 1000 Watt heater along with a controller is used to provide the desired amount of heat to the samples. For humidity, a humidity measuring element is used. The samples are placed in a chamber for 9000 hours. Summer and winter cycles are created and aged according to the conditions as shown in Table 2.

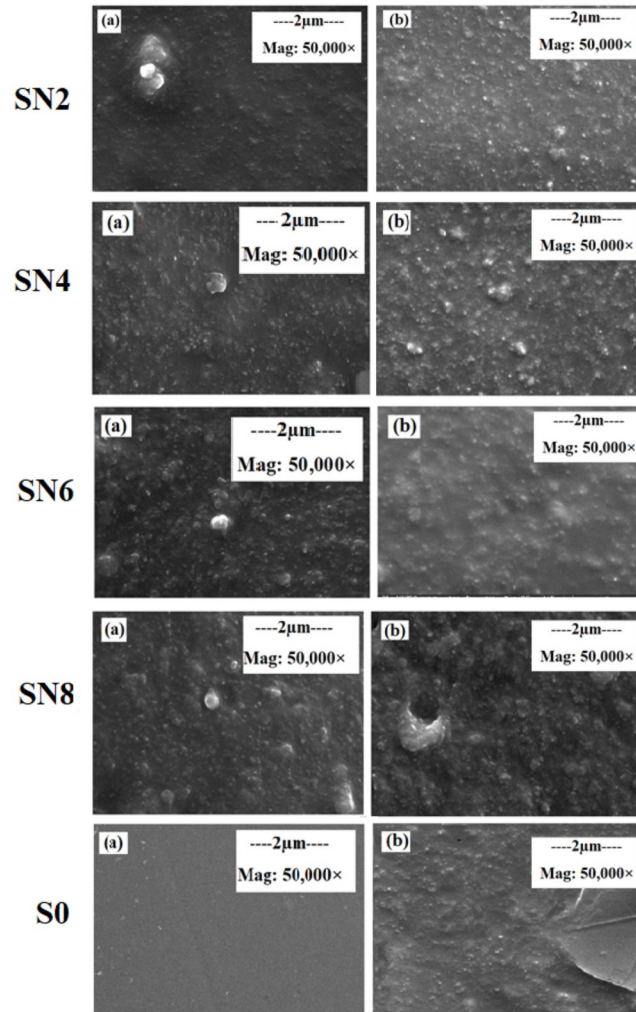
Fig 4. SEM a) Before aging, b) After aging of 9000 hours.

Scanning electron microscopy is performed to study the morphology of neat as well as hybrid samples. SEM analysis is conducted using field emission scanning electron microscope (FESEM, Hitachi U-5000, Japan). Fig 4 presents the SEM images for unaged and aged samples.

After aging, S0 has small cracks on the surface of the sample as compared to the hybrid samples. All the hybrid samples appeared to be less rough with less/no cracks on the surface. However, among all the hybrids, SN2 had higher surface intactness and less surface roughness as compared to the other hybrids. Therefore SN2 sample is less affected by the aging conditions. The main reason for better intactness of the surface in case of hybrid after 9000 hours of aging is due to the large surface area of nano-silica and the excessive presence of silanol group in case of the hybrids. So, the S0 sample without any nano-silica showed the highest degree of degradation when compared with the filled samples.

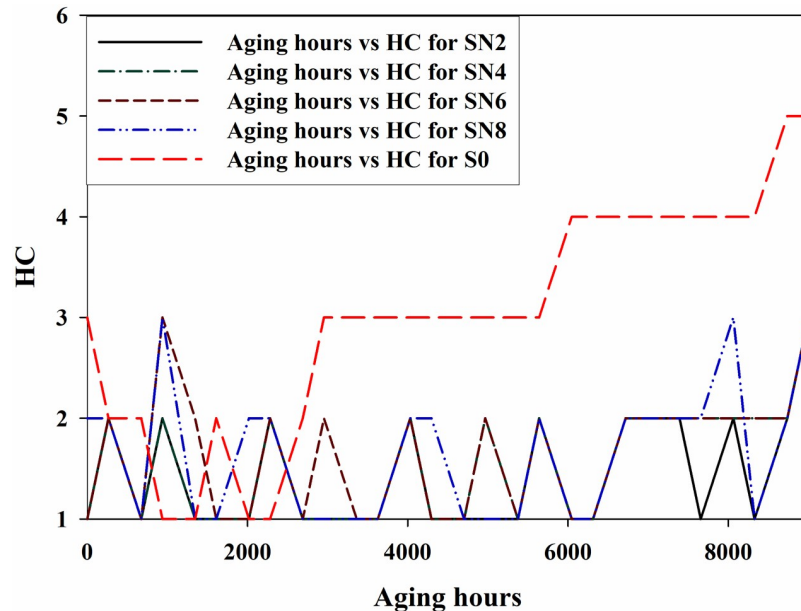
Fig 6. Silicone reaction mechanism with ozone.

chain to low weight molecules (LWMs). The deterioration of the insulation is caused by initiation of chain reaction forming stronger polar bonds, such as $-OH$, $-C=O$ and $C-O$. These bonds start the molecular structure's cross linking, tree and pore formation. The reaction of the mechanism is given in Fig 6. The high HC level is due to the microscopic conductive paths. In [23, 24], the loss of hydrophobicity is due to the algae contamination. However, the recovery in the HC level is because of the movement of lower molecular chains to the surface. Figs 7 and 8 show HC before and after aging results.

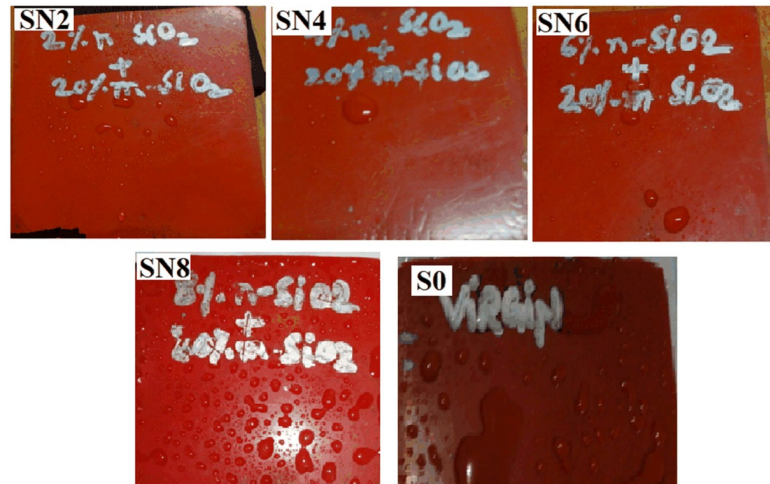
Fig 8. HC after 9000 hours of aging.

The recovery phenomenon is observed by all samples and it is the characteristic of a base material [23]. This recovery phenomenon is more pronounced in the hybrid samples as compared to S0. The main reason for the improved performance of hybrids (SN2, SN4, and SN6)

is due to the better interface of micro and nano-silica with the base material. In case of SN8, the higher loading of the nano-particle gives the saturation effects and instead of increasing the filler and base material interaction, it simply decreases the filler and base interaction. Therefore, increasing the hydrophobicity level.

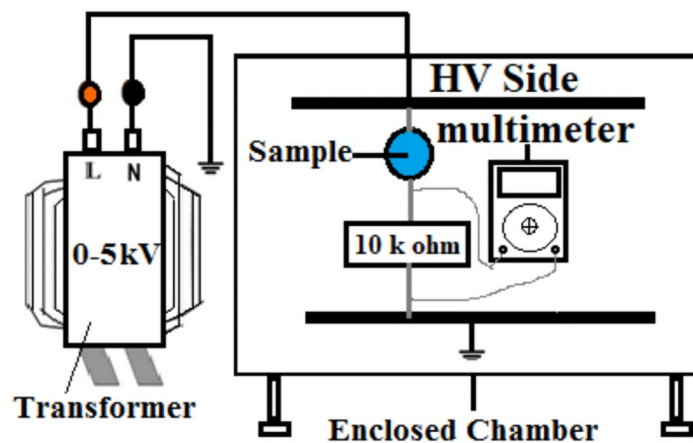
Fig 9. Leakage current setup.

LC is a promising parameter for accessing the condition of an insulator when placed in the field [25]. Closed chamber is utilized for measuring the LC. The enclosed chamber and setup is shown in Fig 9. A 10 k Ω resistor is placed in series with the polymer and a 2kV source voltage is applied. Voltage is measured across the sample with the help of a multimeter. Consecutive five values are measured to calculate an average value. LC value is obtained by using the Ohm's law. The LC is measured for every winter and summer cycle for 9000 hours of artificial aging.

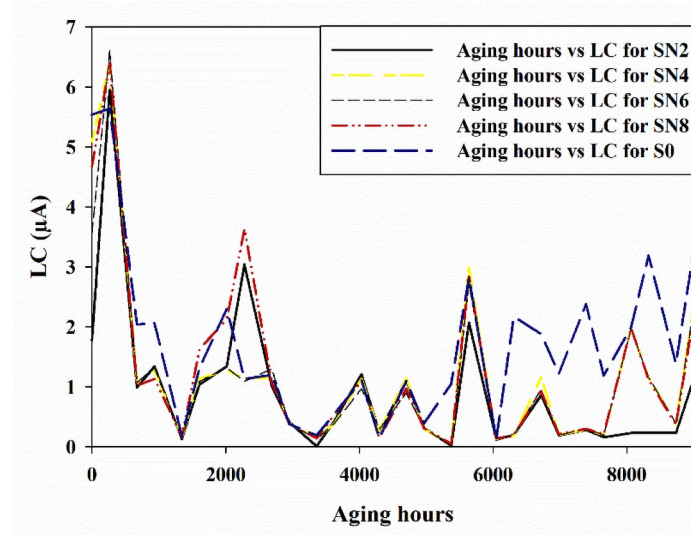
Fig 10. Leakage current aged from 0 hours-9000 hours.

The values are recorded at 40% humidity and 25°C as LC values are greatly affected by the variation in temperature and humidity [20]. The LC is presented in Fig 10 for every summer and winter cycle for the entire 9000 hours of aging.

Without stress application, the highest LC value of 5.54 μA is calculated for S0 sample, whereas the lowest LC of 1.77 μA is for the SN2 sample. As the aging started, an increase in the value of LC was observed for all the samples. The reason for this increase in LC is the relocation of the methyl group [16]. The highest value for the entire aging time of 9000 hours is measured at 264 hours of 6.6 μA by the sample SN6. However, after the increase in LC, all the samples initiated to recover themselves. Our hybrid samples SN2, SN4, and SN6 have the lowest LC value as compared to the S0 sample throughout the artificial aging.

However, SN8 exhibited higher values as compared to the S0 sample. After 2000 hours of aging, again rise in LC is observed and then again recovery pattern is observed. Around 5500 hours, the rise in LC and after that recovery in the LC is measured. The recovery after 5500 hours is not as significant as it is after 2000 hours of aging. At the end of the aging, all the samples showed a trend in the increased values of LC values.

After aging, the highest LC of 3.27 μA is exhibited by the S0 sample and the lowest LC of 1.77 μA is exhibited by SN2 sample. Three hybrids SN2, SN4, and SN6 showed exclusively improved performance as compared to the S0 sample.

Overall, SN2 sample is the one with lowest LC values and thus less affected by the aging stresses. The main reason for increase in LC and less recovery is because of degradation in the polymer due to its exposure to the UV radiation. This phenomenon of the polymer degradation is also observed by other authors [26].

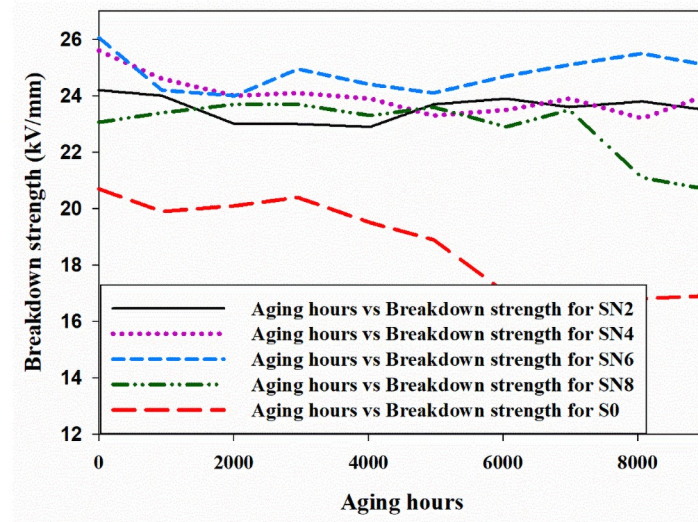
Fig 11. Breakdown strength.

The breakdown strength is evaluated according to the standard ASTM D-149. The voltage rise of 200 V/s with a frequency of 50 Hz is used for this test. Dimensions are selected according to the section II and type II electrodes are used. Electrodes and sample are dipped in oil during the breakdown test.

From Fig 11, it can be deduced that the highest breakdown value is measured for the SN6 sample whereas the lowest value is observed for S0 sample. S0 samples have the lowest breakdown strength for the entire 9000 hours of artificial aging. Breakdown strength is reduced after aging for all the hybrids. Between 2000 hours to 4000 hours, a similar trend in the values are observed for all the samples. After that, loss and gain recovery pattern is noticed for all the samples. SN6 sample started recovering itself after 6000 hours, whereas SN2, SN4, and SN8 again loss breakdown value around 6000 hours of aging. The lowest breakdown strength is exhibited by S0, thus making it the worst option among all the samples after aging. All the hybrid samples responded significantly to the multi stresses, whereas S0 sample is highly affected by the applied stresses. Among all the hybrid samples, SN8 is the one with the lowest breakdown strength value of 23.06 kV/mm. Still this value is higher as compared to the virgin sample. Overall, the hybrids have superior performance in breakdown strength after 9000 hours of aging.

The improved result in case of hybrid is due to the better cross-linking between the nano and micro filler with the base material. This addition of nano and micro filler provides the higher bond energy, homogenous structure, and less surface energy, which results in improved breakdown strength. It was observed that the addition of nano and micro filler improves the breakdown strength [27]. Similar behavior in the case of hybrid is noticed in our research.

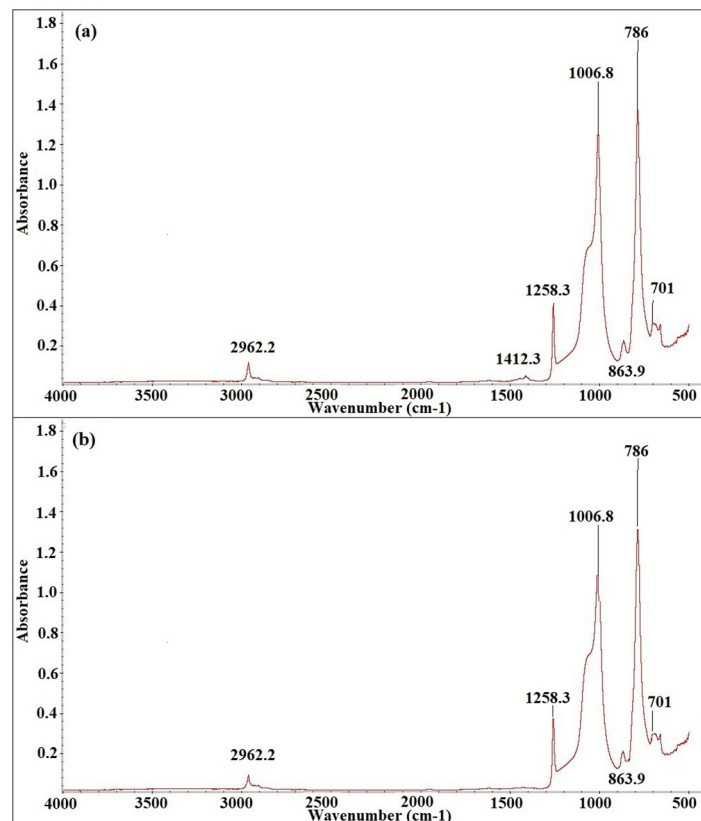
Fig 12. Spectrograph for SN2 a) Before aging, b) After aging.

In Fig 12, the wavenumber and their respective absorbance peaks are shown for SN2. The certain absorbance peaks indicates the presence of important wavenumber numbers. The absorbance peaks are compared with the un-aged sample peaks throughout the aging time. Variation in the magnitude of the peaks show the degradation in the samples caused by the applied environmental stresses. From Fig 12, it can be observed that the wavenumber at 1440–1400 (cm-1) with bond CH₃ in Si-CH₃, is the only one that loses itself completely at the end of the aging. The wavenumbers at 2963–2850, 1280–1240, 1130–1000, 840–790, and 870–850 (cm-1) with bonds C-H in CH₃, Si-CH₃, Si-O-Si, Si(CH₃)₂, Si-O in O-Si(CH₃)₃, and Si- of Si-(CH₃)₃ lose 16.8%, 13.2%, 10.2%, 7.5%, and 5.14% at the end of 9000 hours of accelerated

aging. A gain and loss pattern is found in all the samples. The loss pattern is found till 6000 hours, however the gain pattern is found around 7000 hours of aging. Then again a loss pattern is observed for all the samples. Wavenumber at 1440–1400 (cm^{-1}) is the only wave which does not exhibit gain pattern at 7000 hours of aging.

Figs 12–16 show before and after spectrographs for SN2, SN4, SN6, SN8, and S0. All the important intensities of the specific wavenumbers for all the samples are presented in the S1 File.

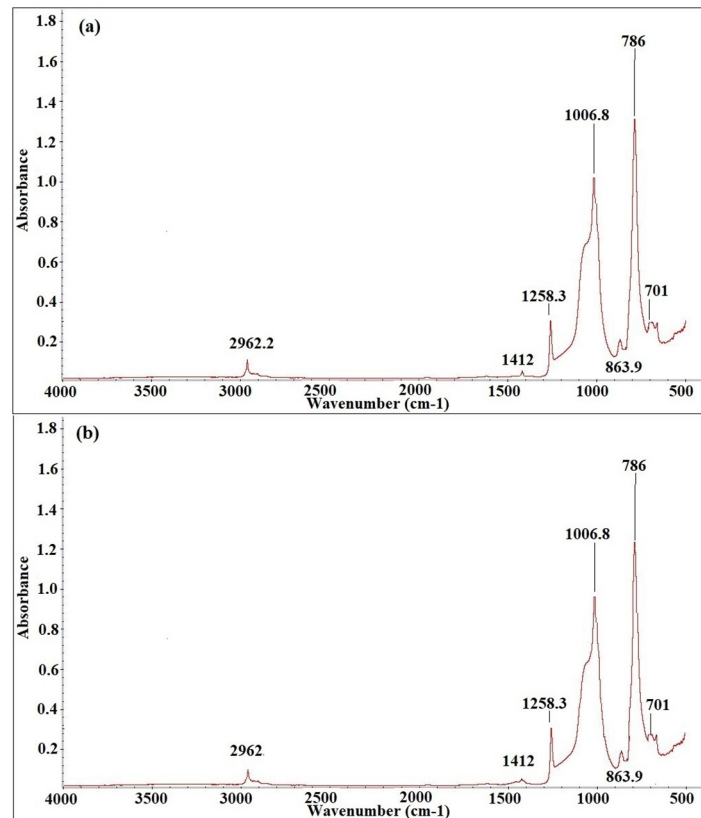
Fig 13. Spectrograph for SN4 a) Before aging, b) After aging.

In Fig 13, the spectrograph for SN4 with important wavenumber before and after aging can be observed. As the aging started, the sample started losing the intensity of certain peaks. At 936 hours, the percentage loss for wavenumbers 1258, 1008, 864, 786, and 700 (cm^{-1}) for bond Si-CH₃, Si-O-Si, Si(CH₃)₂, Si-O in O-Si(CH₃)₃, and Si- of Si-(CH₃)₃ is 1.62%, 3.15%, 11.37%, 0.8%, and 3.125%. Thus the aging started to show its effect on the structures of the important wavenumbers. Overall, loss and recovery pattern is found in this sample. Later, a gain pattern is found after 8000 hours of aging till the end. After 9000 hours of aging, the bonds C-H in CH₃, Si-O-Si, Si(CH₃)₂, Si-O in O-Si(CH₃)₃, and Si- of Si-(CH₃)₃ have the percentage loss of 9%, 25%, 19%, 8, and 14%.

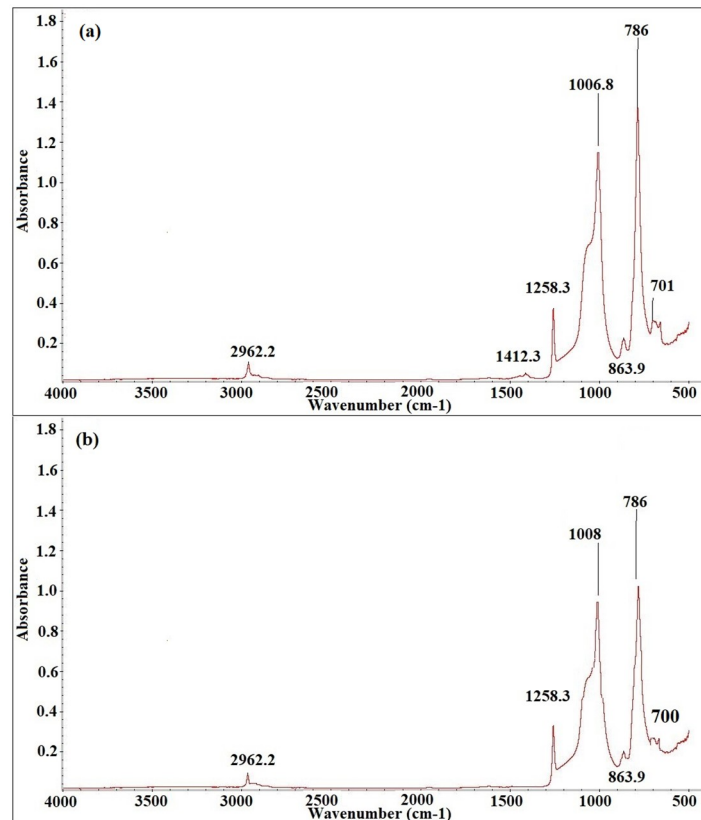
Fig 14. Spectrograph for SN6 a) Before aging, b) After aging.

Fig 14 presents the variation pattern in wavenumber in spectrograph for SN6 before and after aging. Around 936 hours, the percentage loss by the bonds C-H in CH₃, Si-CH₃, Si-O-Si, Si(CH₃)₂, and Si-O in O-Si(CH₃)₃ are 13%, 19%, 16%, 21%, and 9.5%. The sample shows an increasing tendency in the loss till 6000 hours of aging. After 6000 hours of aging recovery pattern is observed. The highest loss observed for the bonds are 34%, 36%, 22.8%, 22.1, and 28%. At 9000 hours of aging, the percentage loss is 31%, 37.55, 20.1%, 21%, and 26% for the wavenumbers C-H in CH₃, Si-(CH₃)₂, Si-O-Si, Si(CH₃)₂, and Si-O in O-Si(CH₃)₃.

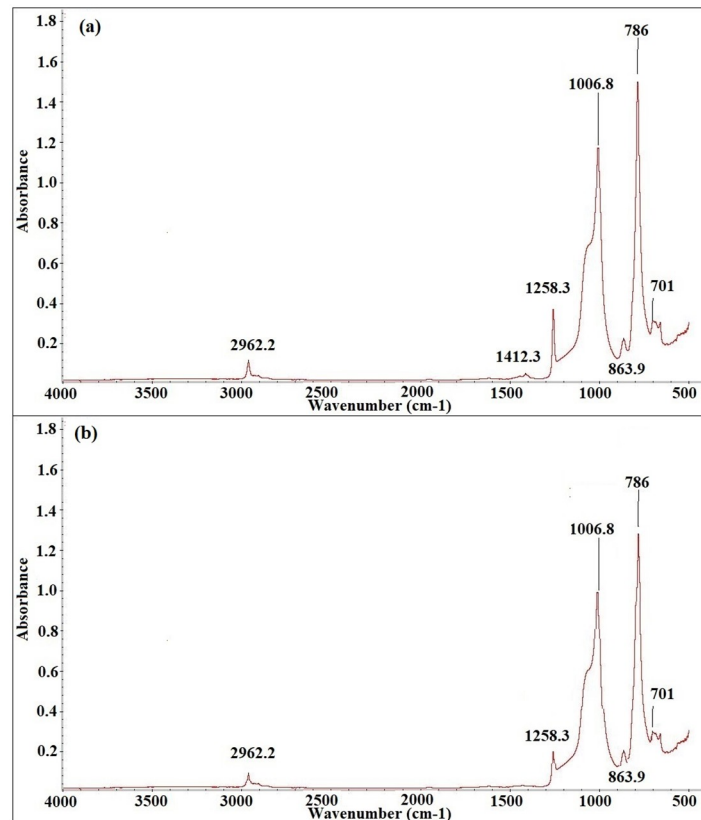
Fig 15. Spectrograph for SN8 a) Before aging, b) After aging.

For SN8, Fig 15 represents the FTIR analysis graph. As the aging starts, the percentage loss around 936 hours is highest among all the hybrid samples. The bonds C-H in CH_3 , Si- CH_3 , Si-O-Si, $\text{Si}(\text{CH}_3)_2$, Si-O in O-Si(CH_3)₃, and Si-Si(CH_3)₃ have the percentage loss of 16.66%, 25.6%, 48.16%, 33.33%, 32.66%, and 100%. The highest loss is observed around 6000 hours of aging for the same above bond number as 33%, 51.2%, 47.12%, 23.33%, and 100%. However, after 6100 hours of aging, the sample starts to recover itself and the percentage loss increases. Before 6000 hours of aging, the loss recovery pattern is observed but with small variation. However, the rise around 6000 hours of aging is significant. At the end of the aging, the samples have lower percentage loss for the bonds C-H in CH_3 , Si CH_3 , Si-O-Si, $\text{Si}(\text{CH}_3)_2$, Si-O in O-Si(CH_3)₃, and Si-Si(CH_3)₃ of 26.66%, 46.1%, 46%, 33%, 14%, and 33.33%.

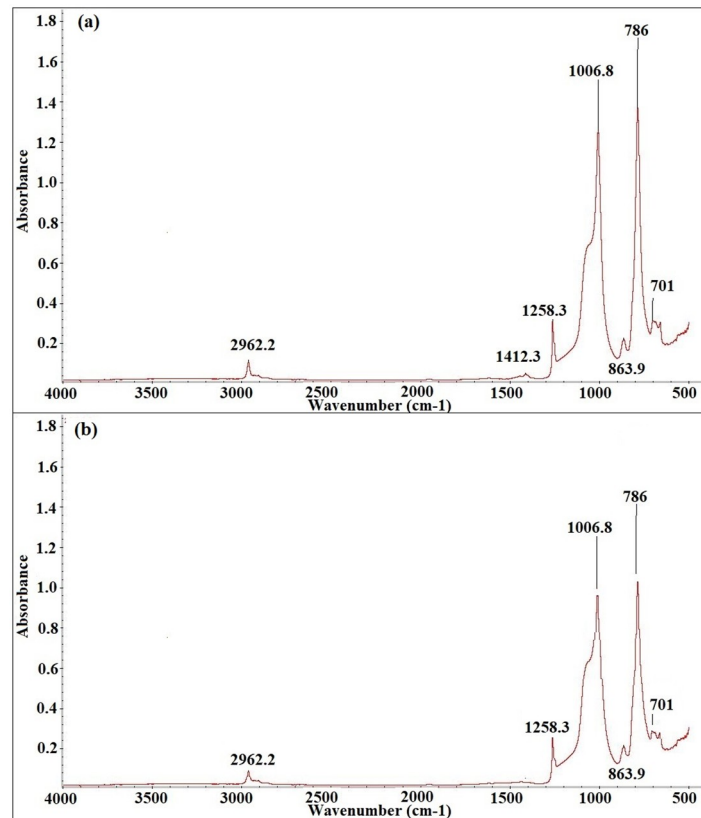
Fig 16. Spectrograph for S0 a) Before aging, b) After aging.

Before and after aging spectrograph for S0 sample is presented in Fig 16. For S0 sample, the loss recovery pattern is observed by all the absorbance peaks. However, the percentage loss for some of the peaks mentioned in Table 4 is highest as compared to the hybrid samples. CH_3 bond in Si- CH_3 at the wavenumber 1440–1400 (cm^{-1}), loses itself 100% and is unable to recover. Wavenumbers 1130–1000 (cm^{-1}) for Si-O-Si bond, 840–790 (cm^{-1}) for Si-(CH_3)₂, and 870–850 (cm^{-1}) for Si-O bond in O-Si(CH_3)₃ are the ones with percentage loss of 25% at the end of the experiment. Loss recovery pattern is observed for all the wavenumbers except 1440–1400 (cm^{-1}). However, as compared to the other samples, this sample does not recover itself as much as the other hybrid samples do. It means this sample is highly affected by the weathering stresses applied on the samples. From The FTIR analysis for all the samples, we can conclude that the hybrid samples specially SN2 and SN4 are the ones with the lowest

percentage loss as compared to the other hybrid and S0 sample. However, SN6 and SN8 recover themselves after having the highest loss percentage. In case of the S0 sample, loss recovery pattern exists but the recovery is not significant as compared to the hybrid samples. The groups Si-CH₃, Si-O-Si, and C-H groups of silicone base material with a decrease in the absorbance peaks at significant wavenumber was also reported by other authors after aging [28, 29]. Loss and recovery is also observed by other authors for silicone rubber as base material [16]. The addition of the filler in the base material simply keeps it intact due to the addition of silanol group present on the nano filler, thus making it resistant to the aging conditions [30]. In our case, the addition of nano and micro particle enhances the recovery pattern of the hybrid samples when compared with the unfilled sample after weathering effects.
