Mendoza, J.C., Vera Cardenas, E.E., Lewis, R. [orcid.org/0000-0002-4300-0540](https://orcid.org/0000-0002-4300-0540) et al. (5 more authors) (2021) Water jet erosion performance of carbon fiber and glass fiber reinforced polymers. *Polymers*, 13 (17). 2933. ISSN 2073-4360

# Water Jet Erosion Performance of Carbon Fiber and Glass Fiber Reinforced Polymers

**Abstract:** Complex engineering challenges are revealed in the wind industry; one of them is erosion at the leading edge of wind turbine blades. Water jet erosive wear tests on carbon-fiber reinforced polymer (CFRP) and glass-fiber reinforced polymer (GFRP) were performed in order to determine their resistance at the conditions tested. Vacuum Infusion Process (VIP) was used to obtain the composite materials. Eight layers of bidirectional carbon fabric (0/90°) and nine glass layers of bidirectional glass cloth were used to manufacture the plates. A water injection platform was utilized. The liquid was projected with a pressure of 150 bar on the surface of the specimens through a nozzle. The samples were located at 65 mm from the nozzle at an impact angle of 75°, with an exposure time of 10, 20 and 30 min. SEM and optical microsc

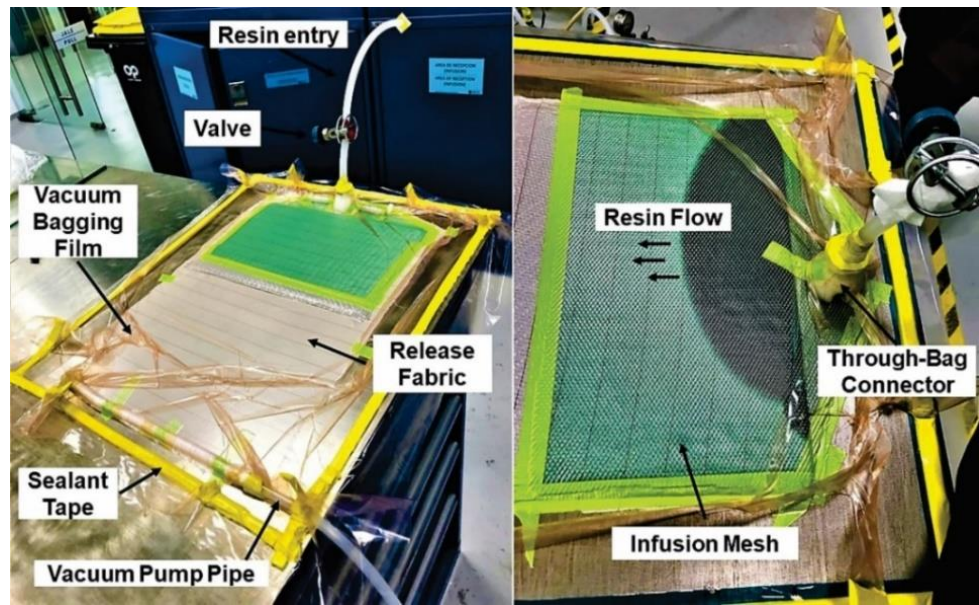
Figure 1. RI process for the manufacture of composite materials.

CFRP and GFRP plates were obtained from the Vacuum Infusion Process (VIP), as shown in Figure 1 [18,19]. This process is considered as closed mold. For the manufacture of the carbon fiber sheet, 8 layers of bidirectional carbon fabric (0/90° fabric) were used, and 9 glass layers of bidirectional glass cloth were used for the glass fiber. For both cases, a mixture was made with 304.6 g of epoxy resin Epolam 2015 and 90.9 g of hardener Epolam 2015. Bidirectional fabrics were placed on a previously polished metal plate, in order to obtain a smooth finish. Additionally, a release fabric and an infusion mesh were placed to help unmold the laminate, in this way the resin flows through the fibers that were sealed inside a vacuum bag. Finally, an inlet valve for resin injection and a suction connection for the vacuum pump were installed. At the conclusion of the RI process, 4-millimeter flat sheets of carbon fiber and glass fiber were obtained. Figure 2a,b show the optical microscopy of the surface of the samples of the sheets obtained from carbon fiber and glass fiber, respectively; in both cases the bidirectional tissue is observed (0/90°). In the glass fiber image, the presence of the polymer matrix based on epoxy resin is much more visible. Some samples of carbon fiber and glass fiber were covered with polyester resin (Gelcoat) to determine its behavior during the liquid erosion test. The average thickness of coating was 0.56 mm (Figure 3). This coating has the function of protecting the surface of the composite materials against UV rays. The application of the Gelcoat was carried out with a brush cured at room temperature.

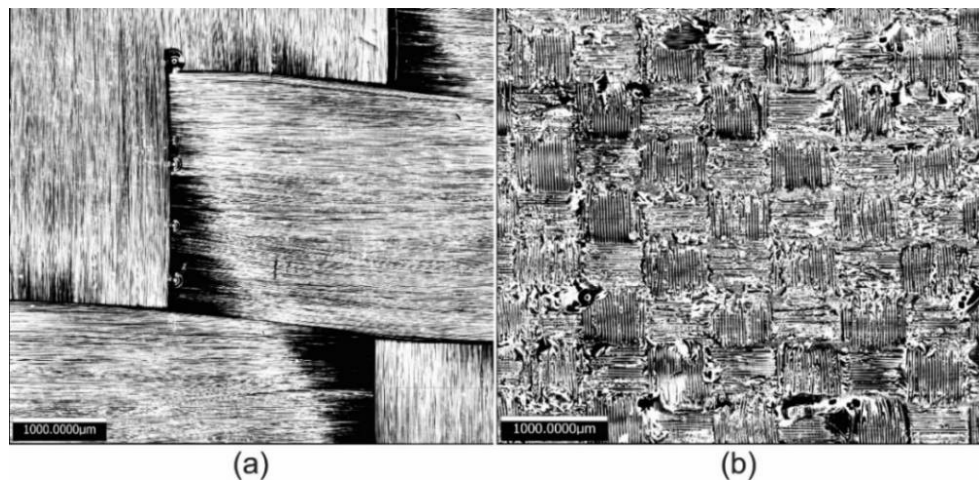
Figure 2. Optical microscopy of (a) carbon fiber and (b) glass fiber sheets.

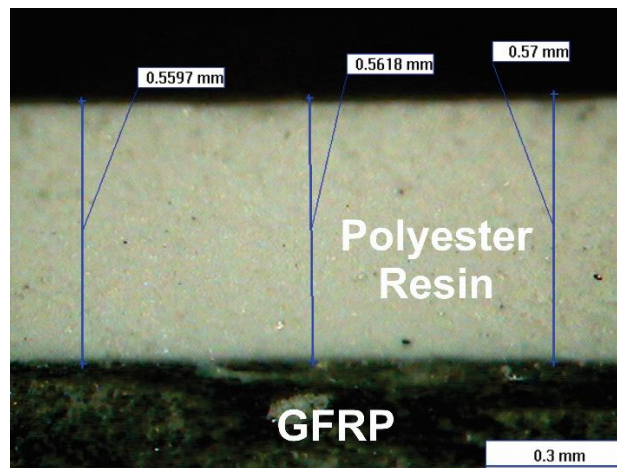
Figure 3. Cross section of glass fiber reinforced polymer and coating of polyester resin.

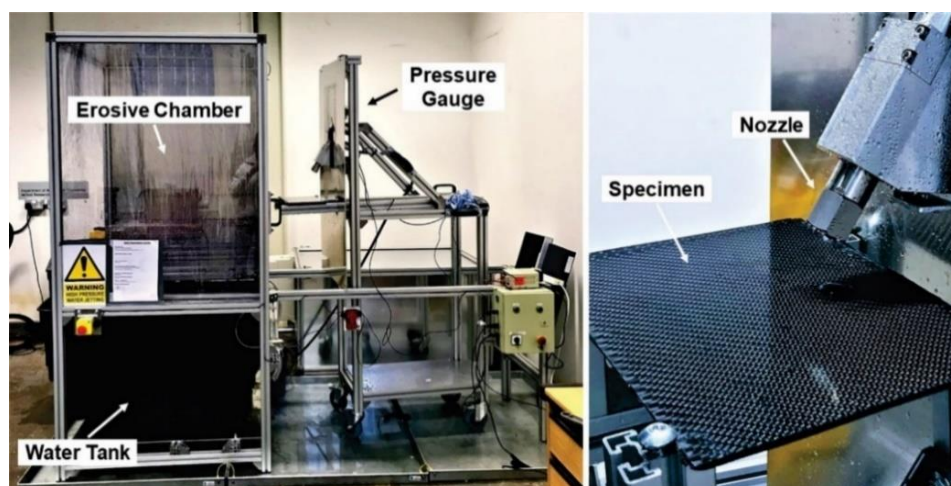
Figure 4. Water jet erosion platform.

The water jet erosion tests were carried out according to ASTM G73-10 (ASTM International, West Conshohocken, PA, USA) [21]. The experimental platform used is shown in Figure 4. The liquid is projected the surface of the flat sheets of composite materials through a nozzle at a pressure of 150 bar using a 25 hp industrial Hydro-pump. The nozzle has a tungsten carbide flat section exit tip with a 110-millimeter long flow stabilizer. The samples to be evaluated are located 65 mm from the end of the nozzle. To determine which of the composite materials has greater resistance to erosive wear, 3 tests were performed on each material at an angle of  $75^\circ$ , with an exposure time of 10, 20 and 30 min.

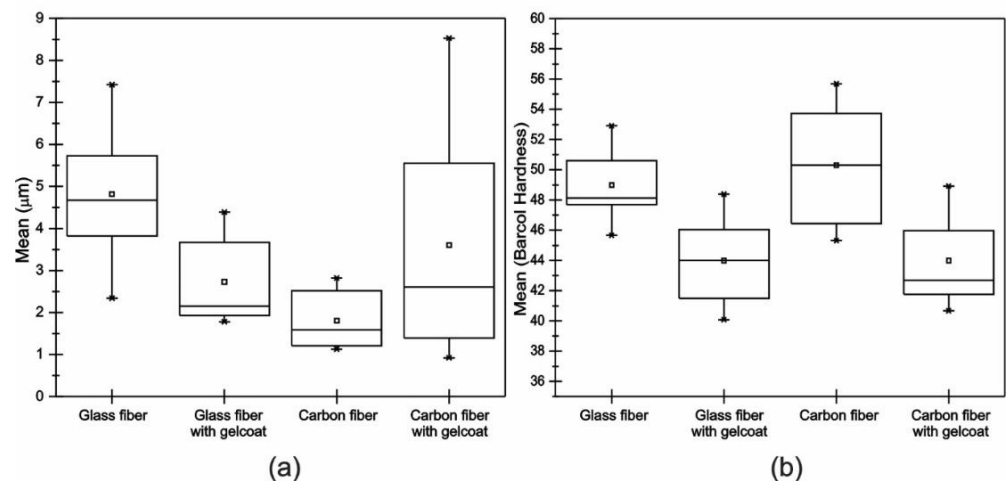
Figure 5. Box diagram of (a) roughness and (b) hardness.

Figure 5a shows the acquired values of roughness of all the samples. It can be seen that, due to the manufacturing of the VIP and the operating conditions applied, mean values of roughness,  $R_a$ , greater than  $1 \mu\text{m}$ , were obtained. This indicates that the surfaces of the samples have significant irregularities, which influences the wear during the water jet erosion tests [22–24]. In addition, it was observed that in the sample of carbon fiber with Gelcoat, there was a wide dispersion of the roughness results. This could be due to the method used to apply the Gelcoat, which, as explained before, was performed using a brush [25]. Figure 5b shows the values obtained for the Barcol hardness. The carbon fiber and glass fiber without Gelcoat show the highest values. This is due to the mechanical properties of the Gelcoat [26], which means that the hardness is lower for samples with Gelcoat [27]. Table 1 shows the average data of roughness and hardness for the materials before the water jet erosion tests.

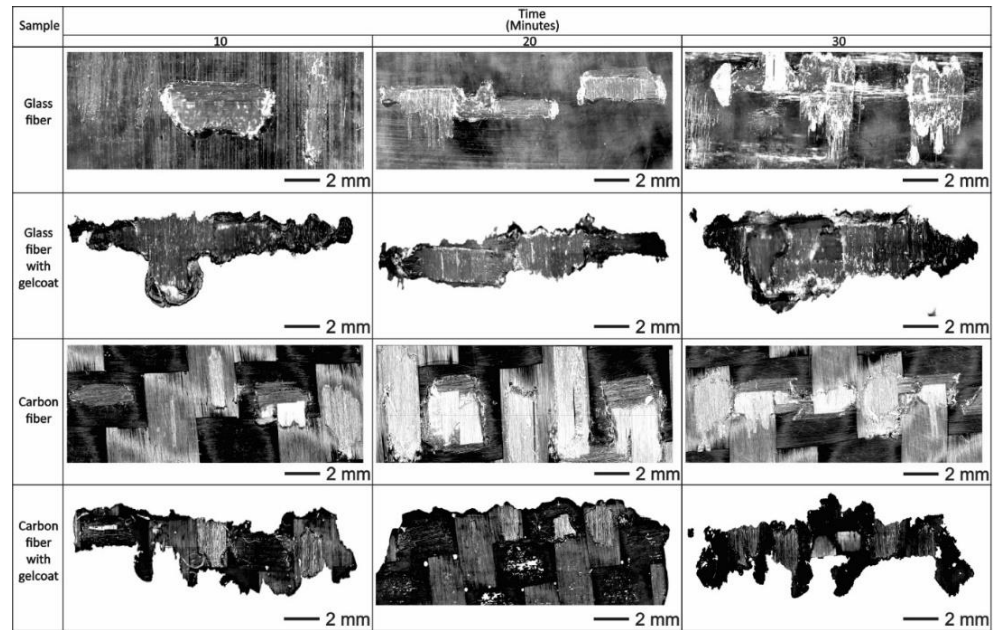
Figure 6. Damage of the surface of the samples using the test of liquid erosion at an impact angle of 75°.

Figure 6 shows the scars generated in the composite materials due to the water jet erosion tests, with and without Gelcoat, at an angle of  $75^\circ$  in periods of 10, 20 and 30 min. These test times were established to examine possible failures in the Gelcoat such as cracking, fractures, pitting and loss of adhesion. Once the test started, it was observed that the samples that showed the greatest damage due to the impact of the liquid, in the first instance, are those that contain Gelcoat on the surface, as a result of their low hardness and high roughness [28]. Despite this, Gelcoat can be considered as a coating against water jet erosion, even for a short period. The acquired shape of the scars in the evaluated materials is due to the fact that the nozzle has a tip with a rectangular geometry. At the same conditions, carbon fiber sheet is the material that presented the least damage. This confirms that its performance, in these tests, is due to the good properties of this composite material that were already reported in other studies [29,30]. The evaluated samples did not present damage in the whole area exposed to water jet erosion, only in certain regions and later spread to more vulnerable sections [31].

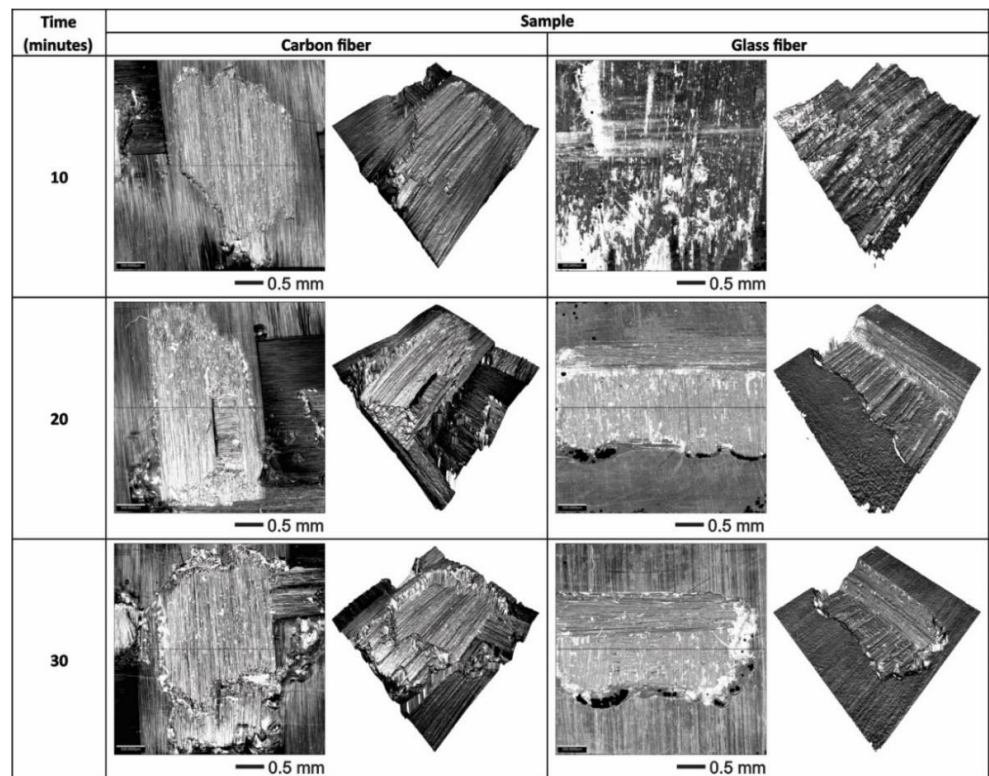
Figure 7. Optical microscopy and 3D view of the wear scars of the samples evaluated using water jet erosion.

Figure 7 shows the optical microscopy and the corresponding 3D view of the damaged regions in the evaluated samples of carbon fiber and glass fiber at different times of duration test. It was observed that, after 10 min, the fiberglass presented a deeper wear scar produced by the impact of liquid on the surface. At 20 and 30 min, it was seen that the damage on the surface gradually increased, generating a deeper scar. In comparison, after 10 min, the carbon fiber shows less damage, because the liquid particles only slightly erode the surface, which corresponds to the detachment of the polymer matrix leaving the fibers exposed. After a period of 20 min, small, eroded areas can be observed, and the surface roughness is modified. At 30 min, the repeated impacts of the liquid particles caused the presence of cuts in the upper carbon fibers and the accumulation of removed material around the wear trace. When making a comparison, it is very evident that carbon fiber presented less wear than glass fiber under the conditions in which the liquid erosion test was carried out, this is mainly due to the roughness, the hardness and the type of fabric of each sample [32,33]. The studies carried out have found results where glass fiber has the lowest resistance to wear [34]. Carbon fiber composites can be used in place of glass fiber

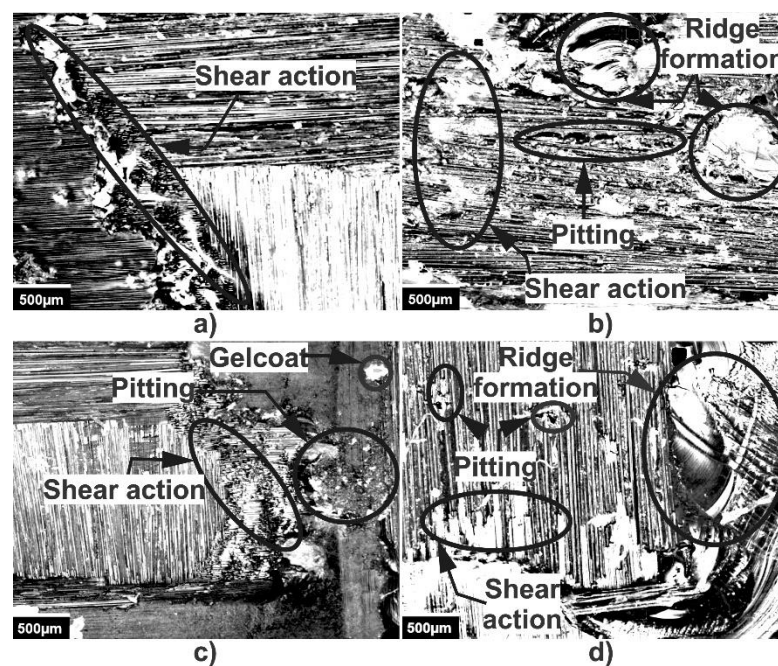
**Figure 8.** Wear mechanisms by water erosion in (a) carbon fiber, (b) glass fiber, (c) carbon fiber with Gelcoat and (d) glass fiber with Gelcoat.

Figure 8a shows the microscopy of the wear zone corresponding to carbon fiber, in which a slight depth was observed, caused by the number of broken fibers due to the

repeated impacts of the liquid on the surface during the test [36]. Figure 8b shows the wear zone of glass fiber where the removal of the polymer matrix and fibers cut randomly by the impact of the liquid on the surface can be seen; in addition, there was the formation of ridges in the direction of impact, which caused an increase in the surface roughness [37,38]. In the sample of carbon fiber with Gelcoat, shown in Figure 8c, the damaged region was observed, where there was the presence of a small remainder of Gelcoat applied on the surface; additionally, small pitting, formed by the continuous attack, was created, which subsequently caused cracks. This leads to the removal of the polymer matrix and the presence of cutting action on the fibers [39,40]. In the case of the glass fiber with Gelcoat, corresponding to Figure 8d, it was observed that the coating was removed quickly at the beginning of the test, leaving the exposed surface of the fiberglass, allowing the subsequent detachment of the polymer matrix and fibers, as well as the formation of ridges, cut fibers and pitting. Once surface damage begins, erosion accelerates due to the roughness changes over the test region of the sample [41–44]. The impact of the liquid particles on the surface produces gradual wear, modifying its roughness. As the test progresses, the roughness increases, creating valleys and ridges in the impact zone. When a liquid particle collides with this rough surface, the particle tends to lose speed while sliding on the surface, and at the same time, due to the impact of the liquid with a valley or a ridge, the detachment occurs, causing progressive erosive wear.

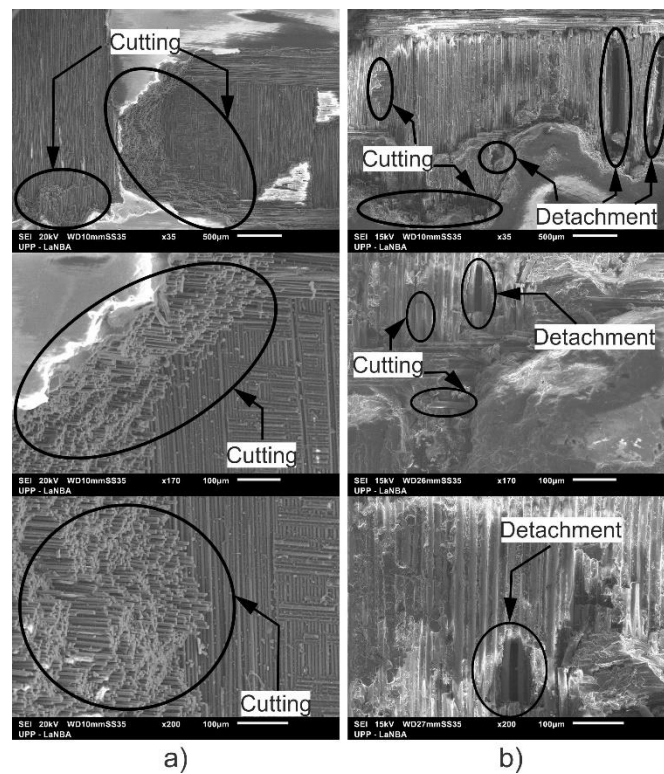
Figure 9. Cutting and detachment action: (a) carbon fiber and (b) glass fiber.

Figure 9a shows, in greater detail, the damage of the cutting action on the fibers and the removal of the epoxy resin due to the constant impact of the pressurized water on the surface of the carbon fiber sample. In Figure 9b, corresponding to the glass fiber sample, cuts in the fibers and the removal of the epoxy resin were also observed, but in this case, there are some regions that showed greater damage and depth due to the impact of water. This confirms that the resistance to water erosion in glass fiber is lower than in carbon fiber.

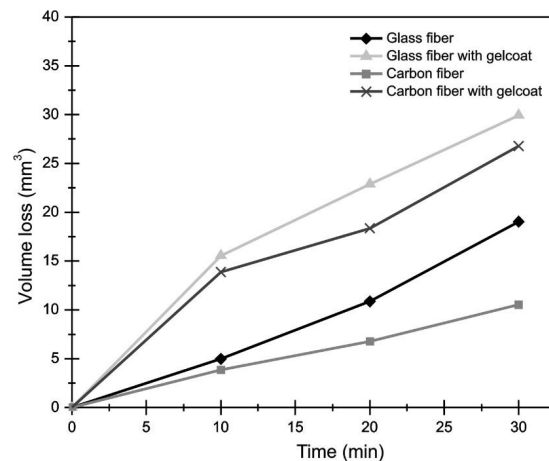
Figure 10. Volume loss during the liquid erosion test with 75° impact angle.

The ASTM G73-10 [21] standard for water jet erosion tests determines that erosion must be reported as volume or mass lost with respect to time. The lost volume was determined from the measurement of the wear scars of samples using a 3D optical microscope. Figure 10 shows the volume lost in the coated and uncoated composites materials. It is observed that the carbon fiber presented, at the end of the duration test, the smallest volume loss; this is due to its good mechanical properties [45,46]. On the other hand, the samples of carbon fiber and glass fiber with Gelcoat are the ones that lost more material during the test, confirming again its low resistance to water erosion [47,48]. It was observed that the behavior between the volume loss and time was linear (Figure 10), due to the progressive damage of the surface and that the increase in roughness is proportional to the increase in erosion wear.

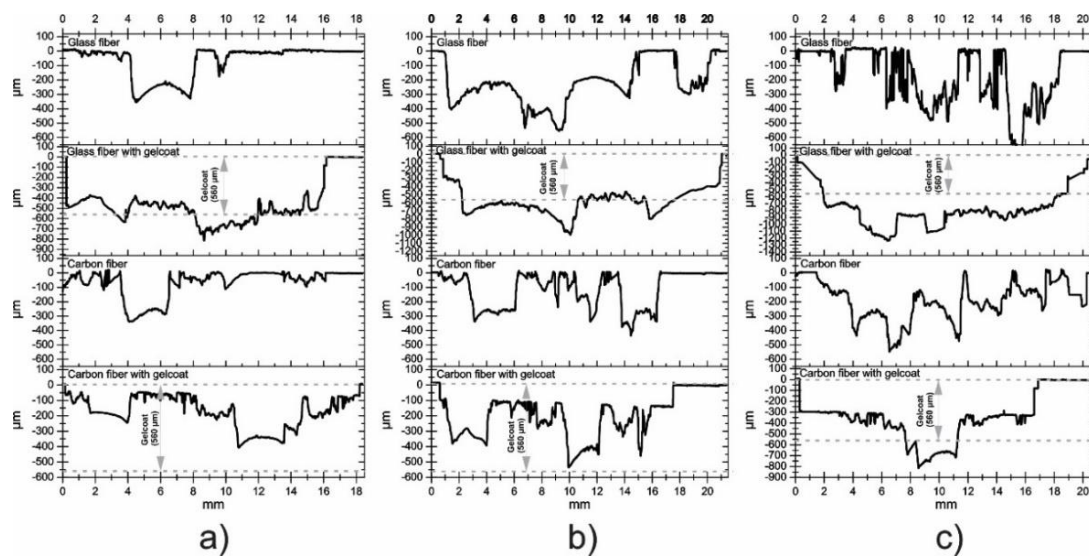
**Figure 11.** Profilometry of carbon fiber and glass fiber samples with and without Gelcoat with a duration test of (a) 10 min, (b) 20 min and (c) 30 min.

Wear profiles across the scars were obtained. Figure 11a,b show the profilometry of the samples at 10 and 20 min of duration test, respectively. In all cases, it can be observed that at 10 min, the impacts of the liquid particles modified the surface roughness of the materials. In both times, the sample of glass fiber with Gelcoat is the one that presented the scar with a greater depth, while the carbon fiber presented the lowest depth. Figure 11c, corresponding to the exposure time of 30 min, shows that the profiles with high magnitudes of depth were obtained in the samples with Gelcoat and again the sample of carbon fiber is the one that presented the lowest depth in the wear scar during the test, confirming its resistance to water erosion at the conditions tested in this experimental study. Additionally, in the case of coated samples, Figure 11 shows, with dotted lines, the thickness of the Gelcoat in order to observe the depth of wear produced both in the Gelcoat and in the composite material, depending on the test time.
