DUT Temperature Coefficient and Power Cycles to Failure

Yuma Kawauchi, Kenji Akimoto, Akihiko Watanabe and Ichiro Omura

Next Generation Power Electronics Research Center, Kyushu Institute of Technology, Kitakyushu, Japan

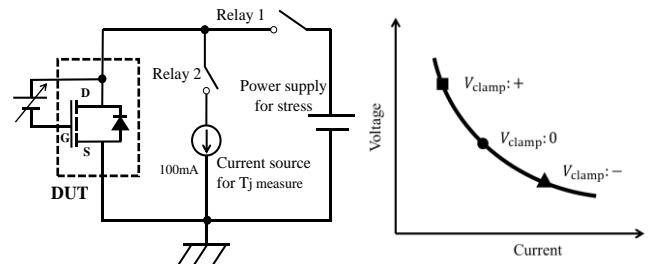
Fig. 1 Test circuit and temperature coefficient

That is, the temperature coefficient becomes large in the small current region where the gate voltage is low. While high current region, coefficient becomes smaller or negative with decreases of electron mobility.

The gate terminal and drain terminal of the DUT were connected via a voltage source (V_{clamp}) as shown in Fig. 1. The temperature coefficient can be controlled by V_{clamp} value. The bias voltage V_{clamp} adjusts voltage drop in the MOSFET and conduction current was controlled so that the generated heat was equivalent for all samples (see Fig. 1). The higher the voltage value of the V_{clamp} , the higher the temperature coefficient. Conversely, the voltage value of the V_{clamp} is set small or negative, the temperature coefficient will be low.

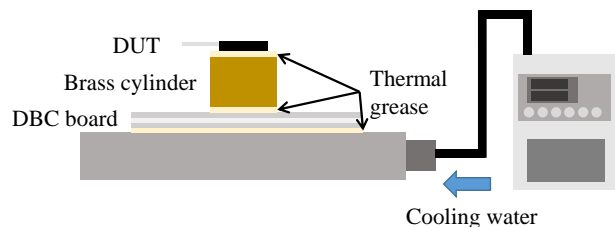
Fig. 2 Cooling method

Fig. 2 shows how to cool the DUT. The DUT was water-cooled by a heat sink via a metal cylinder for adjusting thermal resistance and a DBC substrate (AlN) for insulation. We used brass cylinders as the metal cylinder material. Water at a constant temperature was flowed through the water-cooled heat sink using a 1200 W chiller.

Thermal grease was applied to the joints between the DUT and the metal cylinder, the metal cylinder and the DBC base, and the DBC base and the water-cooled heat sink. The same amount of heat conductive grease was applied under all conditions so as not to change the thermal resistance value under each condition.

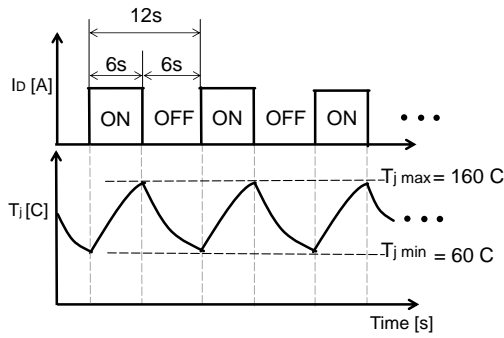
Fig. 3 Test sequence

The test sequence is shown in Figure 3. The test time was 12s for one cycle with an on time of 6s and an off time of 6s. The temperature conditions were such that the junction temperature was 60°C to 160°C and the temperature difference was 100°C. The junction temperature was measured from the temperature dependence of forward characteristics of the DUT body diode[5][6].

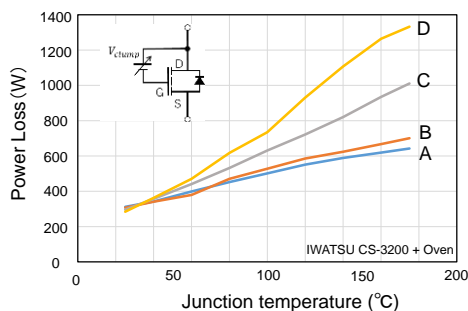
Fig. 4 Temperature dependence of conduction loss generation for DUT samples

The power cycle test was performed under four conditions (Case A, Case B, Case C, Case D) with different temperature coefficients by adjusting the applied voltage of V_{clamp} (see Fig 4). The V_{clamp} values were -1.26V for Case A, 0V for Case B, 3.0V for Case C, and 5.6V for Case D, in ascending order of temperature coefficient. In Case B, since the value of V_{clamp} is set to 0V, the power cycle test was conducted as a 2-terminal element by directly connecting the gate terminal and drain terminal without inserting a power supply.

Fig. 4 In Case D, when stress is applied and the junction temperature rises to 160 °C, a chip loss of 1200 W or more occurs. Since the device's cooling capacity has been significantly exceeded, a failure due to thermal runaway is suspected. Further, since the failure mark is generated only on the central bonding wire and the ground plane of the chip, it is considered that the current is concentrated. Fig. 10 shows a model of the effect of the temperature coefficient on the failure mechanism. In Case B and Case C, a failure mark appears from the receding part of the solder layer, and in Case B, the failure mark extends to the central part along the bonding wire.

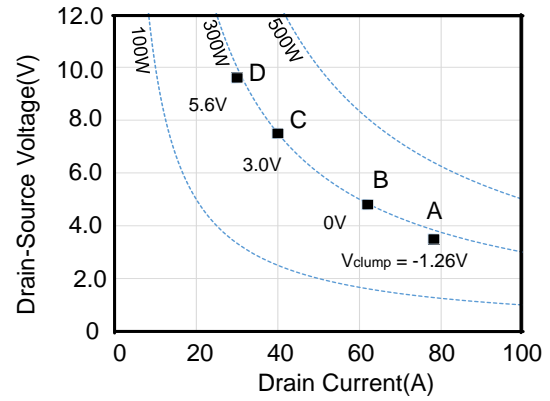
Fig. 5 Conduction loss generation condition of DUT samples

As for the stress application conditions, the applied power was set to almost the same value (about 300 W), and the ratios of drain current and drain-source voltage were adjusted according to the respective temperature coefficient conditions (see Fig. 5). The values of drain current and drain-source voltage under each condition were 78.2A and 3.8V for Case A, 62A and 4.8V for Case B, 40A and 7.6V for Case C, and 30A and 9.8V for Case D.

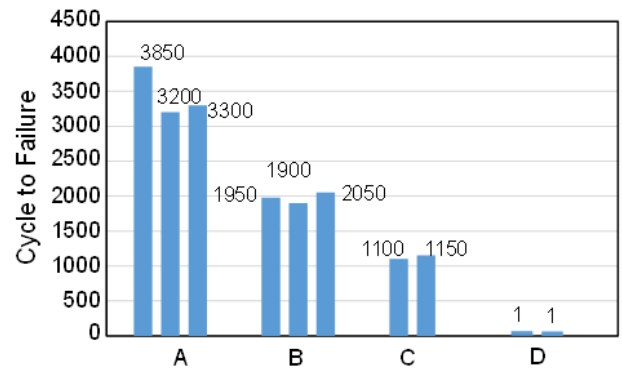
Fig. 6 Cycles to failure for DUT samples of different temperature coefficients, Case A, B, C and D

A power cycle test was conducted with 3 samples of Case A, 3 samples of Case B, 2 samples of Case C, and 2 samples of Case D, for a total of 10 samples. The test results are shown in Fig. 6. In ascending order of the number of cycles until failure, Case D had 1 cycle, Case C had about 1100 cycles, Case B had about 2000 cycles, and Case A had 3200 cycles or more. Case D was able to obtain the same results in the two samples. According to the results, Case A, which has the smallest temperature coefficient, has a longer number of cycles to failure, and Case D, which has the largest temperature coefficient, has a shorter number of cycles. It was also found that the number of cycles until failure decreases as the temperature coefficient increases.

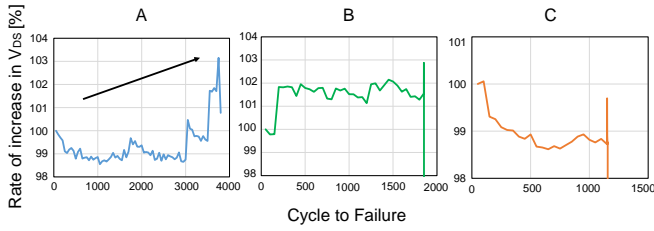
Fig. 7 V_{DS} voltage changes during the power cycling test in case A, B and C

Fig. 7 shows a graph of changes in electrical characteristics of Case A, Case B, and Case C. A graph was created by plotting the voltage value every 50 cycles leading up to the failure. The vertical axis is the rate of increase from the initial drain-source voltage, and the horizontal axis is the number of cycles. Case D failed in one cycle, so it was not possible to capture changes in electrical characteristics. From the graph, it can be confirmed that there is a difference in the change in electrical characteristics between Case A, Case B, and Case C.

In Case A, it can be confirmed that the drain-source voltage gradually increases as the number of cycles increases. In addition, it is considered that the voltage rises sharply around 3000 cycles and 3500 cycles because the bonding

wire is lifted off. In Case B, the voltage change leading up to the failure was small, and the voltage rose immediately before the failure, leading to the failure. In Case C, the voltage gradually dropped from the initial value, and the voltage rose just before the failure, leading to the failure.

The voltage rise rate at the time of failure is 99.1% for Case A, while it decreases to 40% or less for Case B and Case C. It is possible that there is a difference in the failure mechanism due to the difference in temperature coefficient.

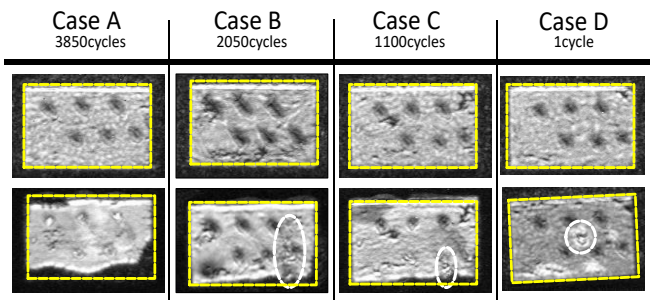
Fig. 8 SAT images of failed samples of Case A, B, C and D (Temperature coefficient $A < B < C < D$)

Fig. 8 shows the SAT (Scanning Acoustic Tomography) images before and after the power cycle test for each condition. The SAT image is the observation result of the interface between the bonding wire and the chip. The upper row is the image before the power cycle test, and the lower row is the image acquired after the failure of each case.

From the result of Fig. 8, the white broken line is considered to be the failure mark in each case. In Case B, failure marks appear linearly from the lower right of the chip to the center of the chip. In Case C, a failure mark can be confirmed at the same position as Case B, but unlike Case B, the failure mark does not extend to the center of the chip. In Case B and Case C, it was found that a failure mark was formed in the part where the retreat of the solder layer was large. In Case D, a spot failure mark different from Case C and Case B can be confirmed in the center of the chip.

Focusing on the bonding wire, Case A makes the connection surface of the bonding wire unclear compared to other conditions. The cause of the failure in Case A is thought to be the lift-off of the bonding wire. Further, it can be seen that there is a large difference in the peeled area of the solder layer depending on each temperature coefficient. The peeled part is the lower part of the chip at all temperature coefficients.

This is because the lower part of the chip is close to the drain, source, and gate terminals of the device, so the temperature tends to rise. The SAT image was binarized and the peeled area was calculated. Case A was 18.5%, Case B was 9.8%, Case C was 9.6%, and Case D was 5.2%. Case A with the lowest temperature coefficient (longer number of cycles to failure) has the largest peeling area, and Case D with the highest temperature coefficient (shorter number of cycles to failure) has the smallest peeling area. It was.

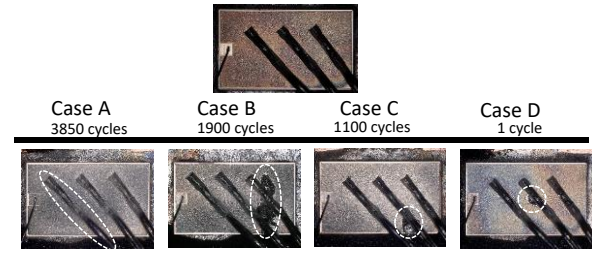
Fig. 9 Top images of failed samples of Case A, B, C and D (Temperature coefficient $A < B < C < D$)

After the power cycle test, the mold resin was melted and the surface of the chip was observed with a microscope. Figure 9 shows micrographs in each case. In Case A, it was found that the bonding wire in the white dashed line was damaged. In Case B and Case C, you can see a black mark on the lower right of the chip that looks like the device has melted. In Case B, it can be seen that the melted part extends to the upper part of the chip. In Case D, the type of failure mark is the same as Case B and Case C, but the location of occurrence is in the center of the chip.

Comparing with the SAT image, it was confirmed that the chip surface was faulty because there were fault marks in the same place and in the same range.

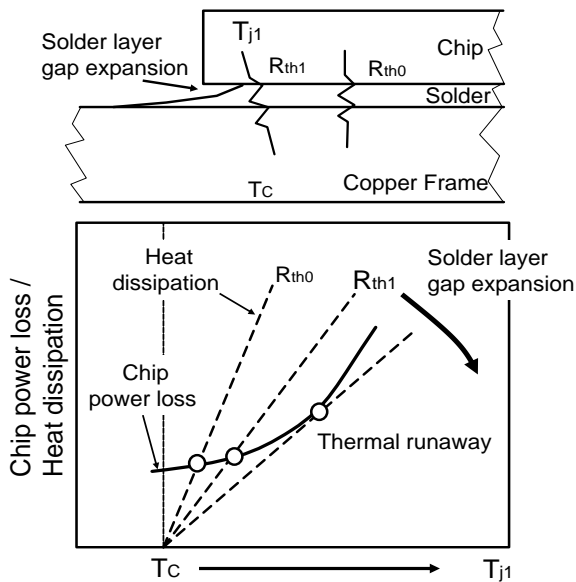
Fig. 10 Model diagram of the effect of temperature coefficient on failure mechanism

As stress is applied and the number of cycles increases, the peeling of the solder layer gradually progresses. At the peeled portion of the solder layer, the value of thermal resistance gradually increases compared to the initial value. As the thermal resistance increases, the heat dissipation capacity of the device gradually deteriorates. When the heat dissipation capacity drops to a certain amount, the power loss of the chip exceeds the heat dissipation capacity and the chip cooling becomes insufficient. As a result, thermal runaway occurs.

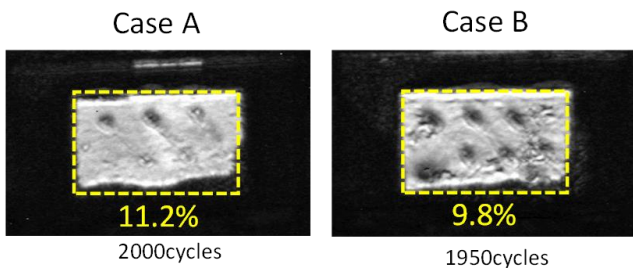
Fig. 11 Comparison of SAT images around 2000 cycles of Case A and Case B

In both Case B and Case C, the lower right part of the device (near the bonding wire in the center) has a large retreat of the solder layer peeling, and failure marks also appear in the peeling retreat part.

From this, it is conceivable that the central bonding wire has a current flowing through it (current concentration is occurring) as compared with other wires. In Case B, it is probable that thermal runaway occurred at the solder retreat in the lower right, and further heat generation was induced by the current concentration, causing thermal runaway to occur in a chain and the failure progressed to the center of the chip.
