Phosphoric Acid Increases the Porosity and Extends the Contact Area of Dental Osseo integrated Implants

Abstract— *The surface treatments are performed in dental implants in order to increase the chemical and mechanical connection between the implant and bone, favoring the stability of implant-supported prostheses. The aim of this study was to characterize dental implant surfaces treated with 37% phosphoric acid. Implant surfaces were evaluated divided into groups of fifty samples being distributed in: porcelain samples without treatment; metal samples without treatment; porcelain samples with treatment with 37% phosphoric acid for 30 seconds; metal samples treatment with phosphoric acid at 37% for 30 seconds; porcelain samples with treatment with 37% phosphoric acid for 60 seconds; metal samples with treatment with 37% phosphoric acid for 60 seconds. The samples were characterized by Scanning Electron Microscopy. After the phosphoric acid treatment porosity changes were observed and expanding the contact area. The results show benefits of using phosphoric acid, as a surface with increased roughness; this is desired to occur matrix deposition and growth of bone tissue and facilita

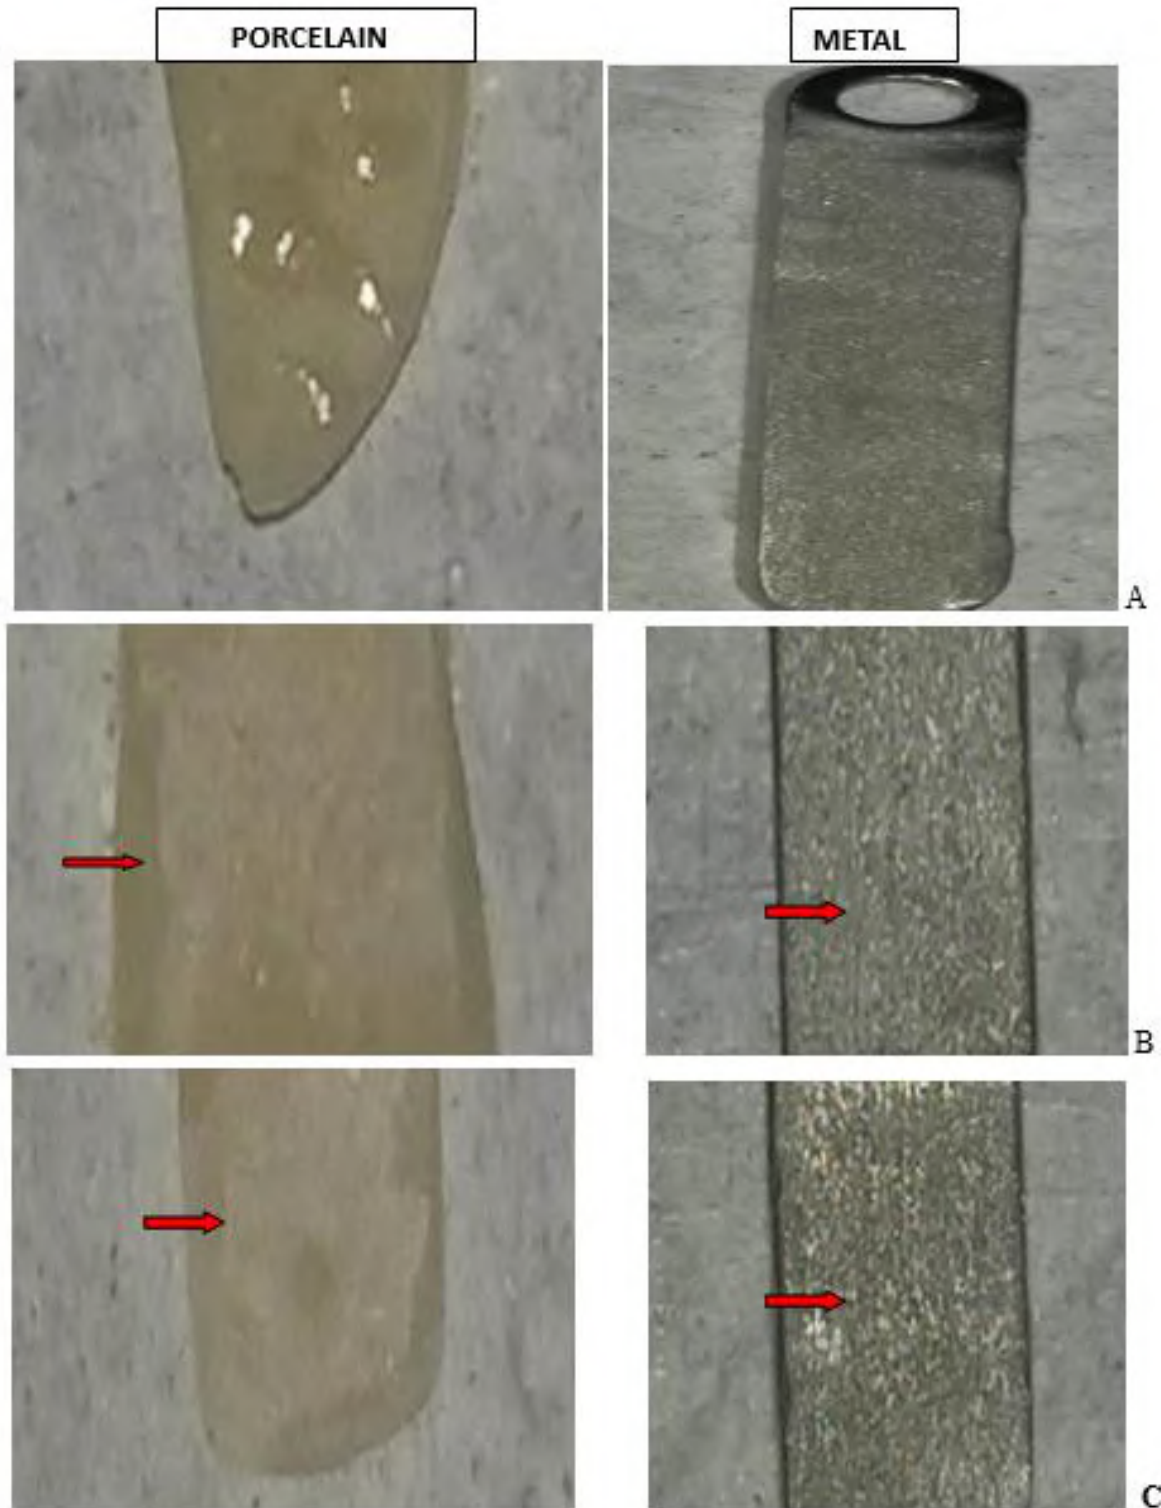
Fig. 1 -1: Visual appearance of porcelain and metal samples without treatment with phosphoric acid attack (A) with phosphoric acid treatment for 30 seconds (B) and treatment with phosphoric acid for 60 seconds (C).

After treatment of the samples with phosphoric acid application at 37% were observed on the surface changes as a function of time. The exposure to phosphoric acid made more opaque surface. Figure 1 shows the differences between the samples without attack on the inner surface of the prosthetic implant and the external surface of the implant, in the presence or absence of phosphoric acid treatment.

What is observed is that surfaces of both porcelain and metal before the treatment with 37% phosphoric acid are smoother and therefore more homogeneous (A), where these surfaces are exposed to the treatment with phosphoric acid 37% for 30 seconds characteristics of surfaces are becoming opaque and therefore less bright (B), however the images in (C) after the surfaces were exposed to treatment with phosphoric acid at 37%, for 60 seconds, the surfaces have much more opaque and less bright, suggesting that the higher the greater exposure to acid changes in their structure.

It is observed that after 60 seconds of treatment with phosphoric acid the surfaces of both porcelain and metal feature are changed, as indicated by arrows in Figure 1.
