Complications Reported in Maxillary Skeletal Expanders (MSE)

Jacqueline Payne, Kristen Lo, Connor Turley, Elizabeth Yee

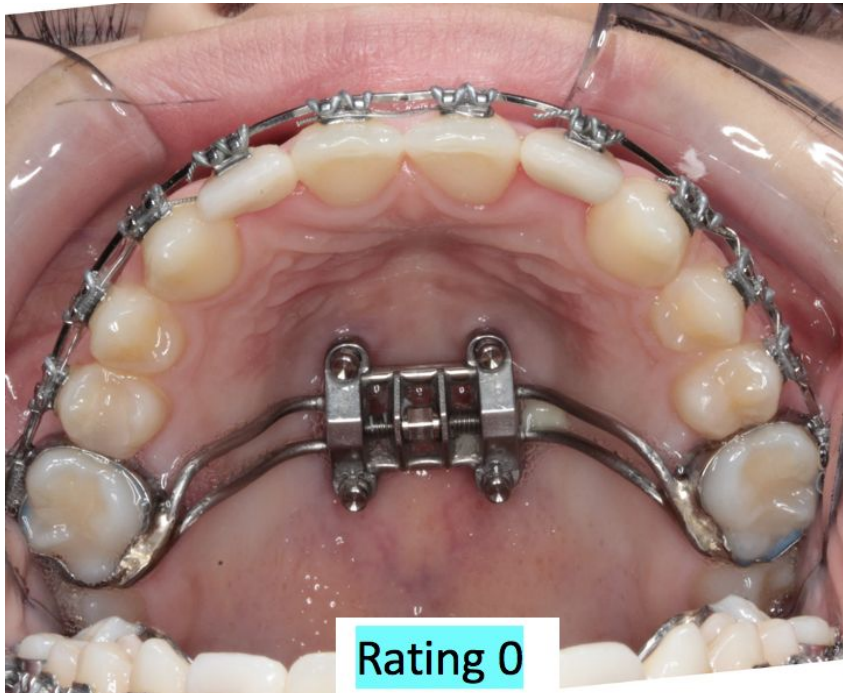
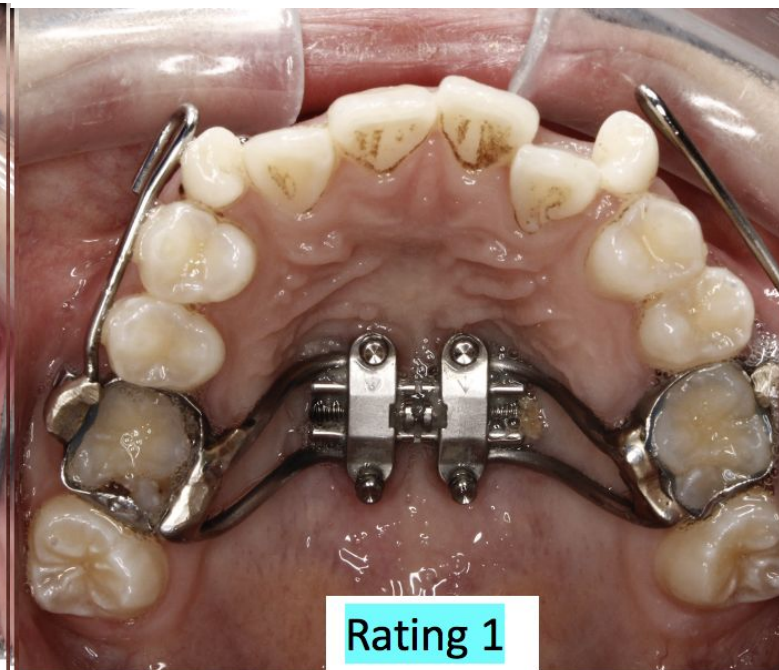
Rating 3: According to chart note, MSE had to be removed early due to inflammation or pain from inflammation

- **3:** Chart note reported expander was removed early due to inflammation
- **2:** Using progress photos, gum tissue covered MSE arms or screw
- **1:** Using progress photos, gum tissue was erythematous or hypertrophic but not covering MSE
- **0:** Using progress photos, no inflammation present

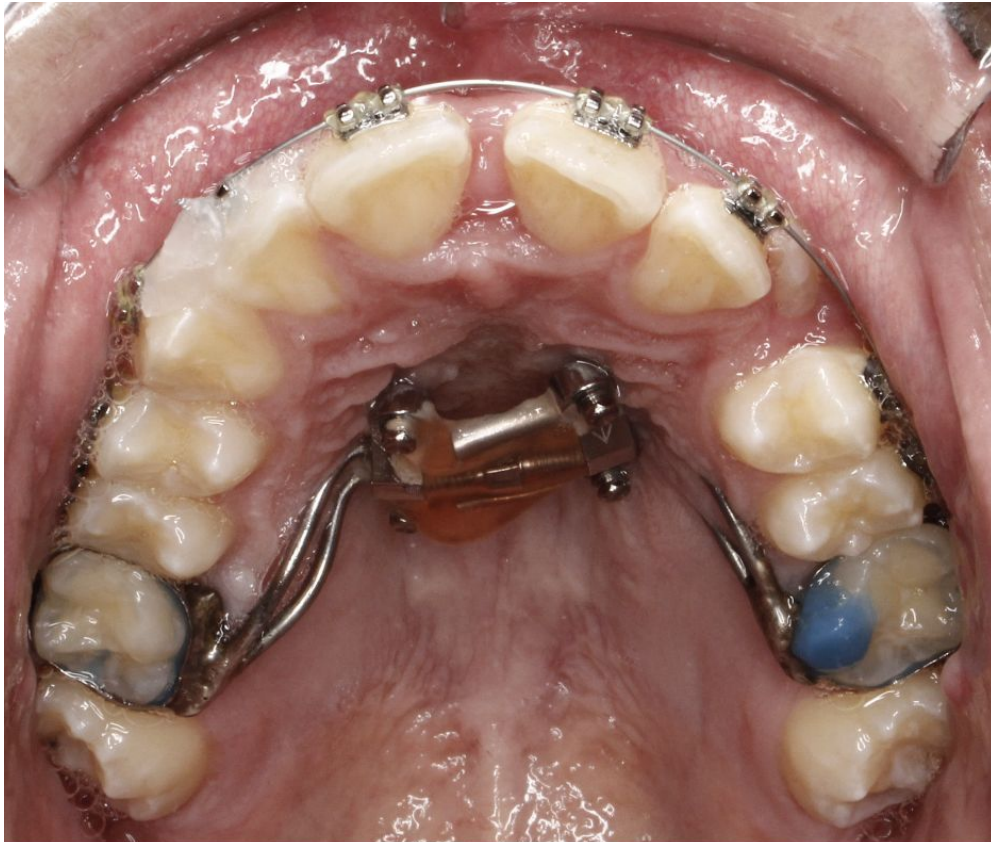
Illustrating appliance breakage-- guide rods have come loose from the expander

Appliance Breakage/ Malfunction

- **1:** Chart noted MSE expander broke or malfunctioned preventing continuation or stability of expansion
- **0:** Chart note did not note the above scenario
