Ethiopian Journal of Environmental Studies and Management EJESM Vol. 5 No. 4 2012

MECHANISM OF GULLY-HEAD RETREAT - A STUDY AT GANGANIR DANGA, PASCHIM MEDINIPUR, WEST BENGAL

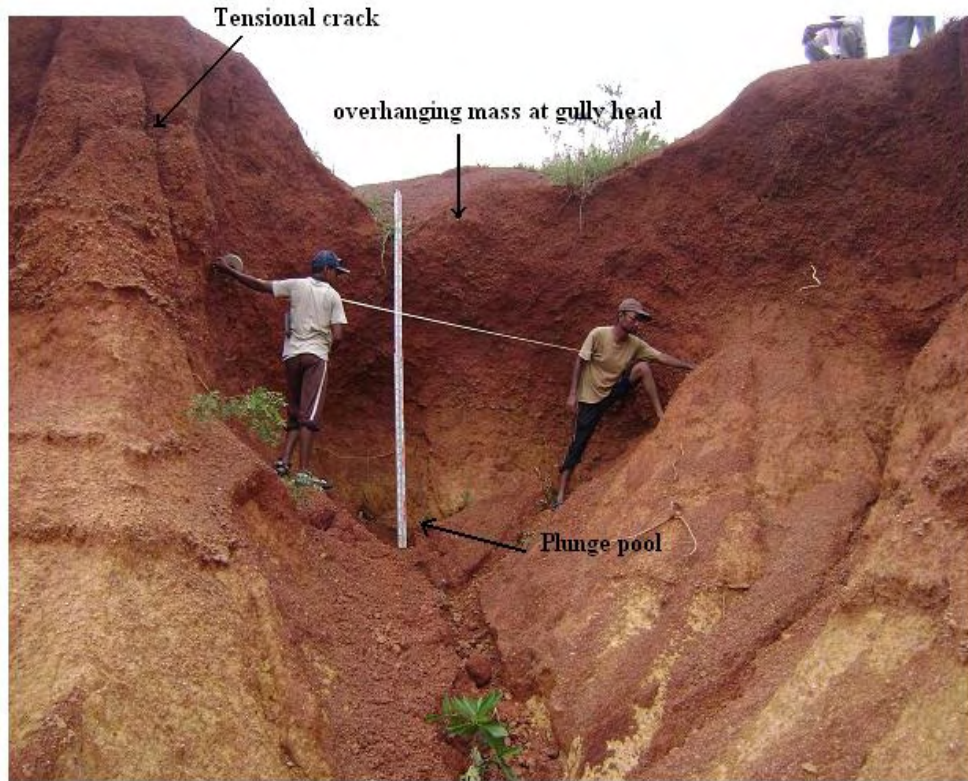
Figure 4 Overhanging mass at gully head, tensional crack and plunge pool

masses collapse later in the season when desiccation cracks develop from their base up to the ground surface. Bradford and Piest, (1985) investigated that basal headcut failure occurs due to collapse of the overhanging mass (Figure 4).

plunge pool erosion, destruction flutes followed by debris erosion, or undercutting of flutes by concentrated flow accelerate wall failure (Oostwoud Wijdenes *et al.*, 2000; Collison, 2001; Vandekerckhove *et al.*, 2001; Poesen *et al.*, 2002; Martinez-Casasnovas *et al.*, 2004). Tension cracks would develop between 30 and 50 cm upslope from the gully-head or gully-wall when desiccation and tension stresses play in combination and the condition would increase the through-flow velocity in the gully-head or gully wall, promoting collapse (Figure 4).
