Scopus 30: 32–39, October 2010

A preliminary assessment of the potential risks from electrical infrastructure to large birds in Kenya

Summary

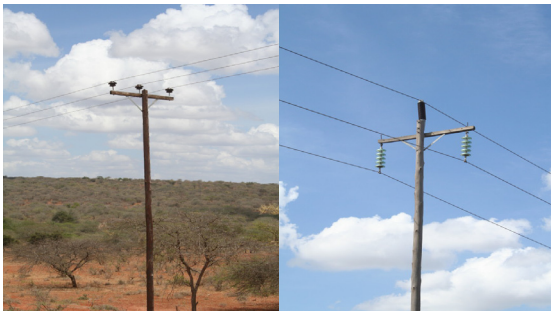
Figure 1a & b. 1a (on the left) shows the typical “T-structure” which poses an electrocution risk to birds perching on the cross arm. 1b shows the “inverted T” pole structure which is safer for perching birds since the outer conductors are suspended below the cross arm out of reach of birds.

Across both circuits, a total of seven different distribution (<132 kV) pole configurations were observed. This excludes various permutations of “in line strain” (bend) and “terminal” (transformer) structures, and the apparent large diversity of structures used in urban areas. Of the seven, six were considered to pose a high risk to medium to large perching birds, such as the “T-pole” (Fig. 1a). A bird with a wingspan greater than about 110 cm, perched on the cross arm, can touch two conductors simultaneously and get electrocuted. The “inverted T” (Fig. 1b) is considered safe because suspension of the outer conductors below the cross arm places them out of reach of a perching bird. Though we did not undertake any formal quantification of the length of line with each pole configuration in each circuit, it appears that unsafe pole structure represents the vast majority of power line by length in both circuits. All transmission structures (>132 kV) were considered to pose low electrocution risk by virtue of the large clearances between live hardware. The extent of electrification was lower in the Magadi circuit compared to the Naivasha one, suggesting that, all other factors being equal, the Naivasha Circuit may be expected to pose a greater risk of interaction to birds in the area. A more detailed risk assessment would relate power line density to bird species abundance more formally.
