# Stress Corrosion Cracking of Additively Manufactured Alloy 625

**Abstract:** Laser bed powder fusion (LPBF) is an additive manufacturing technology for the fabrication of semi-finished components directly from computer-aided design modelling, through melting and consolidation, layer upon layer, of a metallic powder, with a laser source. This manufacturing technique is particularly indicated for poor machinable alloys, such as Alloy 625. However, the unique microstructure generated could modify the resistance of the alloy to environment assisted cracking. The aim of this work was to analyze the stress corrosion cracking (SCC) and hydrogen embrittlement resistance behavior of Alloy 625 obtained by LPBF, both in as-built condition and after a standard heat treatment (grade 1). U-bend testing performed in boiling magnesium chloride at 155 and 170 °C confirmed the immunity of the alloy to SCC. However, slow strain rate tests in simulated ocean water on cathodically polarized specimens highlighted the possibility of the occurrence of hydrogen embrittlement in a specific range of strain rate and cathodic polarization. The very fine grain size and dislocation density of the thermally un

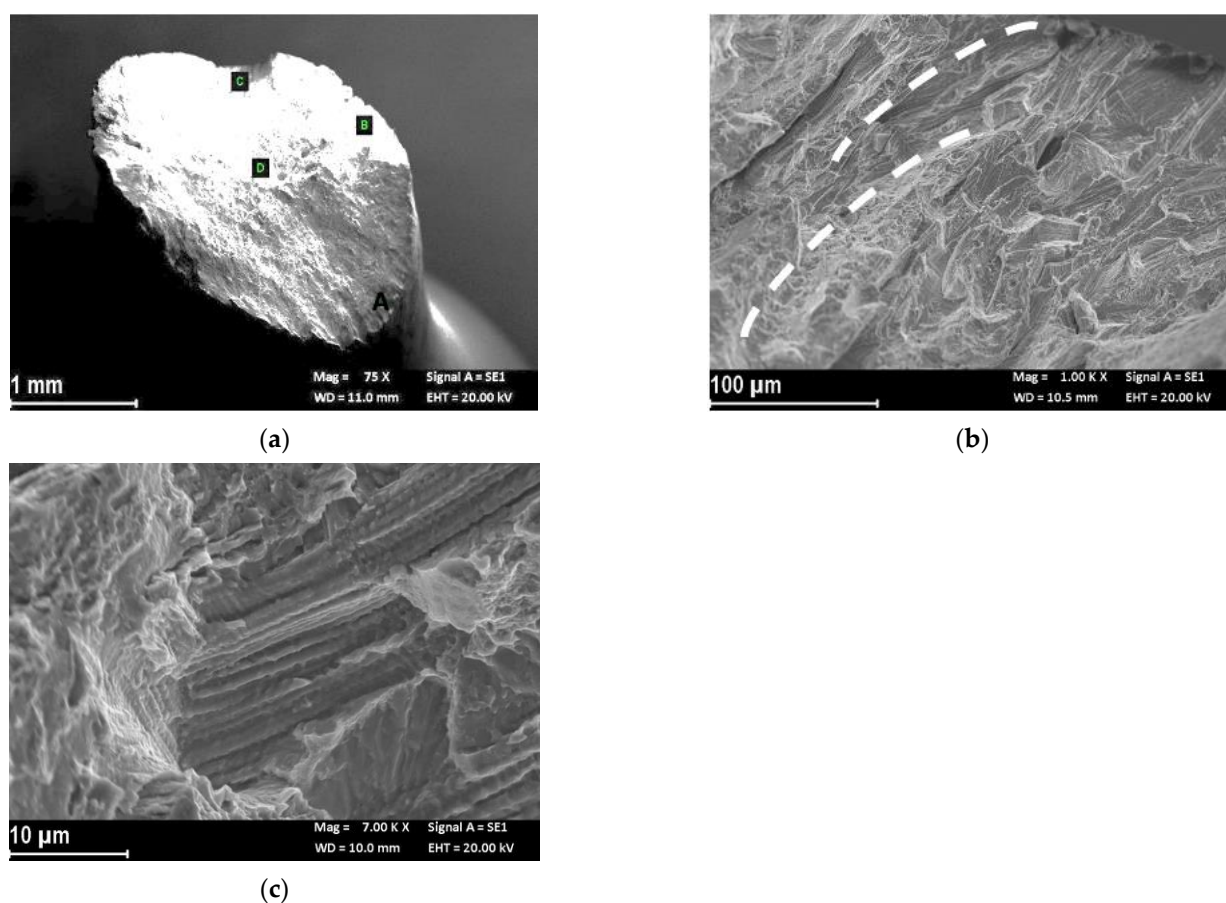
**Figure 5.** Fractographic analysis of the UT-LPBF specimen after the SSRT test at strain rate  $3.15 \times 10^{-5} \text{ s}^{-1}$  in SOW and cathodic polarization at  $-1.1 \text{ V}$  vs. Ag/AgCl after 16 h of hydrogen pre-charging: (a) macro image; (b) close-up of zone A, and (c) a similar morphology is observed in zone C; close-up of zone B; zone D in (a) is fully ductile.

Figure 5a shows the macro image of the fracture surface of the UT-LPBF specimen pre-charged with hydrogen for 16 h and then strained at  $3.15 \times 10^{-5} \text{ s}^{-1}$ . The fracture surface had some small trigger areas with a morphology typical of hydrogen embrittlement (zone A, B and C of Figure 5a; the close-up of zone A is shown in Figure 5b, the close-up of zone B is shown in Figure 5c), while the central area had a mixed fracture consisting of numerous dimples, small brittle facets and rare areas of quasi-cleavage. The final breakage of the specimen occurred by sharing. The value of the normalized reduction of area was very similar to that obtained in the previous case. At high magnification for areas A (Figure 5b), B (Figure 5c) and C of the specimen, a morphology similar to that observed in Figure 4 could be noted, with many brittle facets arranged perpendicularly to the direction of propagation of the fracture (along the dendritic growth) that occasionally jumped on a different plane, and a separation of the border of the melting pool (dotted line in Figure 5b).
