## Archaeological Monitoring for the Buena Vista Corridor Project, San Antonio, Bexar County, Texas

by  
Leonard Kemp

Texas Antiquities Permit No. 8950

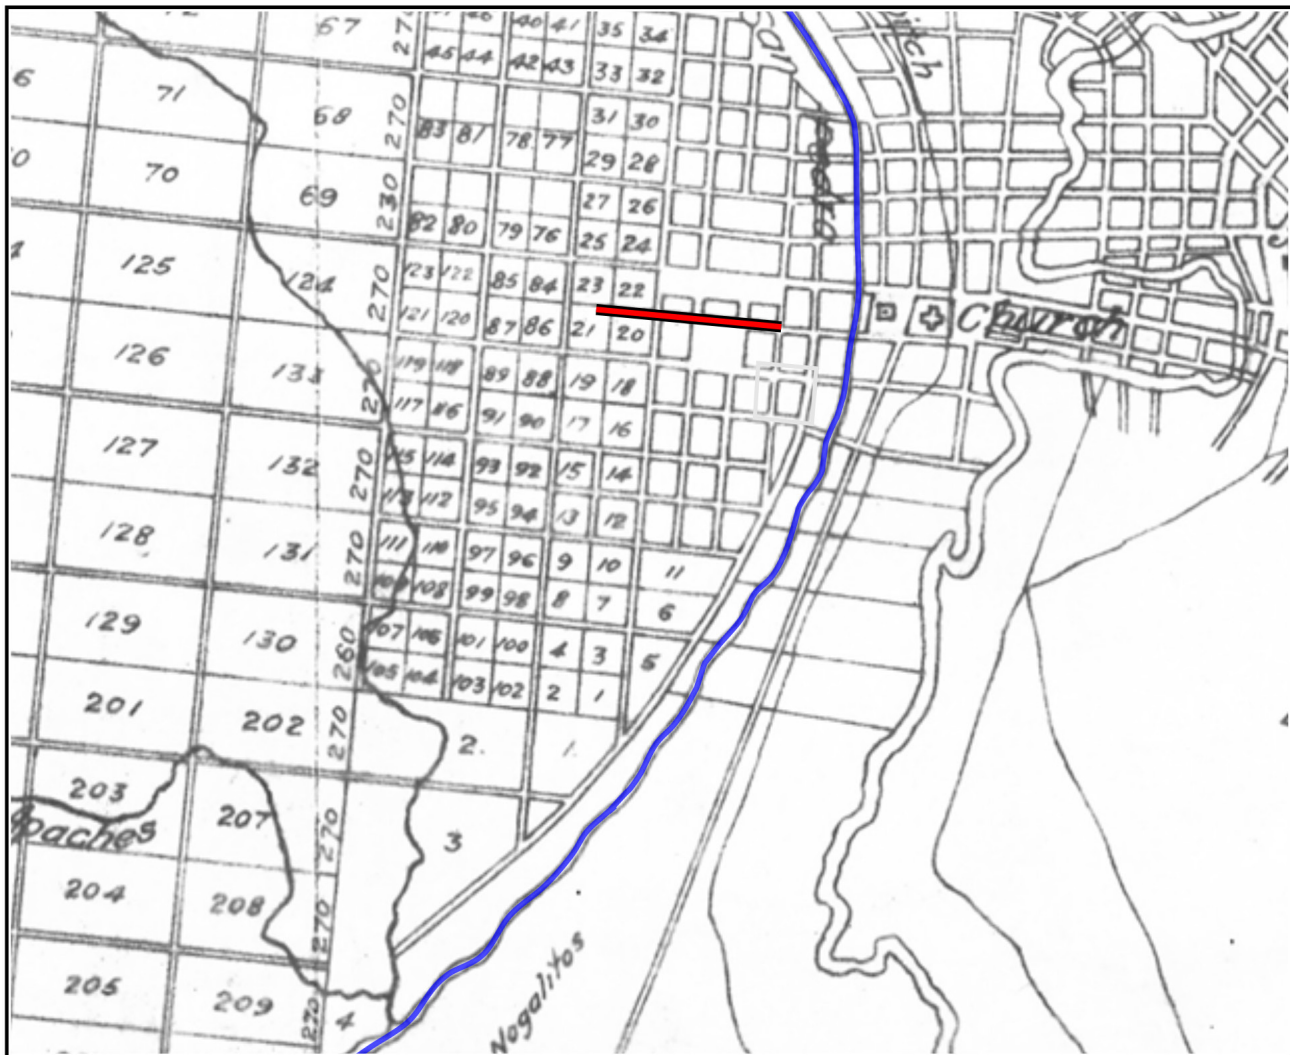
Figure 4-2. Image of Giraud's Survey Map of 1852 showing the plats surrounding the project area (in red), as well as San Pedro Creek (in blue).

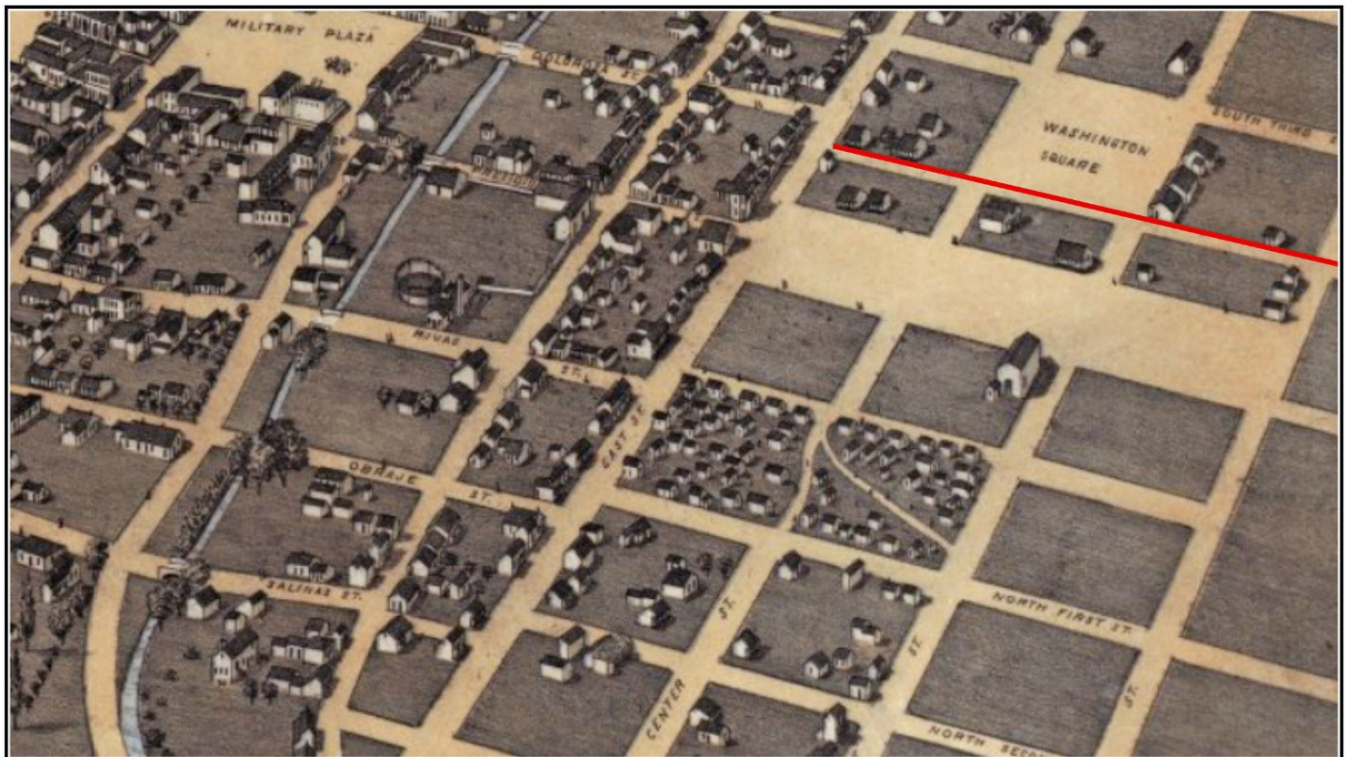
Figure 4-3. Koch's Bird's Eye of San Antonio of 1873 view to the southwest. The west portion of the project area is shown in red.

August Koch's Bird's Eye View of San Antonio 1873 shows modest to small homes belonging to primarily German, French, Italian, and Mexican immigrants who had begun to settle the area (Figure 4-3; Bobbitt 1981; Guerra 1988; Labadie 1987). During this time, the area is sparsely settled, while to the east it was relatively denser. A little more than a decade later, Koch's Bird's Eye View of San Antonio 1886 shows increasing development in the project area and environs (Figure 4-4). It shows Santa Rosa Infirmary that was built by the Sisters of the Incarnate Word around 1875 and Milam Park that was constructed in 1885 (Heusinger 1951). Both properties were built on the former Catholic and City cemeteries, respectively. In 1881, the second rail line, the I&GN Railroad, came to San Antonio (Heusinger 1951). Its station and depot was located two blocks northwest of the project area. The station served as the impetus of commercial growth in the area. The westbound trolley line is shown traveling on Buena Vista Street with the line passing the station and continuing further to the west. The trolley system

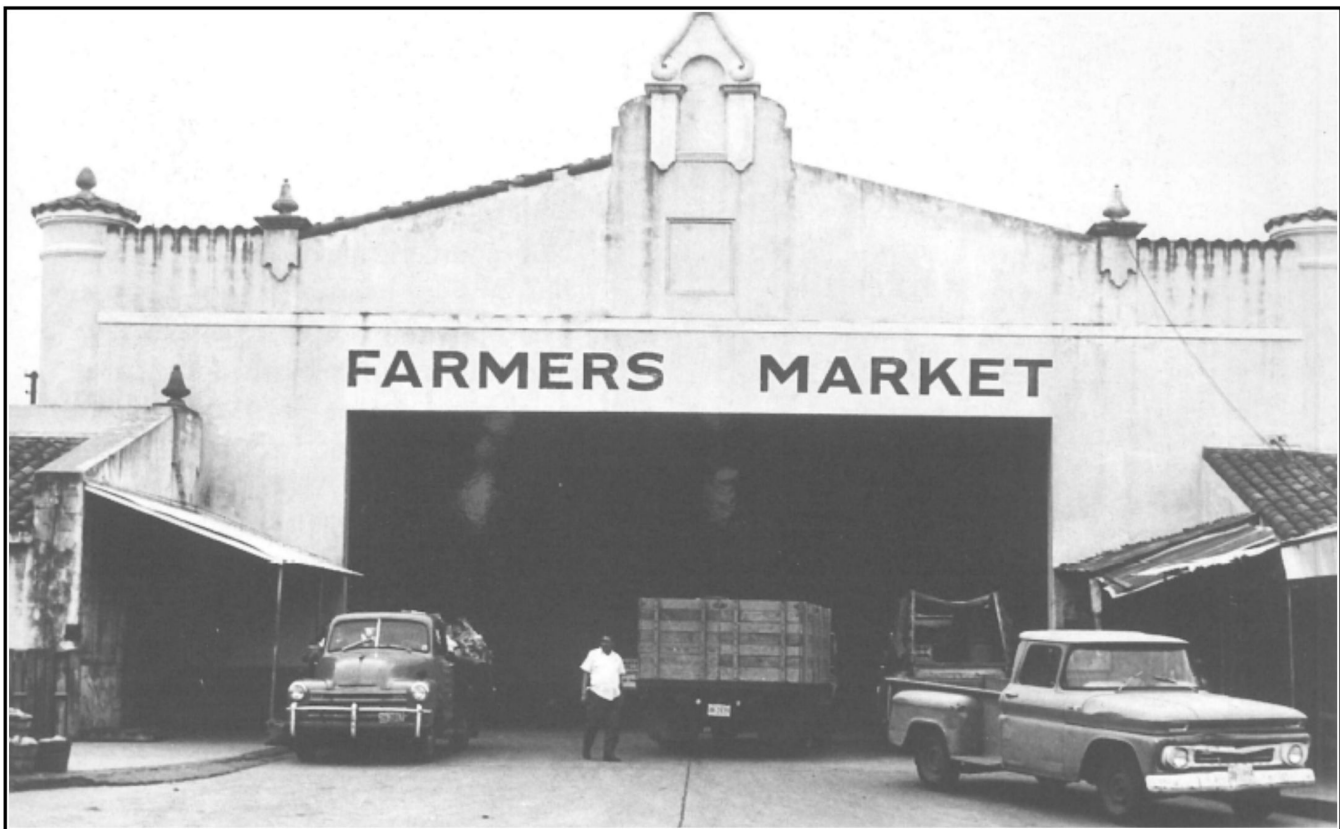
Figure 4-7. The new Market House constructed in 1938. The photo is circa 1960s (UTSA General Photograph Collection).

authorized the construction of a new market house through the National Industrial Recovery Act (Freeman 1972:9). It was a stucco and brick building designed in the Mission Revival style with a tiled gabled roof and turrets on both ends of the roof (Figure 4-7; SADR 1981b). It was open on both ends to accommodate the growing market based on the use of produce trucks (Freeman 1972:9). It replaced the Giles-designed facility by 1938.

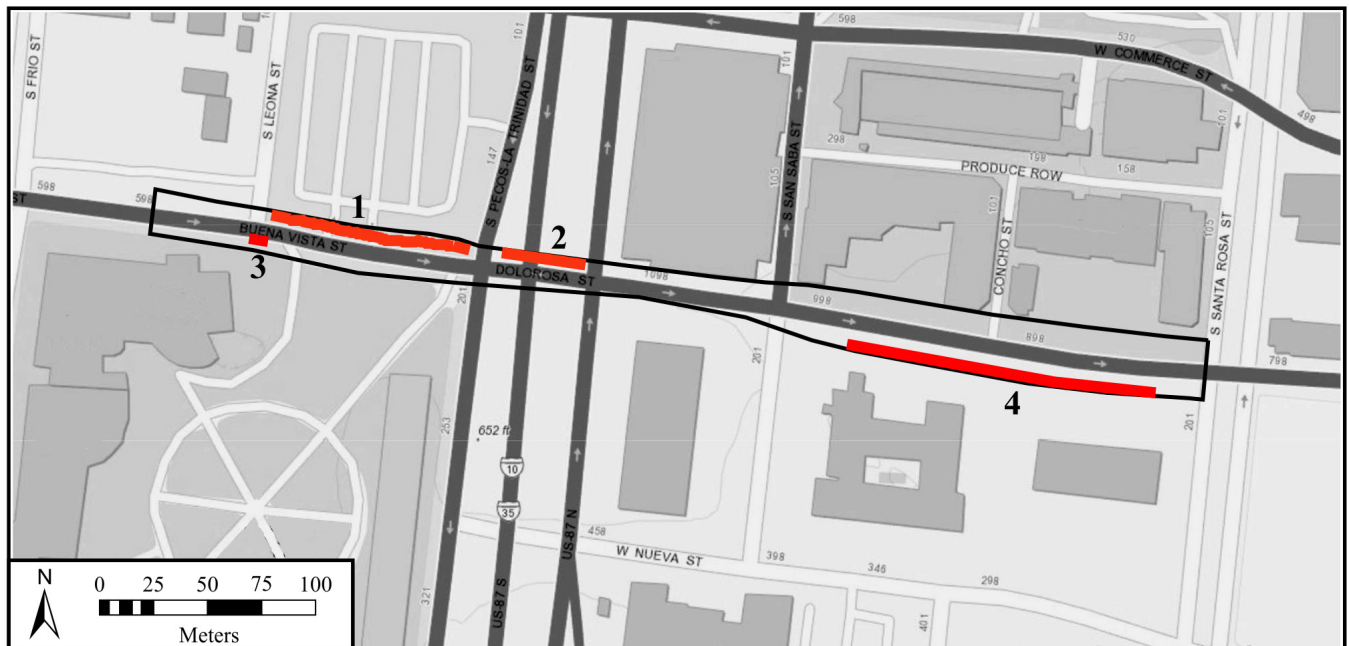
Figure 6-1. Trench locations excavated in the BV Corridor project. Trench numbers are keyed to date of excavation.

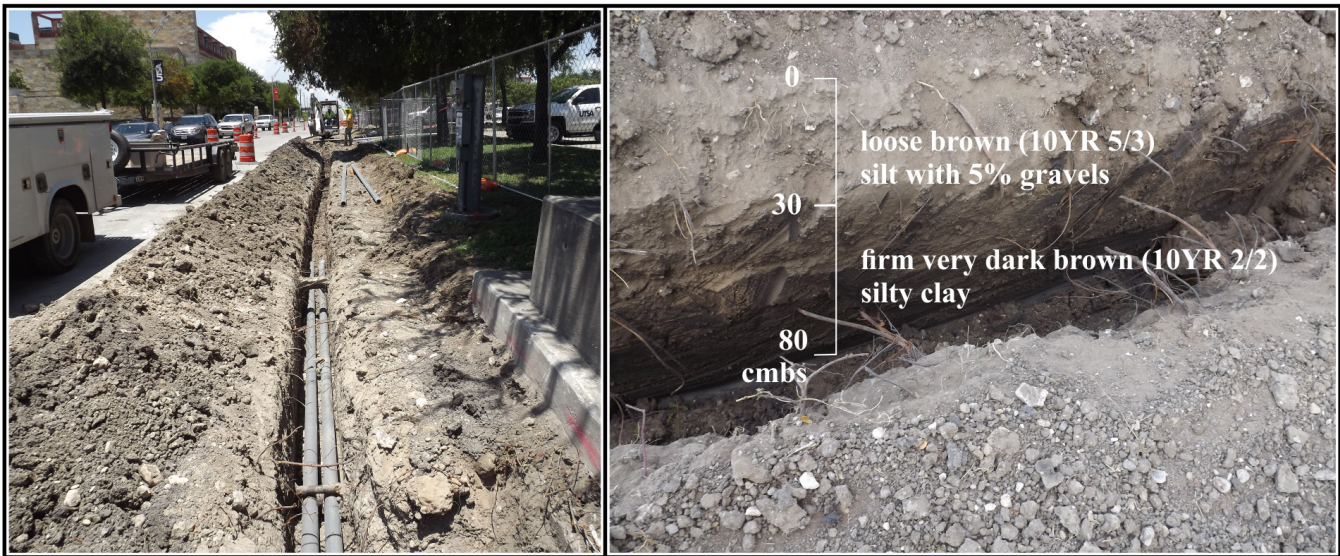
Figure 6-2. Trench 1 excavated on the north side of Buena Vista Street (left). Profile of the southern trench wall (right).

very dark (10YR 2/2) brown to black (10YR 2/1) silty clays. The trench revealed numerous utilities running north to south that serviced the former building(s) in the current UTSA parking lot. Fragments of red brick and non-diagnostic clear glass were observed in the trench backfill.

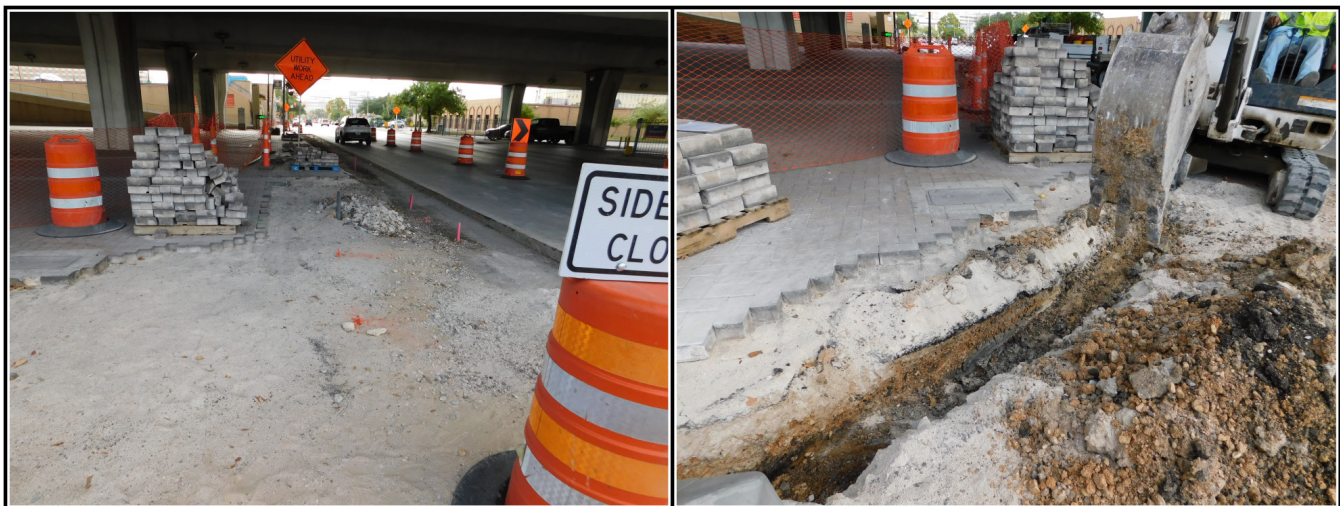
Figure 6-3. The image on the left shows the layout of the trench under the Pan Am Expressway. The image on the right shows the profile of the northern trench wall.

Trench 2 was excavated on the north side of Dolorosa Street under the Pan Am Expressway overpass to the Framers Market Building entrance on August 21 and September 9, 2019 (Figure 6-3, left). The trench was excavated to connect existing utilities from Buena Vista and Dolorosa streets. The trench were 37 m (121.3 ft.) long, 50 cm (19.6 in.) wide, and 30 cm (11.8 in.) deep. The trench matrix consisted of construction fill with the bottom 5 cm (1.9 in.) revealing a dark brown clay (Figure 6-3, right). No artifacts or features were observed in the profiles or backfill.

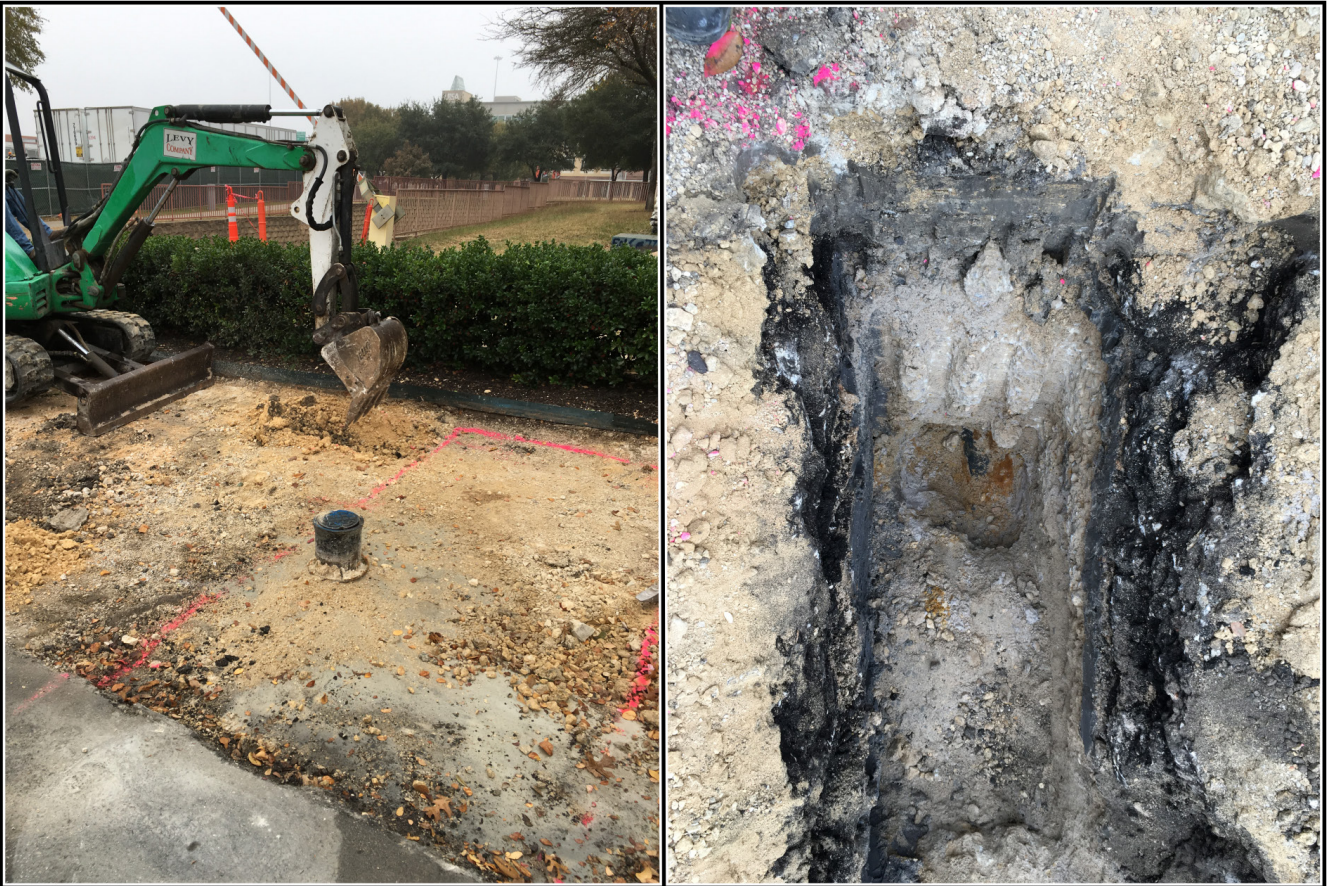
Figure 6-4. Excavation of Trench 3 on the south side of Buena Vista and S. Leona streets (left). The right image shows the trench with asphalt and flowable fill over an existing cast iron pipe.

Trench 3 for a crossing walk signal was excavated on December 5, 2019, on the south portion of Buena Vista Street across from its intersection with S. Leona Street (Figure 6-4). The trench measured 3 m (9.8 ft.) long, 70 cm (27.5 in.) wide, and 1.82 m (5.9 ft.) deep. The trench contained asphalt to 60.9 cm (24 in.) below the grade followed by flowable fill. A cast iron pipe was found at 1.82 m (5.9 ft.) deep. No artifacts or features were observed in the profiles or backfill.

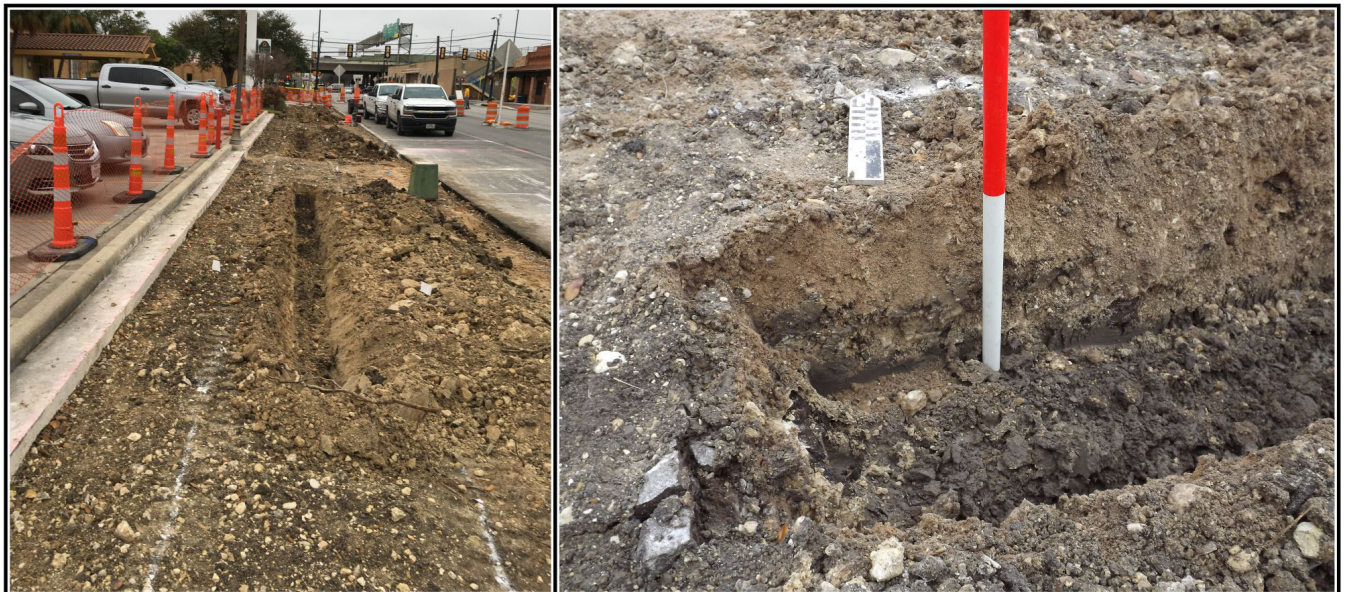
Figure 6-5. View to the west of the irrigation trench excavation with layout for planter boxes painted in white (left). Typical profile of irrigation wall view with construction fill to 25 cm (9.8 in.) below the grade followed by 5 cm (1.9 in.) of silty clay (right).

Trench 4 was excavated on February 19, 2020, on the south side of Dolorosa Street between San Saba and Santa Rosa streets for an irrigation line (Figure 6-5, left). The trench is 140 m (459.3 ft.) in long, 30 cm (11.8 in.) wide, and 30 cm (11.8 in.) deep. The top 25 cm (9.8 in.) of the trench consisted of construction fill and asphalt over a dark brown silty clay (Figure 6-5, right). No artifacts or features were observed in the profiles or backfill.

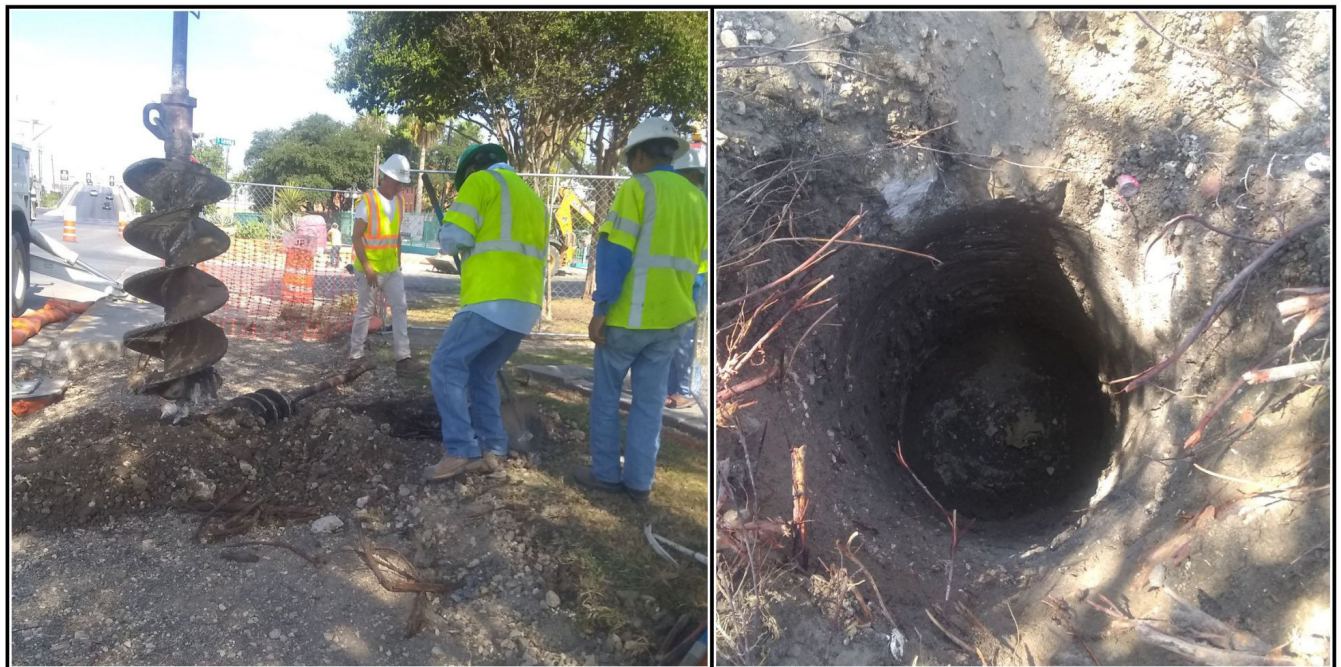
Figure 6-7. Auger excavation at S. Leona and Buena Vista streets (left). The image of the right shows concrete at 152.4 cm (5 ft.) below the surface.

Auger excavations in Areas 1 revealed past construction activities with construction fill and concrete. The auger location at S. Leona and Buena Vista streets contained rebar and unidentifiable metal at 1.2 m (4 ft.) and concrete at 1.52 cm (5 ft.) below the surface (Figure 6-7). The auger excavation at Buena Vista and Pecos streets encountered concrete 60.96 cm (2 ft.) below the surface followed by soils. The final auger

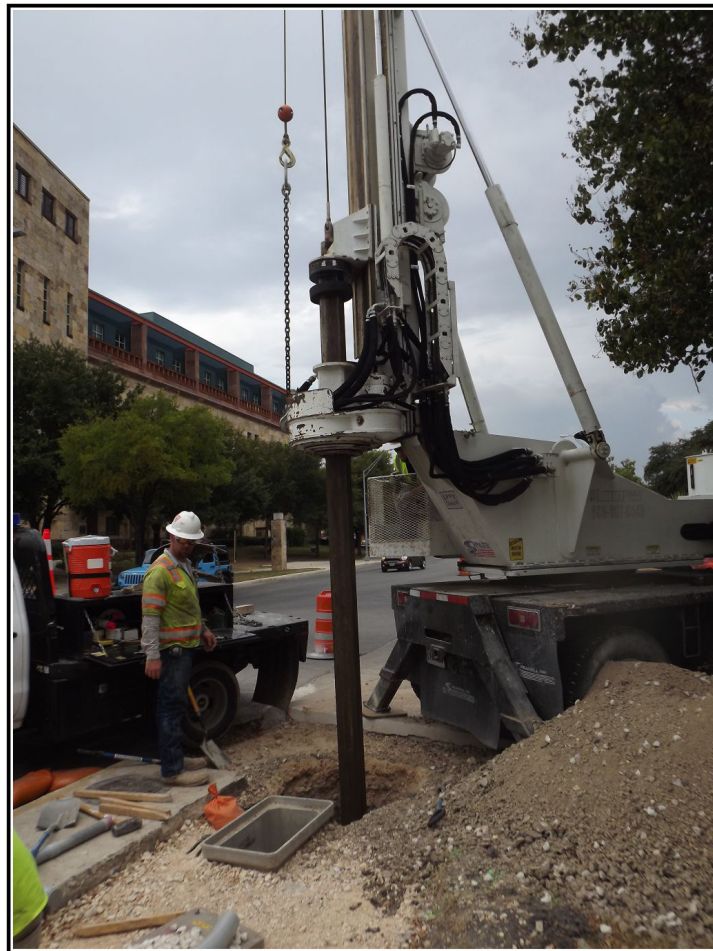
Figure 6-8. Excavation of the auger in Area 2 showing spoil pile.

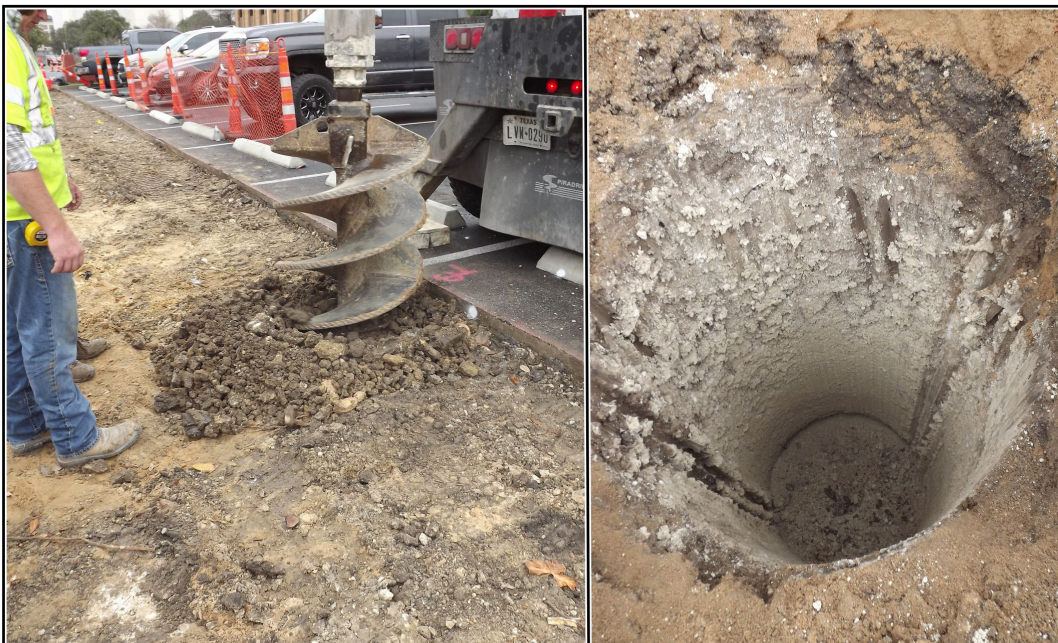
Figure 6-9. Image on the right shows location of Area 5 view to the southeast. Profile view of auger in Area 5.

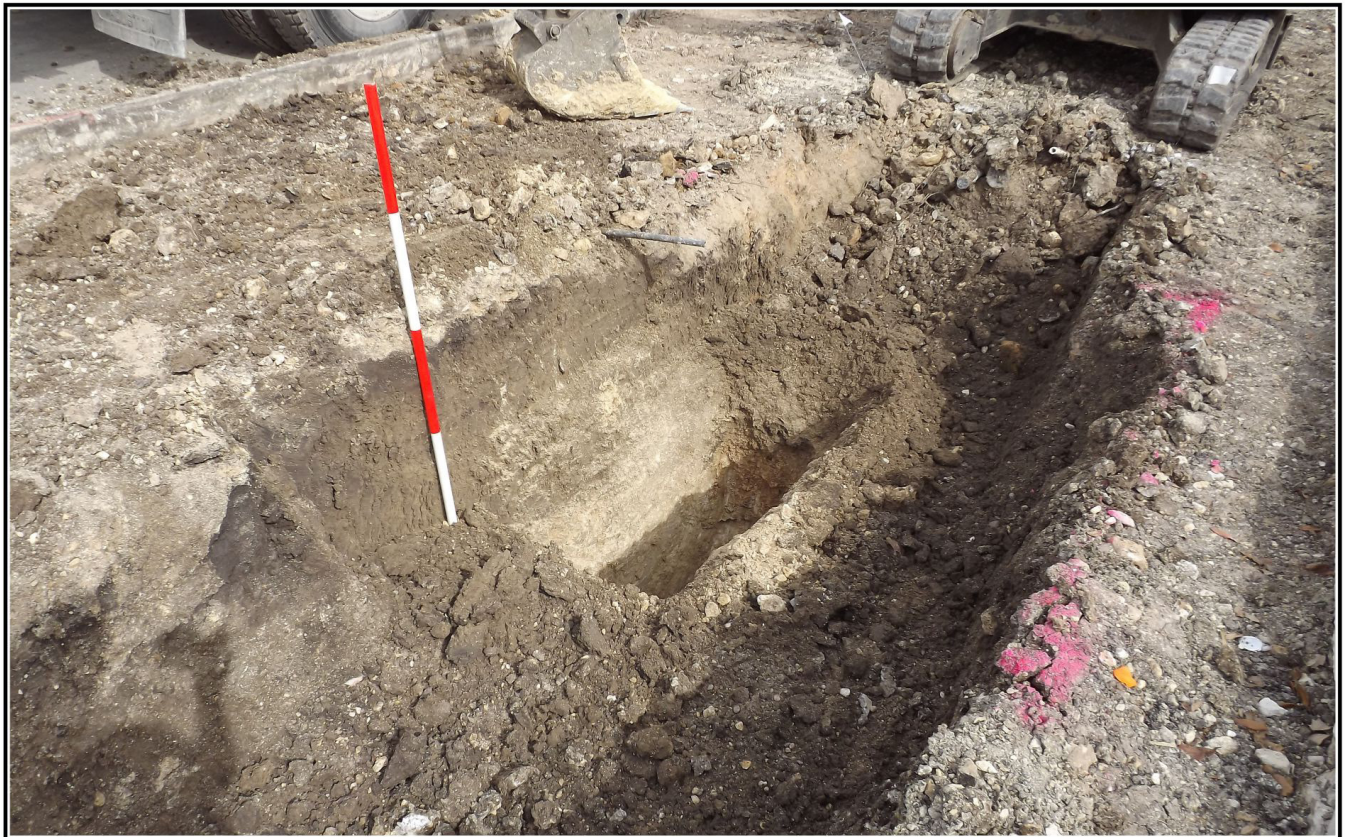
*Figure 6-11. Typical pit excavation with deeper drainage pit against the wall and soil profile.*

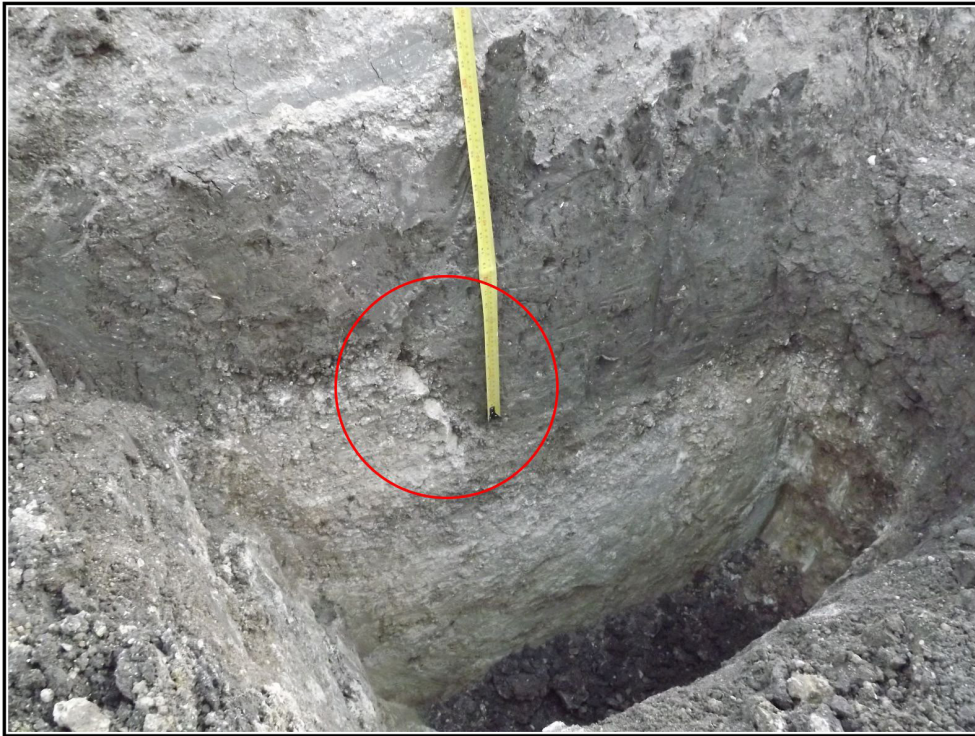
Figure 6-14. Detail of the east portion of the north profile highlight the stones.

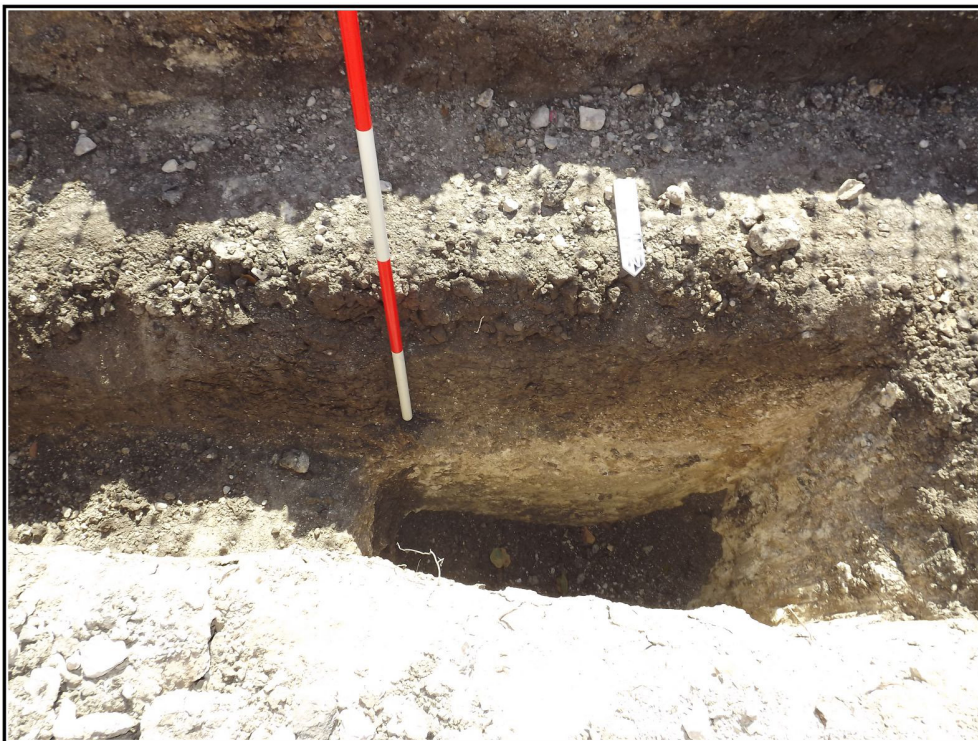
Figure 6-15. South profile of 41BX2345.

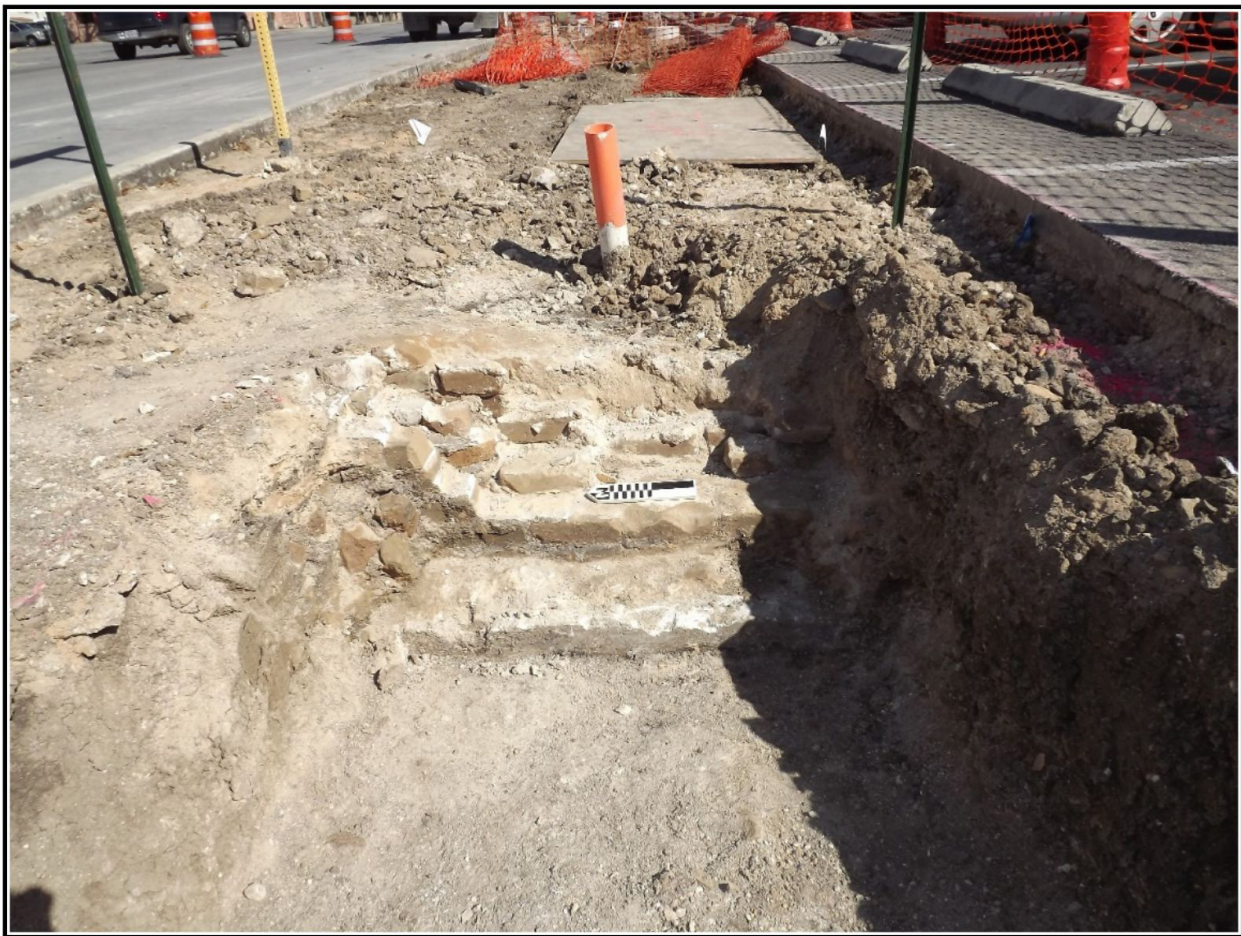
Figure 6-18. A view to the east of the brick foundation comprising 41BX2346.

foundation feature is approximately 40.8 m (134 ft.) from the corner of then Buena Vista and Santa Rosa streets and matches the western wall of No. 108 Buena Vista Street.

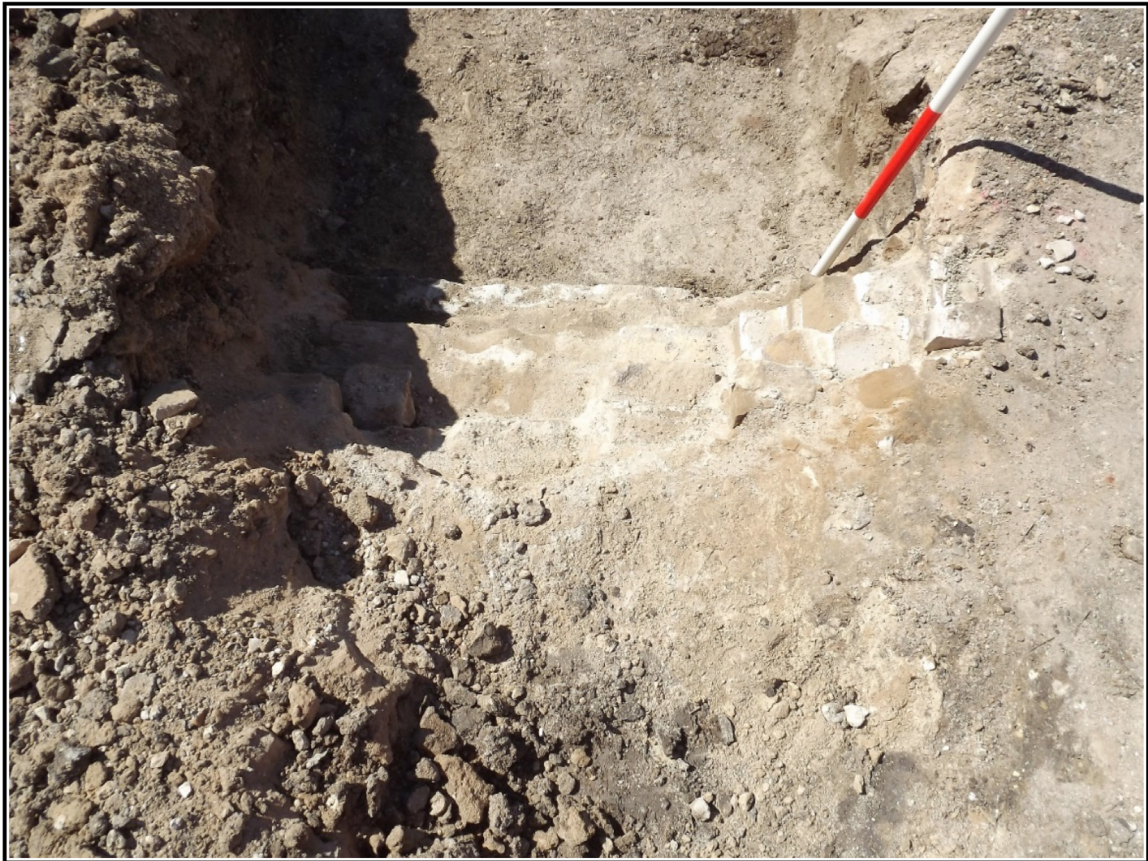
*Figure 6-19. An overhead view of the brick foundation comprising 41BX2346.*

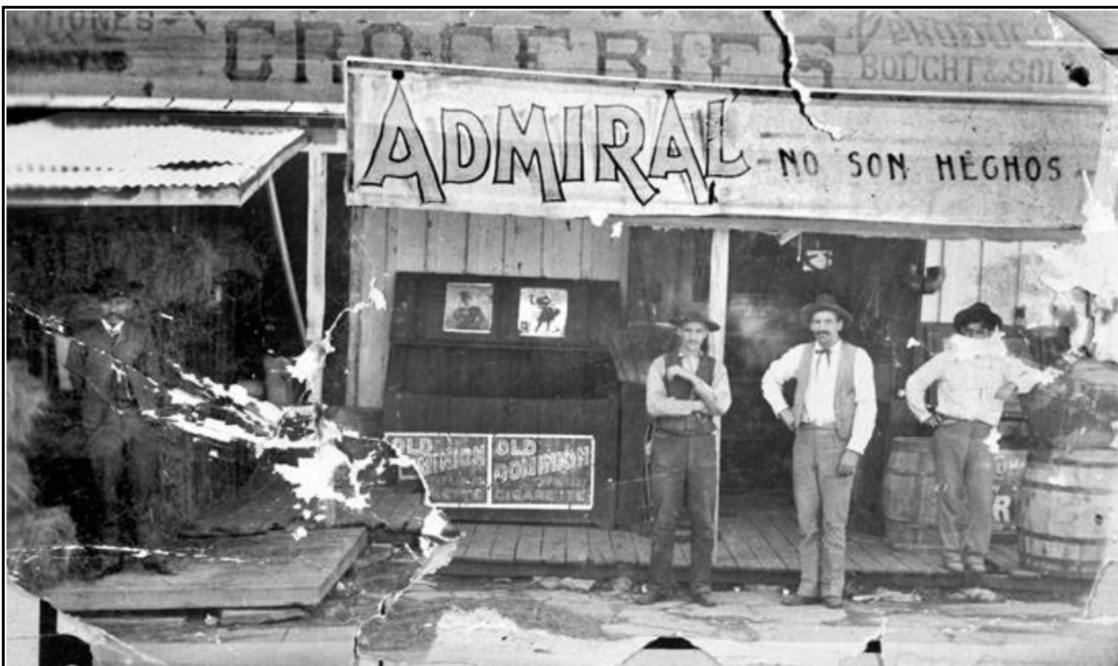
Figure 6-22. A photo of the J. Flores Groceries and Saloon circa 1890 (UTSA General Photograph Collection).

The lot is sold to Isidoro Flores in 1887 (BCDR 1887:57:226-28). The 1880 U.S. census identified Flores as a 51-year-old, widowed farmer with four children (U.S. Census 1880). The oldest son at 22 years of age is José (U.S. Census 1880). The 1886 Koch Bird’s Eye View and the 1888 Sanborn map shows that Flores had expanded the single-room dwelling to a multi-room dwelling (Figure 6-21). The building portion fronting S. East Street is numbered as 201 and listed as a grocery. The San Antonio City Directory (1890-91) lists the address of 201 S. East Street as “J. Flores Groceries and Saloon” (Figure 6-22). This is the same José who is the son of Isidoro (BCDR 1900:193:139-40).
