A CULTURAL RESOURCE SURVEY OF TWO DIRECTIONAL DRILL LOCATIONS ON THE AIR LIQUIDE SOUTH TEXAS SYNGAS PIPELINE WITHIN TPWD'S JUSTIN HURST WILDLIFE MANAGEMENT AREA

Texas Antiquities Permit Number 7029

Negative Findings Phase I Survey Report Justin Hurst Wildlife Management Area Brazoria County, Texas

Technical Report 276

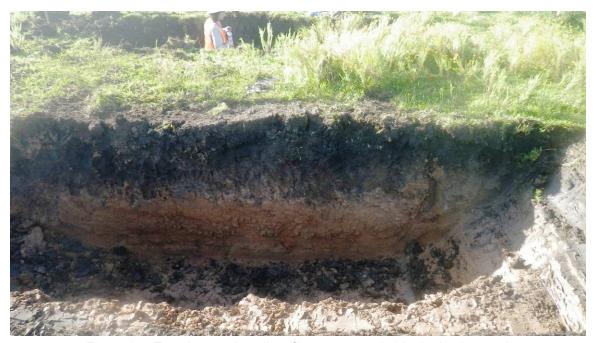
Figure 10. Trench 2 south wall profile - note trench 1 in the background.

Trench 2 is located approximately 2 m north of Trench 1,—and is the proposed location of the mud pit which will be used in conjunction with the drill hole at Trench 1. The trench was 6 m long by 2 m wide by 1.25 m deep. The soil was similar to Trench 1, with 10YR 2/1 black clay over 10YR 5/8 strong brown clay (Figure 10). The south wall, covering 7.5 square meters, was hand cleared and examined for cultural remains. The remaining wall and the back dirt were also examined. No artifacts or features were noted.

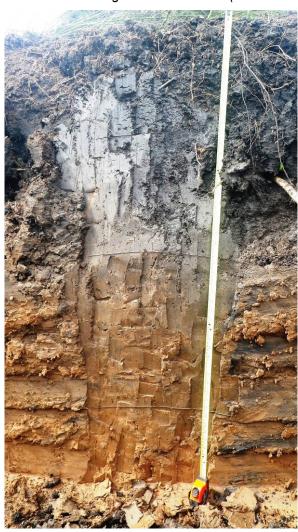
Figure 12. Trench 3 north wall profile.

Trench 3 was dug 130 m east of Jones Creek, in an area that had the highest potential for containing cultural remains. No construction activity will occur at this location. The trench was placed along the northern edge of the existing utility corridor, oriented in an east-west direction at 160 degrees magnetic (Figure 11). The trench was 6 m long by 2 m wide by 1.30 m deep. The soil was slightly different than that at Trenches 1 and 2 and showed 10YR 3/1 very dark gray clay from 0-63 cmbs over 10YR 6/6 reddish yellow clay from 63-104 cmbs covering 10YR 5/8 strong brown clay from 104-130+ cmbs (Figure 12). Examination of the 7.8 square meters of the hand-cleared north wall as well as the south wall and back dirt produced no cultural material.

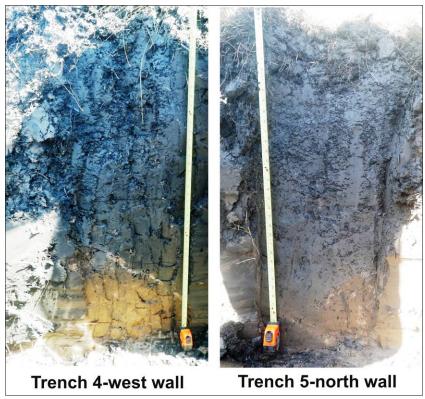
Figure 14. Trench 4 and 5 soil profiles.

Trenches 4 and 5 were dug at the westernmost temporary work location, 1.2 miles east of the western boundary of the JHWMA (see Figures 2, 5). Trench 4 is the easternmost of the two and is located along the central southern edge of the 200 ft by 200 ft temporary workspace (Figure 13). The trench was dug along a generally north-south trajectory at the location of the proposed drill entry/exit pit. The trench was aligned along a 200 degree magnetic compass bearing and was 6 m long by 2 m wide by 1.25 m deep. The soil showed 10YR 2/1 black clay from 0-46 cmbs, over 10YR 3/1 very dark gray clay from 46-68 cmbs over, 10YR 5/4 yellowish brown clay from 68-83 cmbs covering 10YR 5/8 strong brown clay from 83-125+ cmbs (Figure 14). The west wall covering 7.5 square meters was hand cleared and examined for cultural remains. The remaining wall and the back dirt were also examined. No artifacts or features were noted.

Trench 5 is the western of the two and is also located along the central southern edge of the 200 ft by 200 ft temporary workspace (see Figures 13, 5). The trench was dug along an east-west trajectory near the location of the mud pit. The trench was aligned along a 270 degree magnetic compass bearing and was 4 m long by 2 m wide by 0.90 m deep. The soil showed 10YR 2/1 black clay from 0-61 cmbs over 10YR 5/4 yellowish brown clay from 61-78 cmbs covering 10YR 5/8 strong brown clay from 78-90+ cmbs (see Figure 14). The north wall covering 3.6 square meters was hand cleared and examined for cultural remains. The remaining wall and the back dirt were also examined. No artifacts or features were noted.
