## Cone-Beam Computed Tomographic Evaluation of Artifact Effects of Three Different Sealers

Original Article

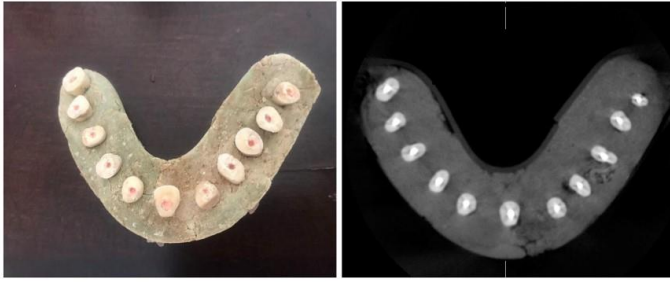
**Figure 1.** Acrylic cassette with mounted teeth (left) and CBCT image of such costumed cast (right)

Teeth were randomly divided into four equal groups. Canals were filled by lateral condensation method using gutta-percha alone as control groups and with Diadent, AH-26 (Dentsply, Tulsa Dental, Tulsa, OK, USA) or Anyseal (Medicus, Cheongju, Korea). Sealers were used based on the manual instruction and placed in the canal by master cone. Teeth were stored in 37°C and 100% relative humidity for 1 week and then were mounted. To simulate PDL space, root of each tooth was covered by 1 mm of wax and teeth were placed in the custom cast, which was formed, similar to human mandible.

After 24 h, all samples were placed in the container and were imaged using CBCT Promax3D (Planmeca, Finland) with voxel size 0.15 and then 0.3 mm. CBCT images were obtained with 87 kVp, 10 mA, exposure time of 12 sec, field of view (FOV) of 8×8 cm and all teeth were depicted in one image. Finally, 8 CBCT
