Atypical Flash Burns following Low Voltage Electrical Explosion: The Importance of Forensic Engineering

Article Type:
Case Report

Keywords:
Electrical Explosion
Flash Burns
Forensic Engineering

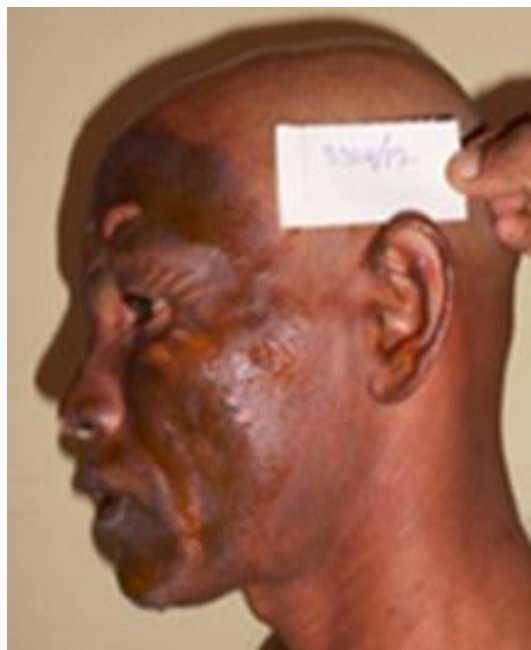
There were dark brown superficial burns on facing and exposed sides. Areas covered by the helmet, hair and beard were spared. There were burn-free radially arranged elongated areas of the skin around eyes and nose. Eye brows were partially singed and eye lashes were completely burnt (figure 1). He had pain in eyes, iritis and photophobia.

Fig. 1. Burn-free radially arranged elongated areas around eyes and nose. Partially burnt eye brows and completely burnt eye lashes. Hair and beard were shaved at the ward and were spared of burns.

The radially arranged elongated spared areas of the skin around eyes were due to sudden tight closure of eyes.

Radiant heat flash burns of low voltage electrocution usually cause only erythema of the skin without singeing of hair (5). Pain in his eyes and photophobia with iritis confirmed the presence of ‘Flash eye’ (4). In flash burns, the eye lashes are singed due to their erected posture (5).

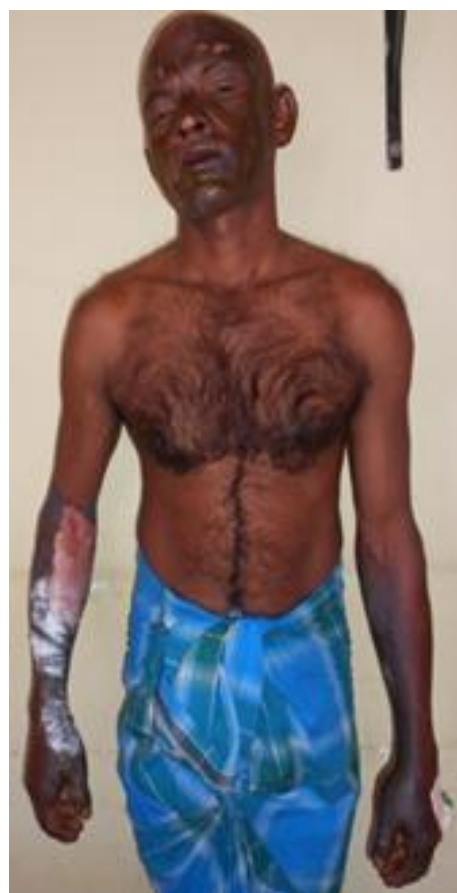
Inner aspects of both forearms (right more than left) were burnt leaving a horizontal upper margin at the elbow (figure 2). The right sleeve of the shirt was melted along the fold with blister formation on the skin. Superficial light brown burns were on dorsum of both feet sparing the areas covered by the straps of slippers (figure 3). There were no joule burns or multiple circumscribed and cavitated lesions.

Fig. 2. Note the burns on inner aspect of right forearm than left and the horizontal upper margins. Only the exposed and facing areas were burnt.

When he was handling the shovel, the inner aspects of the forearms facing towards the explosion were burnt.

Blisters and the severe burns on the right forearm could have been due to closer proximity of the blast when handling the shovel by this right handed person.

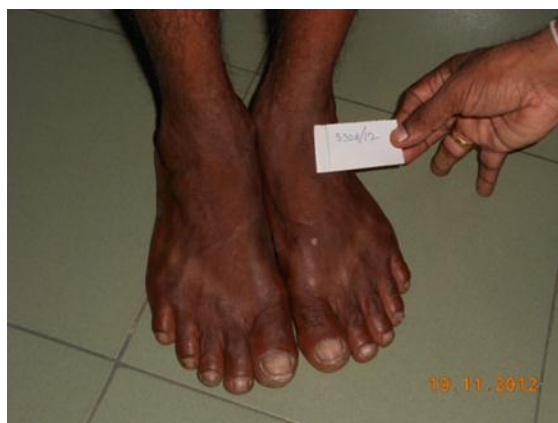
Fig. 3. Very superficial light brown burns on dorsum of both feet sparing the areas covered by the straps of rubber slippers.

Areas covered with clothes, head hair, beard, helmet, slippers were spared. The sleeves of the shirt had prevented the underlying skin being burnt and the

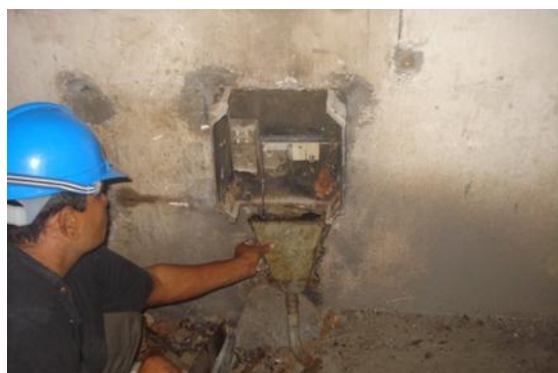
Scene visit revealed a burnt electric appliance fixed to a wall (figure 4). Though it was a severe explosion involving more energy, the local electrical engineer of Electricity Board confirmed that it was a low voltage electrical explosion.

Fig. 4. The electric appliance fixed to the wall was severely burnt and exploded.

The electrical expert who investigated the crime scene confirmed that it was a low voltage electric supply and a defect in the electrical apparatus. The high severity of the electrical explosion was related to the three phase supply and its close proximity to the transformer.
