# Moisture related challenges in the Greenlandic building sector – results from a survey

**Abstract.** The building industry is booming in the larger cities of Greenland; there is a need for housing, and the building stock is in urgent need of renovation, mainly due to the combination of extreme weather conditions and the lack of tradition to maintain buildings. The harsh climate with short summers and long periods of cold weather combined with occasionally high wind speed and precipitation makes it difficult to prevent moisture during the construction phase, causing high drying costs. These challenges highlight the need for guidelines on how to handle moisture especially in the construction phase, both at renovation or when erecting new buildings. To prepare the guidelines, a survey was carried out aimed at building professionals in Greenland. Focus was on identifying construction work challenged by the conditions in Greenland including geography and seasons. The feedback gave an overview on the main challenges and what kind of solutions that do or do not work, showing that handling of moisture in the construction phase is not the only problem. Further, the survey gave feedback o

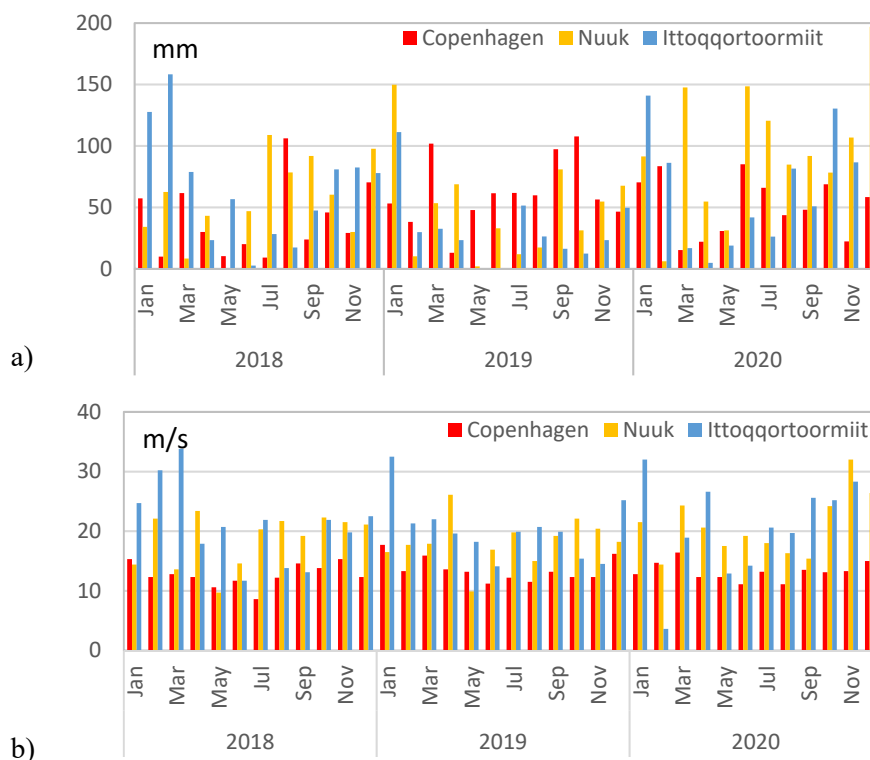
**Figure 2.** Precipitation [mm] (a) and wind speed [m/s] (10 minutes maximum) (b) in Copenhagen, Nuuk and Ittoqqortoormiit. Monthly average values for a 3-year period (Jan 2018 – Dec 2020) to illustrate variations. [2].

Stars mark cities in Greenland, for which weather data are shown at Figure 2; the capital city Nuuk at the West coast, with about 30 % of the population, and Ittoqqortoormiit at the East coast just north of the 70<sup>th</sup> degree of latitude. Although very few people lives at the East coast, Ittoqqortoormiit is chosen as the weather in this area is extreme, however still inhabited.

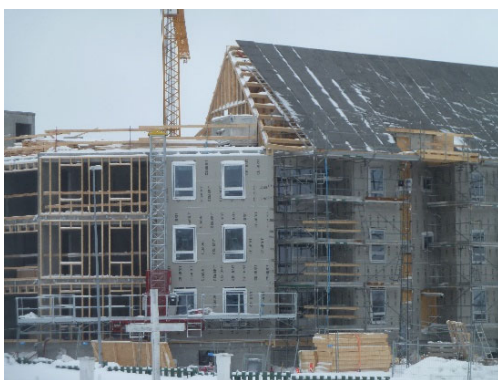
**Figure 3.** Multi-storey building with wood-based facades before and after installing wind barrier, and wood-based roof construction with roofing felt.

Solutions that do *not* work were very much related to not having designed the construction towards the weather conditions, including high rain load (esp. in the southern part of Greenland) and heavy wind. In the case of wood-based facades, widely used in Greenland (Figures 3 and 4), it was pointed out that the cladding was often not sufficiently tight which means that the wind barrier became heavier exposed than expected. As an example, one of the respondents experienced wind barriers not being properly air tight, either due to the material itself or the joints. Cold wind could then enter further into the construction, eventually reach the vapour barrier and giving rise to condensation on the interior side. A vapour barrier was regarded by the respondents as vital to avoid moisture entering the building envelope and to avoid outward bound convection, lowering the effect of the installed insulation.

As Greenland consists of cities with more than 1000 inhabitants living in multi-storey buildings constructed as shown in Figure 3 and small villages with about 50-100 inhabitants mainly living in wooden houses (Figure 5a), guidelines targeted at these two types of buildings might be the most important task to carry out. The results from this survey might not be surprising, but it has not been systematically documented at this scale before. At present, following the setup of GBR (Section 2), guidelines should be quite specific and explainable, however not too rigid as this risks to counteract innovation. This is considered more relevant to introduce than a complex guideline as the Danish [6] that even might not be used, as seems to be the case in Denmark.

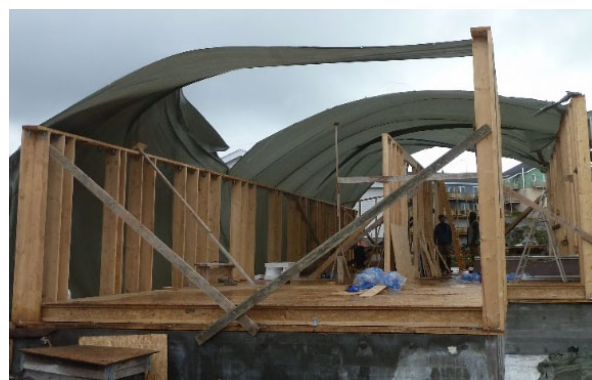
**Figure 4.** Windy conditions at building site during summer.

While weather protection gradually is becoming more used in Denmark, the windy climate and the costs related to scaffolding owing to the topography makes total enclosure of the building a challenge

in Greenland. Even a simple cover can be a challenge (Figure 4). After closing the building envelope, and before installing thermal insulation, the building is heated by means of diesel generators to get rid of the built-in moisture as the natural drying potential in Greenland is quite limited; a time-saving but also expensive and not CO<sub>2</sub> friendly method.

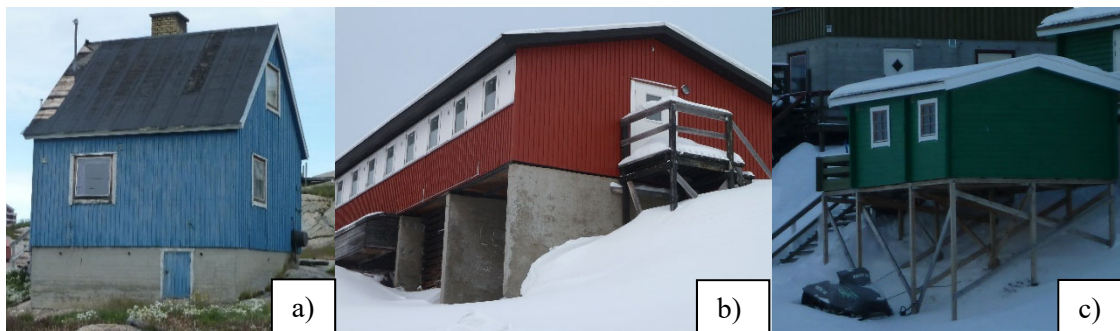
**Figure 5.** Different ways to support buildings in Greenland, a) a closed in-situ casted concrete construction with openings for ventilation, b) a partly open concrete construction, c) a wooden construction, leaving the floor construction fully exposed.

As most buildings in Greenland are placed on sloping terrain, often directly on rock surface, crawl spaces are very common in Greenland, this also reduces the risk of flooding, and avoids a cold lower floor [10]. The crawl space is closed either by in-situ concrete (Figure 5a) or a wooden frame covered with boards of a non-organic material. In other cases, the building is supported as shown on Figure 5b and 5c. This allows for water and melting snow to pass below the building, which is relevant in areas with high rain load or a lot of snow.

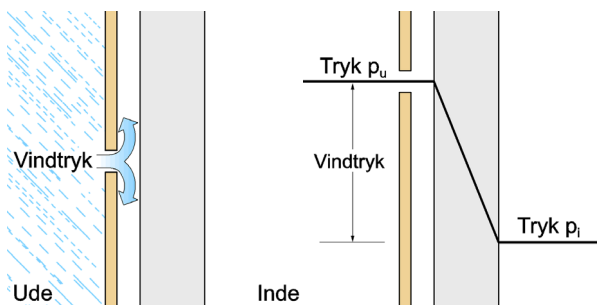
**Figure 8.** Two-step construction with an outermost rain shield and a wind tight part on the inside. Due to the openings, the pressure difference across the rain shield will be insignificant. Then, there is no pressure to force the water through the rain shield and across the cavity. The pressure reduction takes place across the wind tight part [11].

It was highlighted to learn from the performance of existing buildings when designing new ones or preparing renovation. Buildings should to be kept as simple as possible, using the correct materials, to make the solutions as robust as possible, minimizing the risk for mistakes or damage at a later stage. This is not different from what is seen in other countries where exposure to wind driven rain need to be taken into consideration, however highlighted in Greenland due to the merciless conditions; weather, terrain, and infrastructure, making planning and design even more important. In a façade this is typically dealt with using a so-called two-step solution where an outermost rain shield acts as rain sealant, while an innermost wind barrier works as air sealant. The two layers are separated by a cavity ventilated from the outside through ventilation openings placed in the rain shield. The two-step tightening principle is illustrated in Figure 8. Most façades in Greenland today are built using this principle (Figure 9).

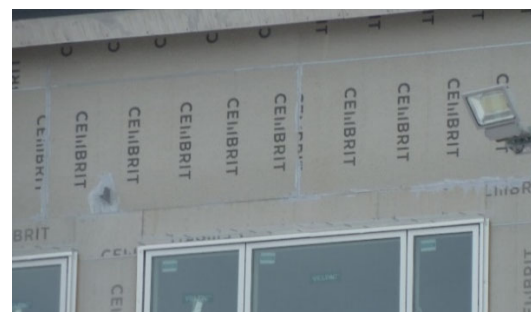
**Figure 9.** Facade before rain shield is installed showing the many joints that have to be sealed between fibre cement boards used as wind barrier.
