Winter Harbor Dredge Channel Data Report

**Shoreline Studies Program
Virginia Institute of Marine Science
William & Mary**

September 2021

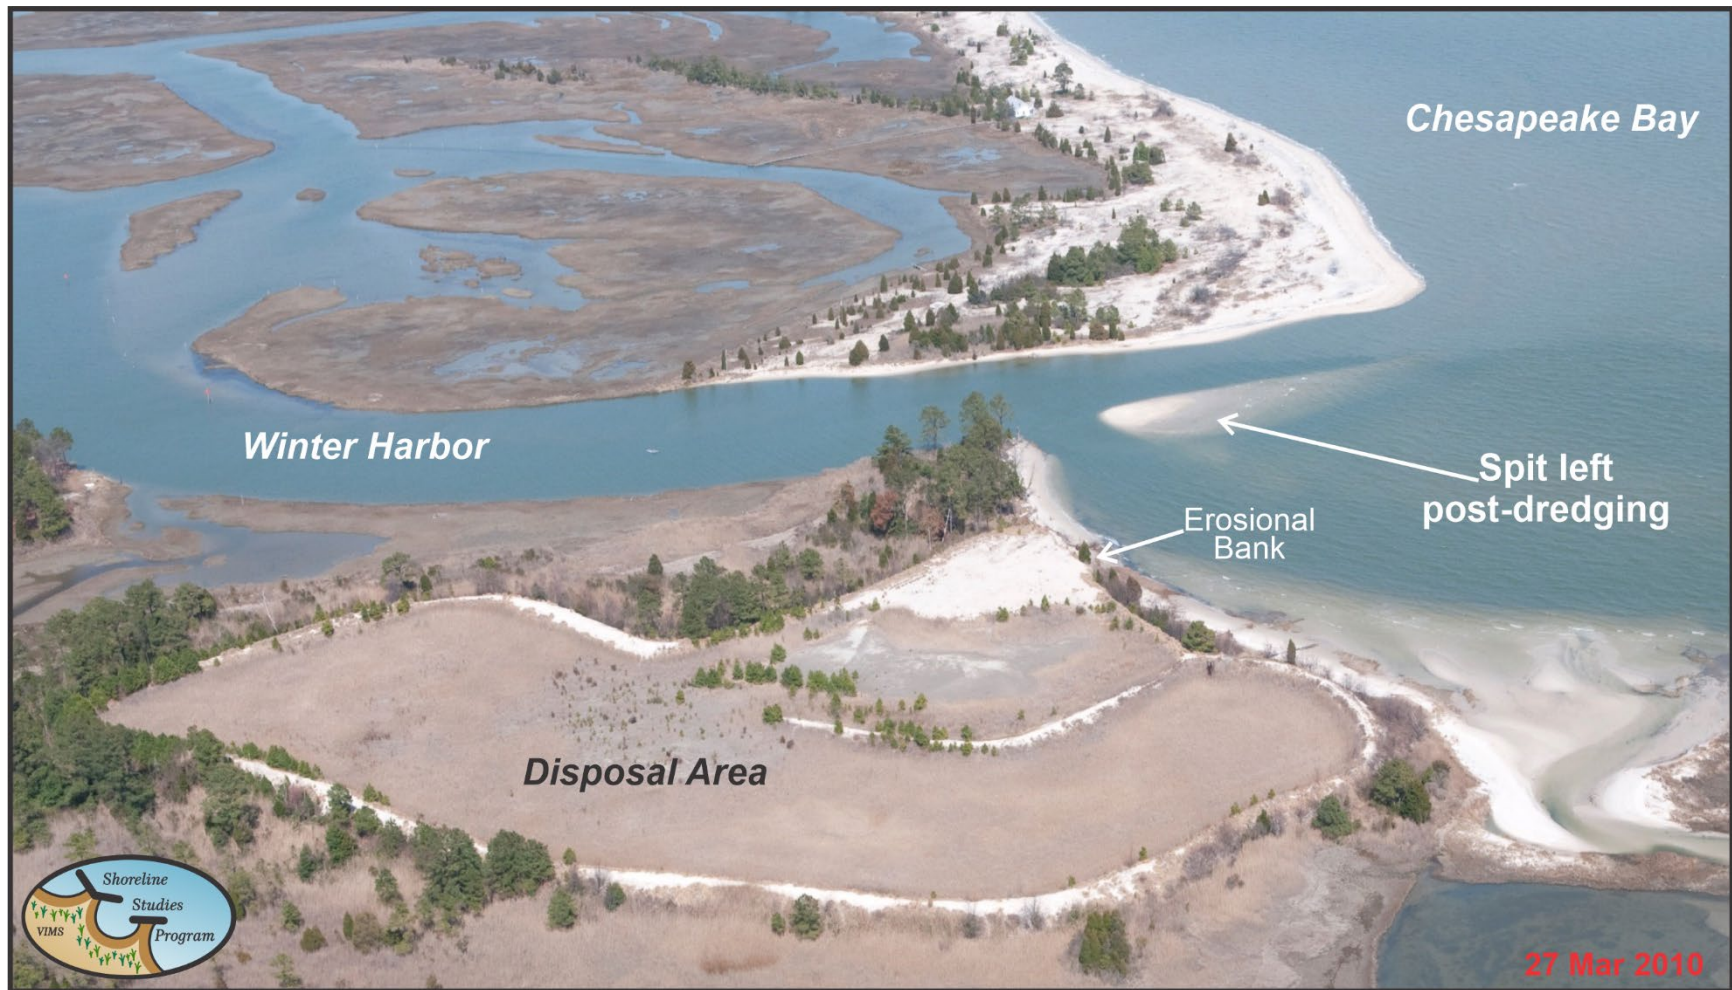
Figure 7. Aerial photo of Winter Harbor Inlet, post dredging in 2010. The material was placed to the north. Only the Federal channel was dredged; the sandy spit south of the channel was left in place.

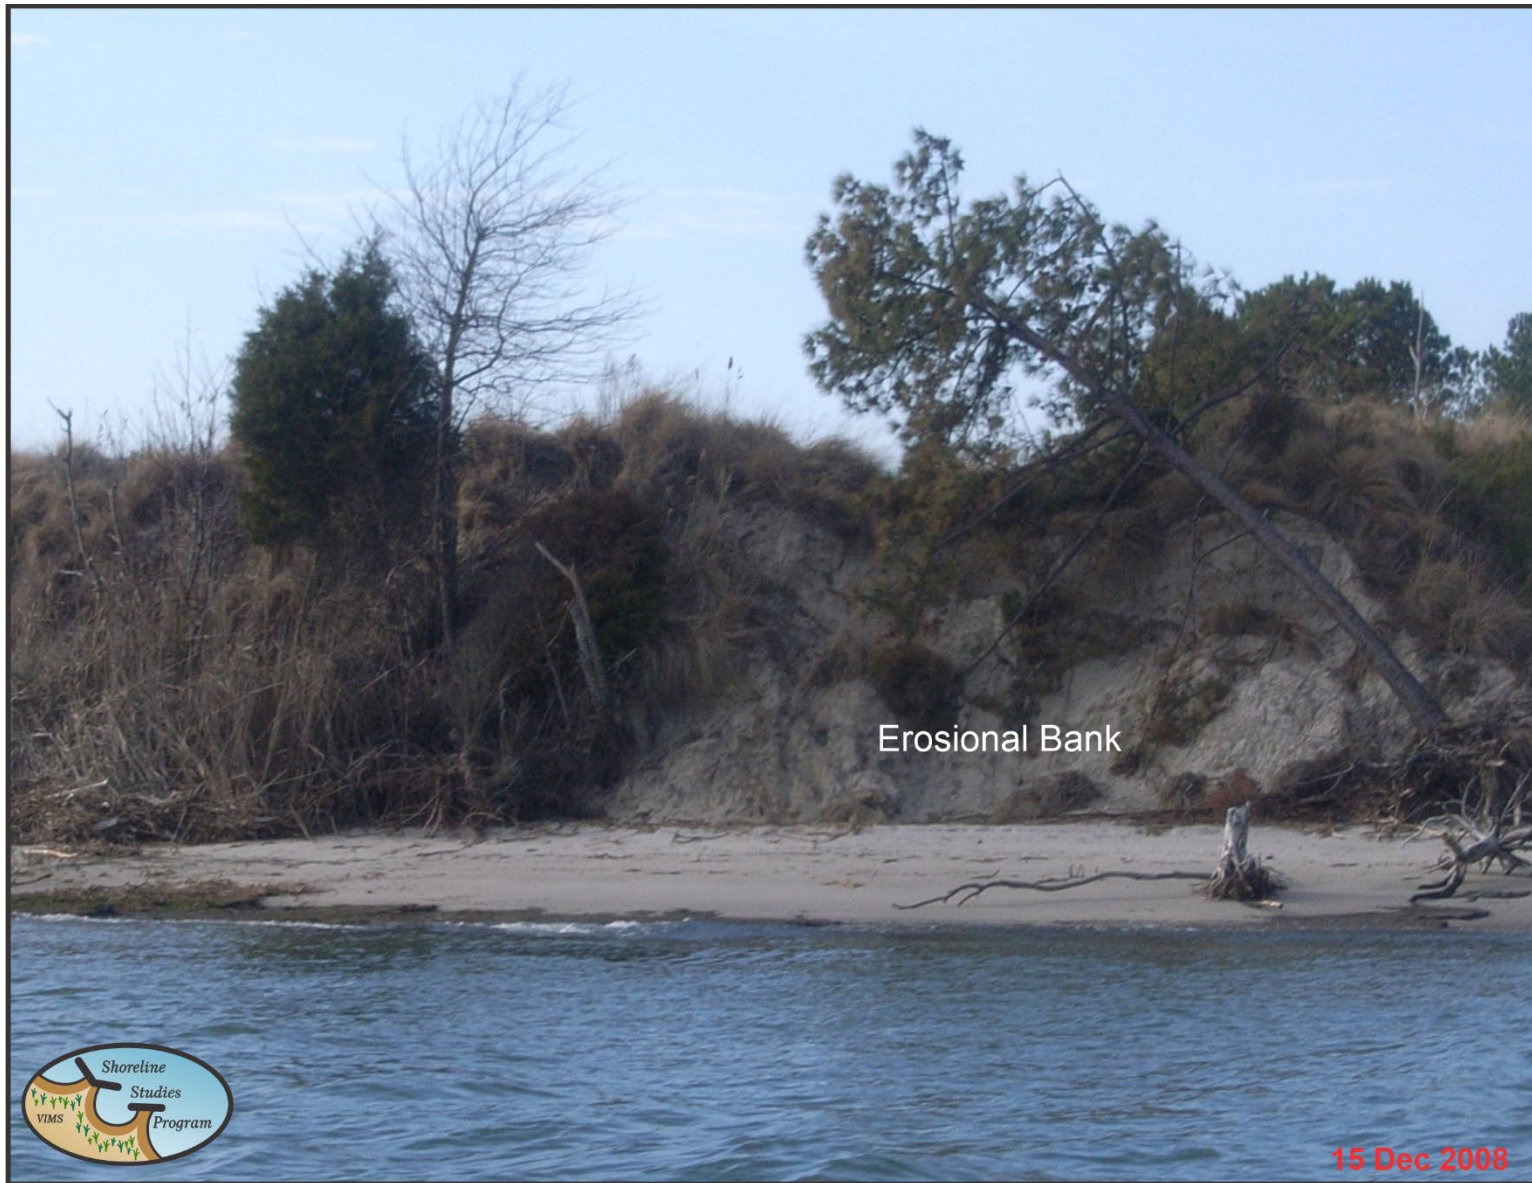
Figure 8. Photo of the upland placement area's eroding shoreline in 2008. Photo credit: VIMS, Shoreline Studies Program.

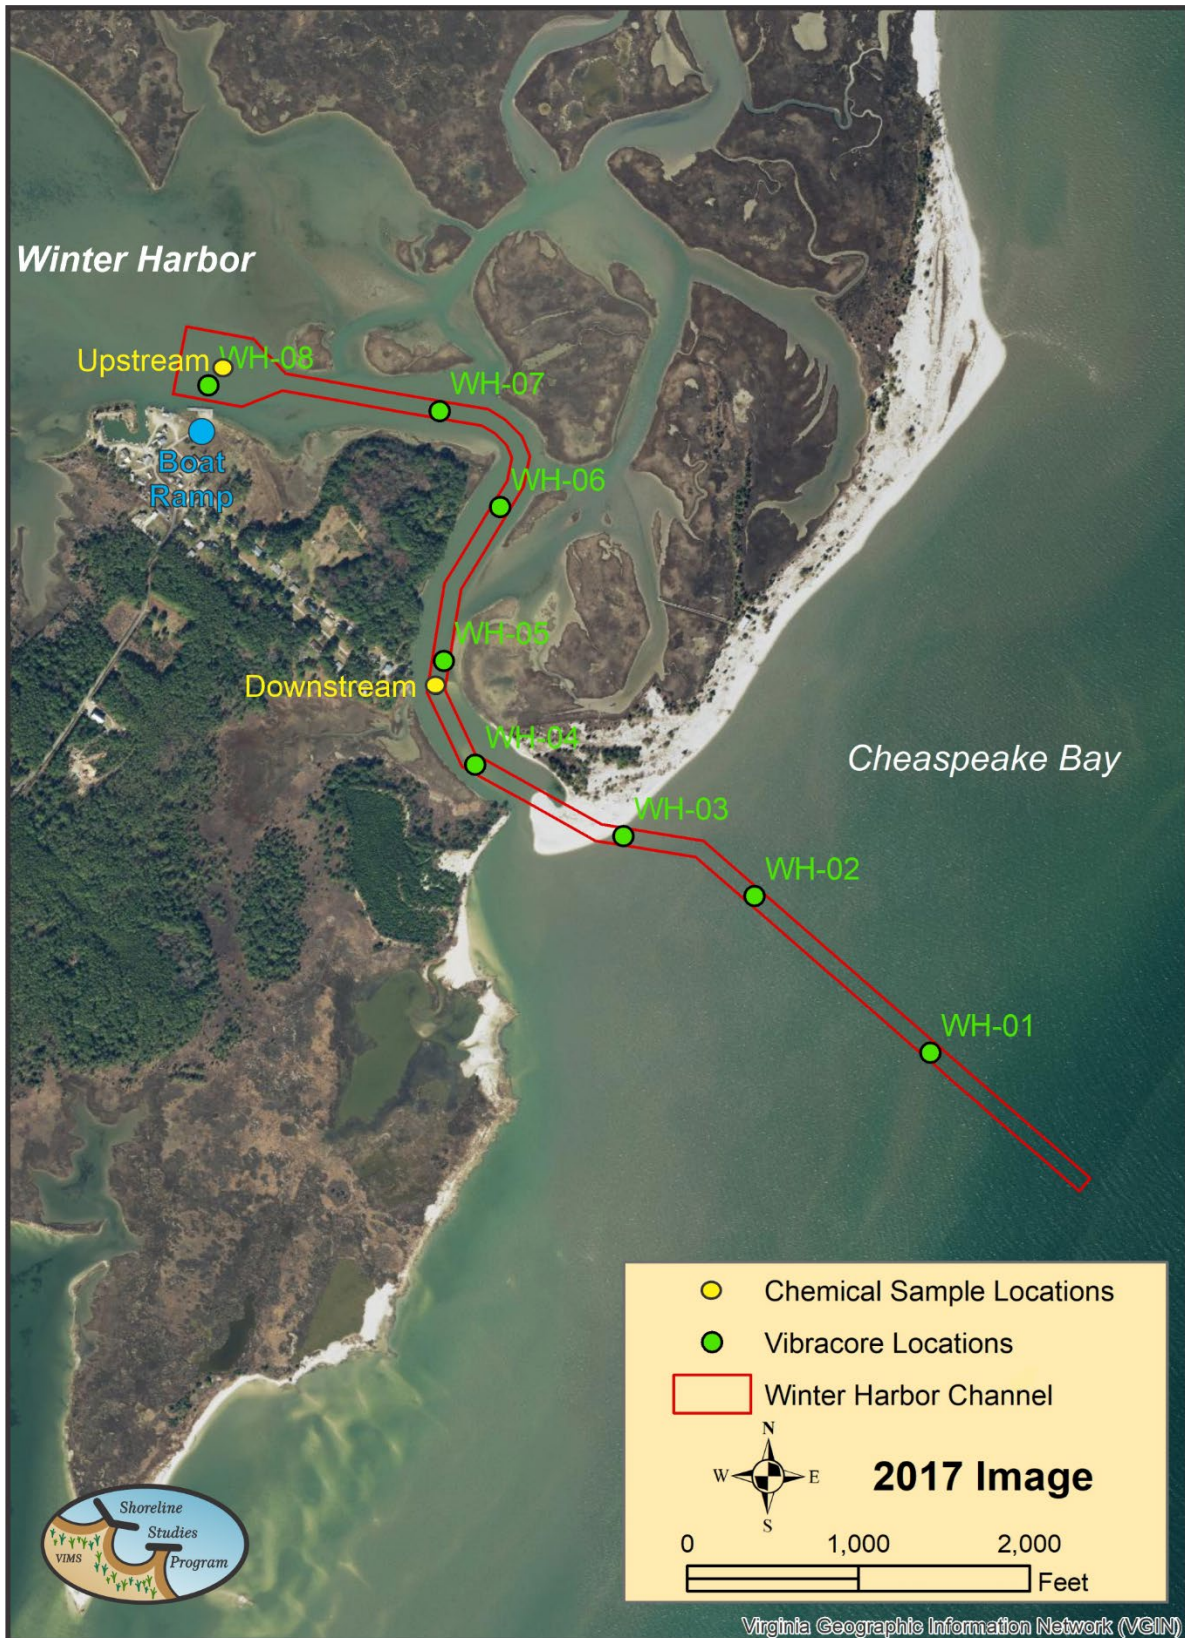
Figure 13. Location of vibracores and chemical samples taken in Winter Harbor.

Using ²¹⁰Pb radioisotopes found within the Winter Harbor Core 7 samples (Figure 13), it was found that the inner channel at Winter Harbor has a high sediment accretion rate of 5.08

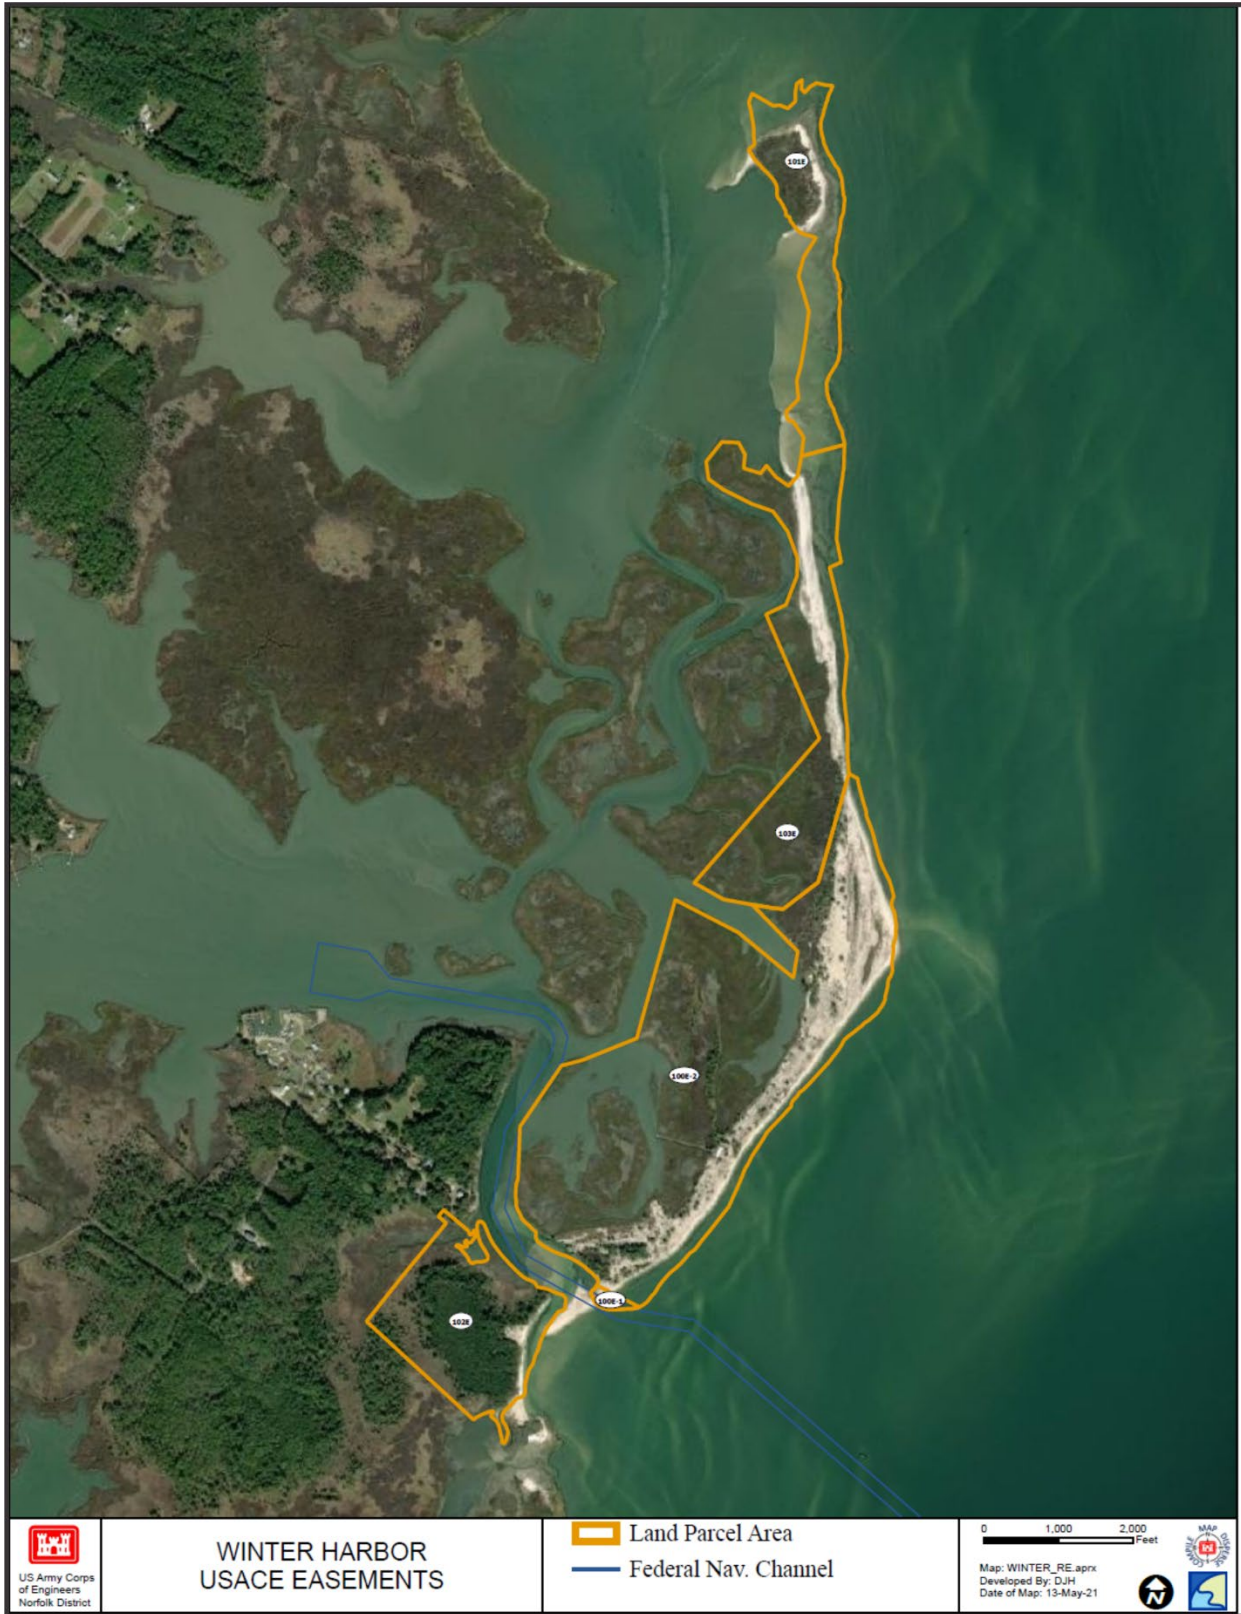
Figure 21. Location of federal easements for use with dredge material disposal. From the US Army Corps of Engineers.

For the recommended -6 ft MLLW with 1 ft overdepth dredging scenario, approximately **78,500** cy of beach suitable sand and about **39,500** cy of fines is recommended to be placed at separate disposal sites (Figure 21). The US Army Corps of Engineers obtained easements for all the area north of the inlet along the barrier islands. They also have an easement at the upland disposal site. The property owners of this area have indicated preliminary support for the concept of sand placement along the shoreline to date and further discussions would need to take place should this option be pursued. The sandy material could be used for beneficial use and be placed north along the shoreline. Though the marsh south of the inlet is eroding, sand placement along this shoreline could be problematic. The sand could be placed in front of the eroding berm and just south where a breach is occurring. However, it is likely that the material could be transported back into the channel. Sand placement farther south along the eroding marsh could be challenging because of the dense SAV coverage in the nearshore. It could be difficult to obtain a permit for covering SAV when other disposal options are available. In previous dredge cycles, the area just to the north of Winter Harbor Inlet was used as the dredge disposal area (Figure 5), but as noted earlier, this sediment moves quickly alongshore and creates the spit that covers the channel. Placing material farther north might be a better choice for placement because it will take longer for the sand to move back to the channel. (Figure 22). The distance the material would have to be pumped is about 1.5 miles.

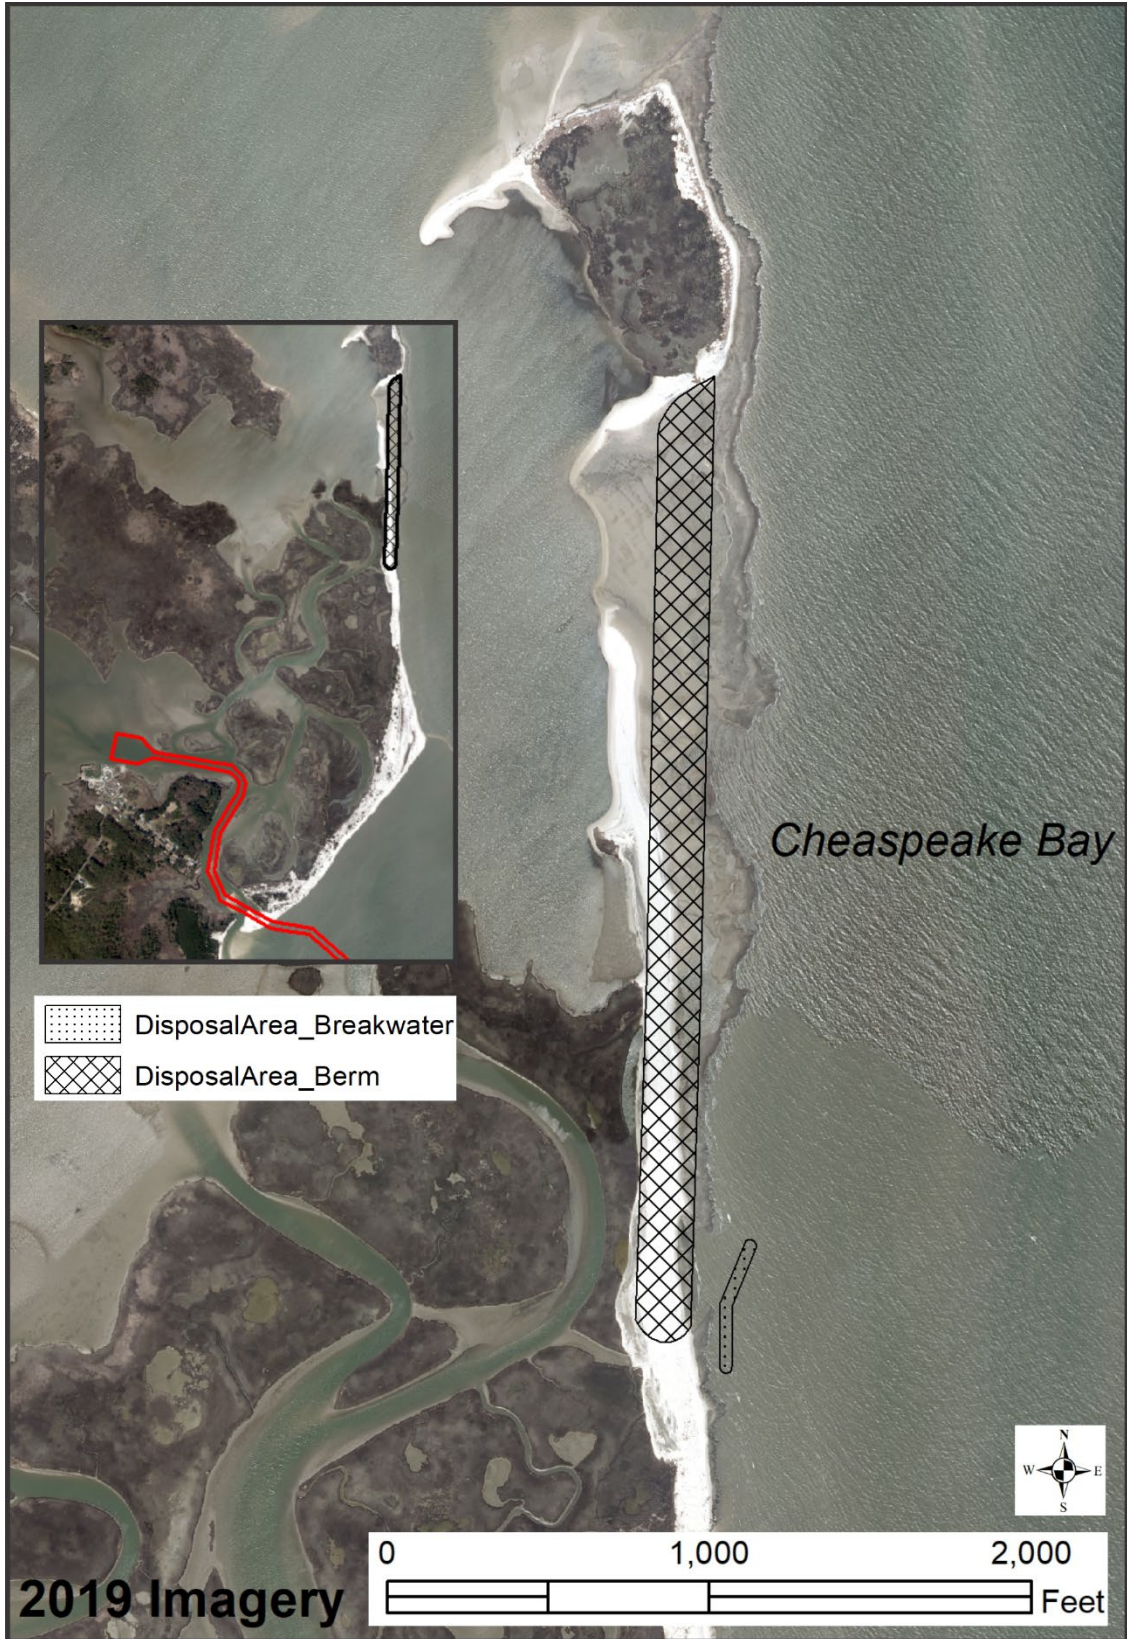
Figure 22. Proposed placement for sandy material beneficial use and proposed nearshore breakwater. The inset shows location relative to the channel. Pumping distance is about 1.5 miles.

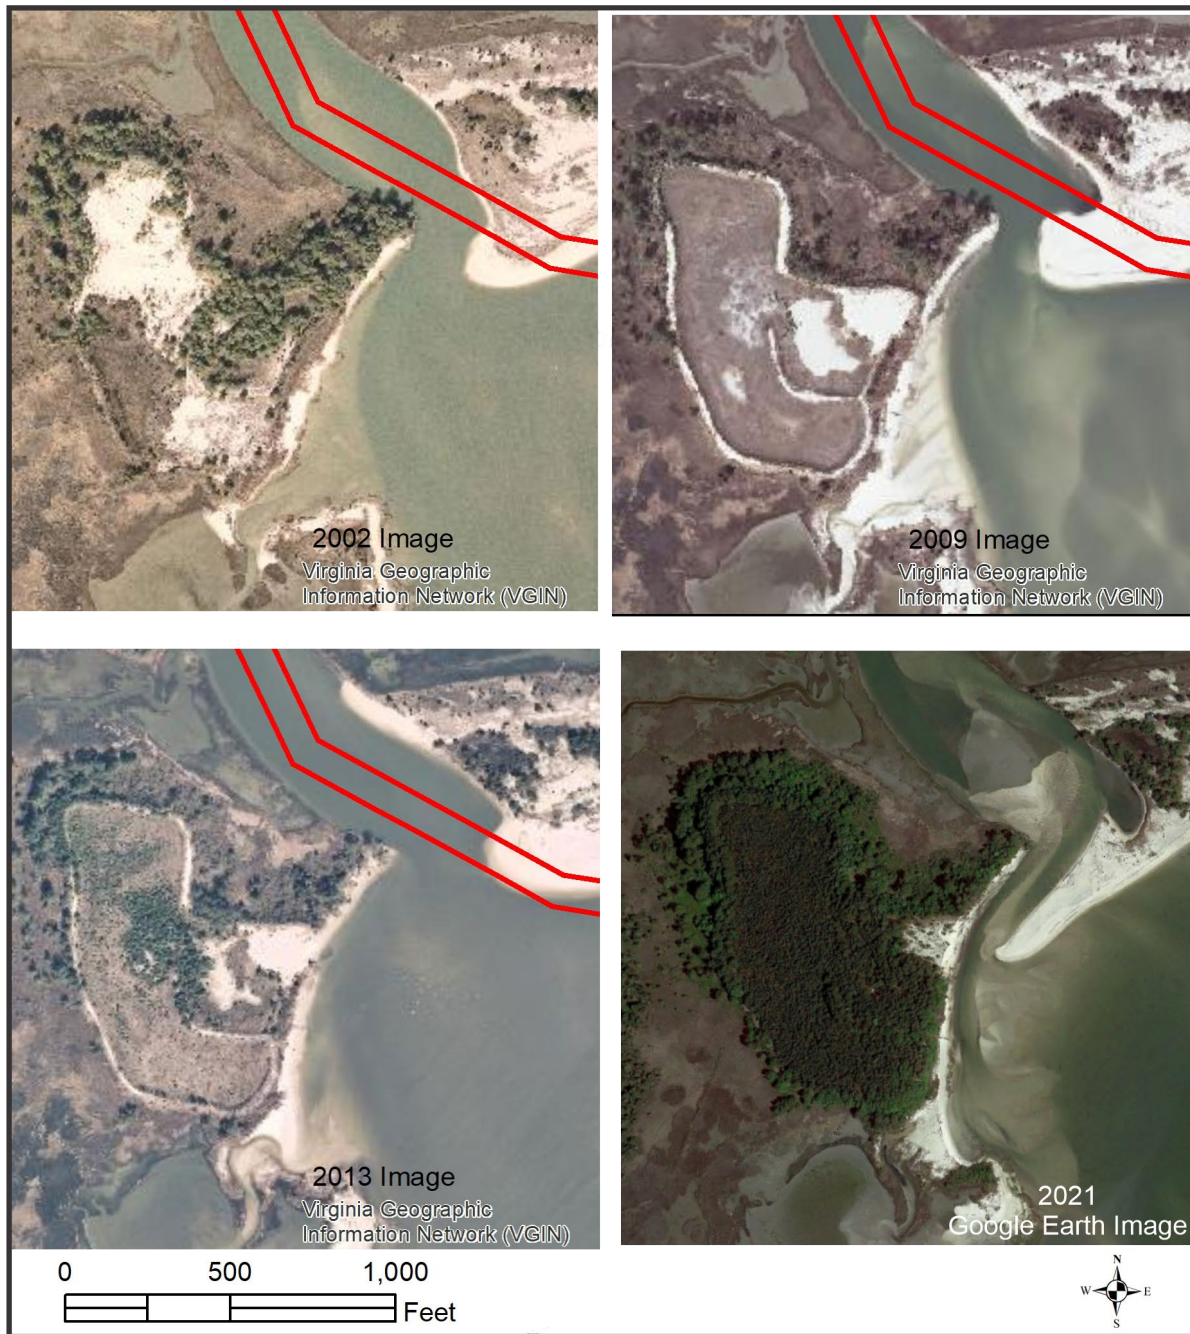
Figure 24. Aerial photos between 2002 and 2021 showing the state of the upland disposal site at Winter Harbor.

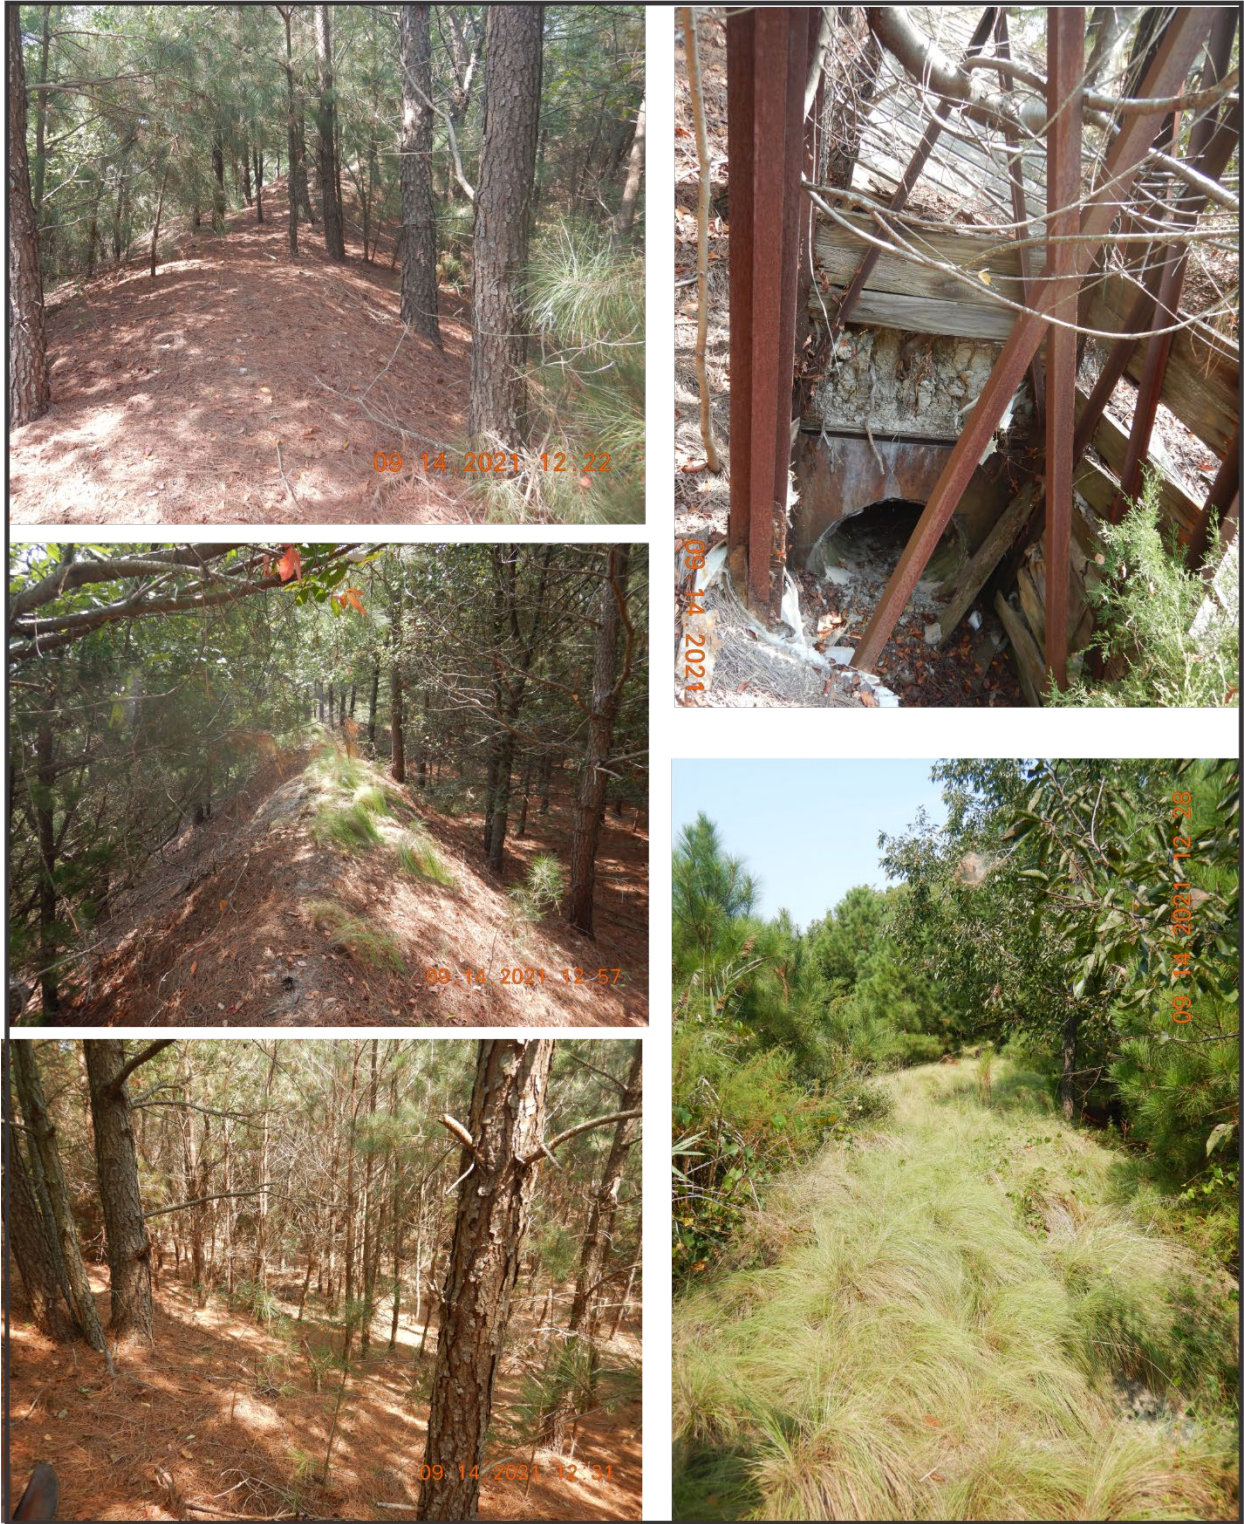
Figure 25. Ground photos showing the state of the berm and the outfall pipe. Photo credit: VIMS, Shoreline Studies Program.

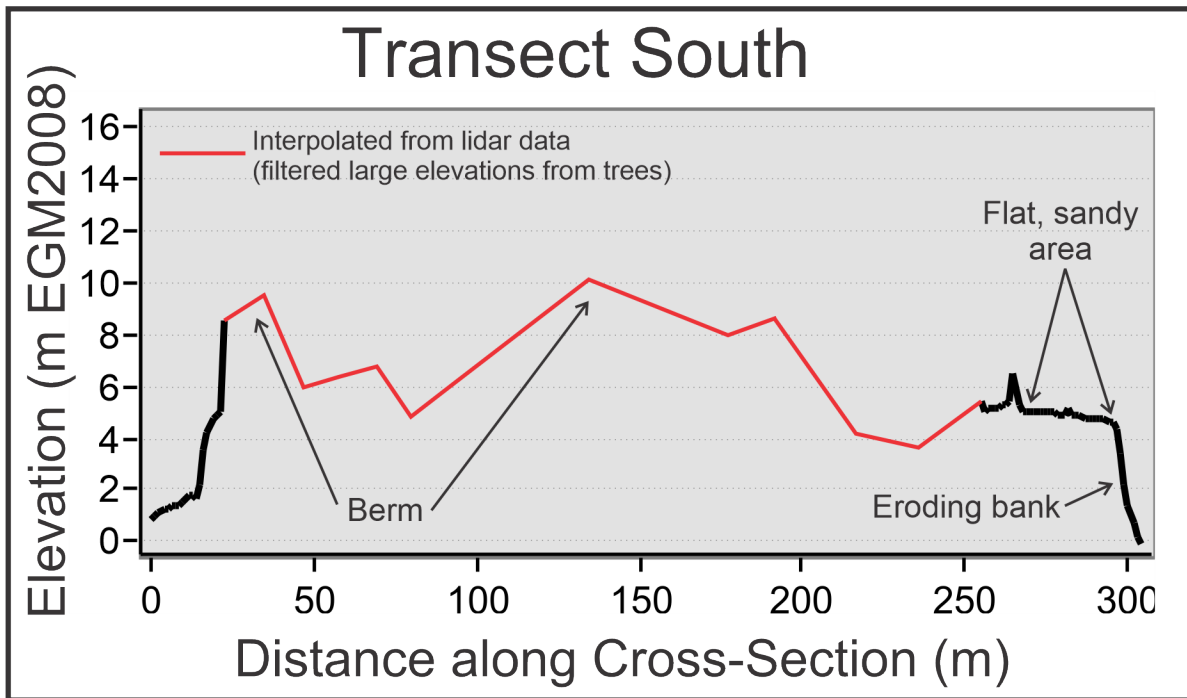
EGM2008 is about 1.3 m above MLW at Winter Harbor

Figure 26. Transects obtained from the lidar data taken at the site. The dense vegetation could not be penetrated in some areas, and transect data were interpolated to show the ground rather than the top of the vegetation. The red line shows the approximate elevations of the ground.

Lidar data show that the berm is intact although on the east side of the transect, material has been placed along the berm widening it (Figure 26). So, this transect occurs at the narrowest portion of the placement area. A basin occurs that can hold about 50,000 cy with material placement no more than 4 ft thick. This is the recommended thickness so that the material will dry. Though the placement area could probably hold a thicker layer, it is not recommended. However, after the material dries, the disposal could be used for future dredge cycles.

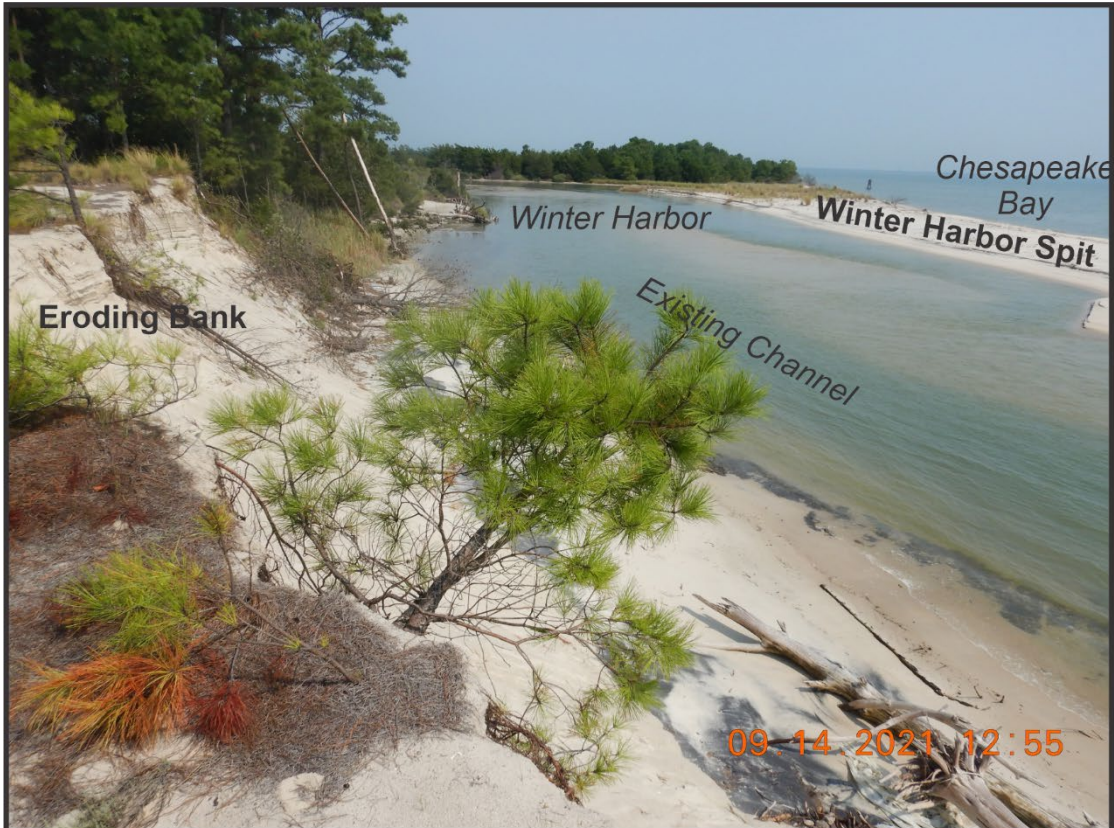
Figure 27. Ground photos showing the eroding bank and sand flat. Photo credit: VIMS, Shoreline Studies Program.

On the bay side of the disposal area, the berm is eroding along the (Figure 27). The existing channel that is exiting Winter Harbor comes in close to the shoreline. The depths are between -2 and -5 ft MLLW very close to the shoreline. To address the erosion issue, Hardaway et al. (2010) suggested structures for this stretch of shoreline. In addition to stabilizing the placement area, it would reduce the amount of eroded sand from moving back into the channel. Because site conditions are different from what they were when the management plan was produced, a different structure is recommended. A brill (a structure larger than a sill, but smaller than a breakwater) could be built along the shoreline (Figure 28). It would be close to the shoreline because of the deeper channel depths alongshore (Figure 29). Sand can be graded from the bank to place behind the structure. This would reduce the coast as well as stabilize the bank by reducing its grade. However, if grading is not preferred, 510 cy sand can be brought in or placed from the dredge project.

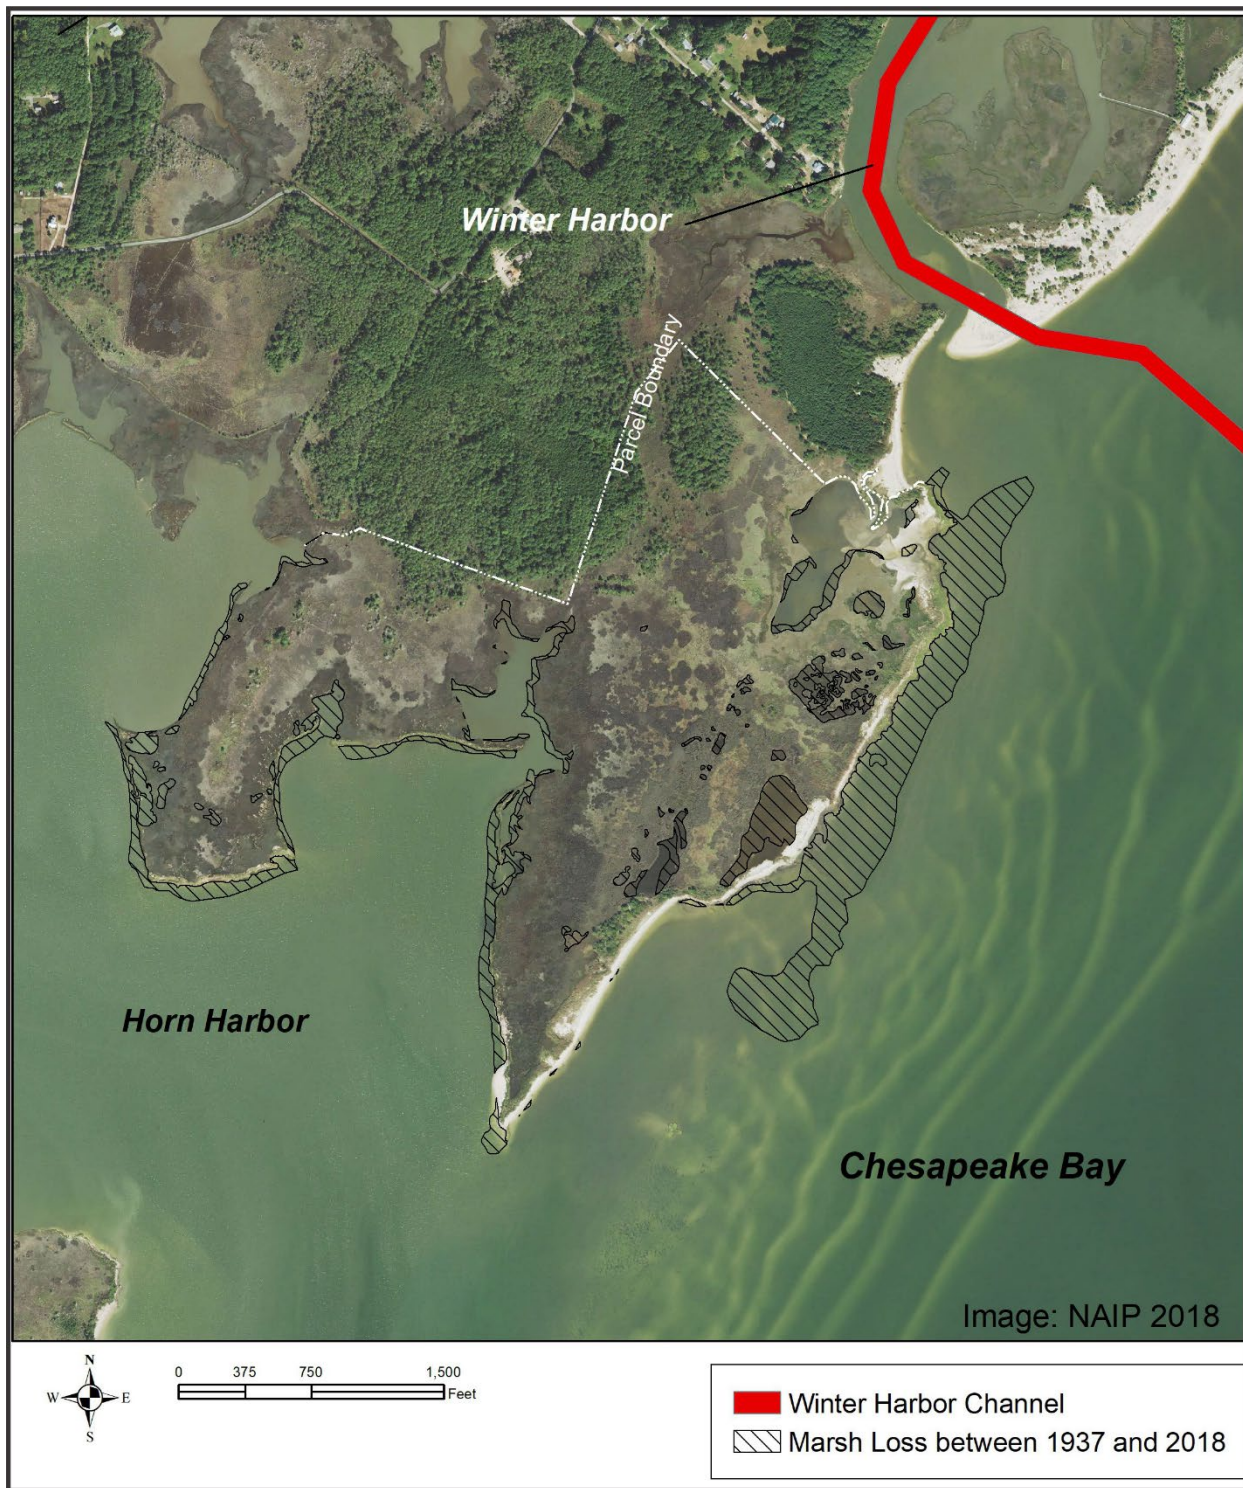
Figure 30. Change in the marsh mapped between 1937 and 2018 using the Shoreline Studies Program Shore Change Database.
