Aberdeen Creek Dredge Channel Data Report

**Shoreline Studies Program
Virginia Institute of Marine Science
William & Mary**

December 2020

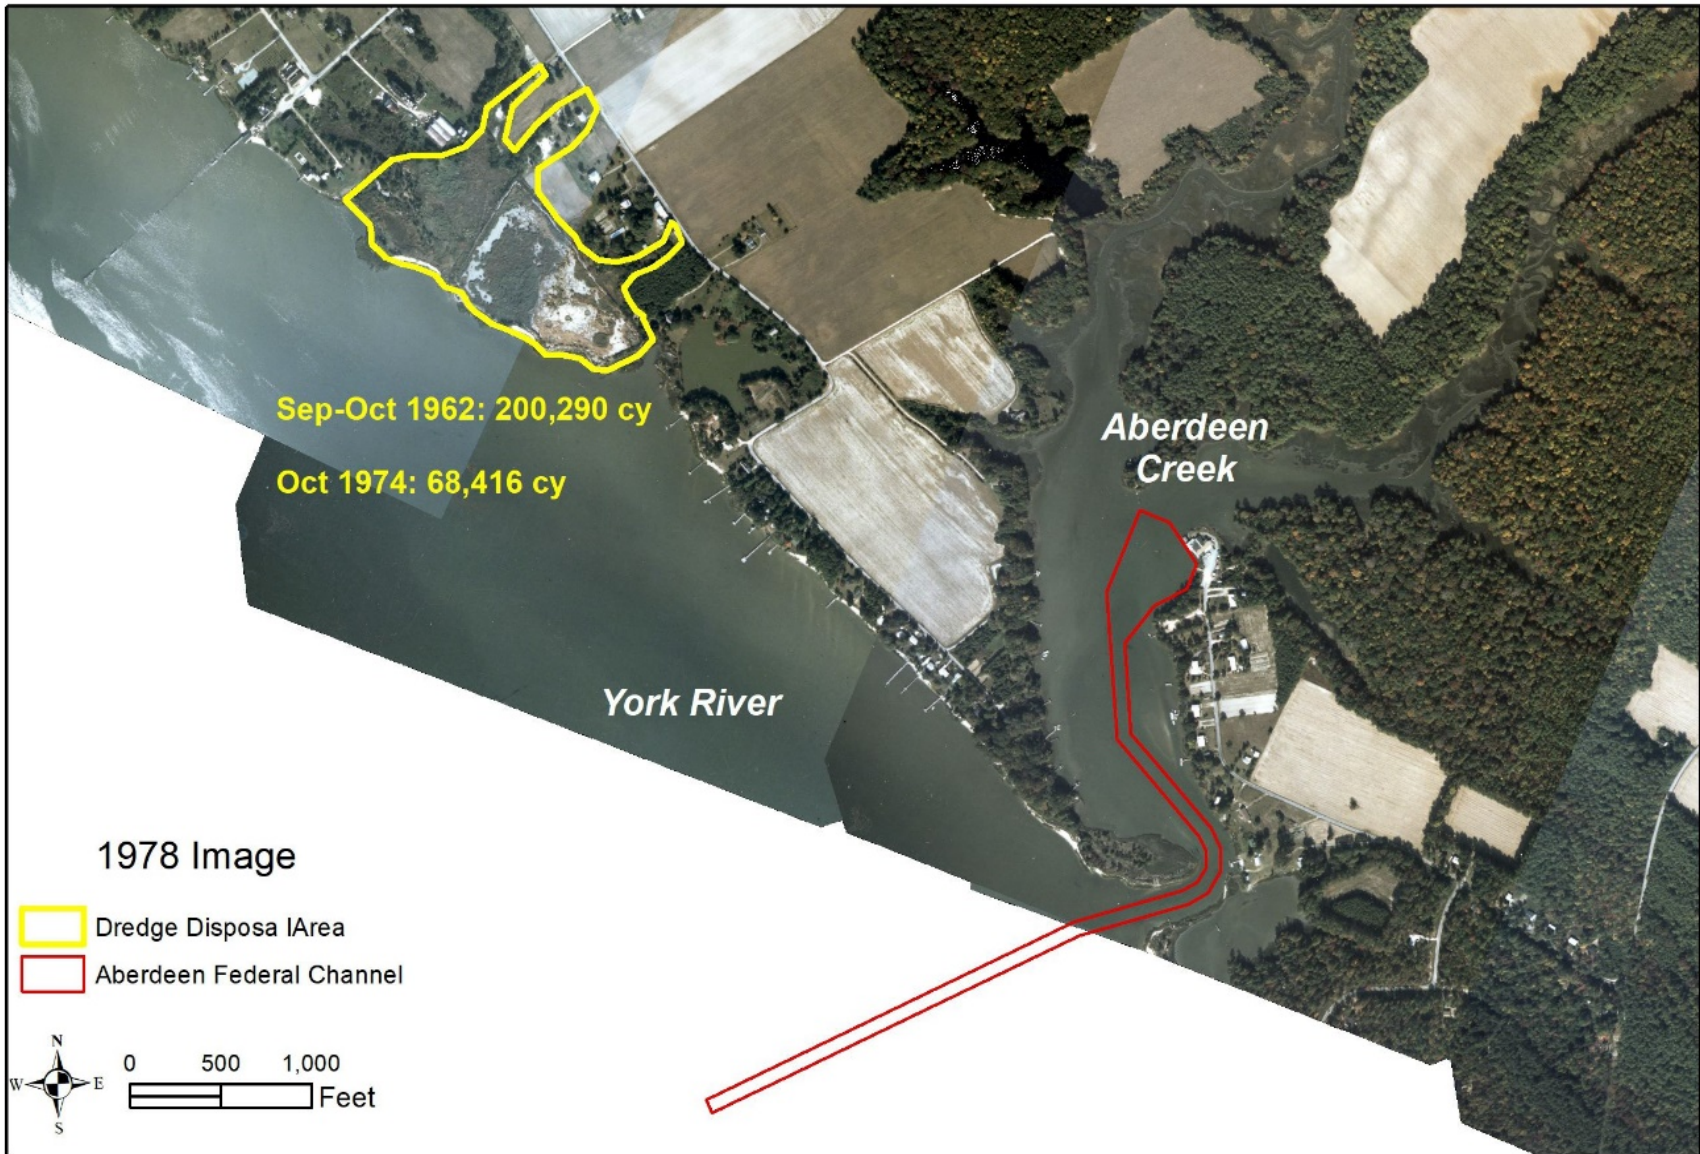
Figure 3. Aberdeen Creek channel outline on a 1978 image showing the placement of dredge material upriver at an upland placement site.

A Federal navigation channel from the York River into Aberdeen Creek was established in 1962 at which point the one-mile channel was dredged to 80 ft wide with a controlling depth of 6 ft MLLW (Figure 2). Approximately 200,290 cubic yards of dredge material was placed in a tidal marsh complex about one mile upriver. Maintenance dredging was performed in 1974 when 68,416 cubic yards (cy) of material was placed upriver (Figure 3). No substantive maintenance dredging has occurred since.

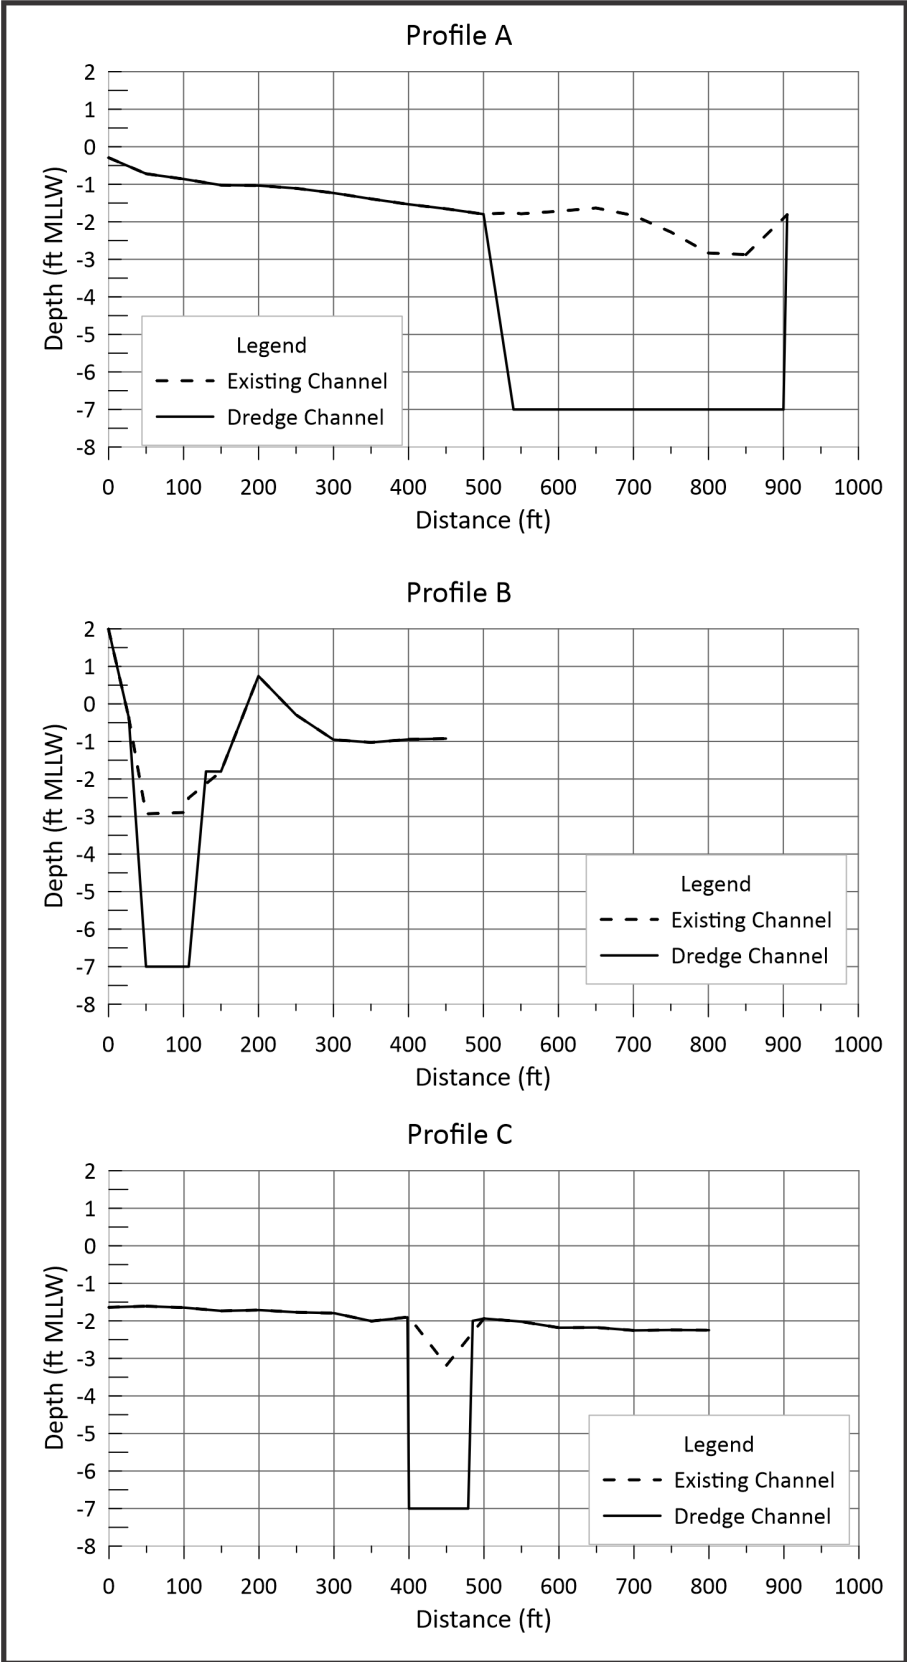
Figure 11. Typical channel cross-sections at Aberdeen Creek. Their location is shown on Figure 10.

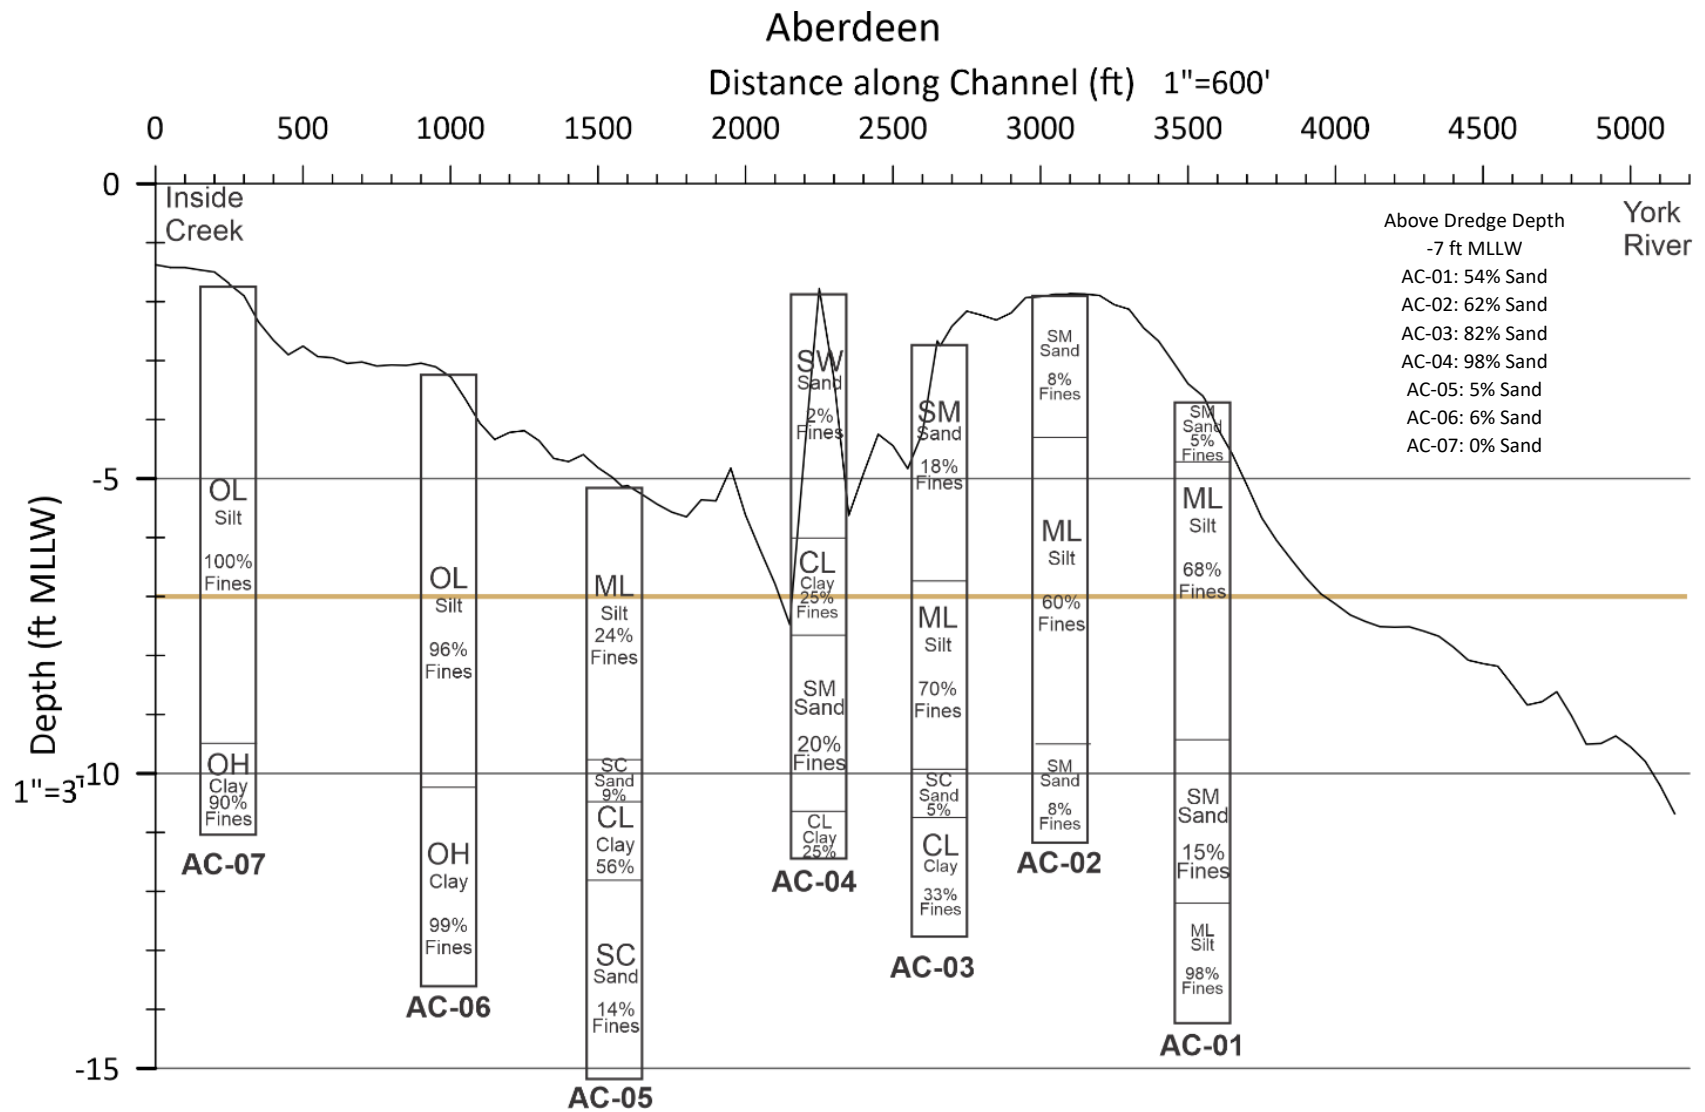
Figure 12. Along-channel cross-section showing the position of the cores and the type of material in the core. The dredge depth is -7 ft MLLW.

The outbound channel extends out another 2,500 ft to 5,500 ft, but dredging is only required out to the 4,000 ft section where the -7 ft MLLW contour is reached in the York River. The sediments in this section are characterized by cores 1 and 2. It appears that after the last maintenance dredge cycle that silts and clays were deposited up to about -4 and -5 ft MLLW. These are overlain by 1 to 2 ft of fine sands. Wood fragments found in these top strata may also indicate recent sedimentation.

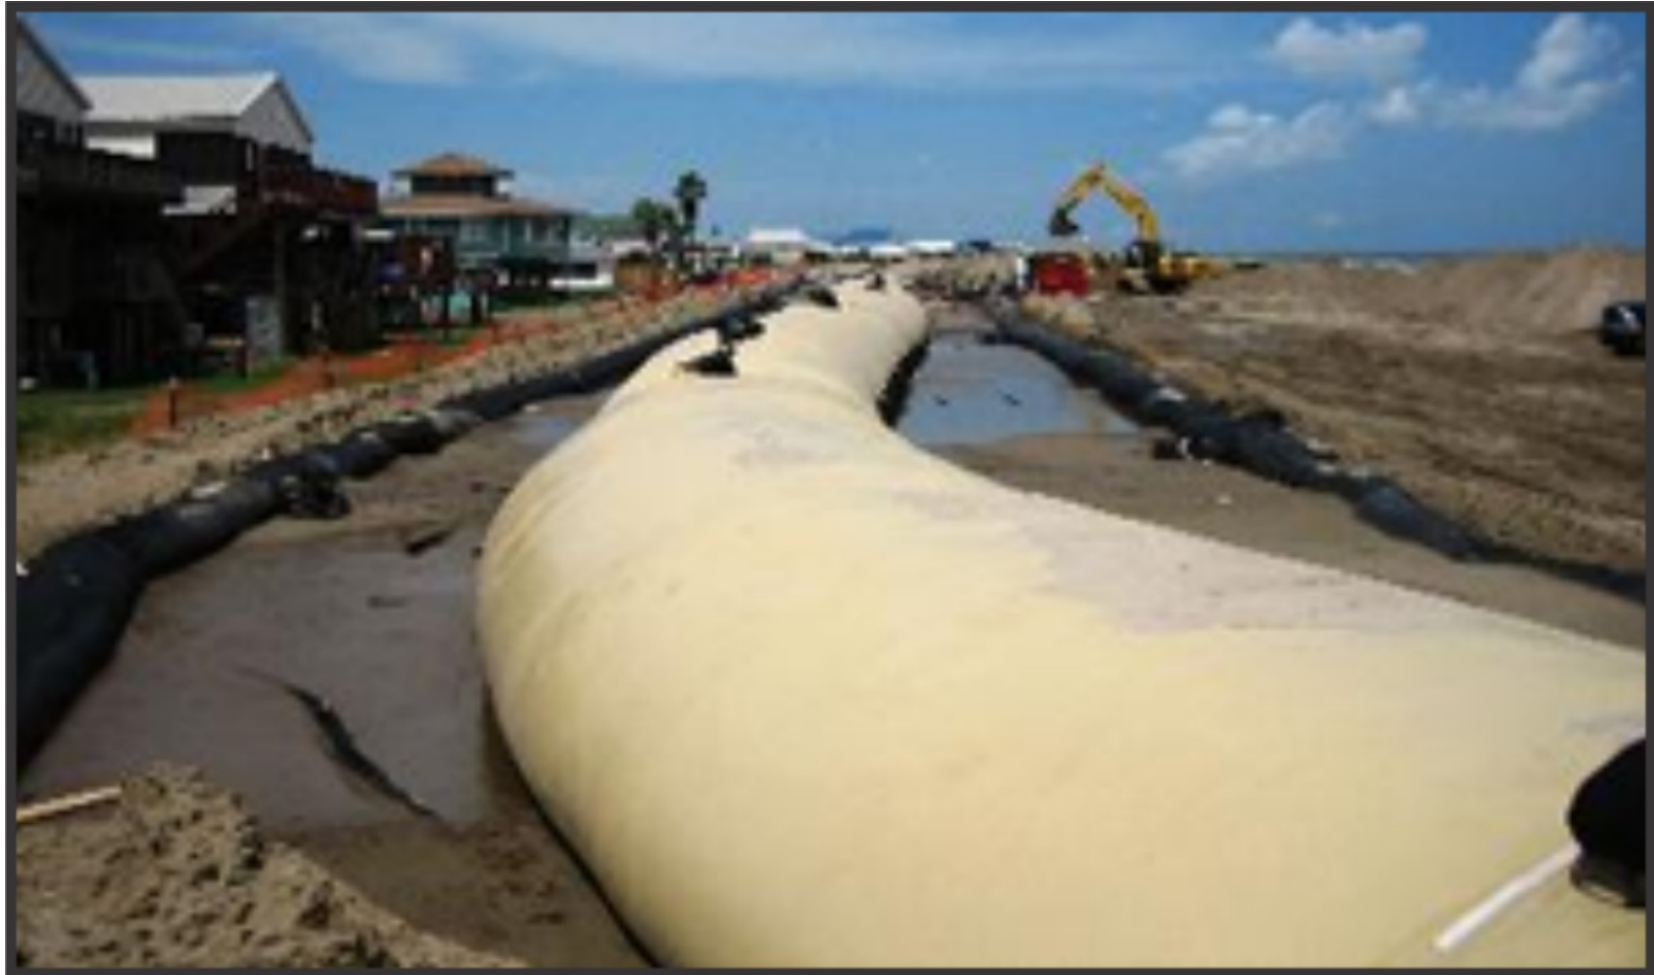
Figure 14. Example photo of a Geotube® used for sediment containment. Source: TenCate website.
