# Hard Wood Utilization in Buildings of Rural Households of the Manqakulane Community, Maputaland, South Africa

**Ethnobotany Research & Applications 5:097-114 (2006)**

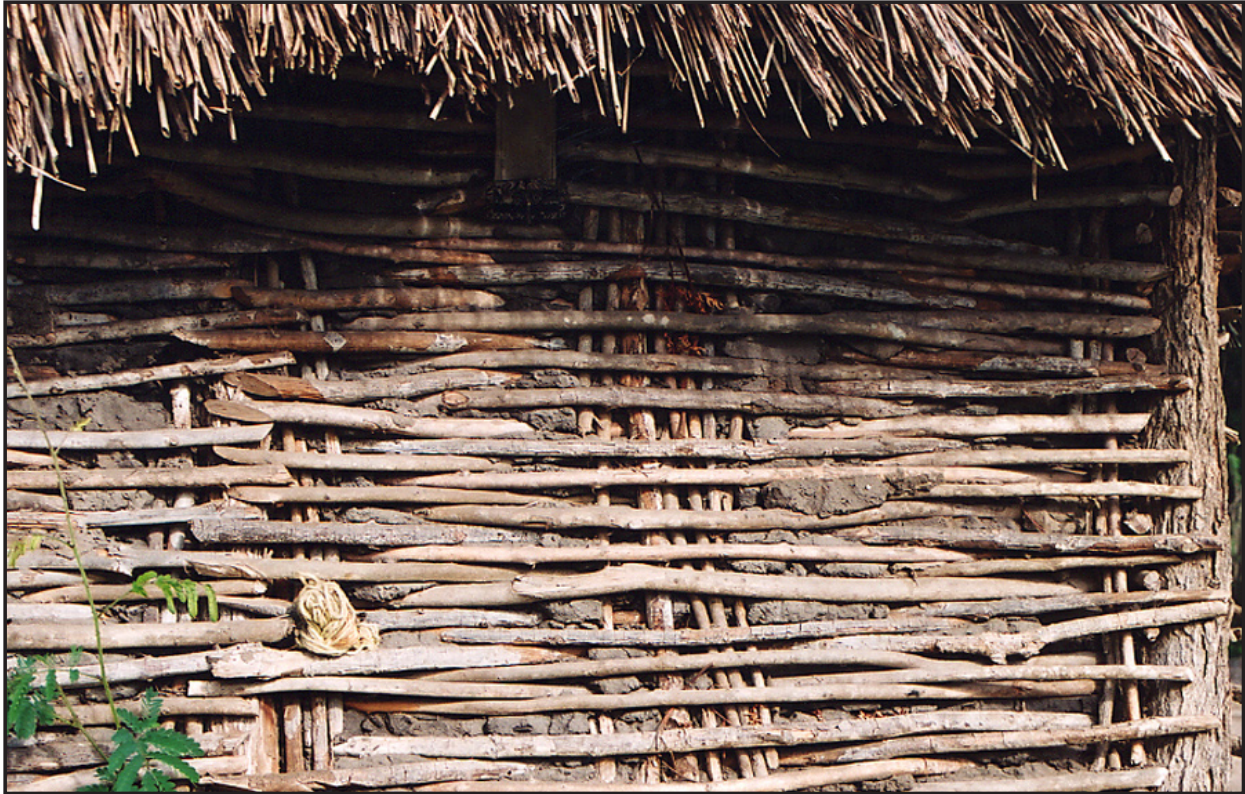
**Figure 4.** A typical wooden wall made from interlocked woven wooden laths laced between main support posts in the community of Manqakulane, Maputaland, KwaZulu-Natal province, South Africa, as established by a survey in 2002.

The wooden and reed walls are the most intricate structures and are built in four different ways. The wall laths

may be woven in between the main posts by using thin spacer laths (Figure 4). An alternative way is to have horizontal wall laths that are nailed to at least the top, middle, and lower sections of the main posts, with the space in-between being filled with thick straight vertical laths. This type of wall is referred to as a wooden wall in the present study (Table 1). A wooden wall is often covered in clayish mud to form a solid wall of wood and mud (Table 1). Recently, after the demolition of some old concrete buildings, some of the villagers used the remaining rubble as wall material. In these cases, wall laths were nailed horizontally at regular spaces on either side of the main posts, and the gap between them was filled with the concrete

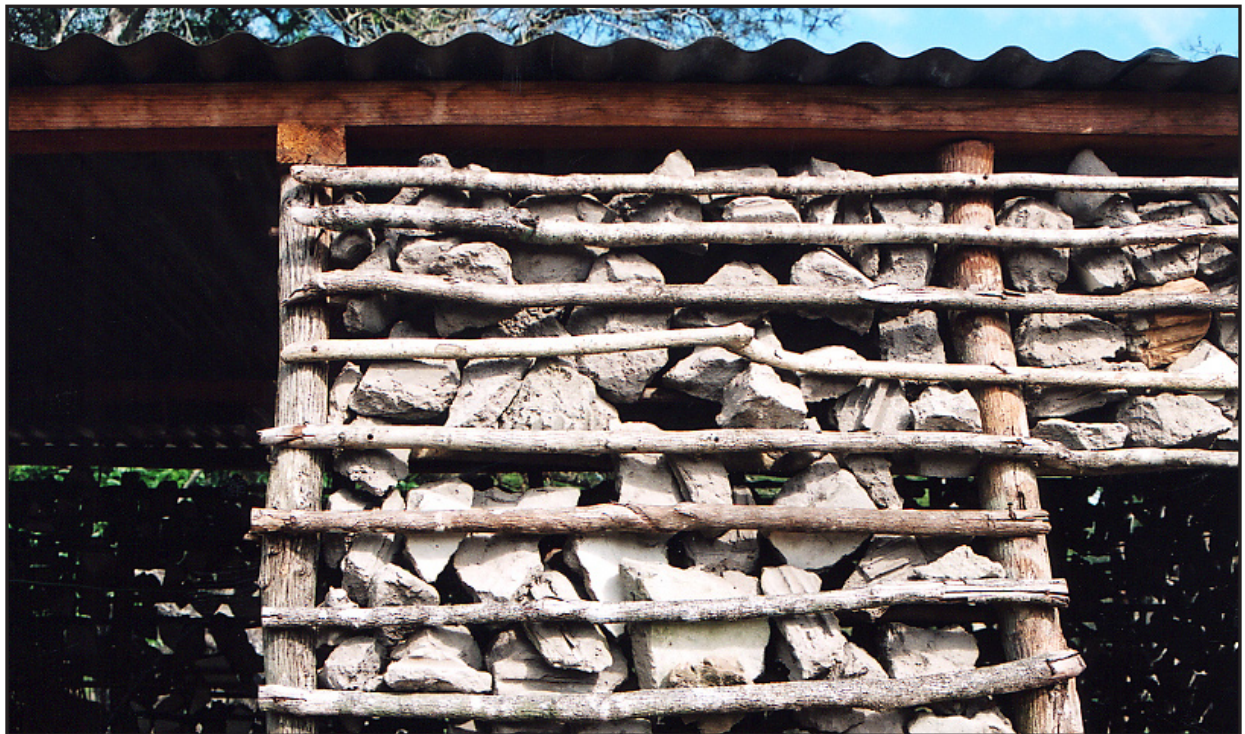
**Figure 5.** An example of a wood and stone wall, with the space between the horizontal wooden laths filled with old concrete rubble. Community of Manqakulane, Maputaland, KwaZulu-Natal province, South Africa, as established by a survey in 2002.

rubble (Figure 5). This type of wall is described as a wood and stone wall in the present study (Table 1). Once the wall has been filled in, the concrete rubble is often covered with a layer of mud or cement to close the gaps between the concrete pieces. The last type of wall is made of reeds. In this case, at least three rows of horizontal wooden laths are used, being nailed to the top, middle and lower sections of the main posts. The gap in between is densely packed with vertical reeds, and the thickness of the wall varies from 30 to 100 mm. These reed walls sometimes have a thin covering of mud.

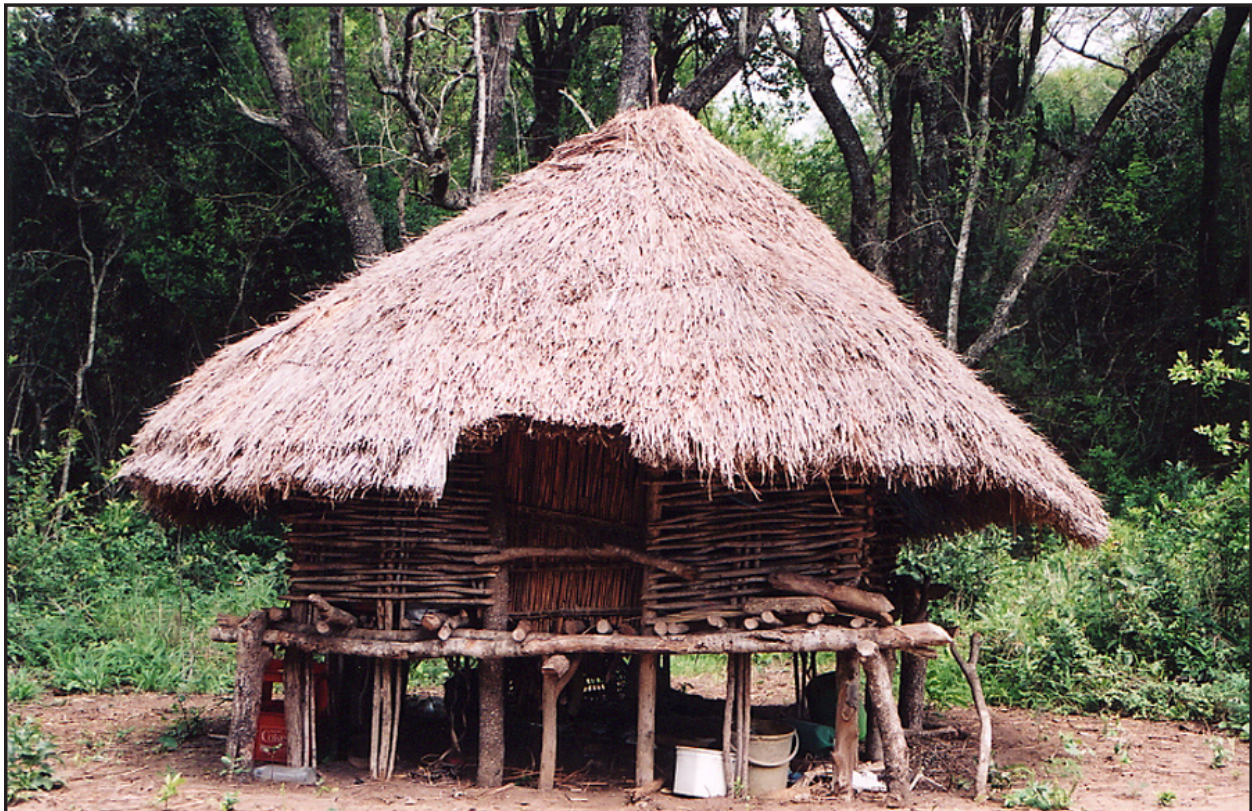
**Figure 6.** A maize store built like a miniature house with a thatched roof in the community of Manqakulane, Maputaland, KwaZulu-Natal province, South Africa, as established by a survey in 2002.

The kitchens and maize stores form a separate category of buildings that do not have the same importance as living quarters. Therefore, kitchens are often old living quarters that are no longer suitable for that use, and would otherwise have been abandoned. The building is used as a kitchen until it collapses. In some instances a shelter is built to protect the area where the cooking is done. In such cases, only the roof is built. It rests on a series of supporting posts and the wall panels that are not completed. Kitchen shelters and maize stores are sometimes combined, with the maize store on stilts forming the roof of the kitchen shelter. This design has the added advantage that the smoke from the kitchen fire keeps seed predators away from the maize store directly overhead. The maize stores are usually built on stilts with the storage platform at a height of 0.5 to 2 meters above the ground. The maize stores are usually thatched. Two main types of maize stores can be distinguished. The first type is a miniature raised thatched house that is built on top of a platform by using the stilts as main posts (Figure 6). The second is a small thatched cupola that rests directly on a raised platform, in some instances it is possible to remove the whole cupola structure and move it onto another platform. Both types have a small access door that is either cut into one of the wall panels, or into the thatching. If a kitchen or a maize store is purposely built, little attention is given to the materials that are used, and the most ac-

cessible resources are used. Maize stores are renewed frequently, often on a yearly basis. The size of the maize store is usually related to the anticipated crop size.
