Trajectory Following with a MAV Under Rotor Fault Conditions

Lately, a novel multirotor aerial vehicle capable of handling single rotor failures was presented. When a rotor fails, physically reconfiguring one of the remaining rotors of an hexarotor allows to compensate for maneuverability limitations. In this work, experimental results show the performance of the vehicle in a trajectory-following task in both nominal and fault conditions.

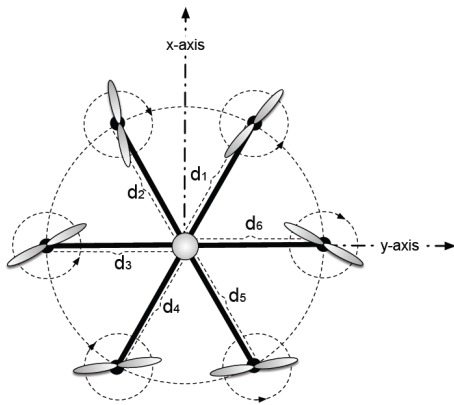
Figure 1: Top view of the proposed vehicle.

When dealing with total rotor failures in hexarotors, it has been proved that a standard hexarotor configuration (one with the rotors spaced evenly in a plane, pointing upwards, with alternated spinning direction, as in Fig. 1) is not fault tolerant in the event of a failure of this type, in the sense of maintaining control over its four degrees of freedom (rotation around its three axis, and vertical speed). One degree of freedom will be lost, being generally the yaw axis the one chosen to be lost control of, as it allows the possibility to land the vehicle safely. From this point on, fault tolerance will be meant in the sense that the system maintains complete altitude and attitude control.

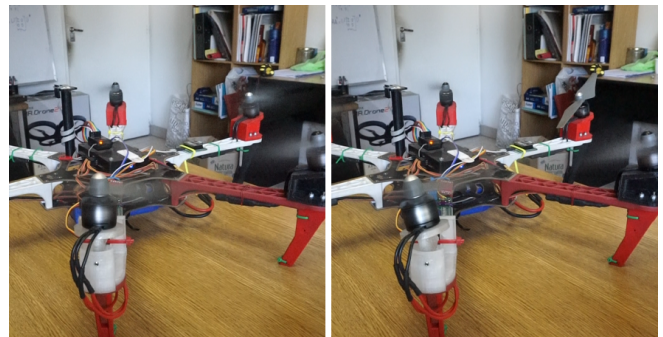
Figure 3: Servomotor in rotor 1 in the case without failure (left) and in the case of a failure in rotor 3 (right).

To switch between the different configuration of the rotors for the nominal and failure case, a servomotor is added in rotor 1, that tilts it over the arm's axis at $\delta_1 = 0^\circ$ for the vehicle without failures, and at $\delta_1 = 10^\circ$ in the case of a failure in rotor 3, as shown in Figure 3.

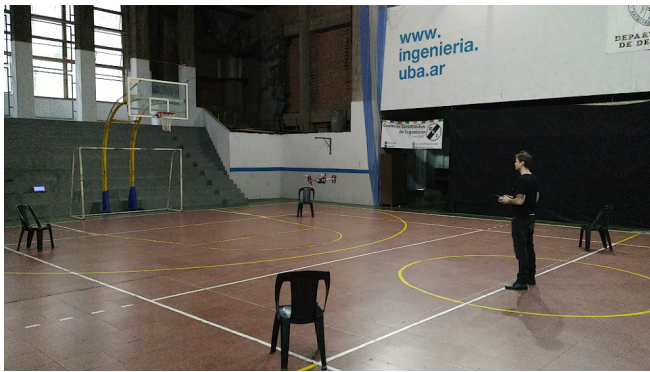
Figure 4: Environment setup for the experiments. The stationary beacons are placed on chairs at a height of 40cm, in a square of 8x8m.

In order to provide position information, an ultrasonic-based indoor navigation system from Marvelmind was used. This system consists of a network of stationary ultrasonic beacons interconnected via radio interface, one mobile beacon installed on the vehicle to be tracked, and one central modem that calculates the position of the mobile beacon. For the experiments, four stationary beacons were placed in a square with a side length of 8m, 40cm above the floor, as shown in Fig. 4.

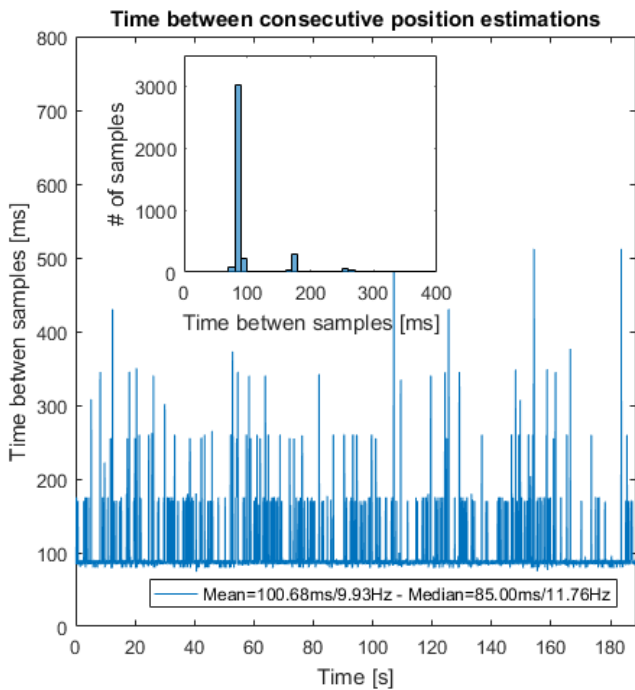
Figure 5: Time between consecutive position estimations from the indoor positioning system, during one of the flights. (Inset) Histogram of the time plot, using 10ms intervals.

The system was configured to provide position estimation at a 12Hz rate, but may not provide data (or provide data with low accuracy) in cases where the line of sight between the mobile beacon and the stationary beacons is obstructed. In Figure 5, the time between consecutive samples of position information (accurate or not) is shown, during one of the flights of the experiments. The data rate of the positioning

system is mostly stable at 85ms (around 12Hz), but it can be observed that there are several occasions where this time is doubled, corresponding to a failure to obtain position information. An inset of axis shows the histogram of the same experiment, where around 90% of the samples correspond to a time interval of $85\text{ms} \pm 10\text{ms}$.

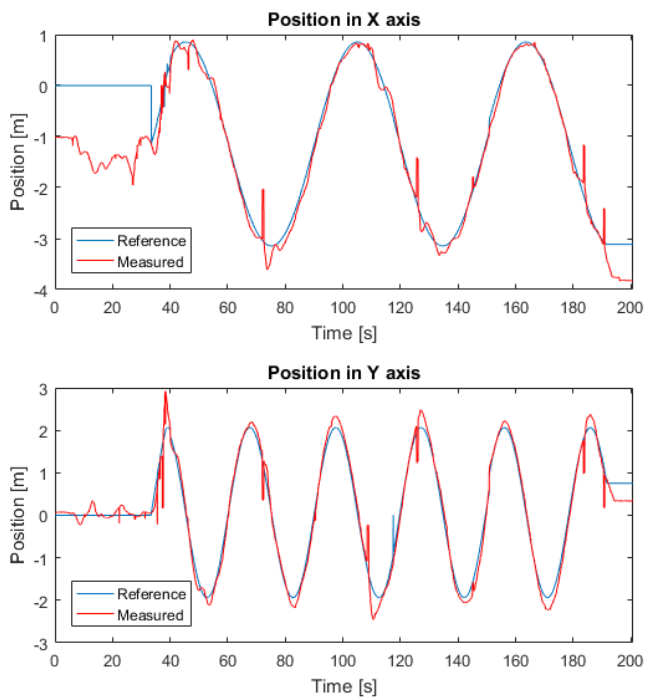
Figure 6: Geron trajectory for an hexarotor without failure.

The flight trajectory for the vehicle without failures is shown in Figure 6. The vehicle takes off at $t = 0\text{s}$, and the position control is activated at $t = 33\text{s}$, where the current position is taken as reference. The vehicle performs three and a half full Geron trajectories, before the position control is deactivated at $t = 190\text{s}$, where it lands safely. It can be observed that there are several outliers in the measured position at $t = 72\text{s}$, $t = 109\text{s}$, $t = 126\text{s}$ and $t = 184\text{s}$, that correspond to errors in the position calculation of the Marvelmind tracking system, to which the vehicle reacts accordingly, but recovers quickly and remains on path.

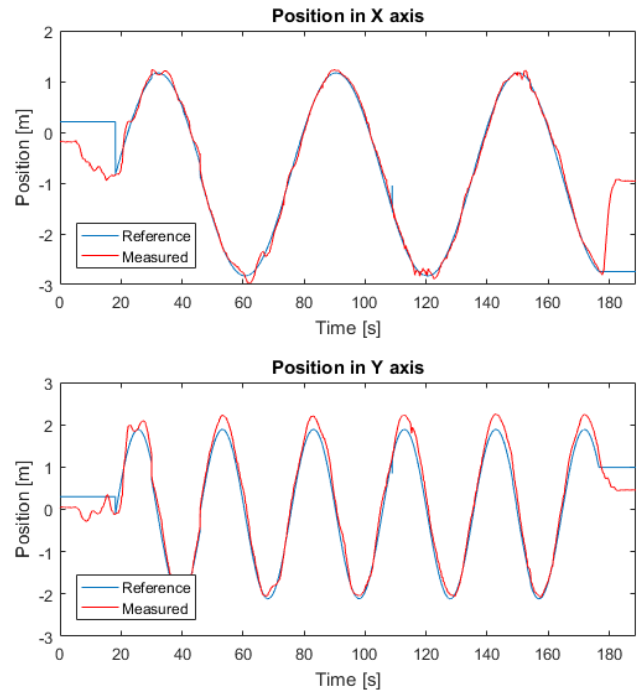
Figure 8: Geron trajectory for an hexarotor with a failure in rotor 3.

The flight trajectory for the vehicle with a failure in rotor 3 is shown in Figure 8. The failure is activated before take-off, and is present during the full flight. The vehicle takes off at $t = 0\text{s}$, and the position control is activated at $t = 18\text{s}$, where the current position is, again, taken as reference. The vehicle again performs three and a half full Geron trajectories, before the position control is deactivated at $t = 176\text{s}$, and is returned to the take-off point to land. In this test, there were no occurrences of glitches in the position estimation.

It can be noticed that in the Y-axis sinusoidal trajectory, there is some overshoot in the positive direction, while there is no significant overshoot in the negative direction. This is because the rotor in failure state is positioned over the Y axis of the vehicle, and the roll maneuver in one direction seems to be less responsive than in the other.

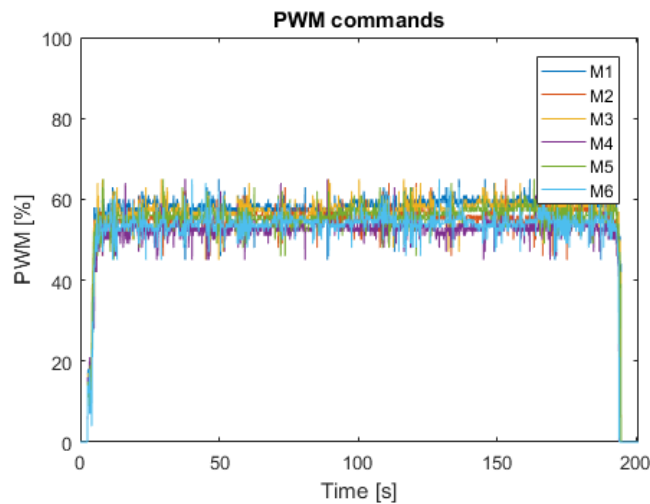
Figure 7: PWM values during the flight without failure

In Figure 7, the PWM values commanded to the six rotors are shown. As expected for a nominal case of a hexarotor in a near-hovering situation, all the PWM values are almost equal, driving the rotors at around 50% of their maximum speed, which provides a wide margin for performing maneuvers without saturating any rotor.

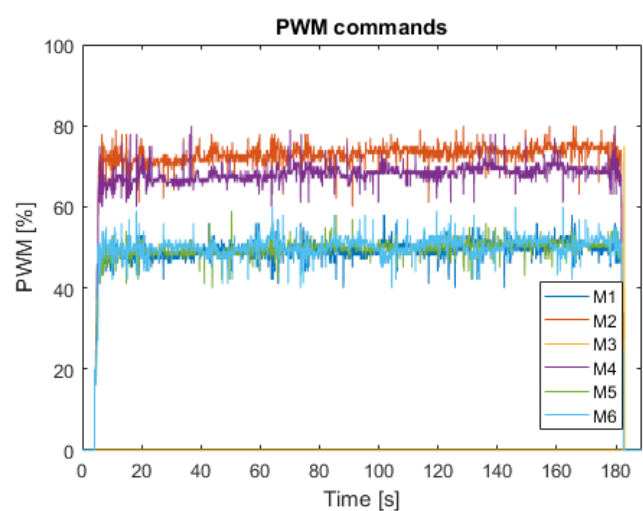
Figure 9: PWM values during the flight with a failure in rotor 3.

In Figure 9, the PWM values commanded to the six rotors are presented for the case with failure. While the PWM value for rotor 3 is zero during the flight, the commands to the rest of the rotors do not significantly differ for the previous case.

Rotors 2 and 4 increase its speed (and thus its thrust), to compensate for the lack of thrust of the motor located between them. All the maneuvers performed during the trajectory do not require a great variation of speed (the PWM values for all the rotors only vary around $\pm 5\%$). This suggests that the vehicle with failure also is able to perform aggressive maneuvers without saturating the rotors.
