# The impact of an ambulance vehicle preparation service on the presence of bacteria: a service evaluation

*British Paramedic Journal*

2019, vol. 3(4) 27–31

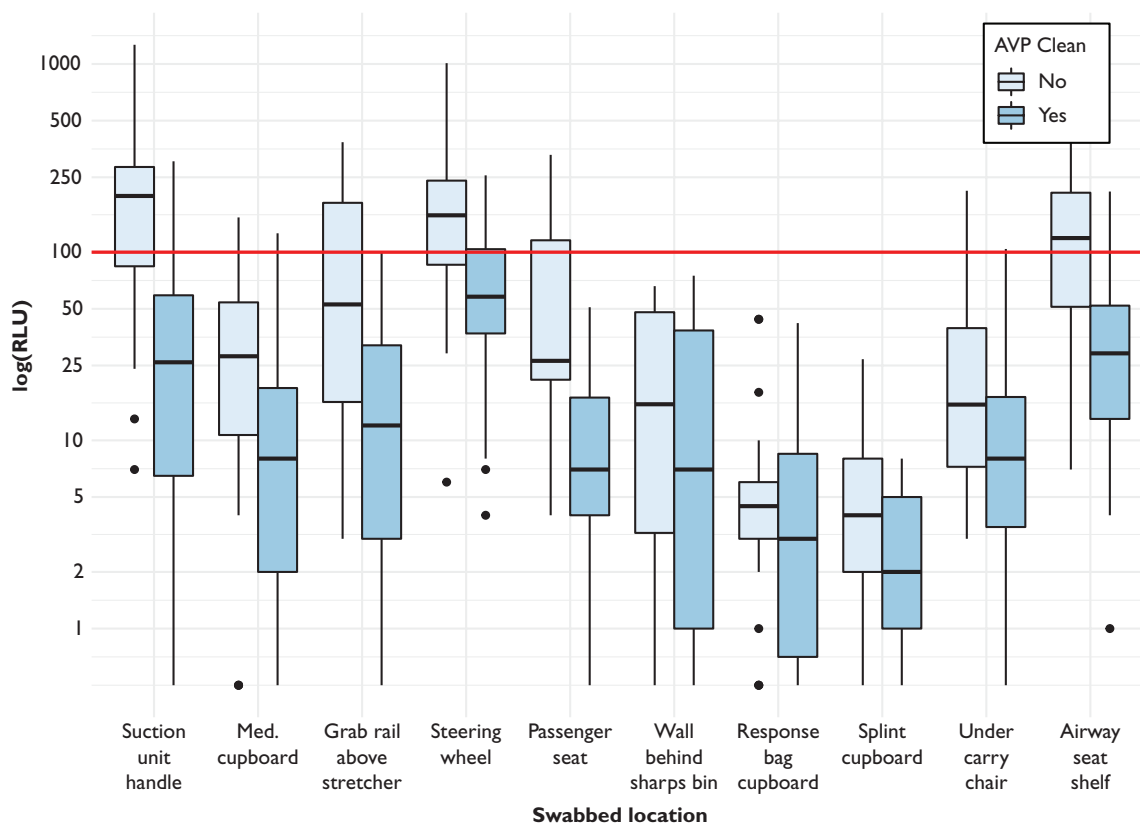
**Figure 1.** Boxplot of swab results, stratified by swab location and whether cleaning conducted by AVPS.

However, when stratified by swabbing area, some areas for concern became apparent (Table 2 and Figure 1). Three areas had a median RLU of > 100 in the BAU group: suction unit handle, steering wheel and airway seat shelf. In addition, the upper quartile RLU values for the grab rail above the stretcher and the passenger seat in the BAU group were also > 100. No swab areas had a median RLU > 100 in the AVPS group, although the steering wheel had the highest median value (58), and had an upper quartile value of 104.

The results of this evaluation clearly show that the median RLU values in all areas were lower in the AVPS group compared to the BAU group. In addition, the interquartile ranges (IQR) for all swabbing sites (with the exception of the steering wheel) in the AVPS group were under the safe threshold of 100 RLUs. This contrasts with the BAU group, where the suction unit handle, steering wheel, passenger seat and airway seat shelf all recorded an IQR that exceeded the 100 RLU threshold. The BAU group also recorded the highest RLU values, with two sites (suction unit handle and steering wheel) recording a maximum RLU of over 1000.
