Monitoring of new and existing stainless-steel reinforced concrete structures by clad distributed optical fibre sensing

Fernandez, I., Gil Berrocal, C., Almfeldt, S. et al (2022). Monitoring of new and existing stainless-steel reinforced concrete structures by clad distributed optical fibre sensing. *Structural Health Monitoring*, in Press.
<http://dx.doi.org/10.1177/14759217221081149>

Structural Health Monitoring
2022, Vol. 0(0) 1–19
© The Author(s) 2022

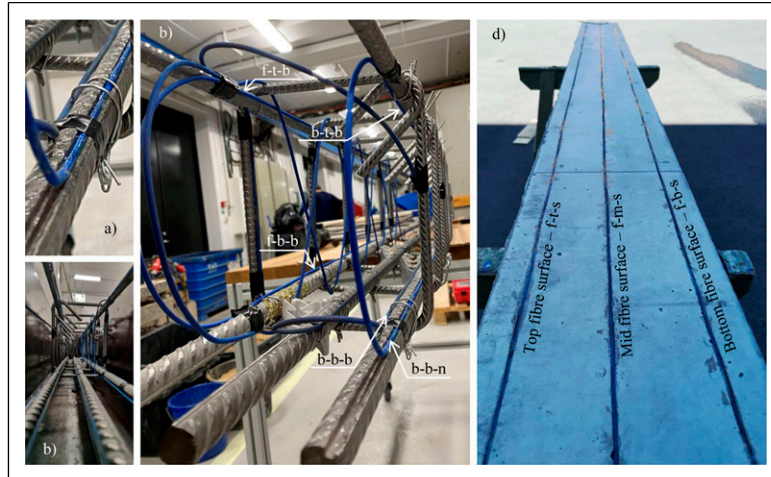
Figure 2. Installation of the optical fibre sensors: (a) installation of clad DOFS cable in a reinforcement bar by inserting it into a previously milled groove; (b–c) installation of clad DOFS on the surface of a reinforcement bar by mechanically anchoring the cable to the reinforcement with electric tape; (d) installation of clad DOFS attached to the concrete surface inserted in previously milled grooves.

A single 50 m long clad DOFS was installed in a multi-layer configuration to monitor the variation of strain along the beam in the region between the supports at 8 different locations of the beam's cross-section: inside the concrete above the two outer tensile rebars (f-b-b and b-b-b); inside the reinforcement bar inserting it into a previously milled groove (b-b-n); inside the concrete under the compressive rebars (f-t-b and b-t-b); inside the concrete at mid-height of the cross-section (f-m-c); and the last three were externally inserted on pre-made notches on the concrete surface, at the top, mid and bottom levels of the section height (f-t-s, f-m-s and f-b-s), see Figure 1(a) and Figure 2(a) to (d) for clarity. The DOFS were either supported along the longitudinal reinforcement (f-b-b, b-b-b, f-t-b and b-t-b), fixed to the stirrups (f-m-c) or glued with a two-component epoxy resin (b-b-n, f-t-s, f-m-s and f-b-s).

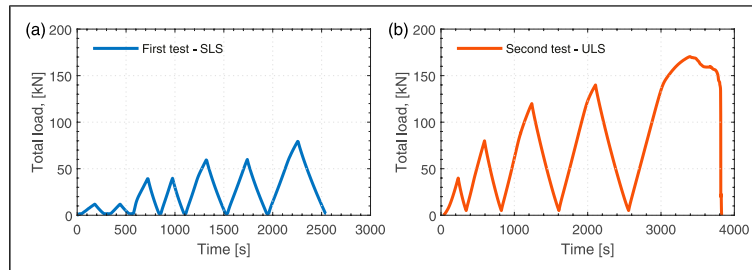
Figure 3. Loading setup and load versus time for both: (a) cyclic test (SLS) and (b) loading to failure (ULS).

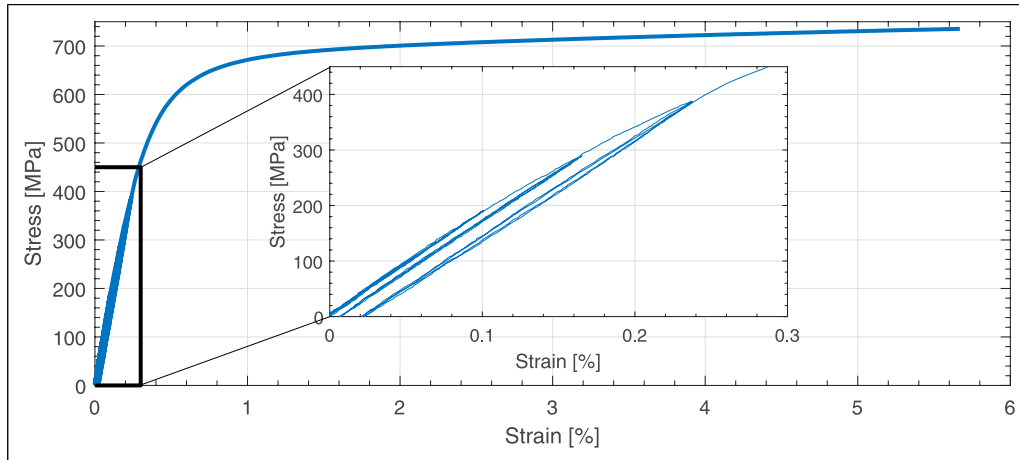
Figure 4. Results of the material test conducted on stainless-steel bars used in this study: characteristic stress-strain curve for a tested bar and a detail of the quasi-elastic branch showing the small plastic strains due to cyclic loading.

The results from the cyclic tensile test conducted on the stainless steel rebars, exemplified the characteristic behaviour of duplex stainless steel. The absence of a clear yielding stress, with the corresponding plateau before the hardening phase, which is commonly seen for carbon steel was observed. Conversely, the results display a smooth transition between the quasi-elastic and plastic phases of the material. However, the quasi-elastic phase of the material shows the presence of plastic deformation after the unloading of the bar, at virtually any stress level reached, see [Figure 4](#). Further, such plastic deformation is observed to grow with the maximum stress level reached in the bar, indicating that the plastic deformation on the bar becomes more significant when the bar is subjected to higher stress levels. On the other hand, as shown in the detail of [Figure 4](#), the plastic strain measured after two consecutive cycles of the same amplitude does not seem to vary, indicating that

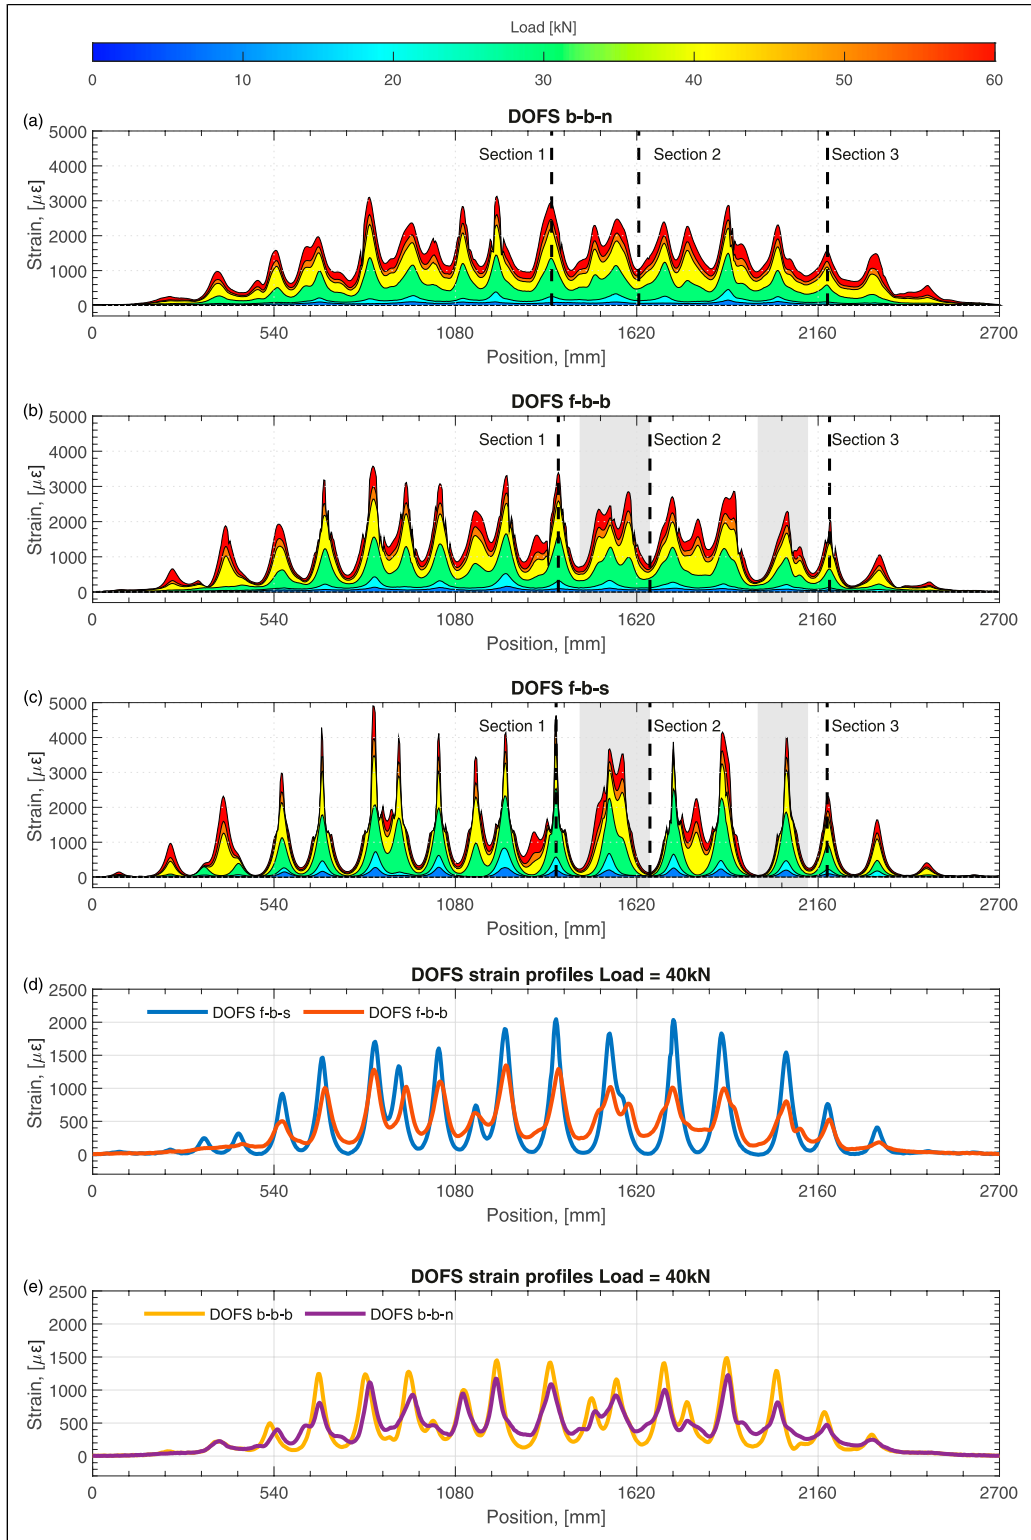
Figure 5. Comparison of distributed strain profiles obtained by DOFS embedded and attached on the concrete surface in the tensile zone.

the DOFS depending on its position and attachment. A direct conclusion from Figure 5(c) is that positioning the sensor on the concrete surface after the concrete has hardened leads to more incipient peaks linked to the crack position. Moreover, when comparing such strain to any other measurement, that is, DOFS b-b-b and DOFS b-b-n, it can be seen that this concentration effect develops very rapidly with increasing load levels, being the strain magnitude in some cases double than for the DOFS placed at the notch (b-b-n). In addition, when comparing the DOFS f-b-s to the strain profile measured by the DOFS simply attached to the steel bar, DOFS f-b-b, for a certain load level, see Figure 5(d), it can be seen that the strain measured between consecutive peaks, is of lower magnitude, being this effect more noticeable at the valley, indicating that the DOFS f-b-s strain is closer to the concrete strain while the strain measured by the DOFS f-b-b is closer to the actual strain in the bar. Similar differences but to a lower extent can be observed in Figure 5(e), for the sensor attached to the bar and the sensor embedded in the notch, namely, b-b-b and b-b-n, respectively, where the latter is expected to measure a strain even closer to the actual steel strain while the former is expected to show an in-between measurement concrete/steel strain.

The observation of different crack patterns on the front and back sides of the beam is confirmed when comparing the strain profiles of b-b-n, f-b-b and f-b-s DOFS, Figure 5(a) to (c) respectively. Likewise, differences in crack patterns between sensors deployed on the same side, namely, f-b-s and f-b-b DOFS, are also denoted. Even though the majority of the strain peaks are located at a similar position, in some cases the strains measured on the surface or inside do not completely agree, indicating that occasionally two cracks observed on the surface may

convolute into one before reaching the bar and conversely, two cracks at the bar level can merge before reaching the surface. This can be seen, for instance, at the shaded zones indicated in Figure 5(b) and (c), between 1500–1600 mm and 2000–2100 mm.

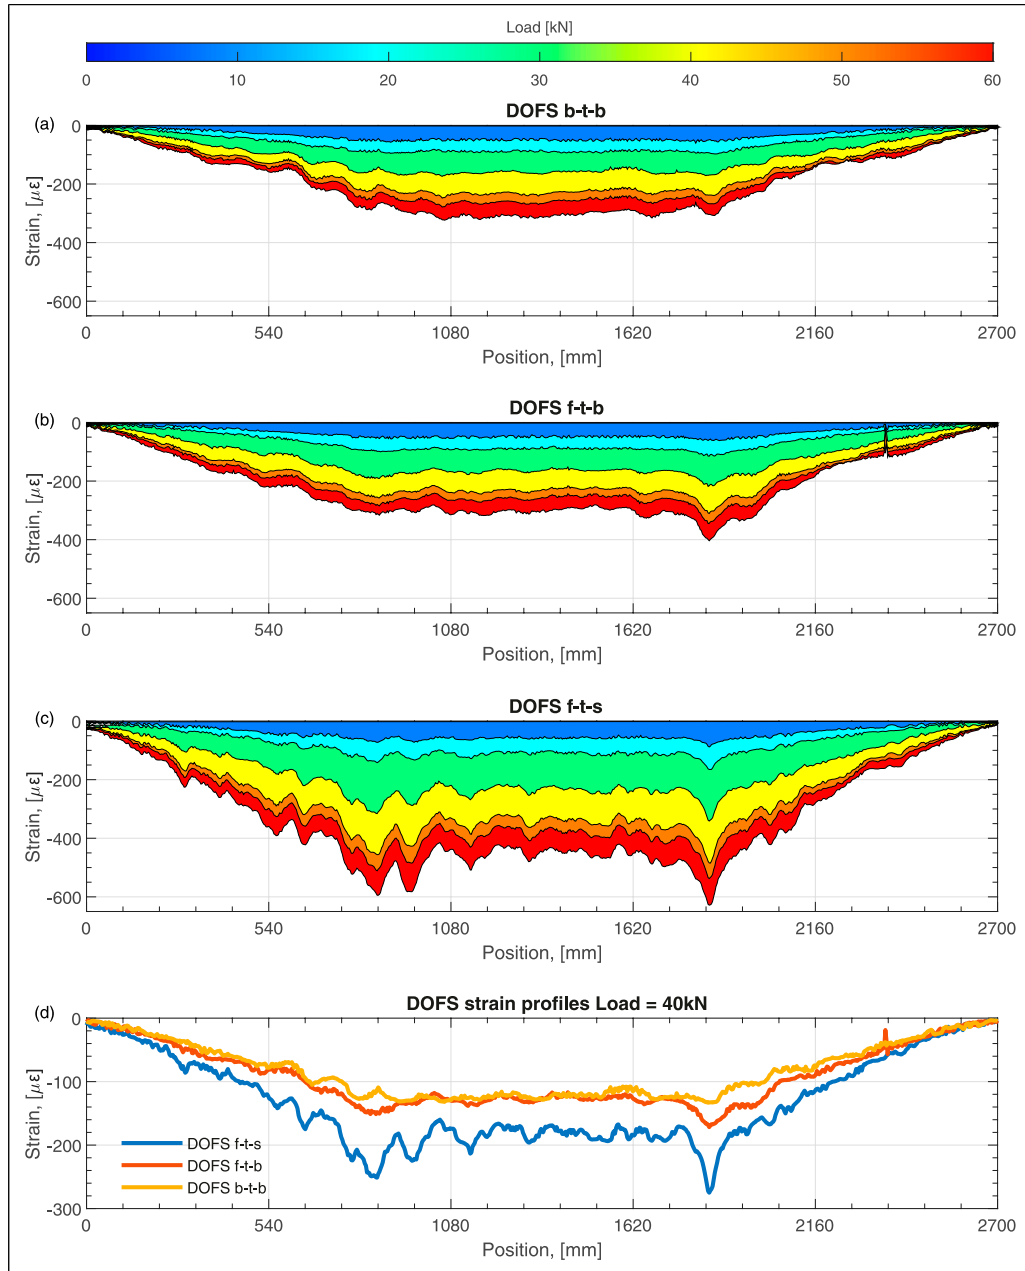
Figure 6. Comparison of distributed strain profiles obtained by DOFS embedded and attached on the concrete surface in the compression zone.

Similar principles are observed when looking at Figure 6(a) to (c). However, as the DOFS are placed in the beam's compression zone, the effect of cracking is not as perceptible compared to the corresponding measurements from the DOFS placed on the tensile zone. Still, a wavy

shape for the strain measurements can be observed denoting the variation of strains due to the presence of cracks; hence, the change of the neutral axis position between cracked/uncracked zones. The comparison between the DOFS measurements of the different positions, inside and outside the concrete, see Figure 6(d), clearly indicates that, once more, the DOFS attached to the concrete surface is more sensitive to strain variations, depicting larger variations of strain between cracked/uncracked zones and being the measured strain between cracks closer to the concrete strain.

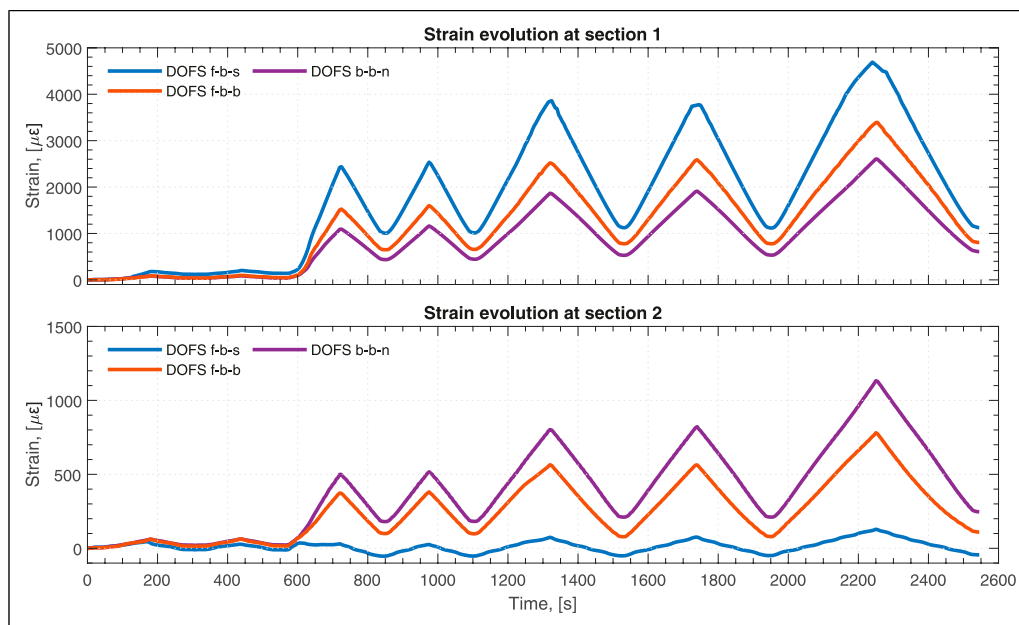
Figure 7. Strain evolution in time for Introduction section and Experimental programme section indicated in Figure 5(a)–(c), that is, crack and valley, respectively.

A further comparison of the tensile strain measurements is presented in Figure 7, where the strain of two sections, namely, *Introduction* and *Experimental Programme* in Figure 5(a) to (c) corresponding to a crack and a valley, respectively, are shown during the entire loading process of the beam. A first observation is that in both cases the measured strains follow the load introduced in the beam, see Figure 3(a), increasing its value with increasing load and decreasing it with decreasing load, independently of the position of the sensor. However, it is as well very clear that the position of the sensor strongly influences the obtained measurement, being the DOFS f-b-s the one giving largest strain values at *Introduction*, cracked, and the DOFS b-b-n the lowest. Conversely, the measurement at the valley yields the opposite behaviour, being the strain measured by DOFS b-b-n the largest and the strain measured by the surface DOFS the smallest. Obviously, this observation is in line with previous observations made, which already indicated this difference of behaviour between cable positions. Nevertheless, a very interesting remark from Figure 7(a) and (b) is that the DOFS is able to accurately capture the plastic deformation occurred in the steel bar, even between cracks where the strain level reached is significantly smaller. This plastic strain, as previously described in the material

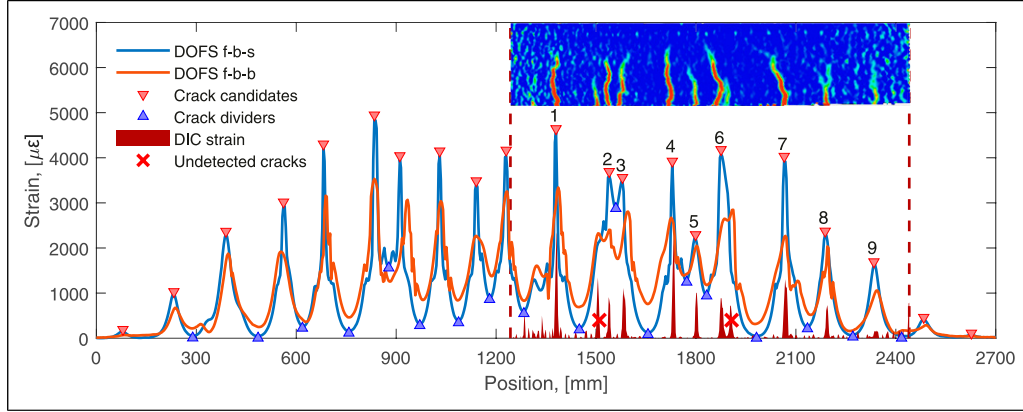
Figure 8. Location of individual cracks based on DOFS strain profiles and comparison with the crack pattern identified by the strain field from measured with DIC. Note that DIC strains are re-scaled and plotted solely to illustrate the location of the cracks.

To show the ability of DOFS for detecting cracks, the strain profiles of the beam measured by DOFS f-b-b and DOFS f-b-s for one load level, namely, 80 kN, are shown

in Figure 8. It can be seen that the locations of the crack candidates, that is, those corresponding to strain peaks, have been identified based on the strain profile of DOFS f-b-s. In the same figure, a picture of the 2D strain field computed by the DIC at the same load level has also been added as an overlay to show the actual crack pattern on the concrete surface. Additionally, the (re-scaled) surface strains along a horizontal line at the height of the DOFS cable (f-b-s), obtained from the DIC, have been drawn in the same plot to facilitate the comparison of the crack locations.

From Figure 8, it can be observed that 10 distinct cracks were formed on the concrete surface based on the DIC strain field, whereas only 9 crack candidates could be identified within the DIC measurement region by both DOFS presented. The disagreement between DIC and DOFS measurements is mainly due to the fact that for some cracks DOFS strain measurements displayed a convoluted strain peak instead of two distinct peaks. This observation is even valid for DOFS measurements performed on the concrete surface, in spite of the increased capacity to accurately detect crack positions, due to more prominent strain peaks at the crack location. In addition, the differences observed between DOFS f-b-s and DOFS f-b-b indicates that the crack formation process differs between the surface and the inside where cracks can grow in different ways from the outside to the inside and from the inside to the outside. Further, in line with previous observations, when using robust DOFS embedded in concrete,²⁶ it is advisable as well for DOFS attached on the surface to perform the crack detection as a recurrent process taking into account the load history in order to identify when the strain rise of a new forming crack merges with the strain peak of an already existing crack thereby hindering their individual identification.

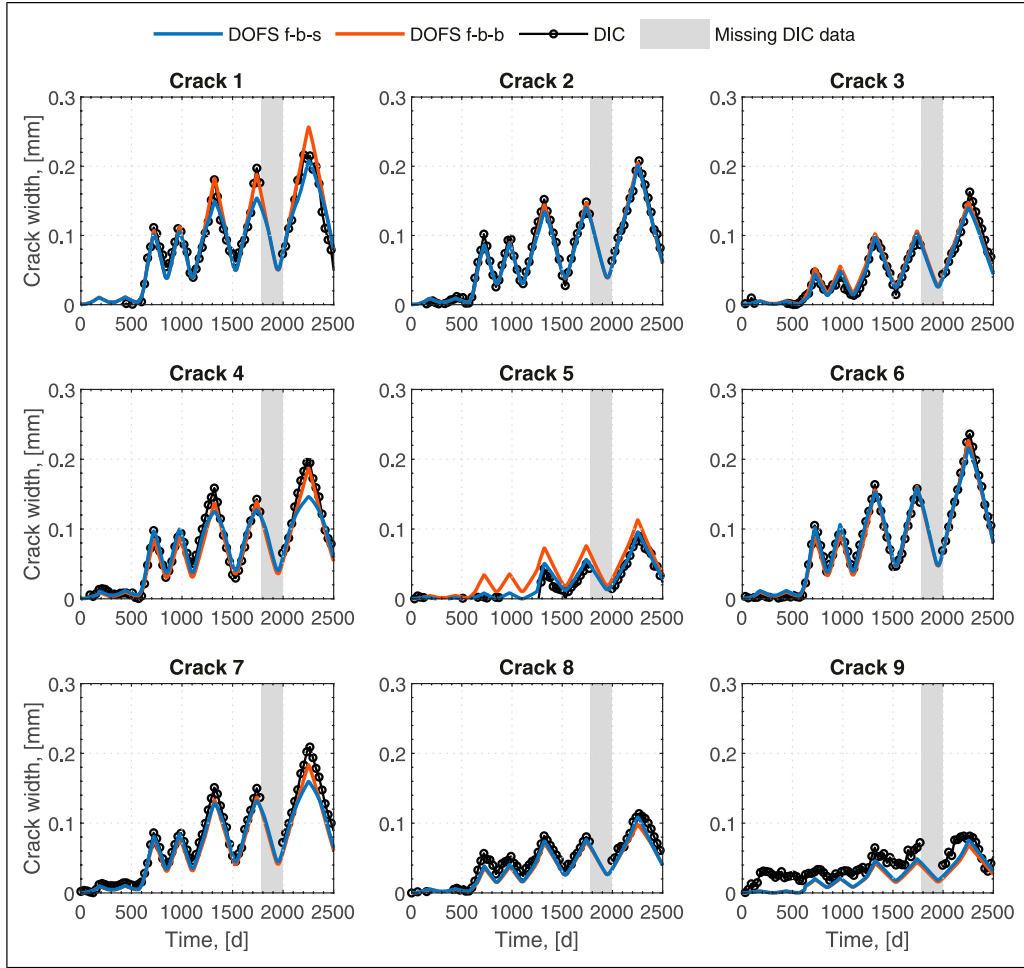
Figure 9. Comparison of crack width computed by DOFS strains and measured by DIC for the cracks identified in [Figure 8](#).

As observed in [Figure 9](#), the proposed method and the corresponding simplification can be used to determine the crack width at different position using DOFS regardless of its placement. However, it is worth noting that for large crack widths the integration of the DOFS f-b-s may lead to some attenuation, which can result in a lower crack width than expected compared to DIC or DOFS f-b-b, for example, crack 1, crack 4 and crack 7. Additional discussion on this phenomenon is provided in later sections. From crack 5, it can be confirmed that the cracking occurs

differently in the inside and outside of the element. In this particular case, the crack starts developing at the bar and subsequently grows to the surface. As a consequence, the crack width measured by the DOFS f-b-b yields larger crack width than both the DOFS f-b-s and the DIC. Furthermore, from crack 9 it is clearly seen that the capacity and accuracy for quantifying the crack width of DOFS is better than the DIC, which for very low crack width and positions close to the image edges yields values with a lot of noise.

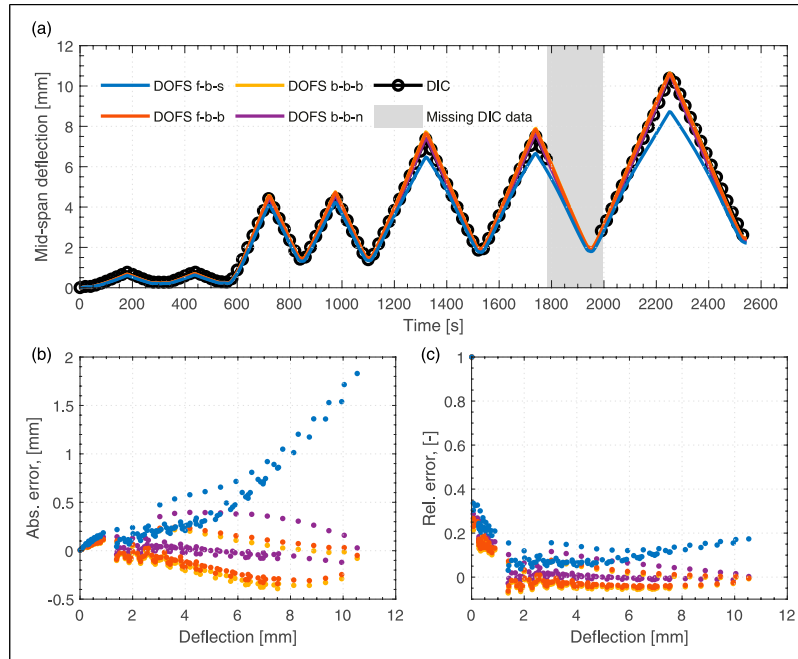
Figure 10. Comparison of deflections computed by DOFS strains and measured by DIC (a) and their corresponding absolute and relative errors (b–c) with respect to the DIC.

vertical distance between the position of the DOFS. This method has been presented in several studies for different types of sensors, always showing very accurate results when validated against alternative measuring systems.^{22,23,42} In order to quantify the ability of clad DOFS to yield accurate values for the calculated deflections depending on its position, the evolution of the maximum deflection calculated by the DOFS was compared to the maximum deflection measured by the DIC system for the entire loading procedure. The results of the comparison for the four positions, namely, f-b-s and f-t-s DOFS, f-b-b and f-t-b DOFS, b-b-b and b-t-b DOFS and b-b-n and b-t-b DOFS, together with the absolute and relative errors to the DIC are presented in Figure 10(a) to (c).

Overall, the deflections calculated by the DOFS showed a consistent agreement with the DIC measurements, except for the DOFS placed on the concrete surface that systematically underestimated the calculated deflection for values exceeding 4 mm of deflection. The maximum absolute error was found to increase with increasing deflection in all cases, reaching a maximum of about 2 mm for the DOFS f-b-s. In relative terms, however, it can be seen how the error is very large at small deflections, basically before concrete cracking. For embedded DOFS, it decreases rapidly with increasing deflection, reaching relative errors close to 0%. Conversely, after an initial reduction of the relative error for the surface DOFS, the relative error grew rapidly after the deflections exceeded a value of 4 mm, reaching up to 20%, which is a direct consequence of the attenuated values seen for large deflections.

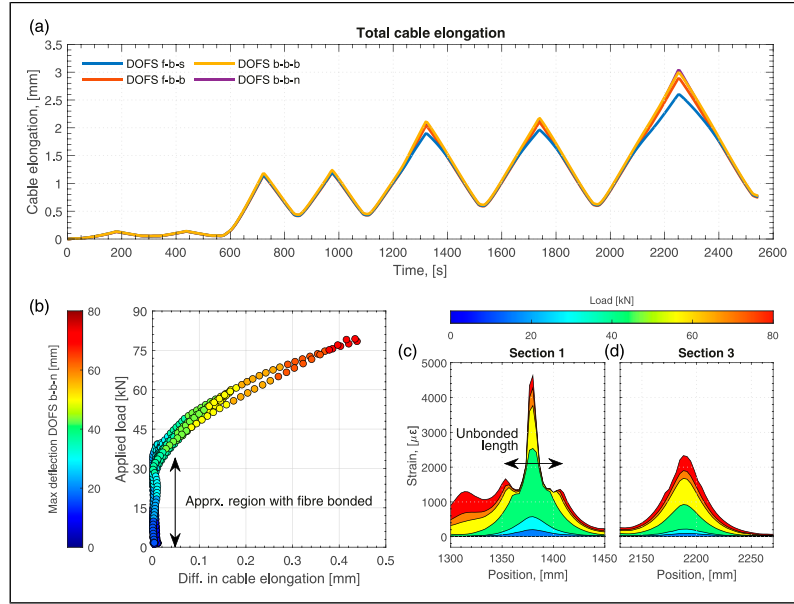
Figure 11. Elongation of the DOFS cable at different positions.

where l_b is the beam length between supports, that is, 2700 mm, and ϵ^{DOFS} the measured strain with the DOFS. A comparison of the computed total elongation for the DOFS f-b-s and the embedded sensors, DOFS f-b-b, DOFS b-b-b and DOFS b-b-n, is given in Figure 11(a). It can be observed that again embedded sensors describe a similar behaviour while the sensor attached on the concrete surface, namely, DOFS f-b-s, is replicating the former observations, that is, an excellent agreement with the other positions up to a certain level where the elongation is calculated to be significantly smaller. This behaviour is then reproduced in the calculated crack width and deflections where systematically both measurements were underestimated after a specific threshold for the DOFS f-b-s. It should be noted that a slight underestimation of the cable elongation is observed as well for the highest load level, that is, 80 kN, in the calculation from DOFS f-b-b; however, it is not that significant as for DOFS f-b-s.

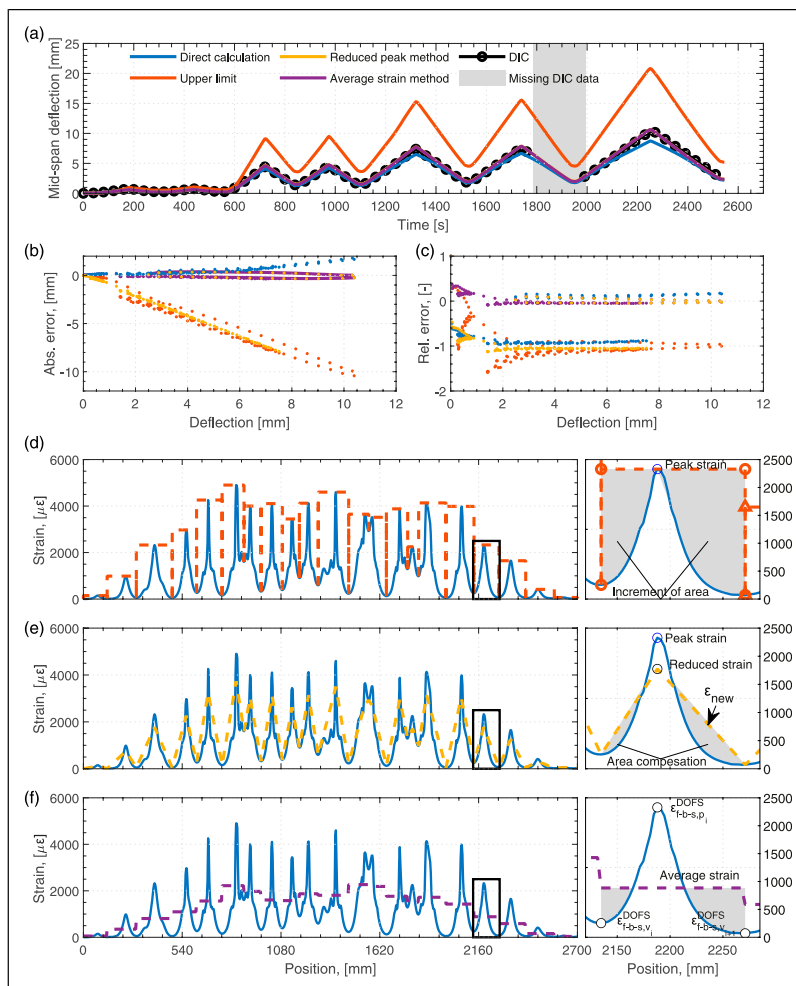
Figure 12. Comparison of deflections computed by DOFS strains and measured by DIC for beams 1, 2 and 3 (a–c) and their corresponding absolute and relative errors (d–f) with respect to the DIC.

triangular shape enclosing every crack is attained, see Figure 12(e). The areas bound between the new and the measured strain profiles, ε_{new} and $\varepsilon_{f-b-s}^{DOFS}$, respectively, are defined as compensation areas that balance for the reduced strain measurements. The curvature is then calculated as

where $\varepsilon_{new}(x)$ is the new strain profile calculated from the DOFS f-s-b measurement, $\varepsilon_{f-t-s}^{DOFS}(x)$ is the measured strain at the concrete surface in the compression zone and z the separation between sensors. Following the presented methodology, that is, integrating two times $\chi_{new}(x)$, a more accurate value for the deflections is obtained. As Figure 12(a) to (c) depicts, it yields very minor errors when

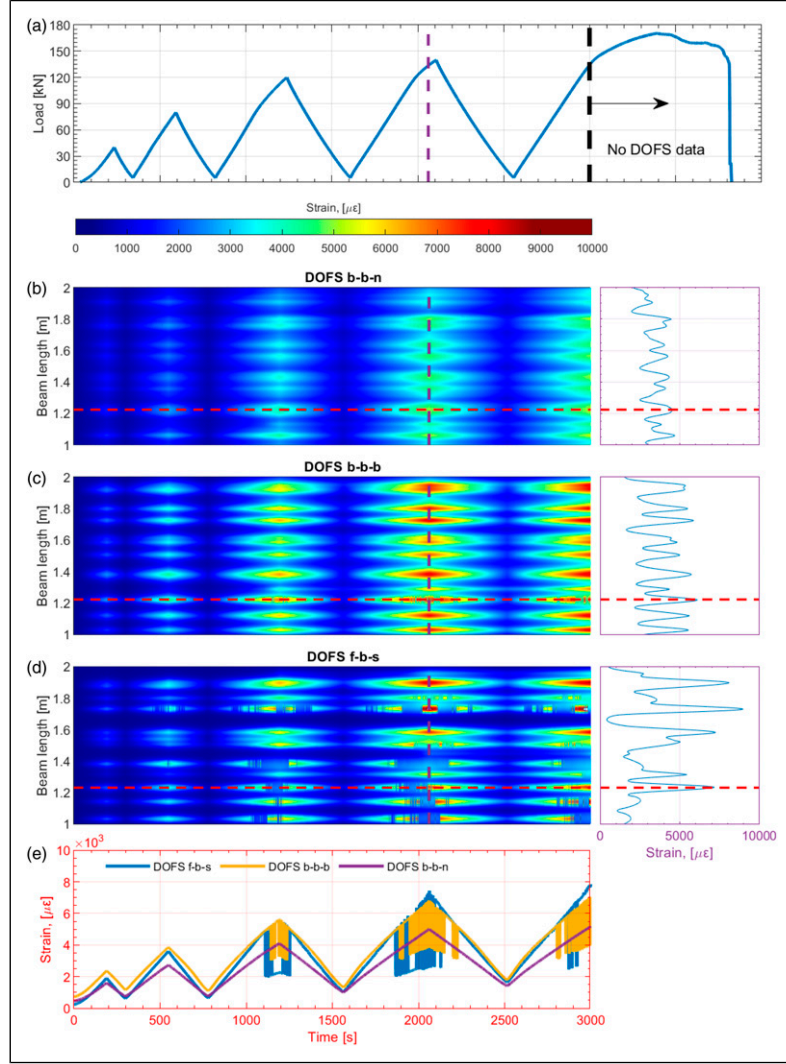
Figure 13. (a) Applied load to failure, (b–d) strain fields measured by DOFS in the constant bending moment zone, (e) strain in time for crack 4 in Figure 9.

natural to the material, strain concentrations can occur and subsequently a loss of measuring capacity. That is not the case of other continuous materials where the strain levels are expected to be uninterrupted in the media and easier to measure for such type of sensors. This issue becomes even more relevant if the sensor is directly attached to the concrete surface since, as it has been previously shown, the concentration of strain in the cracks is much more pronounced. In Figure 13 the strain field measured by DOFS at the different locations, that is, DOFS b-b-n, DOFS b-b-b and DOFS f-b-s, is plotted for the central moment zone of the beam with respect to time, for the loading process of the beam to failure according to Figure 3(b). It must be noted that DOFS did not give strain values for a load higher than 140 kN, as indicated in Figure 13(a).

Several observations can be made from Figure 13. The strain fields depicted by embedded DOFS are similar regardless to the load level, presenting both positions continuous strain values in time and space. It is worth noting that one of the cracks, crack 4 in Figure 8, describes some loss of data in time for the DOFS b-b-b, most likely due to large crack widths occurring there. The DOFS b-b-n presents a clear description of the strains both in time and space. Conversely, the strain field depicted by the DOFS f-b-s shows obvious spatial and temporal absence of strain data for already very low load levels. This absence of data clearly increases with increasing load level, presenting important gaps in several regions of the sensor for load levels around 120 kN or above. Moreover, the presence of gaps in the collected

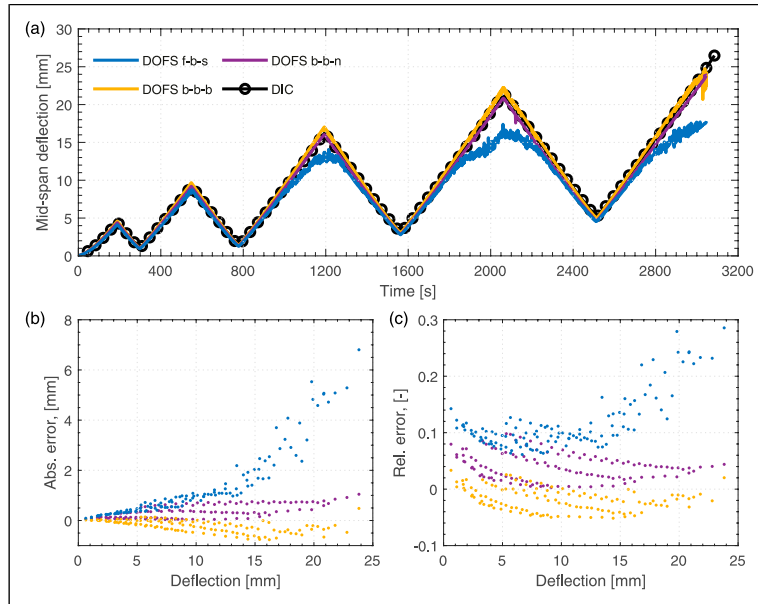
Figure 14. Comparison of deflections computed by DOFS strains and measured by DIC for cracks 1, 2 and 3 (a–c) and their corresponding absolute and relative errors (b–c) with respect to the DIC.
