Finite Element Modeling Application in Forensic Practice: A Periprosthetic Femoral Fracture Case Study

Finite Element Modeling Application in Forensic Practice: A Periprosthetic Femoral Fracture Case Study / Terzini, M.; Aldieri, A.; Nurisso, S.; De Nisco, G.; Bignardi, C.. - In: FRONTIERS IN BIOENGINEERING AND BIOTECHNOLOGY. - ISSN 2296-4185. - 8:(2020), pp. 1-11. [10.3389/fbioe.2020.00619]

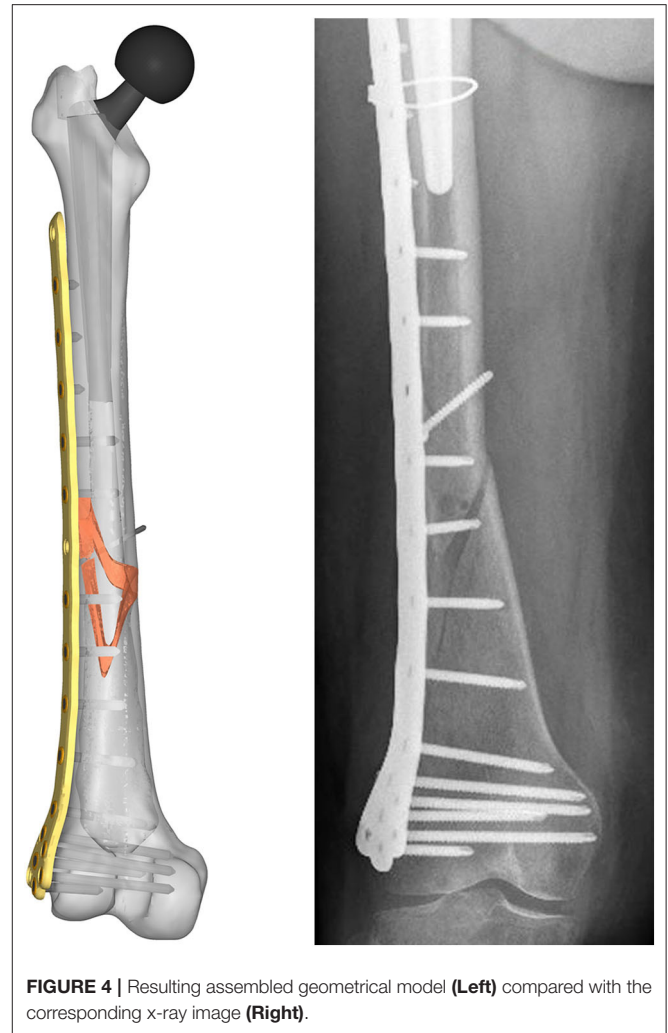
FIGURE 4 | Resulting assembled geometrical model (**Left**) compared with the corresponding x-ray image (**Right**).

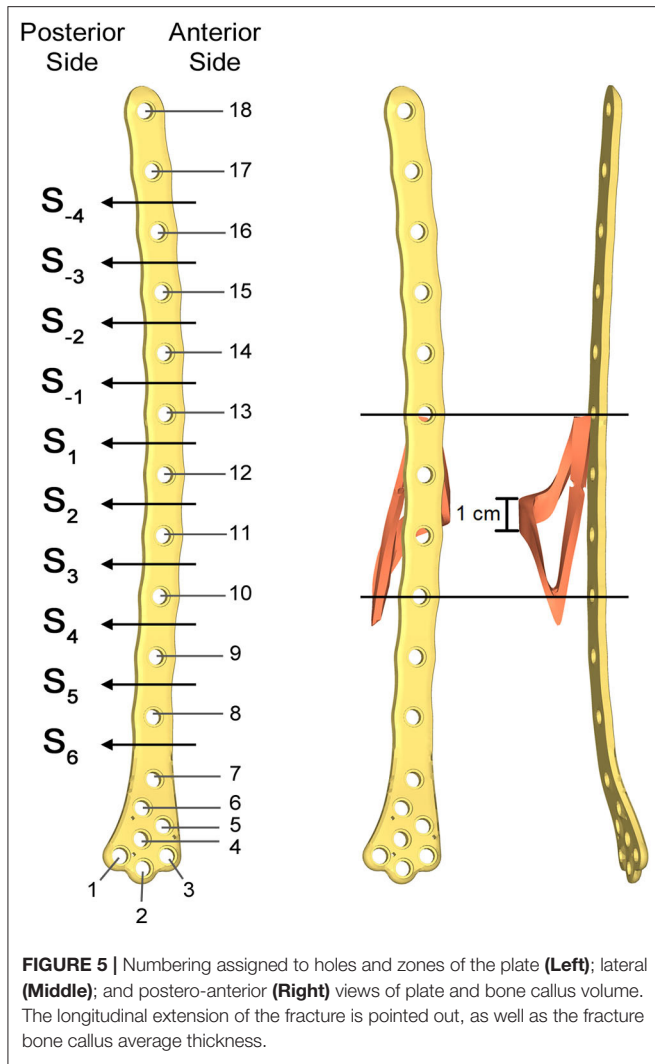
FIGURE 5 | Numbering assigned to holes and zones of the plate (Left); lateral (Middle); and postero-anterior (Right) views of plate and bone callus volume. The longitudinal extension of the fracture is pointed out, as well as the fracture bone callus average thickness.

the main object of investigation of the present study (Papini et al., 2007). Using the software ImageJ (National Institutes of Health, USA) some reference measures were taken on the x-ray images in order to scale the standard femur model and adapt it to the real anatomical case. To recreate the fracture profile, reference points were identified on the x-ray images and reported on the bone surface, so that the fracture shape could be reproduced. The result is a fracture volume characterized by an average thickness of 1 cm (**Figure 5**).

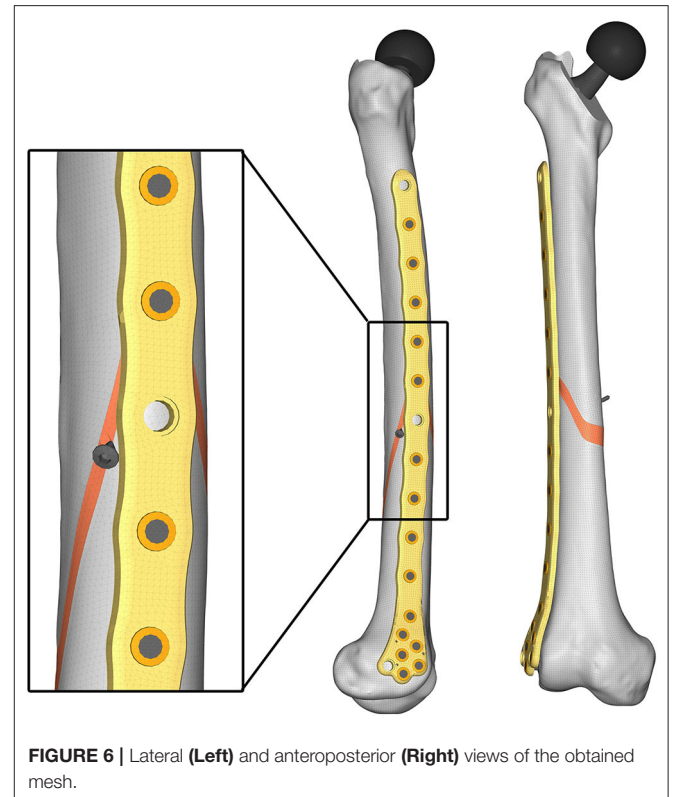
FIGURE 6 | Lateral (Left) and anteroposterior (Right) views of the obtained mesh.

According to Viceconti et al. (1998), Polgar et al. (2001), and Ramos and Simões (2006), a tetrahedral mesh of 388652 elements with a 2 mm average edge length was created (Figure 6).

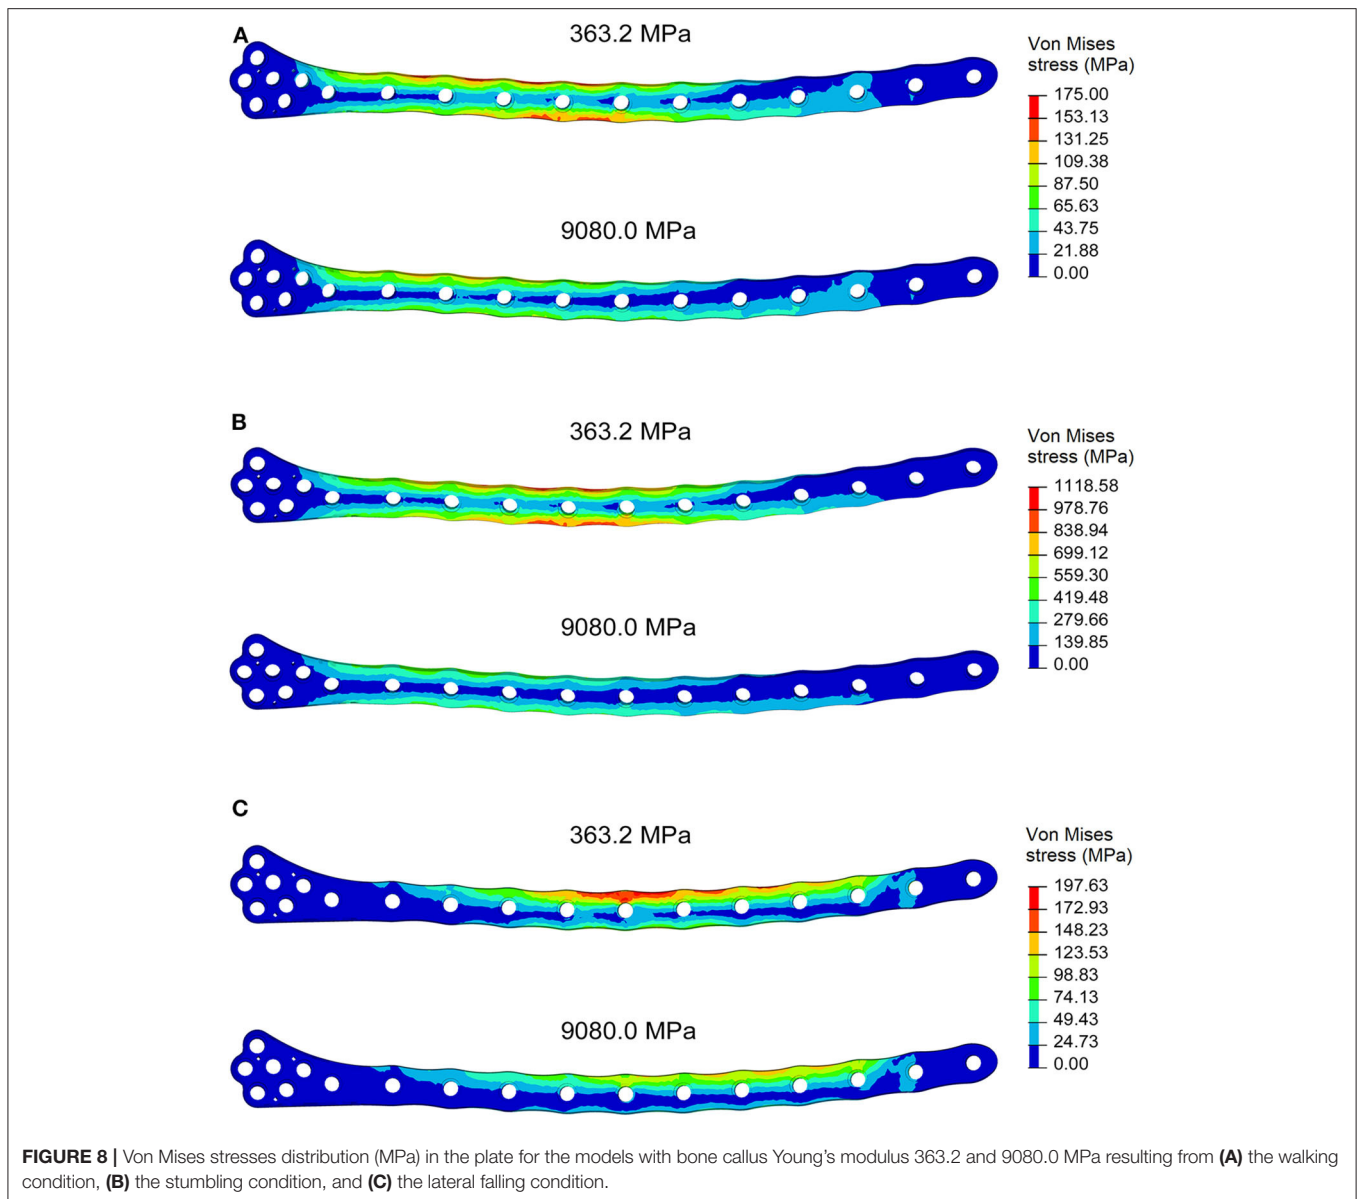
FIGURE 8 | Von Mises stresses distribution (MPa) in the plate for the models with bone callus Young's modulus 363.2 and 9080.0 MPa resulting from (A) the walking condition, (B) the stumbling condition, and (C) the lateral falling condition.

healing achieved. For lower Young's modulus values of the fracture bone callus, the lateral surfaces belonging to the S2 zone are more stressed. As the bone callus stiffness increases, the highest stresses move downwards, affecting the lateral surfaces of the S4 and S5 zones (Figure 8A), while the Von Mises stress values on the femur plate surface in the S2 zone reduce, with initially precipitous progression as visible in Figure 9A. In the S2 zone, the plate stress is distributed evenly between the anterior and the posterior portions, with a slight prevalence of the posterior area in the presence of lowest bone callus stiffness. Conversely, the S5 zone is characterized by a slightly decreasing trend both posteriorly and anteriorly, but with a clear predominance of the posterior values compared to the anterior ones.

However, in the walking load configuration, the maximum stress value reached in the most critical condition (i.e., the case of a bone callus Young's modulus equal to 363.2 MPa) is 248.0

MPa, which settles far below the plate yield point (about 700.0 MPa for stainless steel 316LVM; Srivastav, 2011).

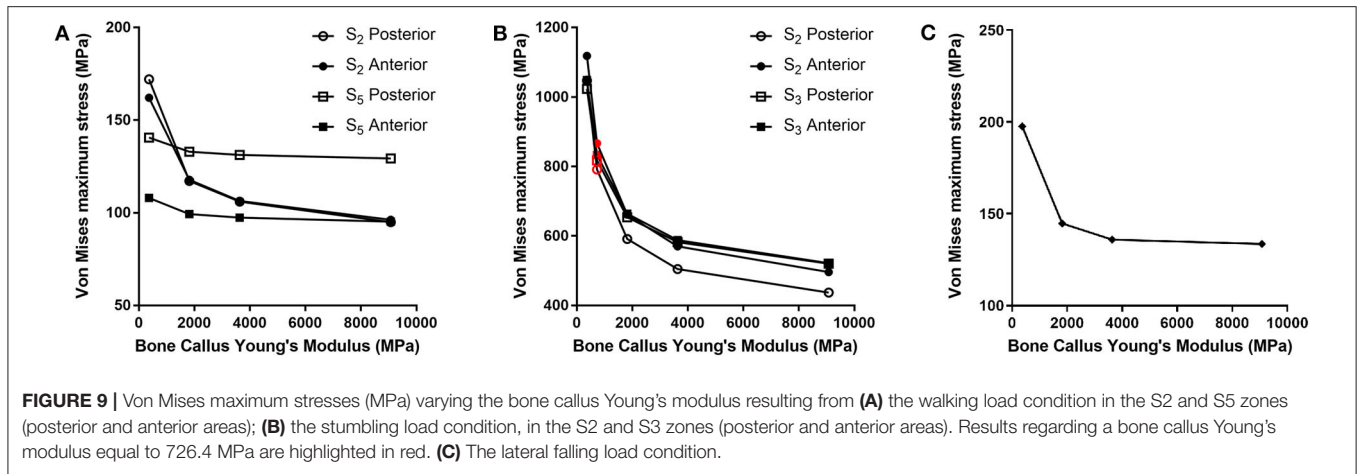
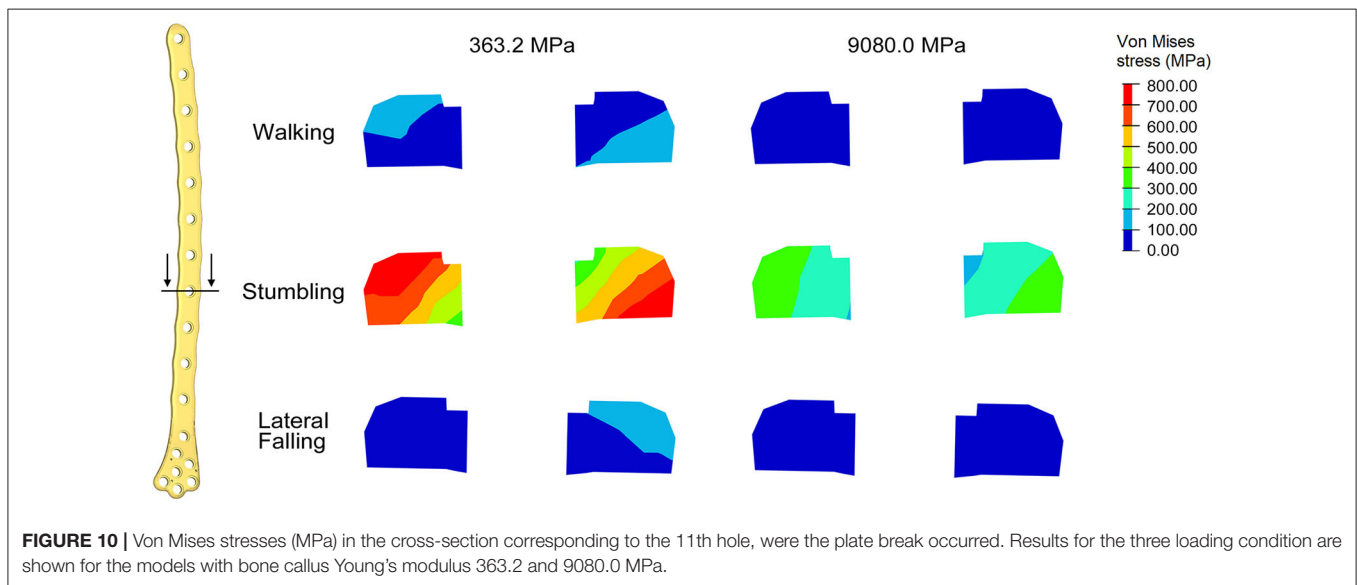
The force acting on the femur during stumbling from standing position have the same direction as that during walking, but its module is amplified. In this case the zones where Von Mises stress is higher are S2 and S3, and in these zones the femur plate yield point is exceeded for lower values of the fracture bone callus Young's modulus (Figures 8B, 9B). This is interesting because, as previously stated, the real plate break occurred at the 11th hole between S2 and S3 zones. For this reason, an additional model was considered to better understand which level of bone healing would correspond to the plate break. Here, the bone callus Young's modulus was set equal to 726.4 MPa after few trials, corresponding to a bone reduction factor of 4%, and Von Mises stress results are represented in red in Figure 9B. The two stress distributions around the hole section where the actual break occurred show how the fracture bone callus Young's modulus influences the femur plate stress state (Figure 8B): indeed, as the fracture bone callus Young's modulus decreases, the higher stress

zone moves closer to the 11th hole. The consequent yield causes the reduction of the plate section and the subsequent break. Being the most representative or the real break event, for the stumbling load condition a further model was considered in which a body mass equal to 75 kg, representative with high probability of the real situation, was addressed and the applied load was reduced accordingly. The obtained Von Mises stresses distribution was similar to the previous one, but as expected the stress peaks were lower and reached the yield stress value for a fracture bone callus Young's modulus equal to 300.0 MPa.

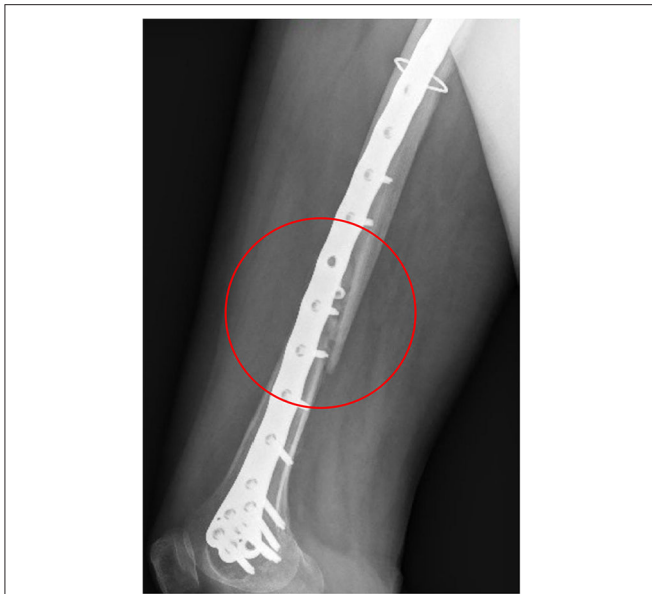
FIGURE 11 | X-ray image taken after 2 months from the surgery. The non-consolidation of the bone fracture is pointed out.

it was deduced that a combination of insufficient bone healing and unexpected high load applied to the prosthesis head with a predominant vertical component is the most probable cause of the plate break occurrence. In particular, the research highlighted how the femur plate implanted during surgery is able to support the loads deriving from daily activities, such as walking, even considering high body masses, as long as an adequate bone healing is granted.
