AIAS 2019 International Conference on Stress Analysis

Monitoring of railway freight vehicles using onboard systems

Nicola Bosso*, Antonio Gugliotta, Matteo Magelli, Nicolò Zampieri

Politecnico di Torino, Torino 10029, Italy

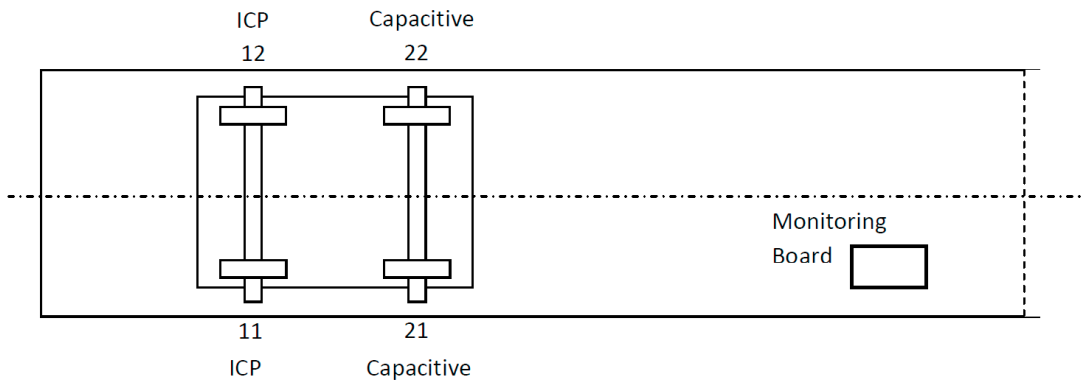
On the Tasca type car, the control unit was installed under the vehicle frame on the right side, in the central portion. The axle-box covers fitted with ICP sensors were mounted on the first axle, the covers fitted with capacitive sensors on the second, as shown in Fig. 5.

Fig. 5. Installation diagram on the Tasca wagon.
