Numerical Study of the Bond Strength Evolution of Corroded Reinforcement in Concrete in PullOut Tests / El Alami, E.; Fekak, F. -E.; Garibaldi, L.; Moustabchir, H.; Elkhalfi, A.; Scutaru, M. L.; Vlase, S. - In: APPLIED SCIENCES. - ISSN 2076-3417. - 12:2(2022), p. 654. [10.3390/app12020654]

# Article Numerical Study of the Bond Strength Evolution of Corroded Reinforcement in Concrete in Pull-Out Tests

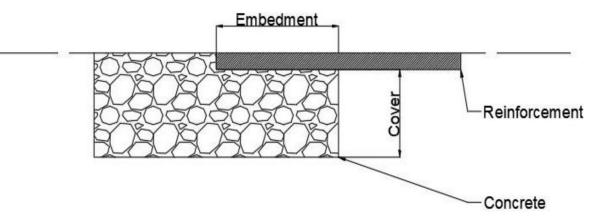
The studied model is a 2D axisymmetric model composed of a plain reinforcement rebar embedded in a block of concrete. The diameter of the rebar is 12 mm in this model, and the embedment depth is 100 mm. The concrete part is a 150 mm  $\times$  150 mm block of concrete with a cover of 69 mm. The Figure 1 represents the detailed geometry of the model.

Figure 1. Representation of the geometry of the pull-out model.

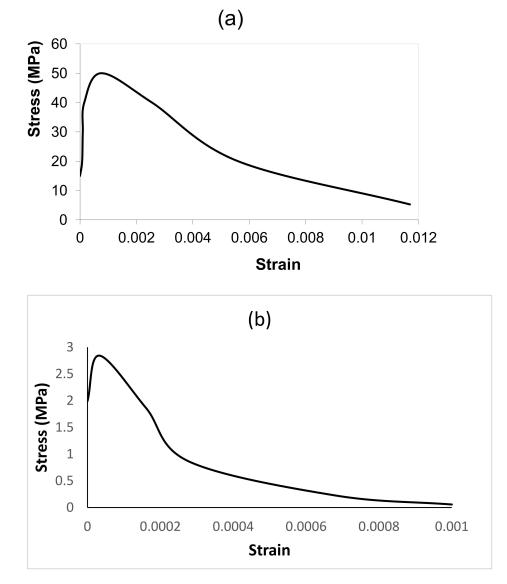
Figure 2 represents the tension stiffening and concrete crushing laws proposed in [18] and used in our work to model the failure behaviors of concrete.

Figure 2. Uniaxial stress-strain curve with damage in compression (a) and traction (b) [18].

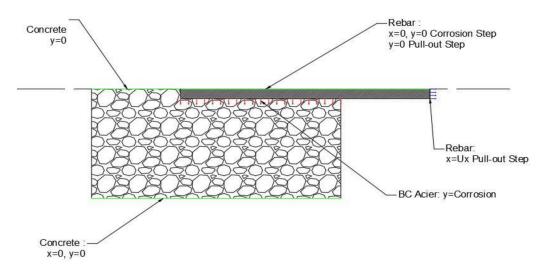
There is only one boundary condition set in the second step, an imposed displacement in the x direction at the free end of the rebar to simulate the pull-out test. No boundary condition is set at the other end of the reinforcement. The boundary conditions applied on the rebar are presented in Figure 3.

Figure 3. Boundary conditions of the pull-out model.

To avoid any movement in the Corrosion Step or in the Pull-out Step, the bottom of the concrete part is clamped throughout the whole simulation. The top of the concrete part is also blocked in the y direction ( $U_y = 0$ ) in order to follow the axisymmetric conditions.

The top of the rebar is blocked in both *x* and *y* direction ( $U_x = 0$  and  $U_y = 0$ ). The first condition ( $U_y = 0$ ) is for the axisymmetric conditions. The second condition ( $U_x = 0$ ) is set to avoid any displacements in the *x* direction that can be caused by the imposed displacement of the volume expansion of the rebar. This condition is relaxed in the Pull-out Step to allow the rebar to move.

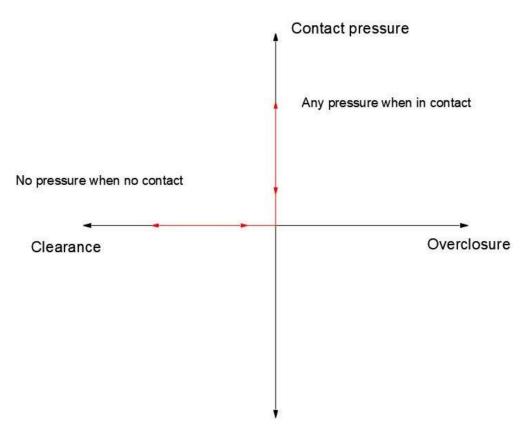
with  $t_n$  as the contact pressure and g the clearance. The first two equations ensure that there is a compressive contact between the two parts, and that there is no penetrability between the two materials. The third equation, the complementary condition, ensures that we can have contact pressure only if we have contact and that there is no contact pressure where there is a gap between the two materials. The Kuhn–Tucker optimality conditions are presented in Figure 4.

Figure 4. Representation of the Kuhn–Tucker contact conditions.

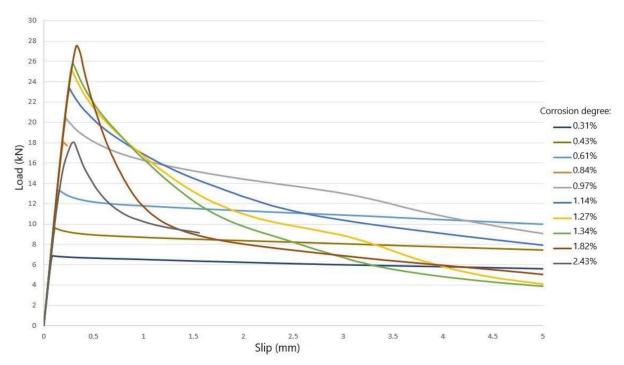
As explained previously, after applying the volume expansion on the rebar, a displacement is imposed at its free end. This allows us to determine the necessary load to pull the rebar for the various degrees of corrosion studied, as presented in Figure 6. As we can see in this same figure, the load necessary to remove the rebar decreases greatly after some slight movements. We can also notice that this same load increases for small degrees of corrosion before it drops for larger degrees. This is due to the fact that, at lower degrees of corrosion, the concrete at the interface region is still not damaged, and the volume expansion only leads to a better adherence between the reinforcement and the concrete cover. The volume expansion of the rebar increases the radial forces applied on the concrete interface which enhances the holding capacity of the concrete cover. Experimentally, this increase is also observed in [14,16,24]; it was explained due to the rough nature of the rust material in contact with concrete. Here, we can conclude that this increase in the pulling load of the corroded rebar in lower degrees of corrosion is more significant in reality since it takes these two behaviors into account.

Figure 6. Load-slip pull-out curves for different corrosion degrees.

When the degree of corrosion starts to grow, the rust damages the concrete at the interface. Cracks start to appear due to the tensile stresses inside the concrete cover, generated by the volume expansion of the rebar, and due to the quasi-brittle nature of the concrete. It is at this moment that the pulling load starts to decrease, as we can see

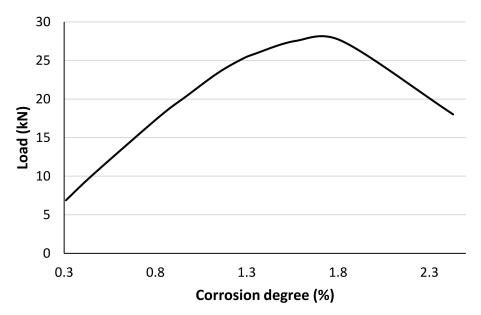
in Figure 6. The evolution of the bond stress as a function of the corrosion degree is also investigated (Figure 7), using the following formula [6,19,25,26]:

Figure 7. Evolution of the maximum pull-out load as a function of the corrosion degree.

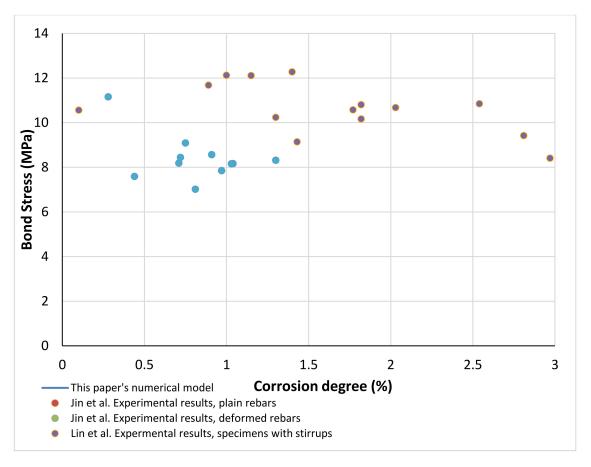
The results of Jin et al. [16] are plotted in Figure 8. They worked on the effect of corrosion on the bond stress of plain and deformed rebar. They carried out pull-out tests on cubic concrete specimens of  $100 \times 100 \times 100$  mm with a 12 mm diameter plain and deformed corroded rebar and with an embedment depth of 80 mm. The corrosion was simulated artificially, and was considered uniform all along the rebar. We can notice that the results they obtained are similar to our numerical model, especially the results with the plain rebars. As for the deformed rebars, we can highlight that the bond stress is significantly higher at very low degrees of corrosion compared to the bond stress of the plain specimens and compared to our models. This is because, with plain rebars, there is no mechanical contact between the reinforcement and the concrete cover, and at lower degrees of corrosion, the ribs of the deformed rebars are still not enough damaged.

Figure 8. Numerical results: bond stress-corrosion degree with comparison with the literature.

The results of Lin et al. [9], where they carried out pull-out test on corroded concrete blocs with also only one deformed rebar, are also plotted in Figure 8. The top concrete cover varied between 25 mm and 35 mm and a fixed lateral concrete cover of 65 mm. The embedment depths were of 300 mm with only 200 mm of contact between the rebar and the concrete. The specimens had either two or four stirrups. They conducted artificial corrosion on the specimens before pulling-out the rebars. They noticed that stirrups were the more corroded than the rebars. The results they obtained are quite similar the ones with our numerical model; we notice the same tendency with small differences in term magnitudes for the bond stresses. This can be explained by the presence of the stirrups and also because the rebar is deformed.

Finally, we also plotted in Figure 8 the results of tested naturally corroded specimens from Horrigmoe et al. [26] from their report delivered to the Integrated Research Project "Sustainable Bridges-Assessment for Future Traffic Demands and Longer Lives", funded by the European Commission. The main objective of the report was to study the impact of corrosion on the structural strength of RC structure. They collected cubic pieces of concrete from the Ullasund Bridge in Norway to test them. The specimens were exposed to the natural environment of the area for approximately 30 years and were corroded naturally. The size of the specimens tested was about 150mm × 150mm × 150mm with a single 25 mm diameter deformed rebar. These specimens were then cast in concrete cylinders of 320 mm diameter. They assessed the corrosion degree of the specimens after carrying out the pull-out test.

Overall, we notice that the results from our numerical model and the experimental results from the literature and plotted in Figure 8 exhibit the same tendency, with some discrepancies in term of magnitudes. There is an increase in the bond stress, and after reaching a certain degree of corrosion (around 1.5% in our model), the bond stress drops significantly. As explained earlier, this is due to the damaging of the concrete at the interface and the cracking of the concrete cover. As for the corrosion degree where the drop occurs, the results in the literature are very scattered. Al Sulaimani et al. [3] noticed an increase of bond stress until reaching a corrosion degree of 1%, the bond stress drops after. Almusallam et al. [4] found that the corrosion degree where a drop in the bond stress was noted was about 5%. Coccia et al. [6] found that the reduction of bond stress happens at a corrosion degree of approximately 0.5%. As mentioned before, there is a wide variety in term of results in the literature, and this had been outlined in [14,24]; furthermore the results show the same trend across the literature.

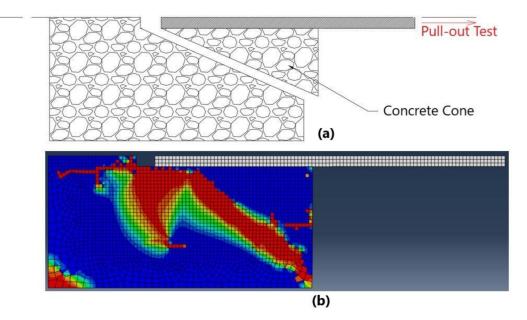
be seen in Figure 9. This failure mode happens when the stress generated by the pullout of the rebar exceeds the tensile strength of the concrete. We can see the failure cone marked out by the damaged zone in tension of the concrete cover in Figure 9. Since the damaging of the concrete is modeled using a finite element model that cannot simulate discontinuities in matter, when the failure cone is fully determined, the model stops running due to convergence issues. This phenomenon happens when the degree of corrosion is approximately 1%, depending on the diameter of the rebar. This has been confirmed in Zhu et al. [8], who also noticed that over a corrosion degree of 1%, the specimens started failing through splitting of the concrete.

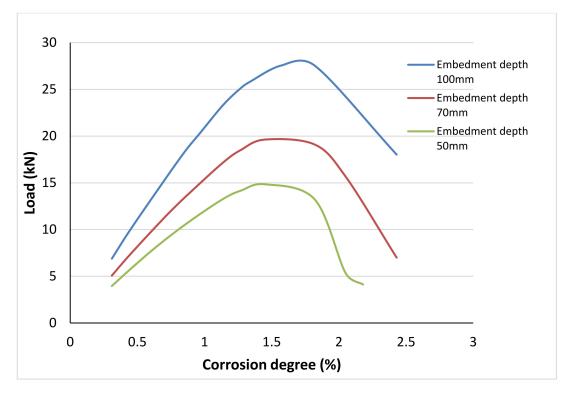
**Figure 10.** Evolution of the maximum pull-out load as a function of the corrosion degree for different embedment depths.

We can notice in Figure 10 that the greater the embedment depth is, the greater the pulling-out load is. This result has been reported in the literature [19,27], and can be explained as follows: the embedment depth is directly linked to the size of the surface in contact with the concrete. This means that there is more friction as the embedment depth is increased, which makes it harder to pull-out the reinforcement, even if it is corroded, as can be seen in Figure 10. We can notice that the pulling load is twice as bigger for an embedment depth of 100 mm than for an embedment depth of 50 mm. Finally, we can also note that there is an increase in the maximum pulling load for lower degrees of corrosion and a significant drop after about 1.5% corrosion, and that this drop happens at around the same corrosion degree for the three models. We can conclude that the embedment depth only affects the load necessary to pull-out the rebar.

In this section, the impact of the embedment depth on the mechanical properties of our model is studied. In total, three embedment depths are considered: 50 mm, 70 mm, and the initial embedment presented in the previous section of 100 mm. For each model, the same degrees of corrosion were considered, and the evolution of the maximum pull-out load for each simulation as a function of the corrosion degree for the three embedment depths studied is presented in Figure 10.

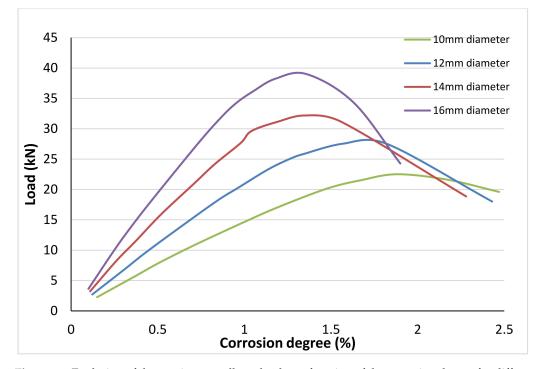
We can see that the greater the diameter of the rebar is, the greater the pull-out load is. The impact of the diameter on the adherence between the rebar and the concrete has been studied, and the results in the literature are scattered. It has been reported in [28] that a greater diameter of the rebar improves the adherence. This can be explained by the fact that when we increase the diameter of the rebar, we also increase the surface in contact with concrete, meaning that the bond stress increases as we increase the diameter of the rebar, for the same corrosion degrees. This can be observed in Figure 12, where we plotted the bond stress as a function of the rebar diameter for the three diameters studied.

**Figure 11.** Evolution of the maximum pull-out load as a function of the corrosion degree for different rebar diameters.

In this section, the impact of the rebar diameter on the pull-out load and the bond stress of the model is studied. In total, four diameters are considered: 10 mm, 12 mm, 14 mm, and 16 mm. The evolution of the maximum pull-out load for each simulation for the four diameters at the same corrosion degrees is plotted in Figure 11.

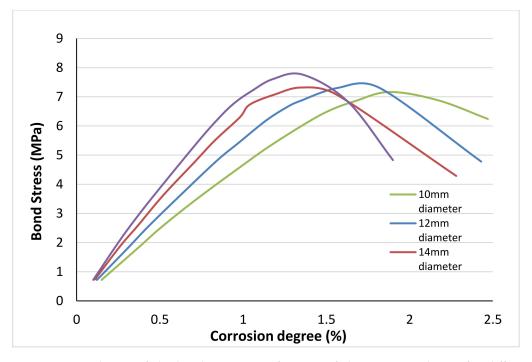
**Figure 12.** Evolution of the bond stress as a function of the corrosion degree for different rebar diameters.

We can also see in Figure 12 that the bond stress is greater for larger rebar for low degrees of corrosion and when the drop of the bond stress happens, this trend is reversed. We note that the corrosion degree where this drop of the bond stress occurs is smaller as we increase the diameter of the rebar. This is because the corrosion degree of a rebar depends mainly on its volume and mass. This means that for the same corrosion degree, the volume expansion of rebar of a diameter of 14 mm damages the interface more significantly than a

rebar of a diameter of 10 mm. We can conclude that the diameter of the rebar impacts not only the maximum pulling load of the corroded rebar, but also the bond stress.

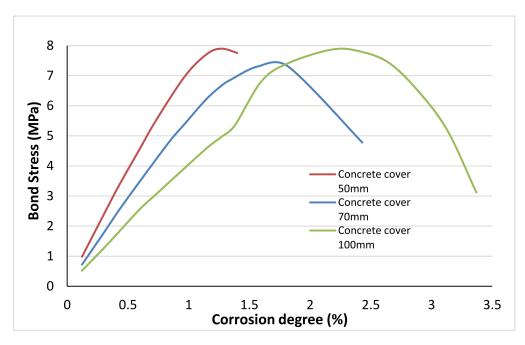
**Figure 13.** Evolution of the bond stress as a function of the corrosion degree for different concrete cover sizes.

We can clearly note that the concrete cover affects highly the bond stress in our numerical model. We can also see that the concrete cover doesn't affect the evolution of the bond stress significantly, but the interface is more easily damaged. For a concrete cover of 50 mm, we can see that at a corrosion degree of around 1%, the interface is sufficiently damaged to affect the bond stress between the reinforce and the concrete, whereas with a concrete cover of 100 mm, the interface is damaged at a corrosion degree of around 2.5%.

We can clearly see that a sufficient concrete cover helps to prevent the early damaging of the bond stress between the two materials. This has been observed in [3,11]. We can also note that with a small concrete cover, 50 mm in our case, the numerical model has significant issues of convergence past the 1.2% corrosion degree. This is due to its extreme state of damaging.
