Fish passage system in an irrigation dam (Pilcomayo River basin): When engineering designs do not match ecohydraulic criteria

Key words: Dam spillway, La Estrella marsh, Pilcomayo basin, Pool and weir system.

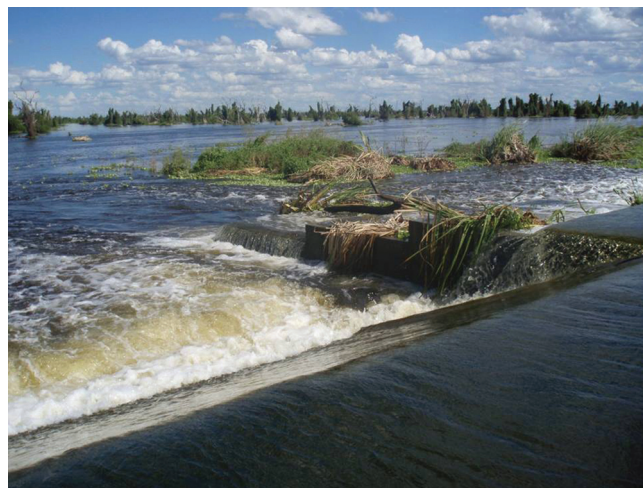
Fig. 6. View of a fish ladder (pool and weir system) operating during high flow conditions showing the contrast between discharge from spillway and attraction flow derived from the fish ladder. Note the debris inside the pools.

Like almost all fish ladders the performance of the pool and weirs systems at the Route 28 Dam is strongly dependent on water level. During high water we noted that the fishways are completely overflowed and filled with debris whereas in low water period the systems stopped functioning as soon as water stopped overflowing the spillway. The Route 28 Dam ladders did not mitigate for the blockage created by the excessive slope of the spillway and also exhibit several structural problems. There are an insufficient number of pools in the ladders and some pool dimensions departed from accepted standard designs. In addition pool hydraulic conditions are barriers to fish passage because the most upstream pool displayed low capacity for energy dissipation. Volumetric dissipated power is an important hydraulic parameter that prevents a transfer of energy between pools. This parameter also controls turbulence and pool aeration and reflects kinetic energy pattern in the fishway (Tarrade *et al.*, 2008). Importantly, the critical values of dissipated power used in this study were derived for salmonids, because appropriate information for South American fishes is unavailable (Oldani *et al.*, 2007). Measured slope also exceeded standard guidelines and was almost twice that observed for Brazilian ladders (Martins, 2005).
