Multi-scale analysis of water alteration on the rockslope stability framework

MULTI-SCALE ANALYSIS OF WATER ALTERATION ON THE ROCKSLOPE STABILITY FRAMEWORK

KEY WORDS: Water, chemical degradation, rock discontinuity, stability.

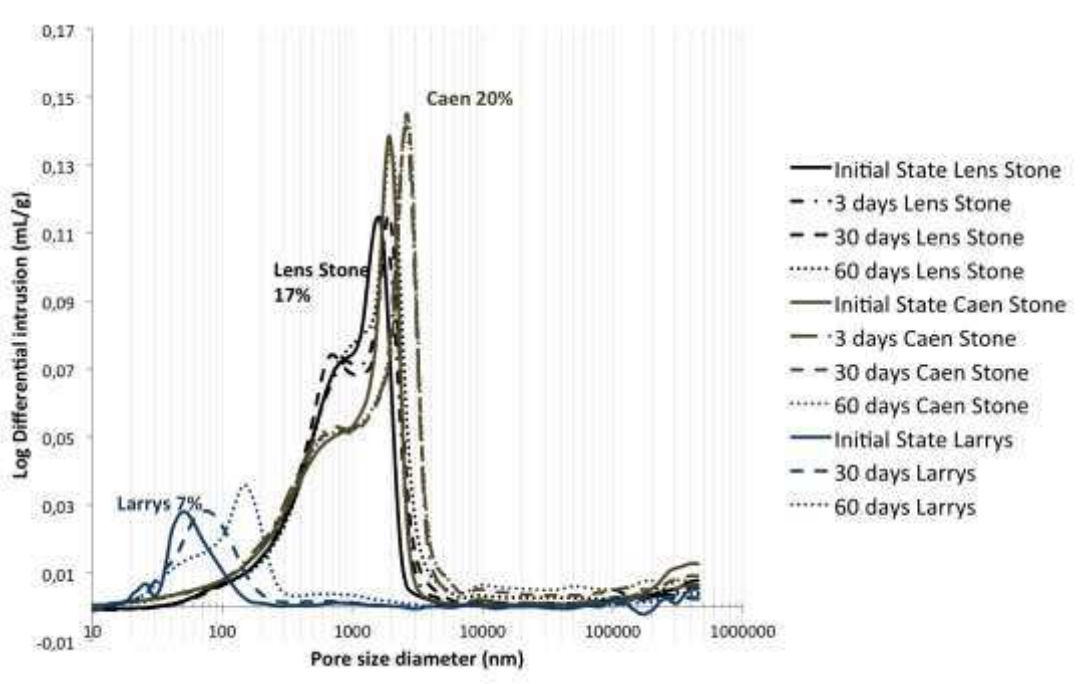
Figure 5: Volume of mercury intrusion versus pore size diameter for samples of Lens Stone, Caen Stone and Larrys and for several state of weathering

In order to evaluate the different states of alteration of the porous matrix evolution inside the sample, mercury intrusion porosimetry (MIP) measures have been done. This method is commonly used to evaluate the total porosity and the pore size distribution of different materials. MIP results are expressed as the total mercury volume intruded (log differential intrusion) in a sample versus pore size (mean diameter pore). Measures were carried out after several cycles of degradation. The Figure 5 shows the volume of mercury intrusion versus the pore diameter. We represent on the graph three of the four limestone used for the study (Larrys (7%) Lens Stone (17%) and Caen Stone (20%)). First of all we can observe the mean pore diameter increases with the limestone's porosity. Then for each type of limestone there is an increase of the mean pore diameter between the initial state and 3 days of alteration. The alteration increase pore volume. Low porosity sample have little mean pore diameter whereas high porosity have their mean diameter higher. Matrix of Lens Stone and Caen Stone samples are modified after the first cycle. Indeed an aperture of the mean diameter pore is measured after the first cycle but the mean diameter doesn't increase for the other cycles. Nevertheless on Lens Stone, the volume of mercury increases between 30 days and 60 days of alteration. This reveals an increase of pores with same size. Larrys' samples show an increase of the mean diameter pore all along the state of degradation (Figure 5).

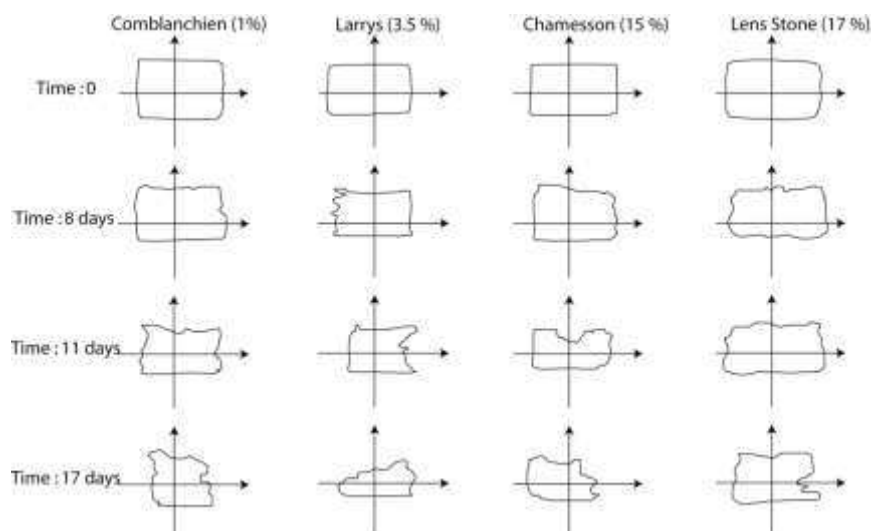
Figure 15: Comparison between the different states of alteration for each limestone of their rock bridges' perimeter measured with laser.

Each type of limestone received 12 liters of acid solution flowed for a period of 17 days. After 8, 11 and 17 days, a geometric analysis by laser is performed. Many profiles were done in order to show the influence of the alteration surface and to establish the decreasing of the rock bridge perimeter. This decreasing of the perimeter is observed during the water flowing for all samples (Figure 15). In addition we noticed an intact part of the rock bridge below. The recession of the rock-bridge perimeter may imply a decrease of the mechanical resistance of the rock bridge.
