# Methods applied to investigate the major UVCE that occurred in the TOTAL refiner's Fluid Catalytic Cracking Unit at La Mède, France

## **Methods applied to investigate the major UVCE that occurred in the TOTAL refinery's Fluid Catalytic Cracking Unit at La Mède, France.**

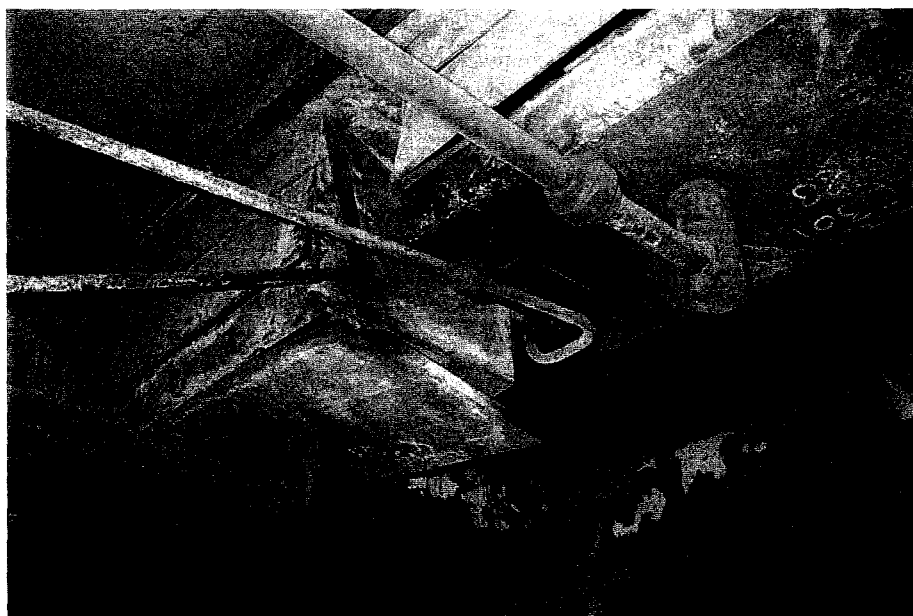
Figure 5. Ignition source: FCC main furnace.

On the other hand, several findings were made under the F301 furnace. The flammable cloud burnt up to the two thirds of the south part of the furnace. Traces of combustion were found on the external box of the third burner at east. More, in the direction of the Gas Plant, several burns, were found on the electrical cabinets and cables indicating the travel of a slow flame front. Several investigations on the electrical equipment were made in order to justify the exclusion of this kind of equipment.

Finally, the ignition on the F301 furnace was found to be the only solution that is consistent with evidence and with the observed traces of combustion. (see photograph of figure 5).

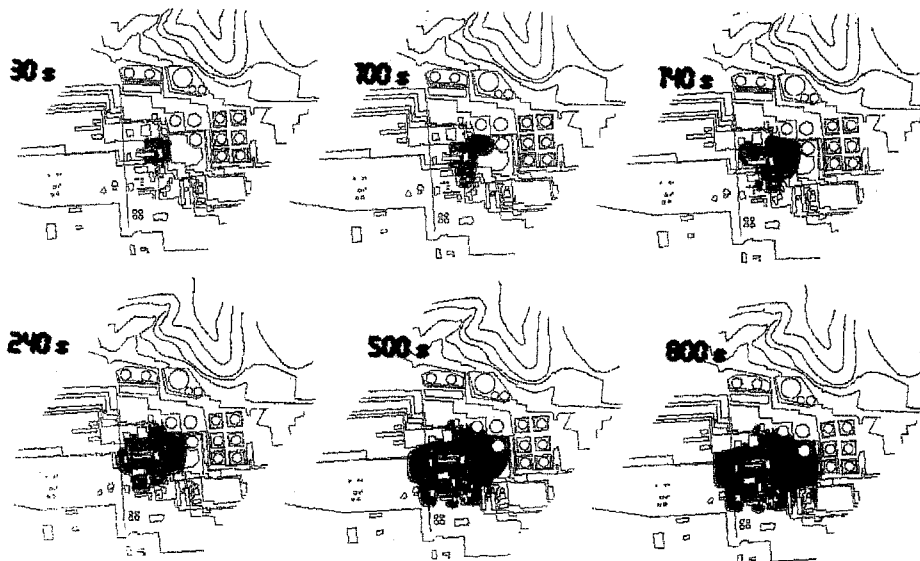
Figure 7. Wind tunnel simulation: dispersion and transport of the vapour cloud (8" by-pass case) as a function of time.

This definition of the Richardson number, used by Köning-Langlo and Schatzmann (1990) is routinely used for continuous releases in a calm atmosphere, characterized by wind speeds under 1 m/s. A different definition is used for non-zero wind velocities, where the local flow velocity is used to determine the characteristic scales (Britter and McQuaid 1988). Validation tests, presented in particular by Köning-Langlo et al (1990) Hall et al (1982) and Y. Riou (1987), have shown good agreement of the wind tunnel results with those obtained in situ, mainly at Thorney Island (MC Quaid 1984), Porton (Picknett 1978, 1981) for instantaneous gas releases and at Burro (Koopmann et al 1982), Maplin Sands (Puttock) et al 1982) and Thorney Island for continuous gas releases. Instantaneous concentrations are measured by means of a hydrocarbide analyzer (Cambustion Ltd) the passband of which is about 500 Hz for a 150 mm sampling probe length. The tracer gases used in the wind tunnel are mainly hydrocarbides whose densities are close to the considered release conditions. The main test results for the three scenarios under consideration have shown, despite the very conservative hypotheses adopted for this simulation, that the maximum gas leak from storage tank C24 could not be the cause of the accident, since the concentration levels reached at the ignition point are far lower than the gas inflammability limit (LEL). Regarding the two absorber stripper cooler EA 103 scenarios, the tests showed that scenario break at the by-pass bounds the second one (failure of 1" branch connection). The gas concentrations at the ignition point (furnace F 301) only reach the LEL for the first scenario. The simulation made for this scenario by east wind led to the results closest to the evidence. Note in particular that the gas cloud reaches both the gas detector P80-1 and the ignition source. The dispersion and transport of the gas cloud particularly made it possible first, to characterize the progression of the explosive mixture as far as the presumed ignition source and, secondly, to evaluate the average time to reach the ignition point by the LEL at  $675 \pm 110$  seconds for 98 simulations, compatible with the estimations made elsewhere (see figure 7).
