# Impact Assessment Report

## Integrated Wasteland Development Project (IWDP-Batch I)

**Medak District  
Andhra Pradesh**

**Research Program on Resilient Dryland Systems**

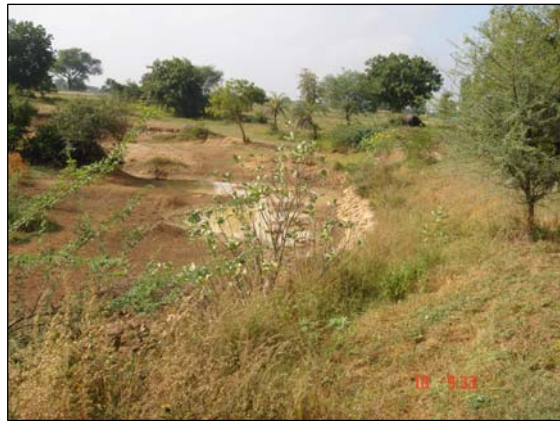
- i. Visited Mallaiah kunta percolation tank constructed in private land with about 1000m<sup>3</sup> water storage capacity. There are about 6 bore wells with 10 farmers and area benefited is about 12 ha. Nearby farmer says when there is stored water in the tank, groundwater availability increases in bore wells.
- ii. Visited another Percolation tank constructed on cart road going to Gudikandula and it is not useful now due to road formation by filling it. This PT was constructed in the cart road to Gudikandula village. It was filled up by JCB and not useful now. This was not at all a suitable location and money is being wasted.

*Picture 4. Mallaiah kunta PT in Bussapur watershed, Medak district*

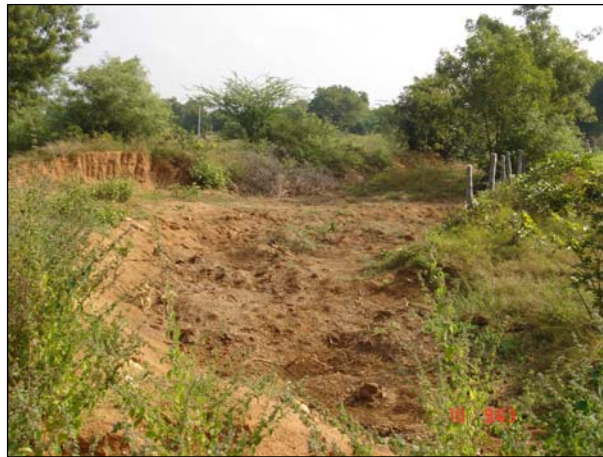
*Picture 5. Filled up PT constructed on Gudikandula village cart road in Bussapur watershed*

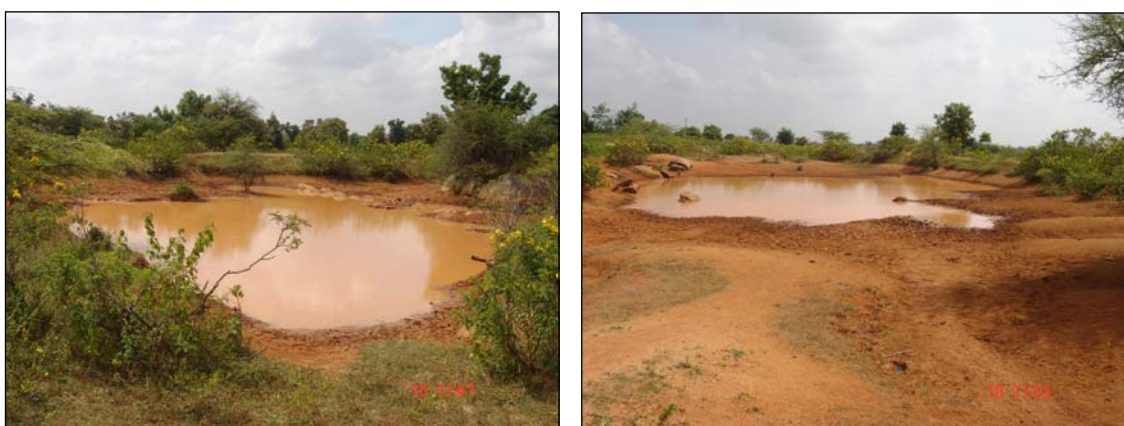
- i. Two PTs were visited one with about 2000 m<sup>3</sup> and another one with about 3000 m<sup>3</sup> water storage capacity and about 400 m<sup>3</sup> water was stored in both the PTs on the day of visit. Both are good structures but surrounding area is uncultivated fallow land with scrub vegetation. No wells and no beneficiary farmers with in 500 m radius. Water is useful for cattle drinking only.

*Picture 6. Percolation tanks constructed in uncultivated area in Chinna Gundavelly watershed*

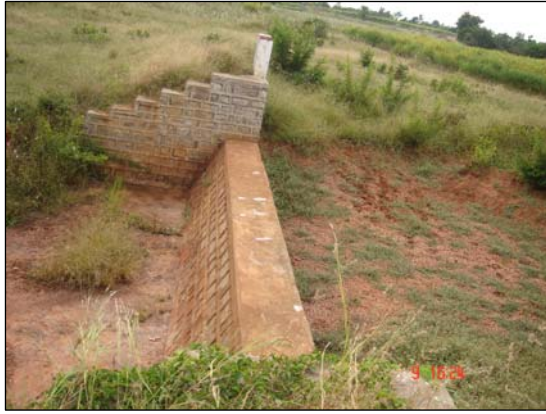
- i. A masonry checkdam was seen with about 500m<sup>3</sup> storage capacity. Silt accumulation has reduced its storage capacity by about 25%. There are 2 bore wells about 100 m away from the structure with 2 beneficiary farmers and area benefitted is about 3 ha. Almost entire area is under dryland agriculture with Maize/Pigeonpea intercrop. Good pigeonpea crop is seen in large area.
- ii. A loose boulder structure was seen in the same drain, it is partially damaged and no maintenance of the structures in the watershed.

*Picture 7. A masonry check dam in Duddeda watershed filled with silt.*

- i. Check dams are useful to control erosion as well as to store water for drinking water to live stock. Hence old structures are to be repaired and there is a lot of scope for construction of new structures.
- ii. Feeder channels are to be renovated to divert water into the village tank so that water availability in the village will be increased.

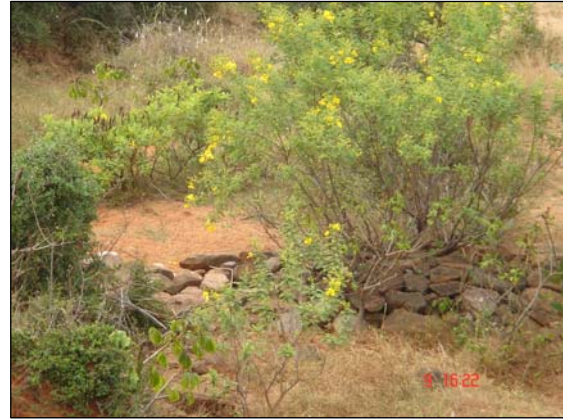
*Picture 8. Partially damaged loose boulder structure in Duddeda watershed.*

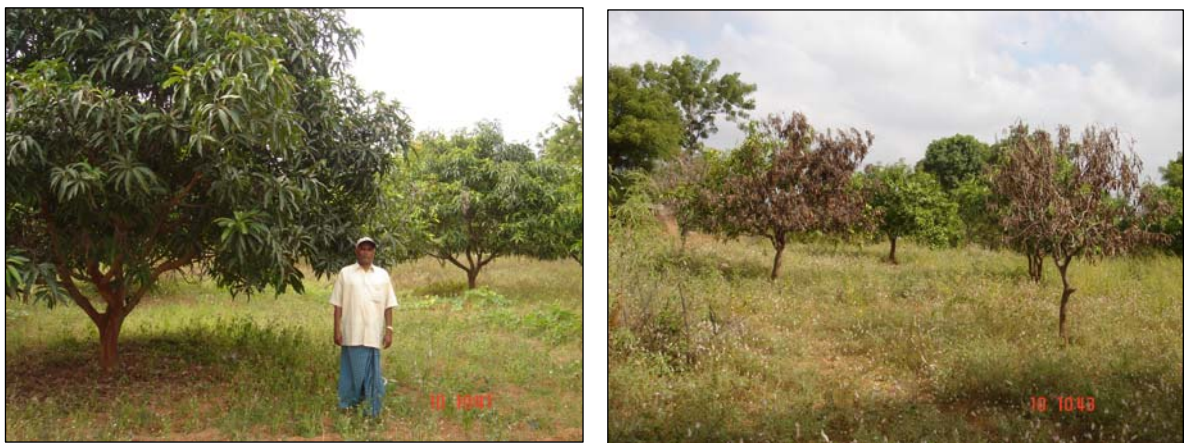
*Picture 9. Mango orchard of Mr. U. Anjaneyulu (left) and dead plants (right) due to stress in the Irukodu watershed, Medak district.*

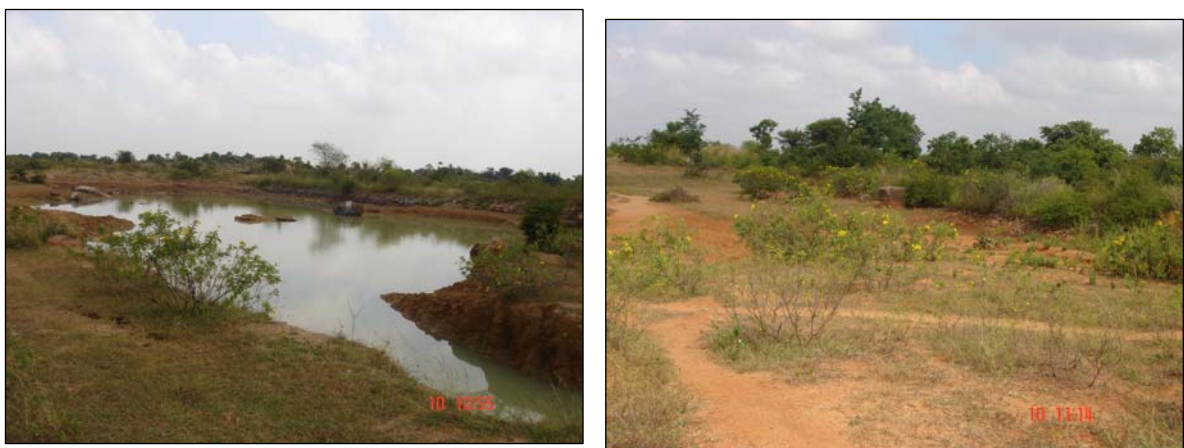
*Picture 10. Percolation tanks constructed in the fallow land (left) and in the cultivated land (right) in the Irukodu watershed, Medak district.*

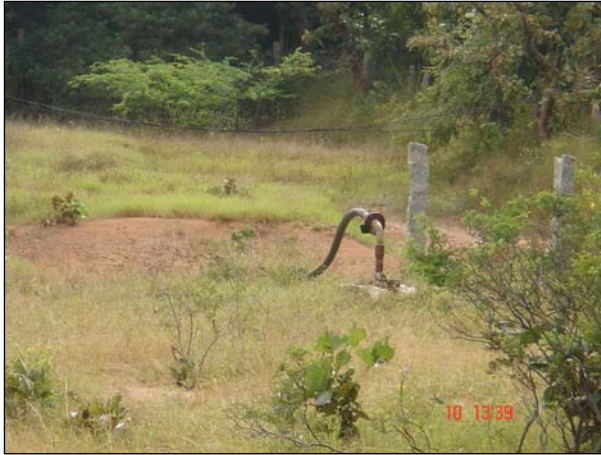
- i. A percolation tank of about 4000 m<sup>3</sup> capacity was inspected during field visit.
- ii. It is a good structure serving the purpose effectively. There is one bore well dug in the same tank and one open well exist in the down side. There are 3 beneficiary farmers with area benefited is about 2.5 ha. Maize crop was grown in 0.8 ha under irrigation under bore well and paddy and cotton under crops under open well (1.6 ha). Good ground water will be available in the bore well when water is stored in the PT.
- iii. A masonry check dam of about 1500 m<sup>3</sup> capacity was seen. This structure was constructed in plain land in a big farmer field and stored water occupies large area. There are 4 open wells and 1 well with about 10 beneficiary farmers and area benefited is about 12 ha.

*Picture 11. Percolation tank with bore well in Bakrichepyala and Nancharipally watershed, Medak district.*

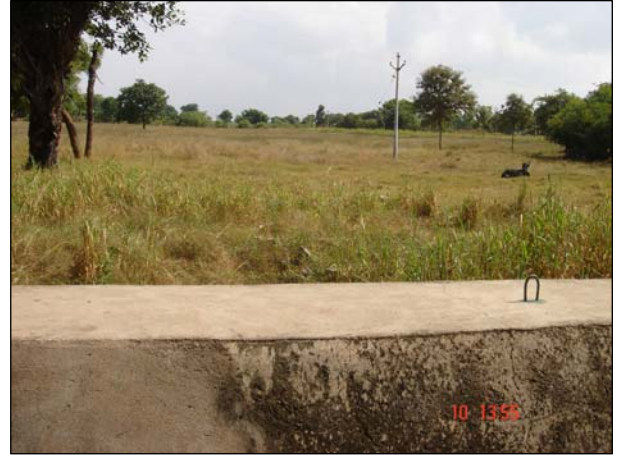
*Picture 12. Masonry check dam constructed in plain land in Bakrichepyala and Nancharipally watershed.*

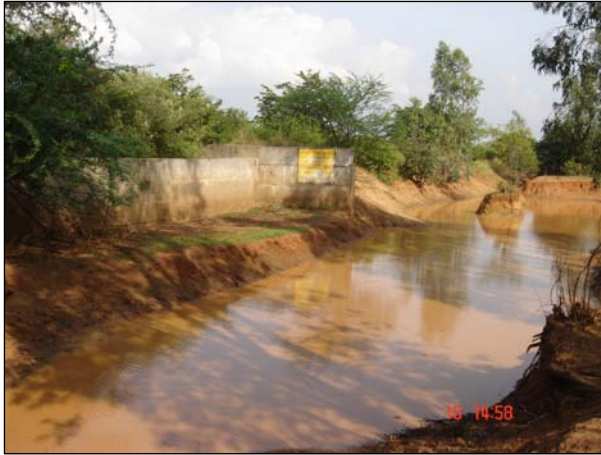
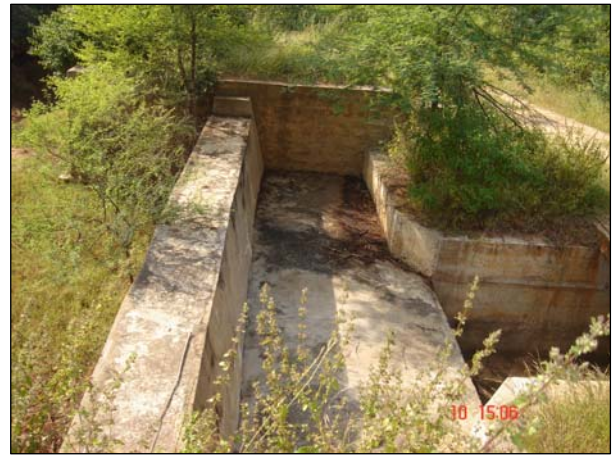
- i. A big masonry check dam with 20 m body wall length, 2m height with about 6000 m<sup>3</sup> was seen. About 500 m<sup>3</sup> water was stored in the trench which was constructed in the forest land. Down side area is private patta lands and benefiting large area. There are about 20 wells, 30 beneficiary farmers, benefiting about 30 ha. Good work done and good groundwater availability if water stored in the structure.
- ii. Another masonry check dam was seen with about 3000 m<sup>3</sup> water storage capacity which was constructed in the forest land. Down side area is private patta lands. There are about 10 wells with 15 beneficiary farmers and benefiting about 20 ha area. Paddy and vegetable crops are grown under irrigation.

*Picture 13. Masonry check dams constructed in the forest lands in Ponnala watershed.*

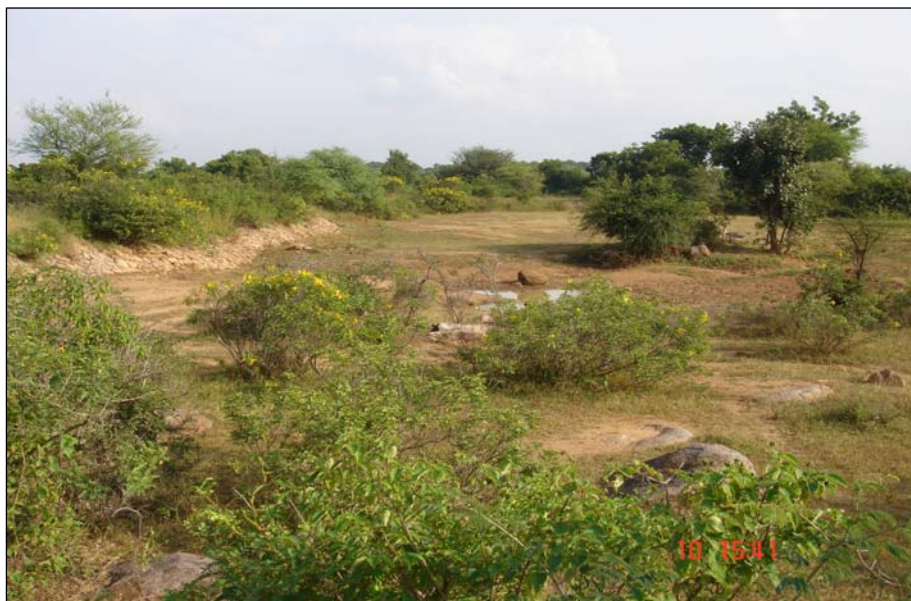
- i. A percolation tank was seen with about 2500 m<sup>3</sup> capacity. Cost of construction was Rs. 80,000/- There are no wells and beneficiary farmers in the vicinity of 300 to 400 m distance. About 8 wells are there after 300-400 m distance with 15 beneficiary farmers and area benefited is about 12 ha. Paddy and sunflower crops are grown under irrigation.

*Picture 14. Percolation tank constructed in Tadkapally watershed, Medak district.*

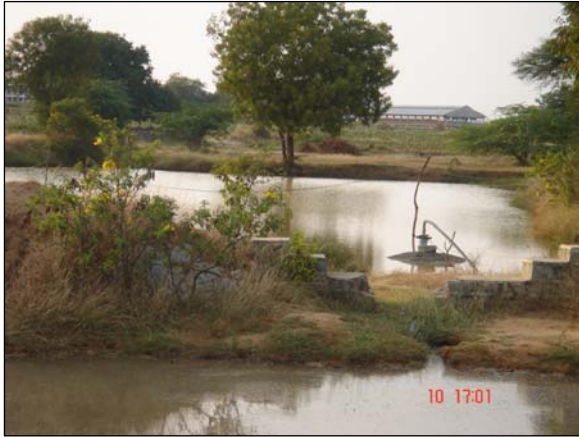
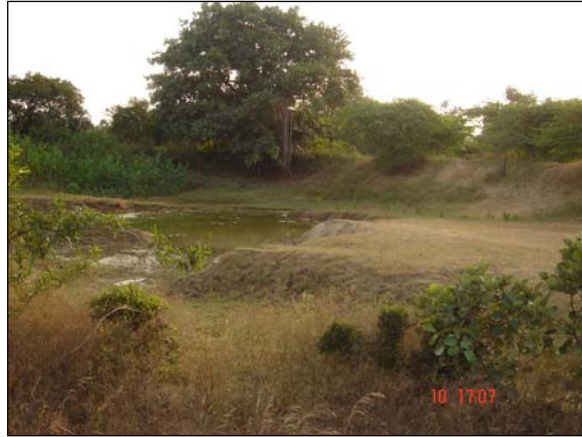
- i. A percolation tank with about 4000 m<sup>3</sup> capacity was seen in low-lying area/saline patch, good amount of water, about 2000 m<sup>3</sup> stored in the PT. It was looking like a dug out pond because no bunds and water is stored below the normal ground level. There are about 6 bore wells, 10 beneficiary farmers and area benefited is about 10 ha.
- ii. Another percolation tank with about 3500 m<sup>3</sup> was seen in the watershed. PT is good and spillway was also constructed but damaged by upside farmers to drain out water from the PT to avoid submergence of their fields ups. There are about 8 bore wells, 10 farmers and area benefited is about 14 ha. Good water availability in the nearby wells if water is stored in the PT.

*Picture 15. Percolation tanks constructed in Thoguta watershed, Medak district.*

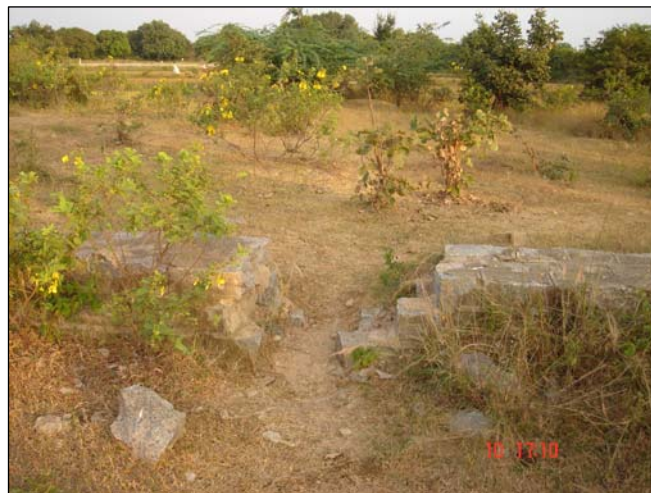
*Picture 16. Damaged spill way of PT constructed in Thoguta watershed.*

- i. Repair and maintenance of the water harvesting structures is very crucial for getting sustainable benefits due to watershed project.
- ii. Promotion of horticultural crops can give better benefits to farmers.

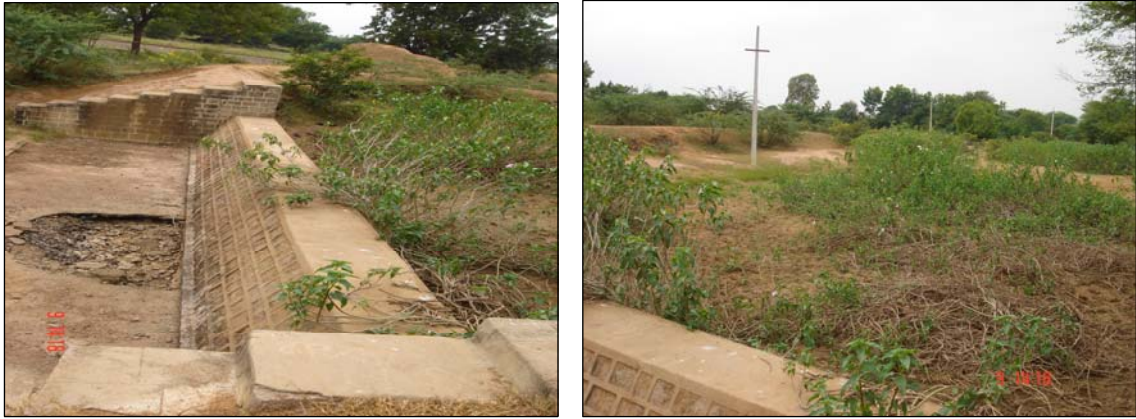
- i. A masonry check dam with 20 m body wall length, 1.3 m height with about 1500 m<sup>3</sup> capacity was seen but size has been reduced to half by siltation. There are 15 wells with 20 beneficiary farmers and area benefited is about 16 ha. Good check dam but size has been reduced drastically by about 0.5 m height silt deposition. Apron wall is damaged and no care is taken. Water availability in the nearby wells increased after the check dam construction.
- ii. A percolation tank with about 3000 m<sup>3</sup> capacity was seen with about 500m<sup>3</sup> water stored in it. Spillway /surplus weir was not constructed. There are about 20 bore wells with 20 beneficiary farmers and area benefitted is about 20 ha. By constructing spillway more quantity of water could have been stored. Deepening of bare outlet leading to less storage capacity.

*Picture 17. Damaged apron wall (left) and accumulated silt (right) in a check dam in Velikatta watershed, Medak district.*

- i. More check dams are to be constructed as there are more numbers of drains in the village.
- ii. Repair and maintenance of water harvesting structures is to be done.

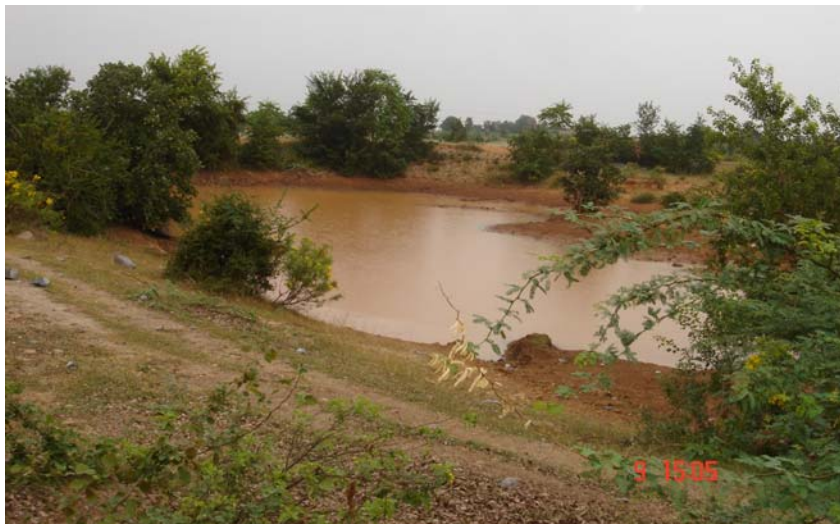
*Picture 18. Stored water in a percolation tank in Velikatta watershed, Medak district.*

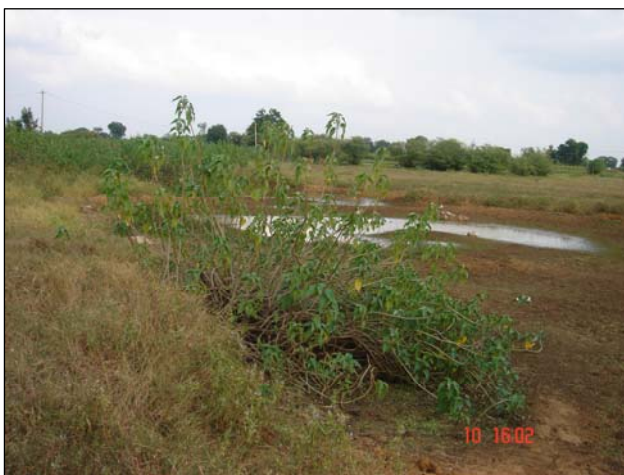
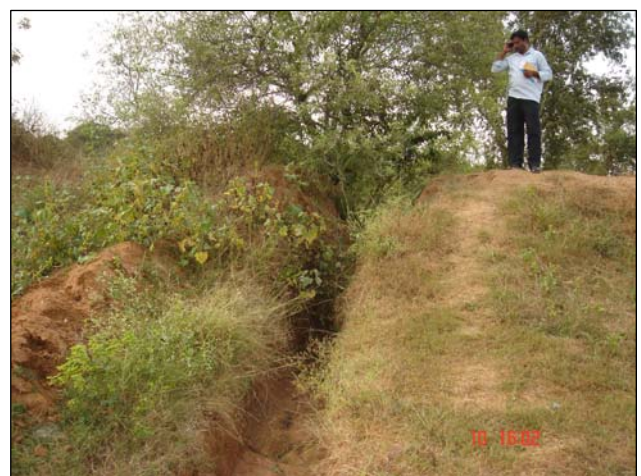
- i. A percolation tank was seen with about 2000 m<sup>3</sup> storage capacity. Length of bund is about 100 m but storage capacity has come down due to draining out of water to irrigate down side paddy fields and may be to avoid submergence of dry lands up side. Otherwise capacity would have been more and no water is stored in the PT due to less rain and draining out of water from it.

*Picture 19. Condition of percolation tank (left) and drain made across the bund (right) to drain out water and to irrigate paddy fields down side in Yellareddypet watershed, Medak district.*

- i. New assigned lands given to SC/ST and small holder marginal farmers should be allowed to develop like CLDP type development with funds, as it will become a good example of livelihood for individual farmers.
- ii. Repair and maintenance of water harvesting structure should be taken up on priority basis to get good benefits from watershed works.
