VIII Congresso Nazionale di Archeometria  
Scienze e Beni Culturali: stato dell'arte e prospettive  
Bologna 5 - 7 Febbraio 2014

## COMPARATIVE ANALYSIS FOR THE ASSESSMENT OF RESTORATION TREATMENTS ON STONE MATERIAL FROM THE ROMAN THEATER OF MERIDA (SPAIN)

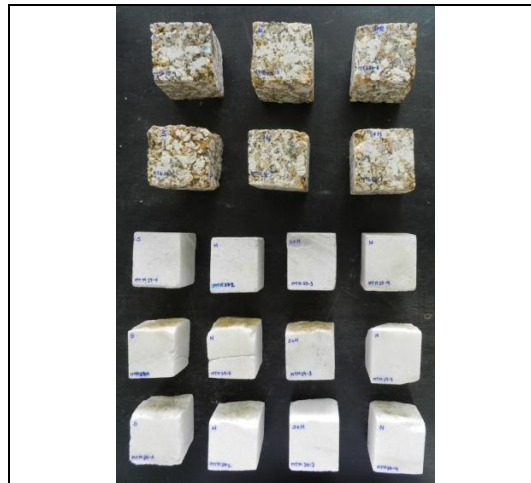
Fig.2: Marble and granite samples: (S) samples treated with Ethyl Silicate, (H) samples with a hydrophobic product, (S+H) samples with both treatments, and (N) non-treated samples.

and granite from the Front Stage of the Roman Theatre (Figure 2), material present in many other remains of the city, due to the proximity of the quarries [1].

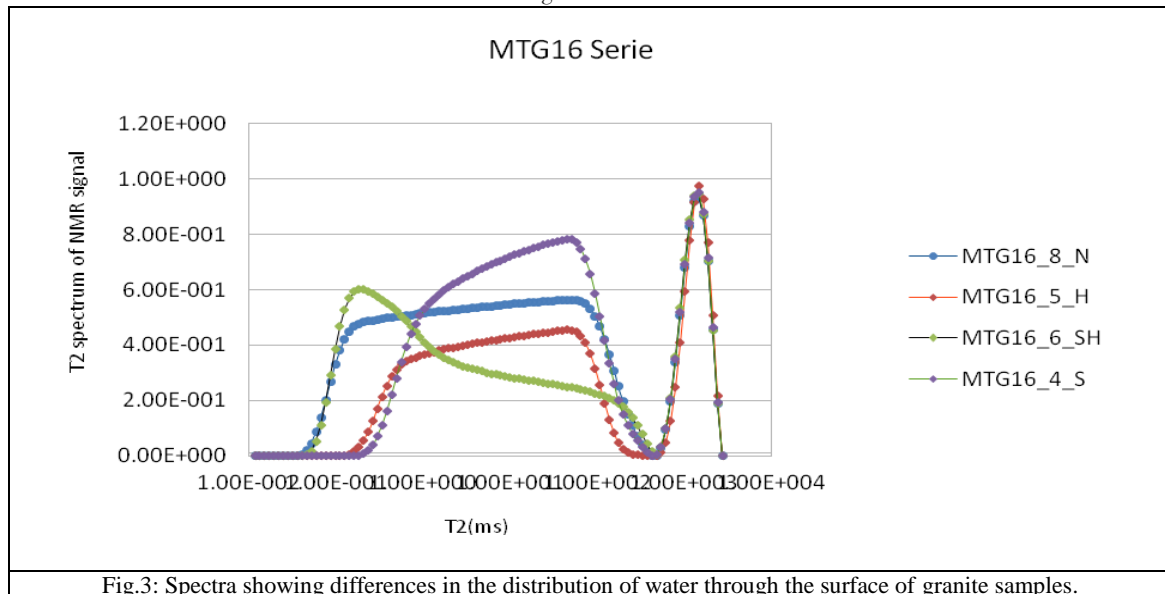
A general review of NMR spectra shows exceptional changes in the distribution of water in the pore system by the effect of the different treatments (Figure 3). In contrast, Porosimetry Hg tests show an overall decline of the porosity (from a 3.84% in untreated samples to a 0.21% in treated with S+H in MTM27 samples) as well as a shift in the balance between micro and macro-porosity, favouring the first one in the case of granites.

Finally, NMR measurements, although showing more heterogeneous outcomes, allow observing some changes in the balance between micro-, mid- and macro-porosity. It also shows a tendency to homogenize the distribution of water in the pore system in samples treated with a hydrophobic product, thus, the water gets all kinds of pores, while in the untreated sample it is mainly located in micro-pores.
