FiberWire tension band for patellar fractures

Abstract

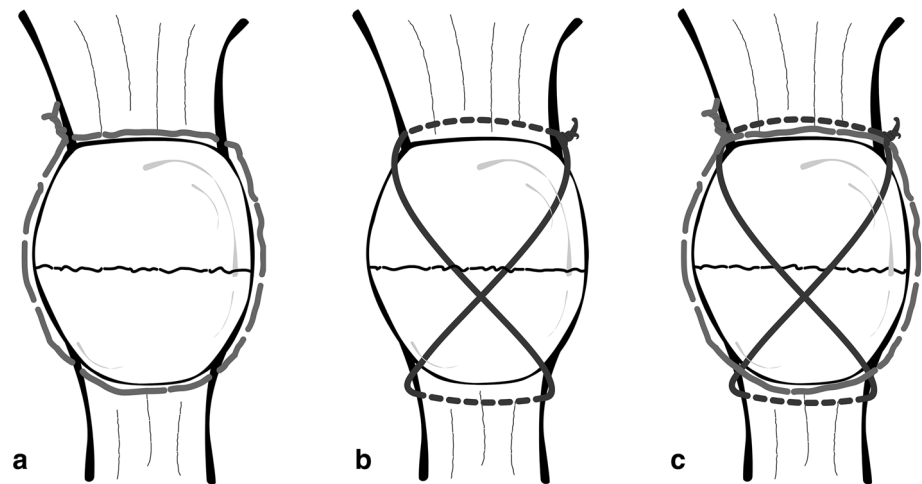
Fig. 1 FiberWire tension band. Peripatellar circumferential cerclage (a); modified anterior tension band (b); final construct (c)

In all patients, surgery was scheduled 2–3 days after the trauma and was performed by the senior author. Patients were operated on in a supine position, and a tourniquet was placed high up on the thigh. In all cases, a longitudinal skin incision on the knee was performed. An extemporaneous reduction was performed with a reduction clamp and checked under fluoroscopy. In this phase, care was taken to obtain the best possible reduction and congruence of the articular patellar surface. At this point, a modified Puyfroid technique was used for fracture fixation [8]. A no. 5 FiberWire nonabsorbable suture was used, and a peripatellar circumferential cerclage was performed in a purse-string fashion close to the bone. This allowed initial fracture stabilization. A second no. 5 FiberWire suture was then placed in a figure-of-eight fashion through the quadriceps and patellar tendon to obtain a modified anterior tension band. Each of the two FiberWire bands was manually tensioned and knotted on the superior board of the patella (Fig. 1). Additionally, retinacular defect was repaired with an absorbable suture.

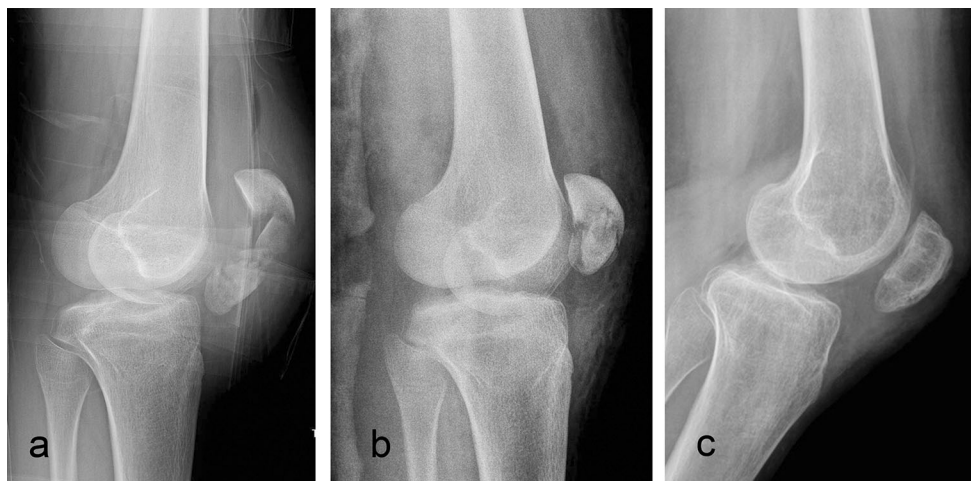
Fig. 2 Comminuted patellar fracture. Preoperative X-ray (a); postoperative X-ray (b); final follow-up X-ray (c)

All fractures healed (time to union 9.2 ± 2 weeks) and no fixation failure was observed in the group studied. Slight losses of reduction (<4 mm) were noted in two patients at 4 weeks postoperatively [19, 22]. Because of noncompliance with the postoperative rehabilitation protocol, one patient presented knee stiffness at 2 months postoperatively that required gentle manipulation under anesthesia (Fig. 2). The same patient was the only one in the study to require elective FiberWire removal 24 months after surgery. This was performed secondary to a superficial infection, which did not affect the final clinical outcome (ROM 0 – 125°). Another patient underwent knee arthroscopy in another Institution because of anterior knee pain. No patients referred localized pain deriving from prominent suture knots (Fig. 3). Demographics, fracture type, and outcomes are presented in Table 1.

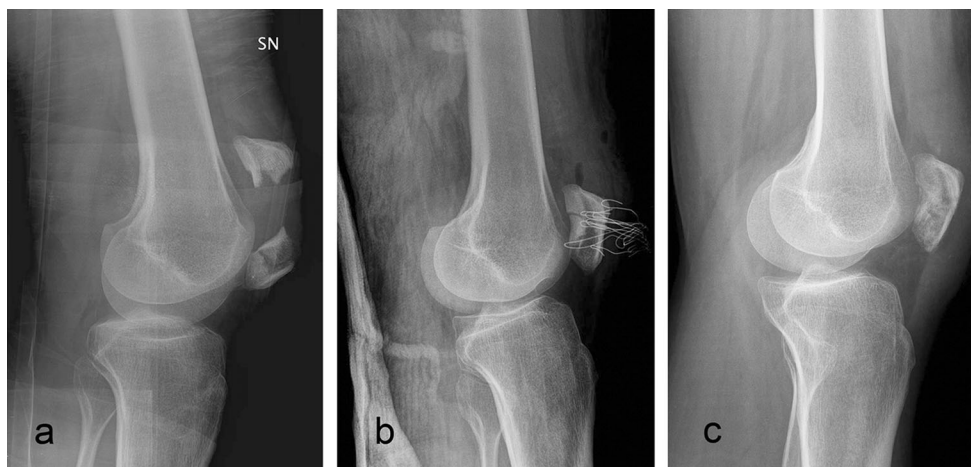
Fig. 3 Transverse patellar fracture. Preoperative X-ray (a); postoperative X-ray (b); final follow-up X-ray (c)
