Article

Use of the Sentinel-2 and Landsat-8 Satellites for Water Quality Monitoring: An Early Warning Tool in the Mar Menor Coastal Lagoon

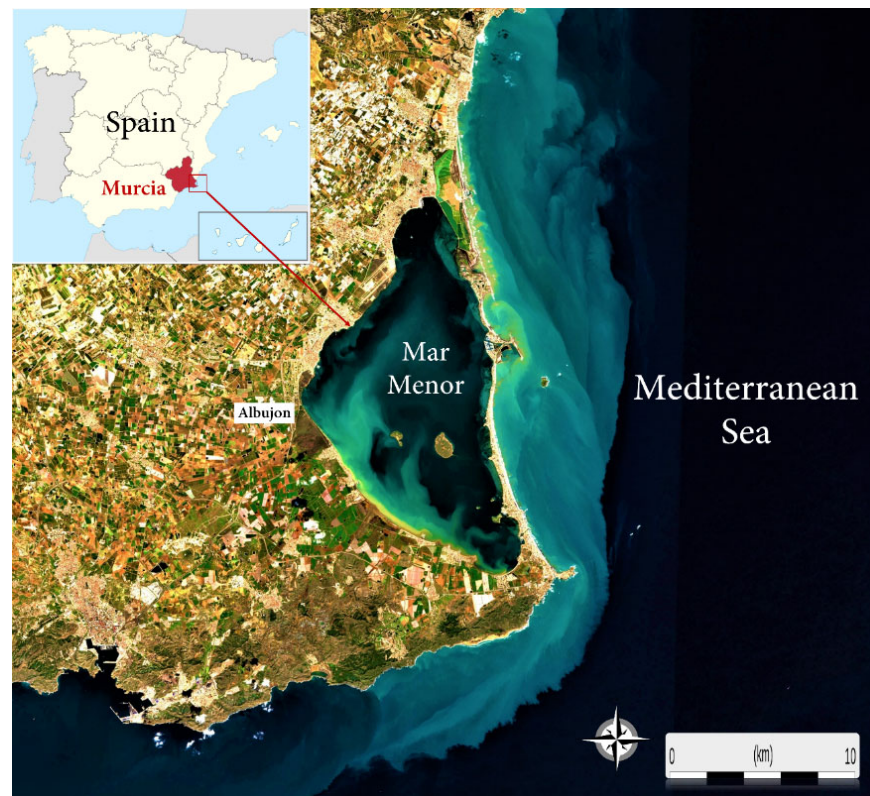
Figure 1. Location of the Mar Menor coastal lagoon on the southeastern coast of Spain and Sentinel-2 image captured on 21 March 2021 indicating the final transect of the Albujon watercourse flowing into the lagoon.

This is the case of Mar Menor, the largest hypersaline lagoon in the Western Mediterranean Sea (Figure 1) and one of the most iconic and emblematic natural areas in Spain due to its significance in terms of habitats and species, its ecological value, and the uniqueness of its ecosystem. Mar Menor, its surrounding wetlands, and natural areas, are of vital natural importance and a protected landscape as a Wildlife Protection Area, Natura 2000 network, Wetland of International Importance (RAMSAR Convention), and a Regional Park. Moreover, the area is a key component of the regional economy, development, and policy plans due to the variety of uses and human activities developed there. The lagoon, with a maximum depth of 6.5 m and a surface area of 135 km², presents a long sand bar called “La Manga” acting as a barrier between the Mediterranean Sea and the lagoon, only connected through five shallow inlets called “golas” [11]. The lagoon is close to the Campo de Cartagena region, one of the most intensive agricultural areas in Europe. Several ephemeral wadis drain into the western part of the lagoon, transporting nutrient-enriched waters from agricultural runoff after rainy periods, the Albujon watercourse (Figure 1) being the main collector of the Campo de Cartagena drainage basin and the only permanent wadi flowing into the lagoon [11–16]. Therefore, most of the discharges are located in the southern half of the lagoon where the Albujon watercourse maintains a regular flux of water, albeit depending on the torrential and sporadic rainfall regime, as occurred in September 2019 during one of the most extreme storms, known as the “Cold Drop” [13].

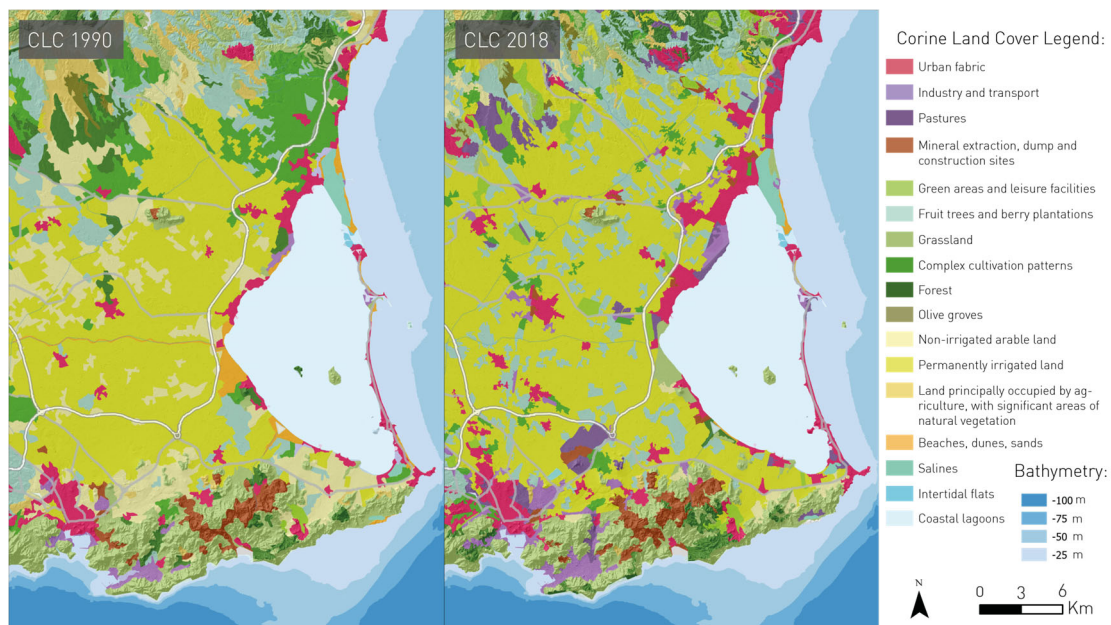
Figure 2. Land cover classification for the Mar Menor lagoon and its surroundings according to Corine Land Cover datasets (<https://centrodedescargas.cnig.es/CentroDescargas/>; accessed on 1 January 2022) for 1990 and 2018.

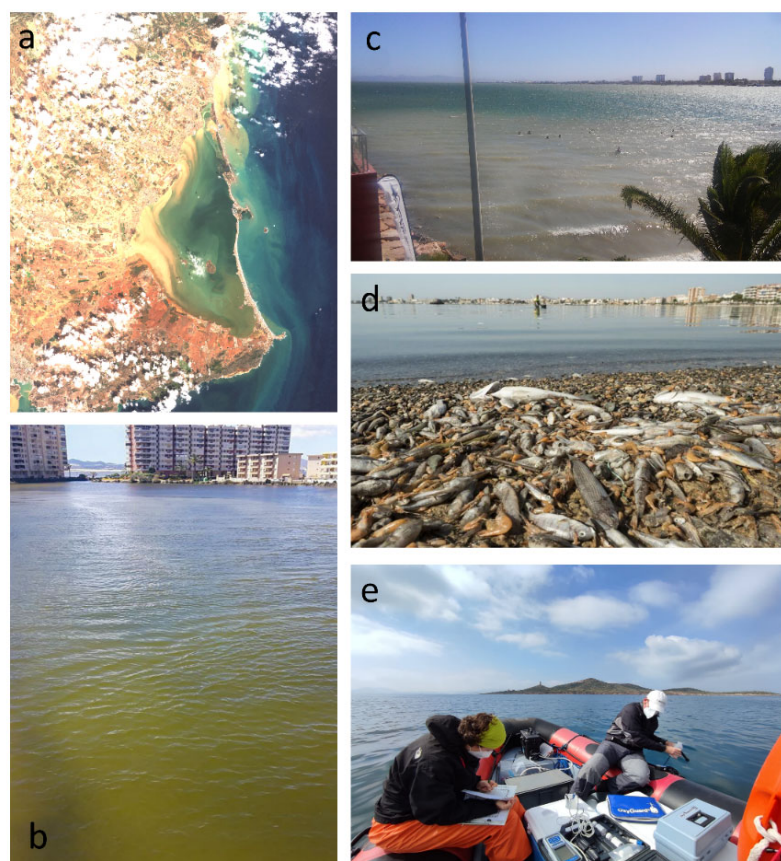
Figure 3. (a) Sentinel-2 scene in Mar Menor after the extreme weather event known as the “Cold Drop” and the catastrophic flooding on 13 September 2019; (b) surface of the water in the lagoon in July 2016 during the environmental crisis; (c) typical resuspension of sediments and increased turbidity during strong winds; (d) latest environmental catastrophe with massive dead fish and crustacean in August 2021 (authorship: Greenpeace); and (e) field campaign carried out in the lagoon in March 2021.

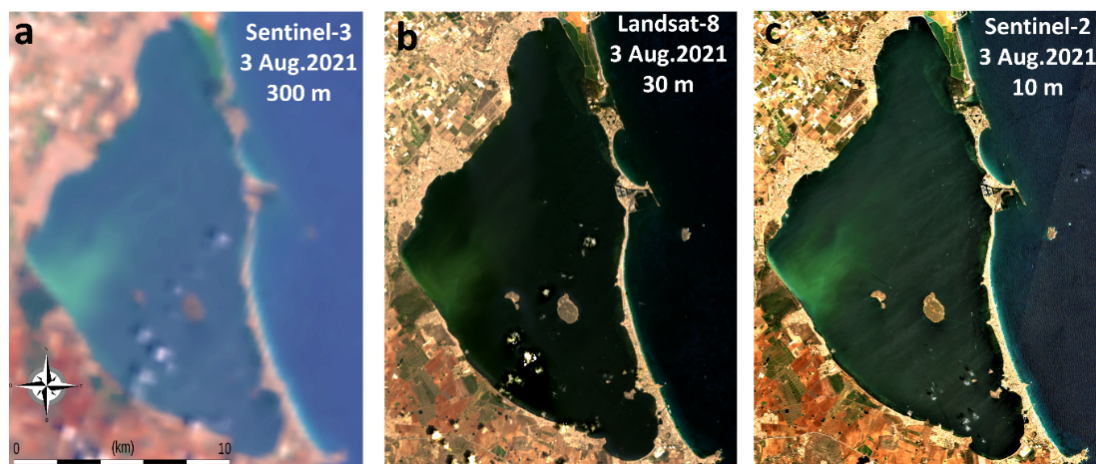
Figure 4. RGB (Red–Green–Blue) composite image on 3 August 2021 of (a) Sentinel-3 satellite (300 m spatial resolution), (b) Landsat-8 satellite (30 m spatial resolution), and (c) Sentinel-2 satellite (10 m spatial resolution).

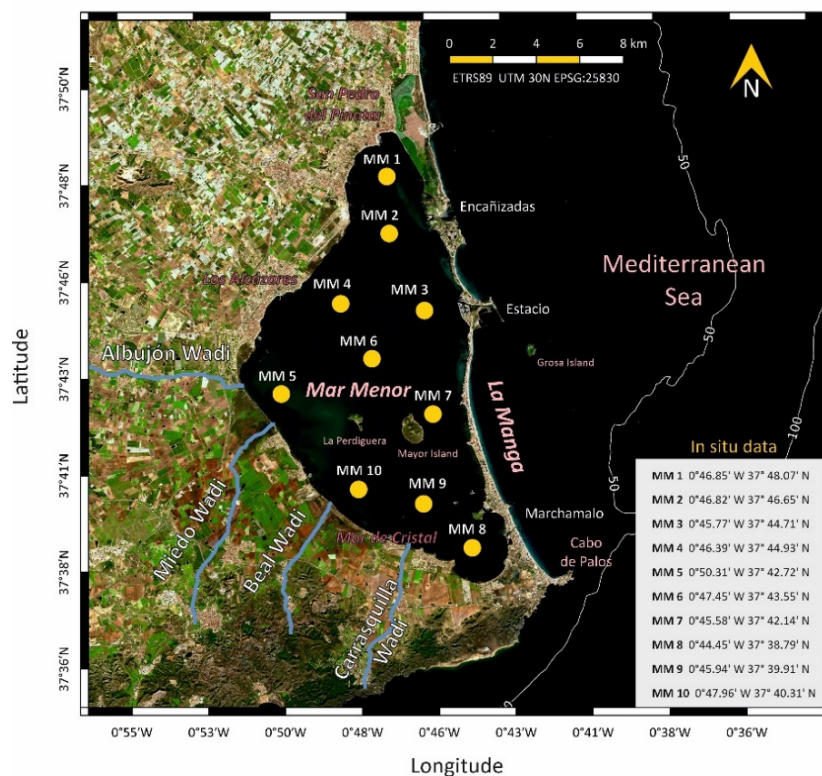
Figure 5. Control points for data collection during the four in situ campaigns carried out in March, July, August, and November 2021.

Four sampling cruises were carried out during 2021 (March, July, August, and November), where seawater was collected at 10 points homogeneously distributed in the Mar Menor lagoon (Figure 5). The dates of the in situ campaigns during the study period corresponded to 23–24 March, 27 July, 26 August, and 16–17 November 2021. Matchups between in situ and satellite samples were generated when both data acquisitions occurred within 30 h of each other, and the satellite value was calculated as the mean of the 3×3 10 m pixel region around the sampling station.

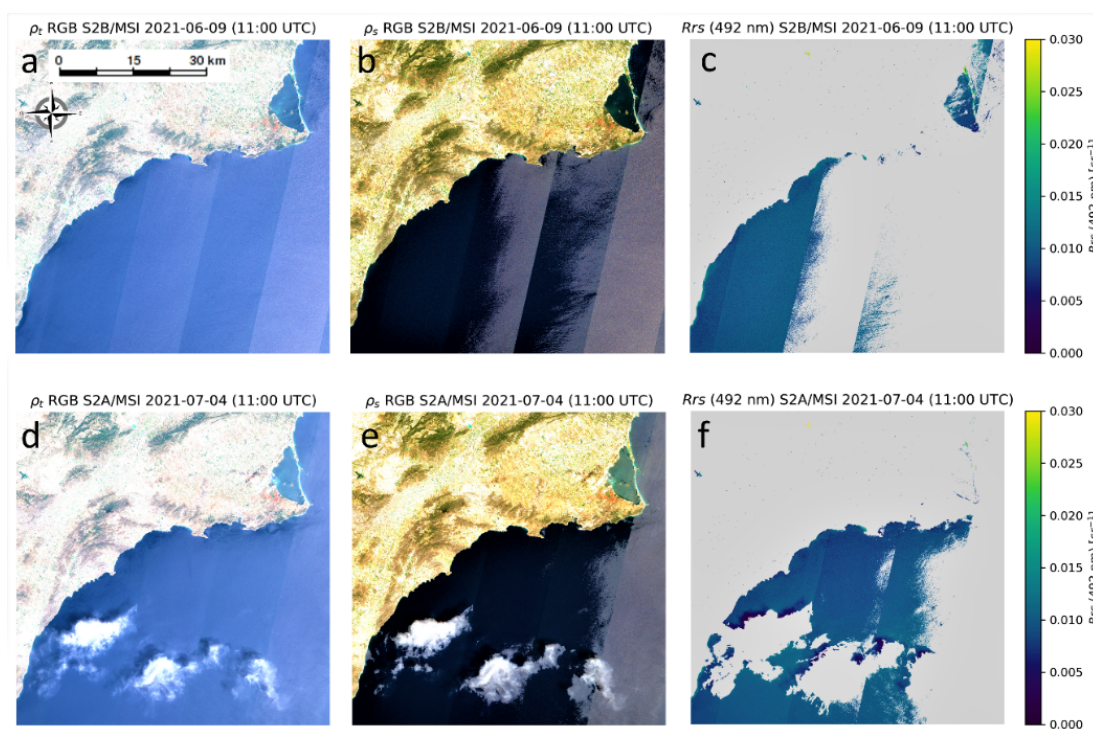
Figure 6. RGB (Red–Green–Blue) composite image on 9 June 2021 from the Sentinel-2 satellite (10 m spatial resolution) at (a) top-of-atmosphere (TOA) level, (b) bottom-of-atmosphere (BOA) level after ACOLITE, and (c) remote sensing reflectance (R_{rs} , sr^{-1}) of the blue band (492 nm); (d–f) the same on 4 July 2021. Severe sunglint contamination can be clearly observed in the eastern section of the Sentinel-2 tile affecting Mar Menor.

Menor is located. This effect is significant during spring and summer, given that minimum information could be retrieved with severe sunglint, restricting the amount of available data when the majority of the blooms occurred. Comparable results were generated in other coastal regions, such as in North Atlantic [53] or Caribbean waters [54]. Irregular residual issues still require further advancements in the sunglint and atmospheric correction approaches to facilitate the extensive combination of Landsat-8 and Sentinel-2 products during summer. In addition, the typical stripping patterns are clearly observed at both TOA and BOA levels.

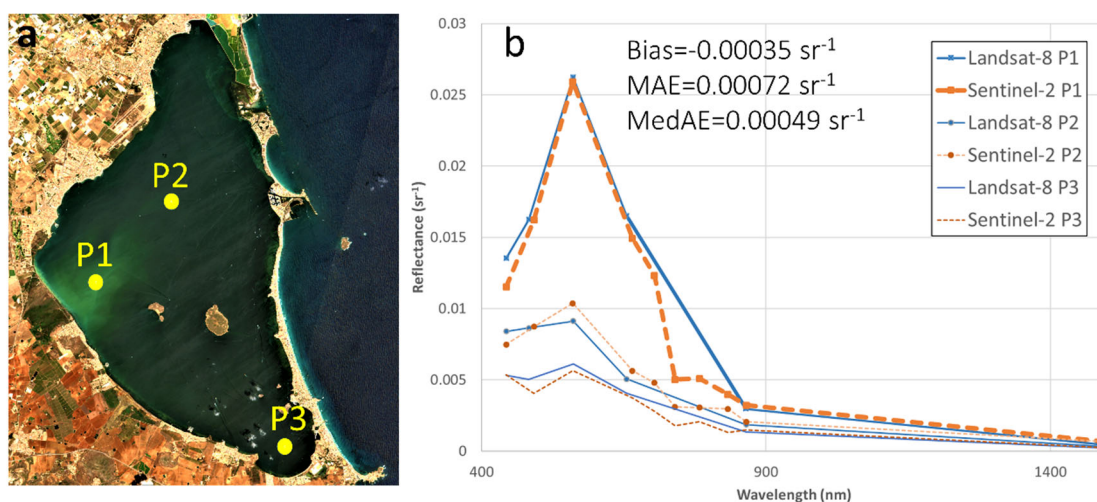
Figure 7. (a) RGB (Red–Green–Blue) composite image on 3 August 2021 of the Sentinel-2 satellite at bottom-of-atmosphere (BOA) level, (b) spectral signal of the Sentinel-2 and Landsat-8 satellites over different control points (P1, turbidity of 18.11 and 17.28 FNU; P2, turbidity of 5.5 and 6.1 FNU; and P3, turbidity of 4.08 and 3.93 FNU for Sentinel-2 and Landsat-8, respectively). Yellow circles in (a) indicate the location of the control pixels.

On 3 August 2021, Landsat-8 and Sentinel-2 acquired a scene at 10:45 am and 11:00 am GMT, respectively. Figure 7 shows the spectral signal of both satellites with only a 15 min time difference over three control points distributed across different areas of the lagoon. This exhibits the consistent performance of ACOLITE for both satellite missions, retrieving the spectrum with similar R_{rs} values for each point and sensor (P1, turbidity of 18.11 and 17.28 FNU; P2, turbidity of 5.5 and 6.1 FNU; and P3, turbidity of 4.08 and 3.93 FNU for Sentinel-2 and Landsat-8, respectively), thus further corroborating the remarkable value of the combined products. Comparison of Sentinel-2 and Landsat-8 R_{rs} over the visible and NIR bands yielded a bias of -0.00035 sr^{-1} , MAE of 0.00072 sr^{-1} , and MedAE of 0.00049 sr^{-1} . Consistent sunglint and atmospheric correction models are needed to empower the application community to explore these products in order to thoroughly address the ecological conditions of Mar Menor using remote sensing technologies. Recent research already demonstrated the potential of ACOLITE to provide robust information for aquatic and marine applications [30,43,44,54]. A study applied Sentinel-2 data to monitor water quality in Mar Menor using the Sen2Cor atmospheric correction processor (designated for land application with restricted performance in water application) and to generate products at 60 m spatial resolution [35]. However, Pahlevan et al. (2019, 2021) sug-

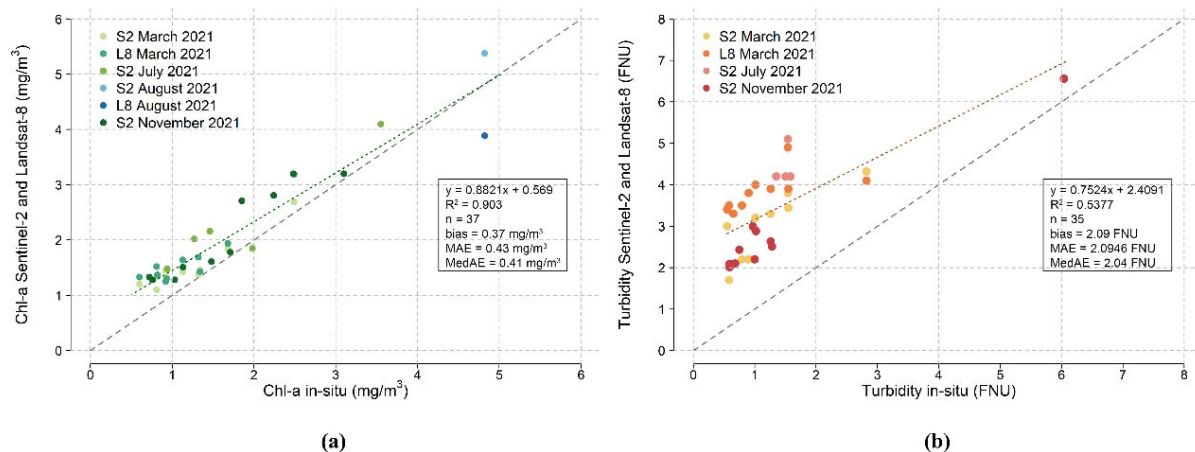
Figure 8. Validation of water quality parameters obtained with Sentinel-2 (S2) and Landsat-8 (L8) during the four in situ campaigns carried out in March, July, August, and November 2021 for (a) chlorophyll-a concentration (chl-a, mg/m³) and (b) turbidity (FNU).

Figure 8 shows the validation matchups for the water quality parameters obtained with Sentinel-2 and Landsat-8 during the four in situ campaigns carried out in 2021. We applied the standard OC3 algorithm to calculate chl-a concentration and a regularly used semianalytical algorithm for the determination of turbidity [44,45]. The performance of both algorithms is illustrated in Figure 8a and Figure 8b, respectively. The chl-a matchups cover the range of 0.5–5 mg/m³ with a bias of 0.37 mg/m³, MAE of 0.43 mg/m³, and MedAE of 0.41 mg/m³ ($R^2 = 0.903$, $n = 37$), whereas the turbidity ranges from 0.5–6 FNU with a bias of 2.09 FNU, MAE of 2.09 FNU, and MedAE of 2.04 FNU ($R^2 = 0.54$, $n = 35$). The validation assessment indicated robust statistical analysis, with accurate chl-a retrieval and minimum bias. Predictions of chl-a from both Sentinel-2 and Landsat-8 yielded precise results after the ACOLITE atmospheric and sunglint correction. The performance of the ACOLITE and the turbidity model is accurate, but a general satellite overestimation was encountered with biased outcomes, as seen in Figure 8b. Pahlevan et al. (2022) also found overestimation of turbidity retrievals by means of the ACOLITE processor [56]. The turbidity model has already been validated in different regions worldwide with accurate performance [46–48,57] and has previously been used in Mar Menor during an extreme weather event [13]. These methodologies are consistent and valid approaches for the assessment of suspended material or turbidity, which contribute towards achieving more precise performance worldwide [45,58].

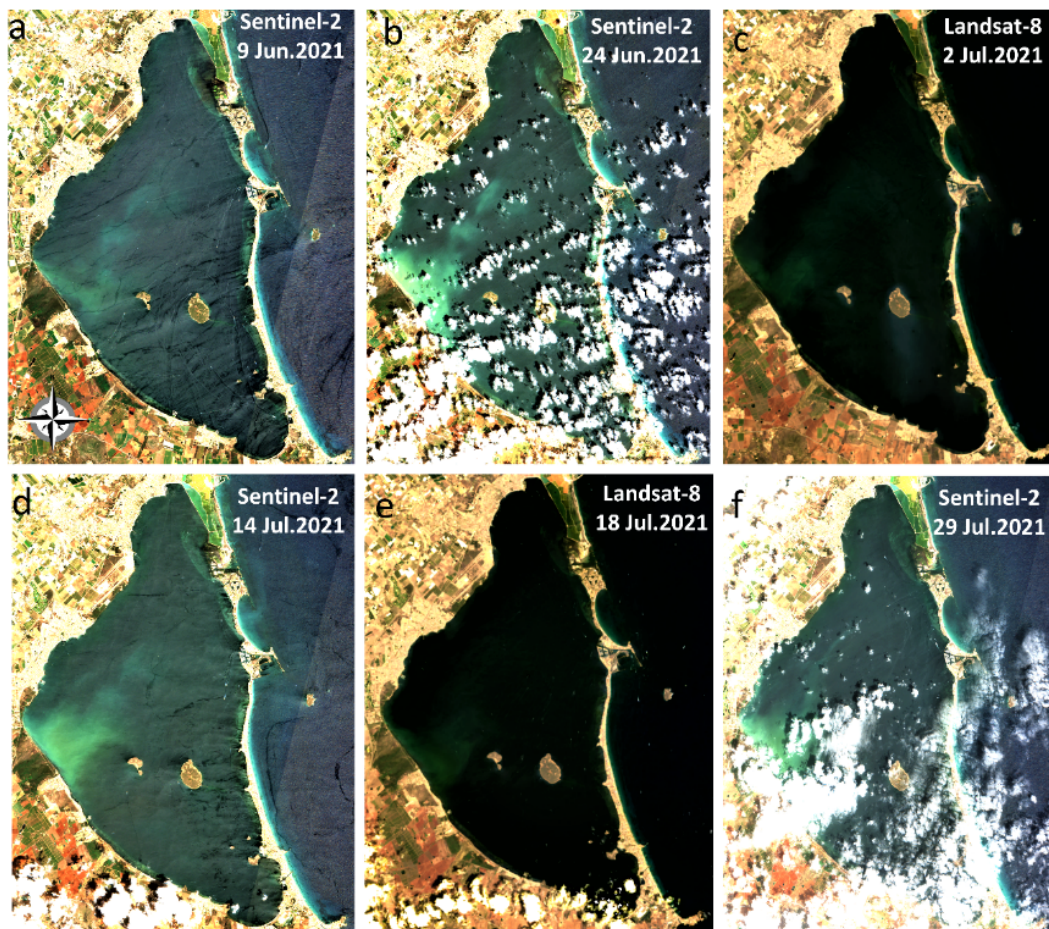
Figure 9. Sentinel-2 and Landsat-8 RGB (Red–Green–Blue) composite image acquired on (a) 9 June 2021, (b) 24 June 2021, (c) 2 July 2021, (d) 14 July 2021, (e) 18 July 2021, and (f) 29 July 2021.

Figure 9 shows the RGB composite scenes acquired on 9 and 24 June and 2, 14, 18, and 29 July 2021, whereas Figure 10 and Figure 11 display the image-derived maps for turbidity and chl-a, respectively. The imagery corresponded to the months prior to the ecological crisis in mid-August 2021. Generally, the turbidity levels were low in the lagoon (<5 FNU), except in the western section on 24 June and 14 July 2021, indicating higher levels (~25 FNU). A turbid plume appeared near land where the Alujon watercourse flows into Mar Menor. The most common chl-a condition during this period was <1.5 mg/m³, while higher chl-a concentration (~2.5 mg/m³) was observed close to the turbid plume. Figures S1 and S2 indicate the available (cloud and sunglint-free) Sentinel-2 scenes in August 2021 for further evaluation. On 3 August, a turbid plume was observed in the western section close to the input of the Alujon watercourse with peaked levels ~20 FNU, whereas minimum turbidity was encountered in the rest of the lagoon. The chl-a concentration for this date seemed to increase in the western section, indicating maximum values within the lagoon. The turbidity maps depicted high and constant turbidity values ~20 FNU in August 2021, except a slight decrease on 18 August 2021 on the western side (Figure S2). Moreover, chl-a maps displayed higher concentrations compared with July and the beginning of the bloom during this month, in particular on 13 August 2021 with chl-a ranging from 4 to 9 mg/m³, a strong indicator of algal blooms in Mar Menor. Clear-water lagoon phases are characterized by chl-a concentrations ranging from 1 to 3 mg/m³ [59], as occurred during June and July 2021. However, these typical low chl-a values tipped rapidly towards more eutrophic conditions, with chl-a concentration higher than 3 mg/m³, such as last year's [18,19,21,60]. We reported that using the multisensor approach during the eutrophication episode in 2021, the beginning of the bloom (chl-a concentration higher than 3 mg/m³) was detected mainly in the western and southern section. This is critical information for early detection of the eutrophication processes, given that the massive mortality of fish and crustaceans occurred during the last weeks of August 2021 [21], as well as an opportunity to enhance emergency management response in early deterioration stages.

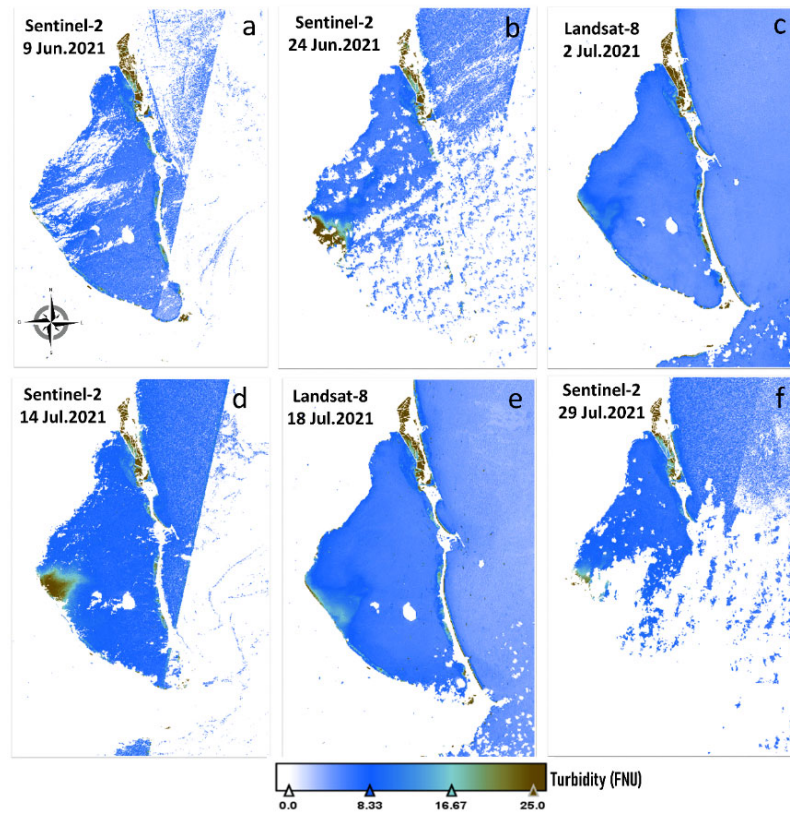
Figure 10. Turbidity (FNU) from Sentinel-2 and Landsat-8 acquired on (a) 9 June 2021, (b) 24 June 2021, (c) 2 July 2021, (d) 14 July 2021, (e) 18 July 2021, and (f) 29 July 2021.

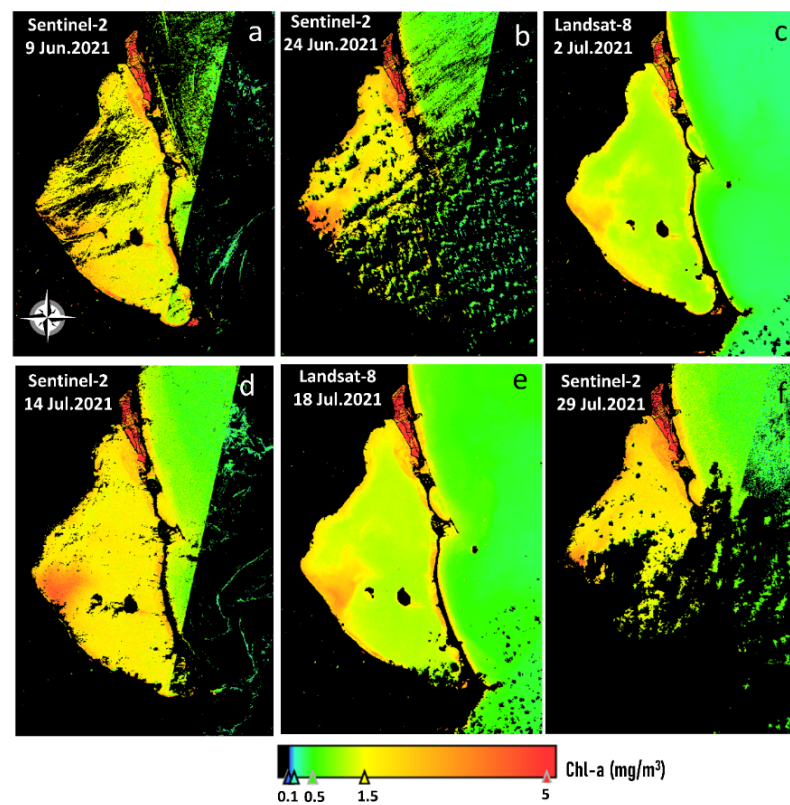
Figure 11. Chlorophyll-a concentration (Chl-a, mg/m³) from Sentinel-2 and Landsat-8 acquired on (a) 9 June 2021, (b) 24 June 2021, (c) 2 July 2021, (d) 14 July 2021, (e) 18 July 2021, and (f) 29 July 2021.
