SMS for Part 135 Commuter and On-Demand Operations - The Practitioner's Perspective

Michael Ott MSAAM, FRAeS, ATP
Phoenix Air Group, Inc., Ott18@purdue.edu

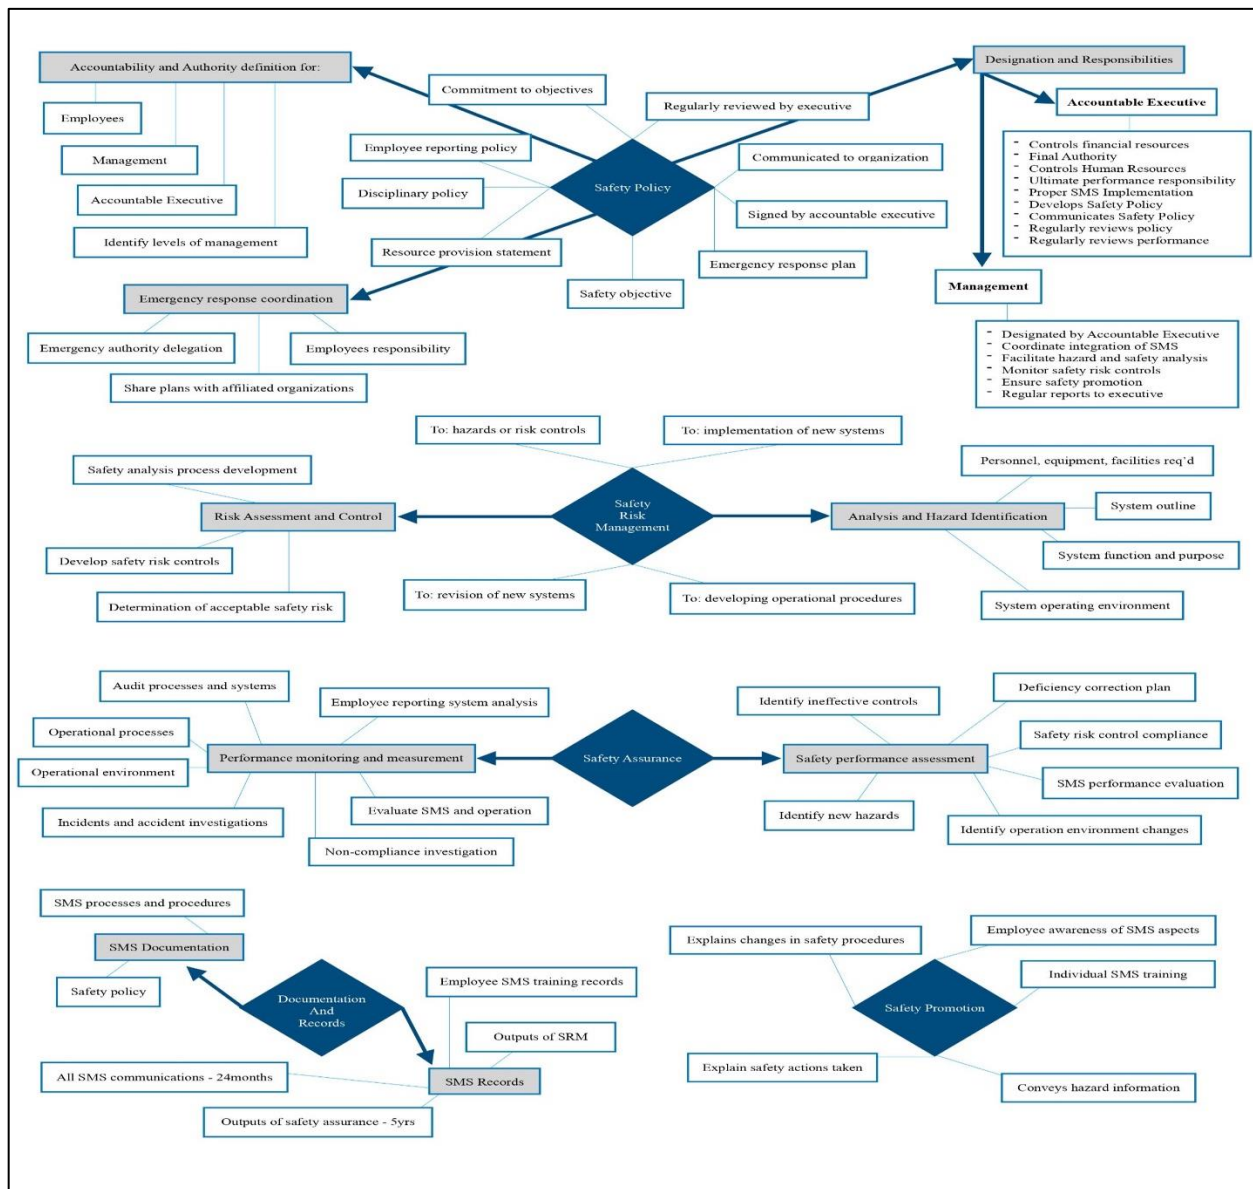
14 CFR Chapter I Subchapter A Part 5 – An SMS Visual Aid

Even in this abbreviated depiction, the complexity and nearly unreadable fine print in Figure 1 reflects the overall complexity and difficulty in understanding the information itself, as well as the overall difficulty in implementing an SMS complying with this guidance.

The language of the NTSB safety recommendation, A-16-36, only asked that the FAA mandate that Part 135 carriers maintain an SMS. The researchers chose to use 14 CFR Chapter I Subchapter A Part 5 as it demonstrated the FAA's expectations of an SMS, despite its unsuitability to most Part 135 operators. To simulate how Part 5 would challenge Part 135 safety teams, the researchers created Figure 1 to demonstrate a Part 5 compliant SMS' complexity.

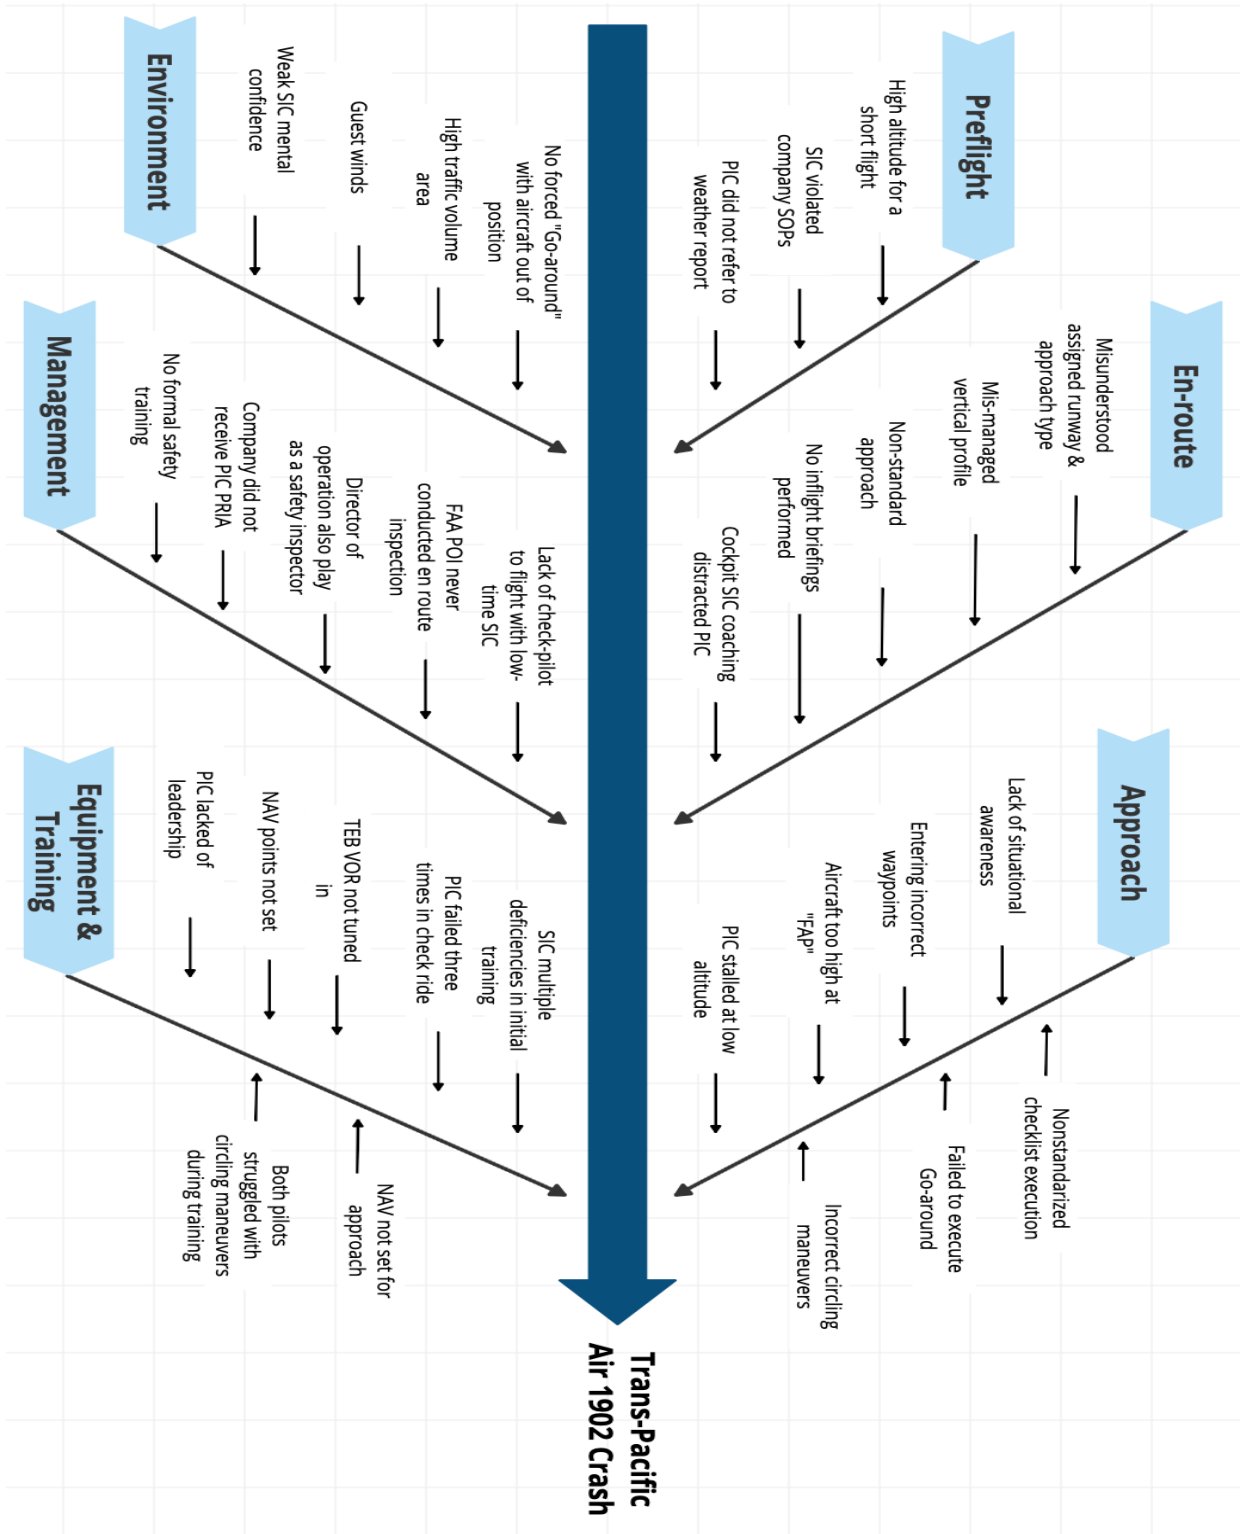
Appendix A

Fishbone Analysis Diagram

environment, and technical capability were considered. In the Fishbone Ishikawa Analysis, each branch represented a different area of the flight with one or more apparent failures. Group discussion and triangulation also revealed contributing causes of each selected factor. Please see Appendix A.

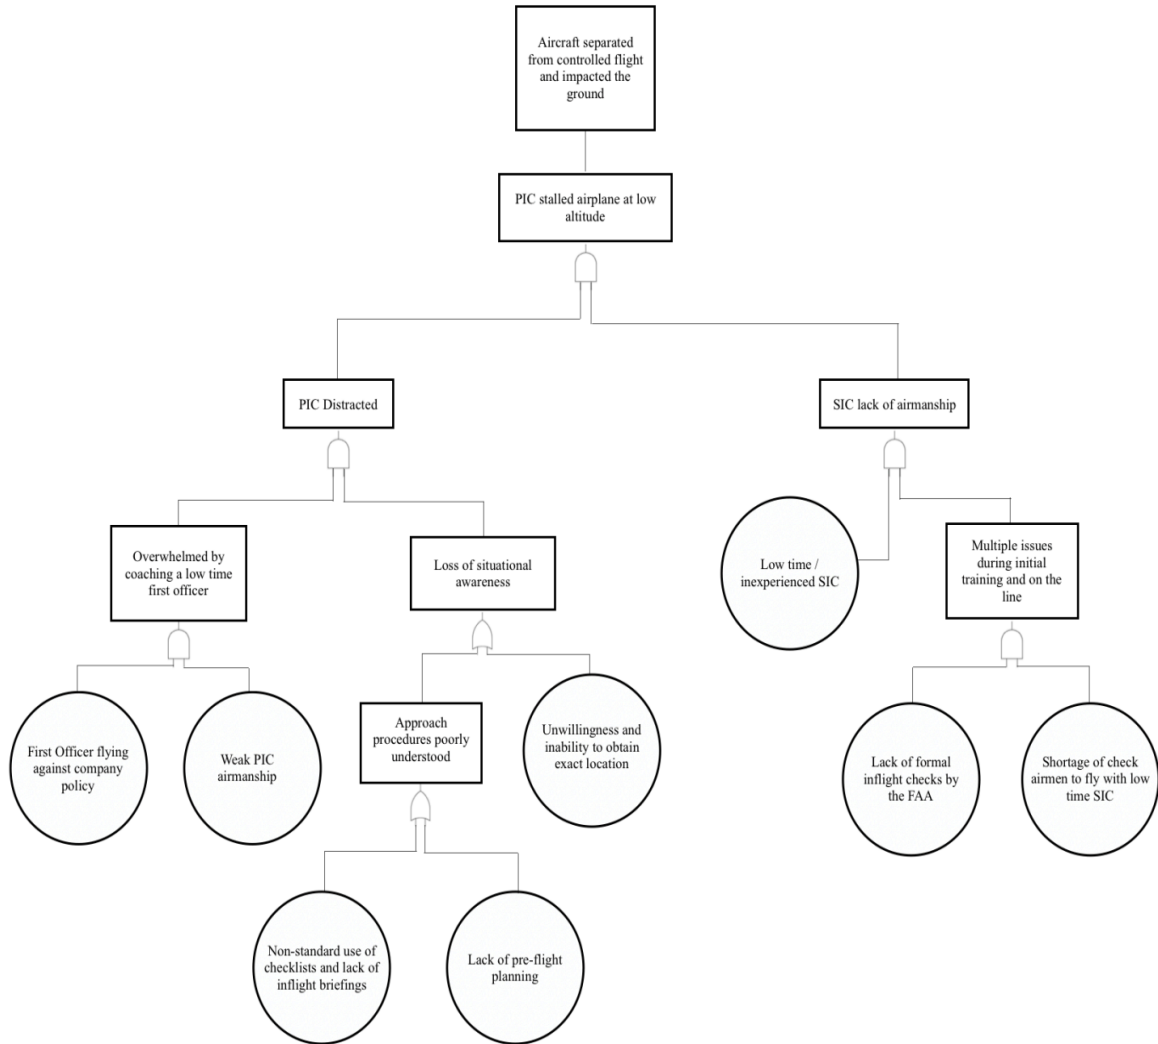
Appendix B

Fault Tree Analysis Diagram

The FTA diagram in Figure 2 used two branches: PIC and SIC. The cut-sets included [SIC's violation of SOPs, Weak PIC airmanship, lack of inflight briefing, inexperienced SIC], [SIC's violation of SOPs, Weak PIC airmanship, lack of preflight, inexperienced SIC], [SIC's violation of SOPs, Weak PIC airmanship, the unwillingness of obtaining information, inexperienced SIC] regardless of the failure probability associated with each root cause. (Full-size diagrams are available in Appendixes A and B.)

On the FTA's left-hand branch, five primary tree initiators contributed to the PIC's distraction involving Anti-Authority, Impulsivity, and Macho attitudes. All five events pointed to a poor safety culture within the company's flight department. First and foremost, the first officer performed PF duties for all but the last thirty seconds. Not only was the SIC less experienced, but his participation as PF exhibited a blatant disregard for company policy. The NTSB's (2019) report also mentioned that the SIC had likely acted as PF before the fateful flight, further demonstrating a systemic lack of rule adherence or antiauthority attitude. The first officer's lack of airmanship and attitude of resignation likely overwhelmed the PIC, leading to additional distraction. As a result of the PIC's distraction level, the PIC suffered a complete loss of situational awareness (SA) throughout the flight. This event began when the crew failed to perform their preflight duties and chose to depart without the current Teterboro weather and on
