Combining Integrated Informative System and Historical Digital Twin for Maintenance and Preservation of Artistic Assets

Citation: Marra, A.; Gerbino, S.; Greco, A.; Fabbrocino, G. Combining Integrated Informative System and Historical Digital Twin for Maintenance and Preservation of Artistic Assets. *Sensors* **2021**, *21*, 5956. <https://doi.org/10.3390/s21175956>

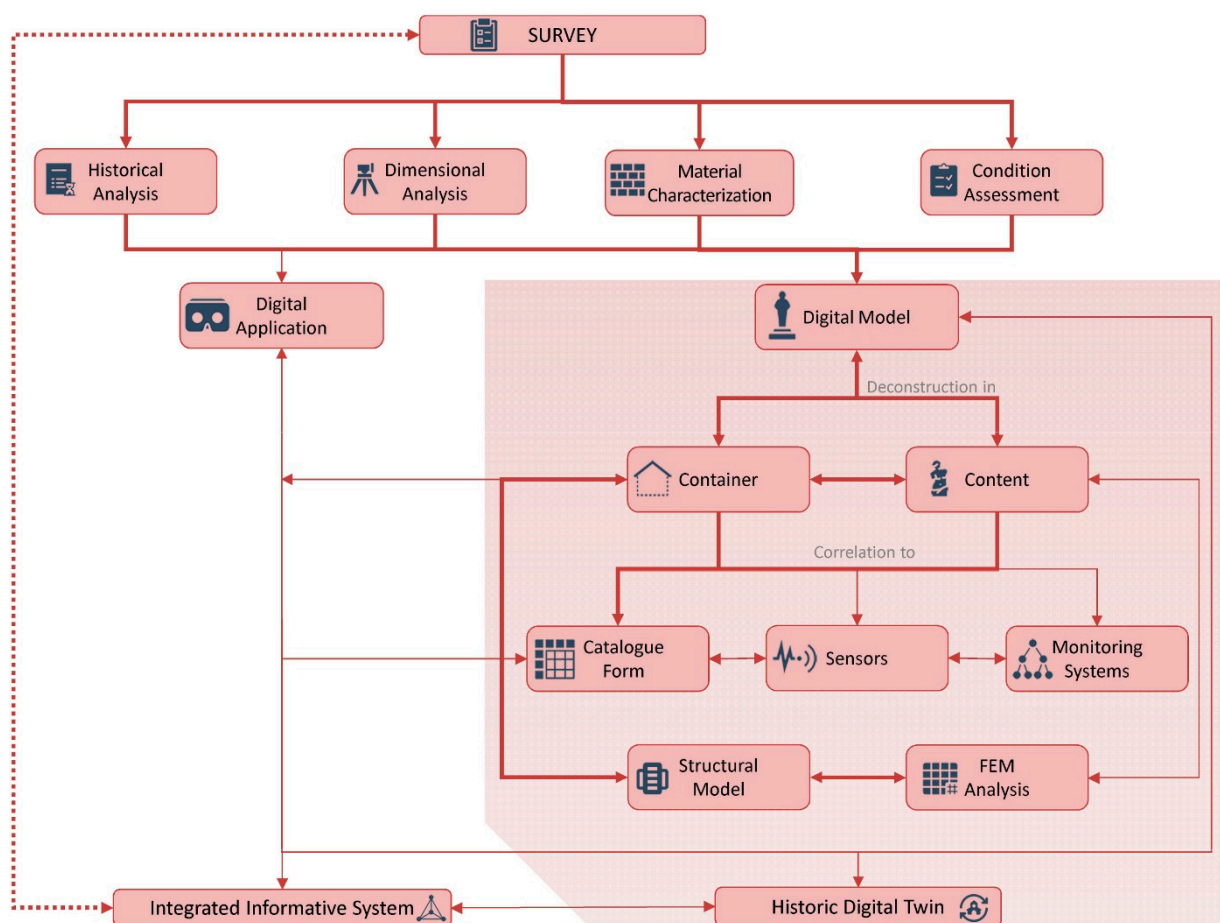
Figure 1. General framework of the research workflow.

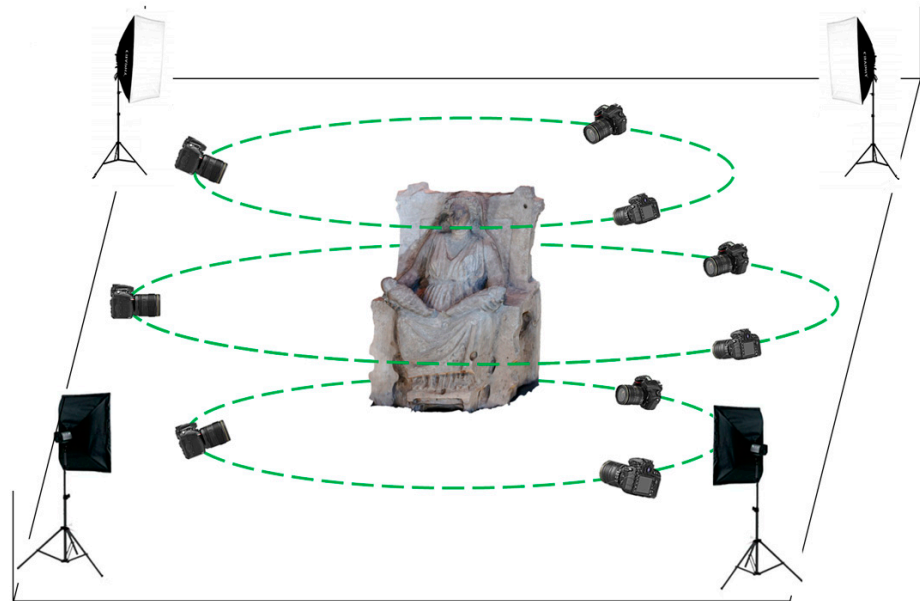
Once the photogrammetric acquisition was completed, the statue was covered with about 200 small circular targets for laser acquisition, as requested by the handheld laser scanner, HandyScan 700 by Creaform [38]. This metrological device acquires high-quality measurement data (device accuracy up to 0.03 mm and measuring speed of at least 480 k points/s according to the Creaform product sheet). Targets work as three-dimensional references for the free handheld scanner to allow it to be moved all around the object.

Figure 4. Layout of the photogrammetric acquisition area.

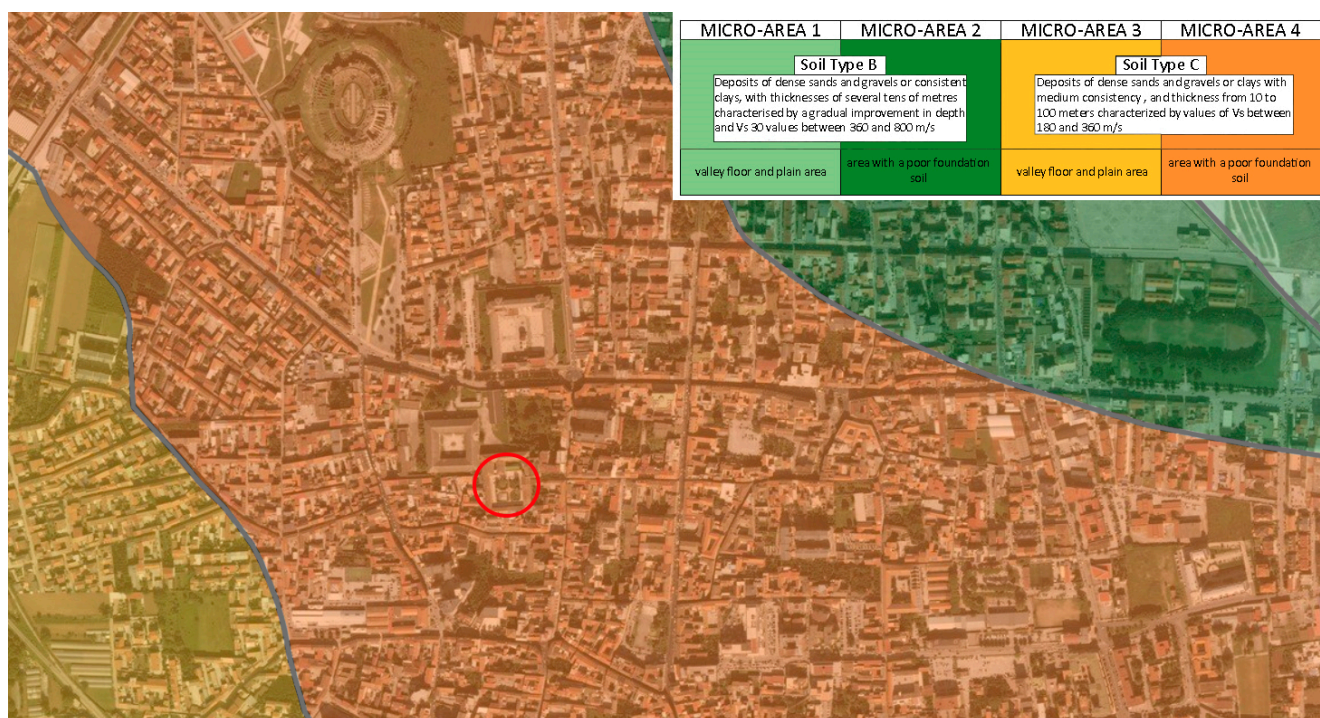
The results of the abovementioned investigation have enabled the development of the seismic zonation map of the city, from which is clear that the Archeological Museum of the Ancient Capua is located in a flat area with a poor foundation soil (Figure 5). Therefore, the museum area is characterized by a type C foundation soil, namely “deposits of dense sands and gravels or clays with a medium consistency, and thickness from 10 to 100 m characterized by values of vs. between 180 and 360 m/s” [47].

Figure 5. Map of homogeneous areas zoning in seismic perspective: the red circle identifies the location of the Archaeological Museum of the Ancient Capua.

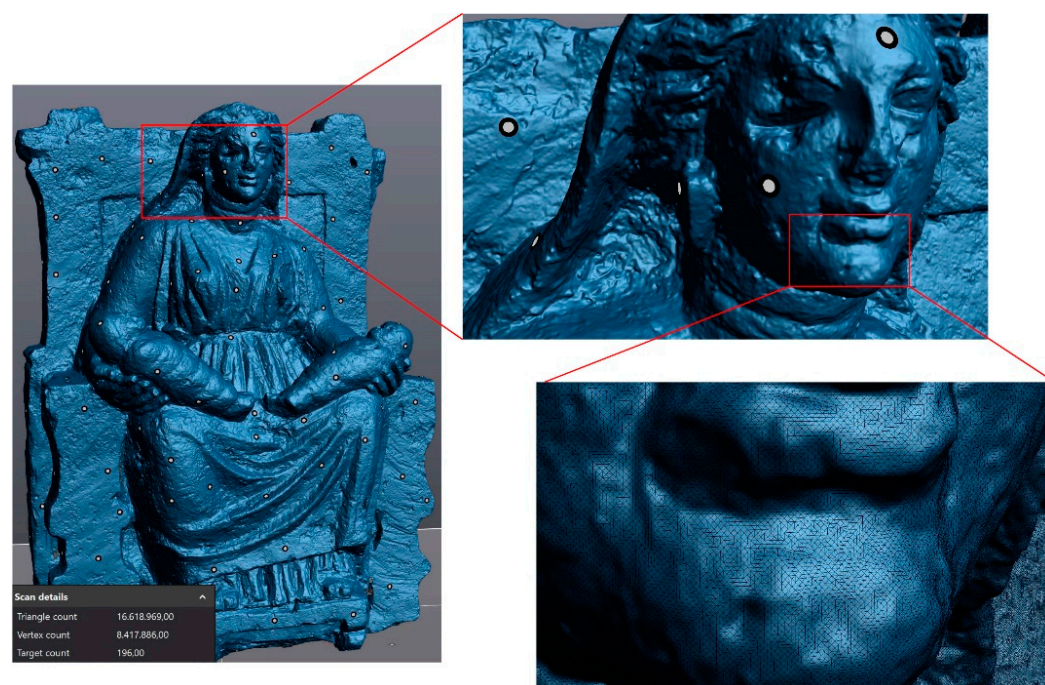
The accuracy of the scanning process [51] is strictly related to the provided calibration table for the selected device. This test is made once before running any new measurement task. The accuracy changes according to the calibration certificate as $0.020 + 0.060$ mm/m. All the recommendations in using the scanner (as suggested by the manufacturer to achieve the best results) were adopted. Examples are the orientation of the scanner with respect to the object and the feature to be captured, the speed of movements, the average distance between markers, etc. After scanning the statue, the acquired mesh model was post-processed (in VXelements by Creaform [38]) removing outliers, reducing noise, filling small holes, reconstructing the base plane to obtain a closed model, and re-meshing the whole model to make the mesh elements more uniform and regular, but keeping the same original accuracy (average nodes spacing about 0.05 mm). Figure 7 shows the result of the 3D laser scanning process where the mesh model has a high level of detail due to the scanner precision. The final cleaned mesh model, after the post-processing phase, counts more than 8.4 M vertices and 16.5 M triangular elements, starting from the original data set with more than 17.3 M elements. The final model is 734.5 mm wide, 439.5 mm deep, and 991.5 mm high.

Figure 7. Result of the laser scanning process.

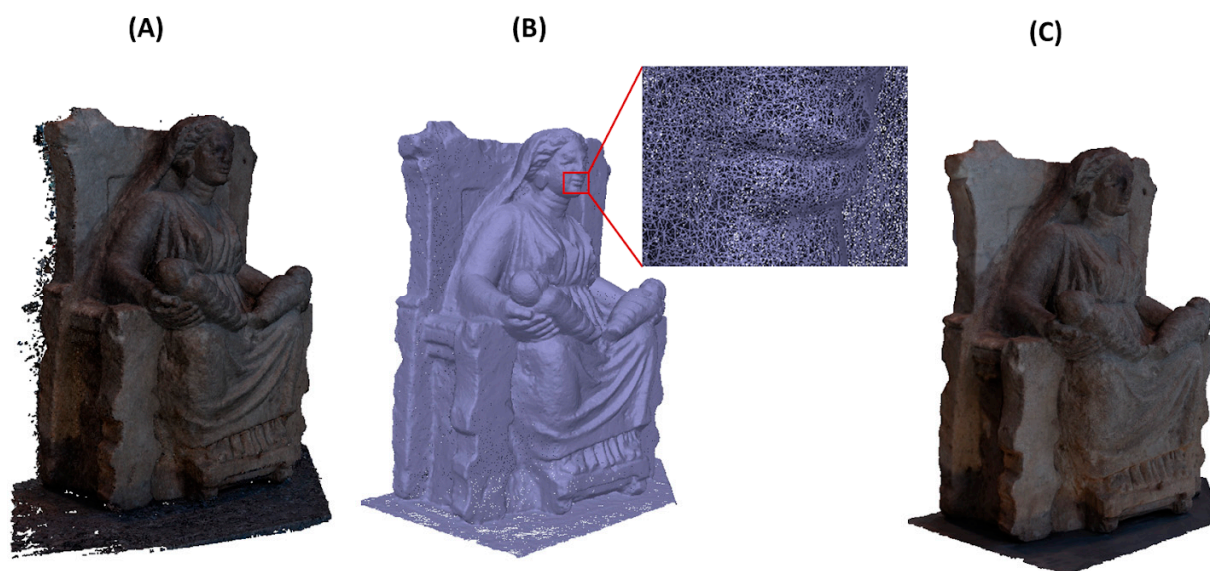
In order to obtain a reliable documentation of the current state of the asset [6,52], 120 photos were taken all around the statue, discarding blurred or low-quality photos. Only 98 photos were processed by Metashape Professional (Agisoft) software, reconstructing a model characterized by about 127 k triangles and 63 k vertices (Figure 8). The editing of

Figure 8. Initial dense point cloud model (A), mesh model (B), and textured model (C) resulting from photogrammetry after the mesh editing phase.

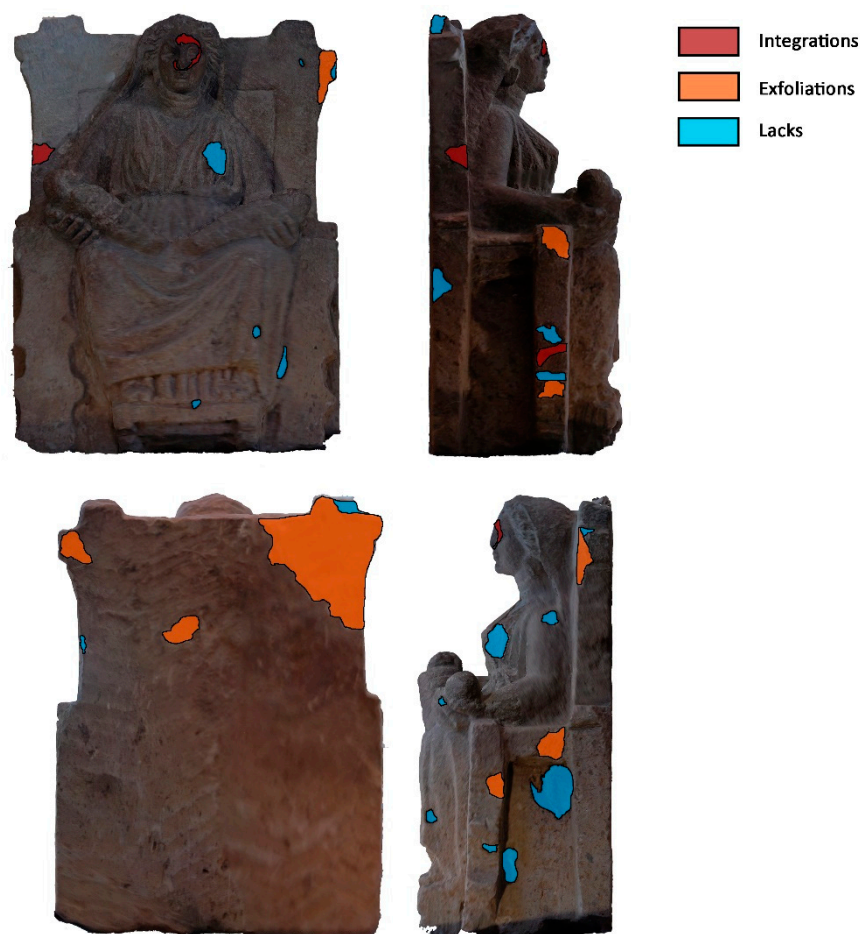
However, as the processed orthomosaics demonstrated their reliability in describing the current state of the asset, the refinement of the photogrammetric survey was skipped and the orthomosaics processed in order to perform specific thematic analysis in digital form. Figure 9 shows the above mentioned orthomosaics and outlines the main outcomes of the analysis of the conservation state of the investigated *Mater Matuta*. In particular, the sculpture shows some degradation and alteration forms probably caused by the material properties—the gray tuff is a porous material—and by its permanence under soil deposits. Several missing parts, exfoliations, and chromatic alterations can be detected, both in the main figure and in the throne.

Figure 9. Analysis of degradation forms on the orthomosaics.

Some stucco work and additions can be observed in the upper part of the throne, in the *Mater's* left hand, and in the reconstruction of the face, where the sign of the union between the two elements is evident. It is worth noting that the assessment of conservation state benefits from the photogrammetric survey. Indeed, this operation can be repeated over time, recurring also to the crowd sensing systems [60,61], and the results can be easily updated thanks to an operator or through deep learning algorithms [62].

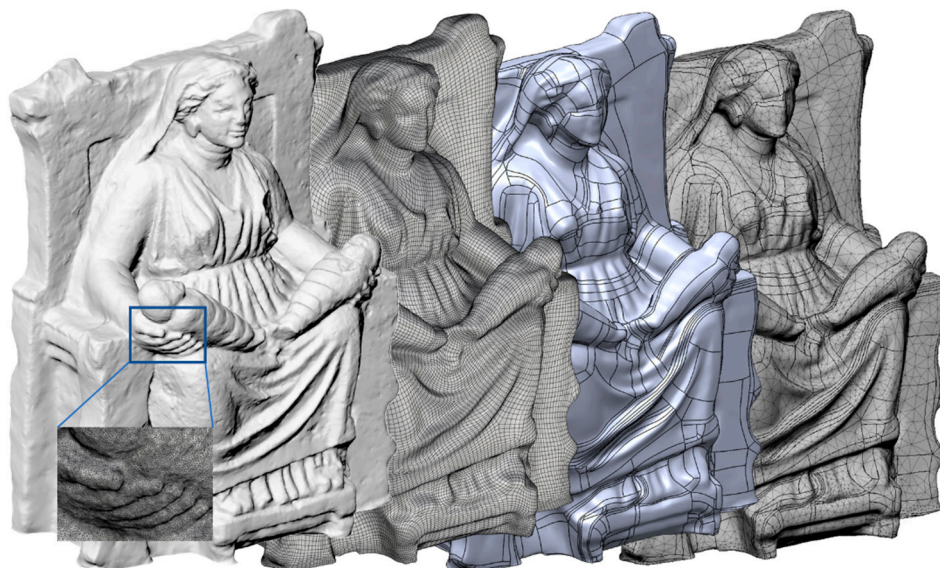
integrated CAD-CAE platform, Fusion 360 (by AutoDesk), by using T-Spline functionalities (a kind of SubD modeling tool [68]) and then converted in a FE model to carry out the modal analysis in the same environment (Figure 10 on the right).

Figure 10. From the very dense scanned and tessellated model to the FE (Finite Element) mesh model, passing through the quad mesh and the surface model (from left to right).

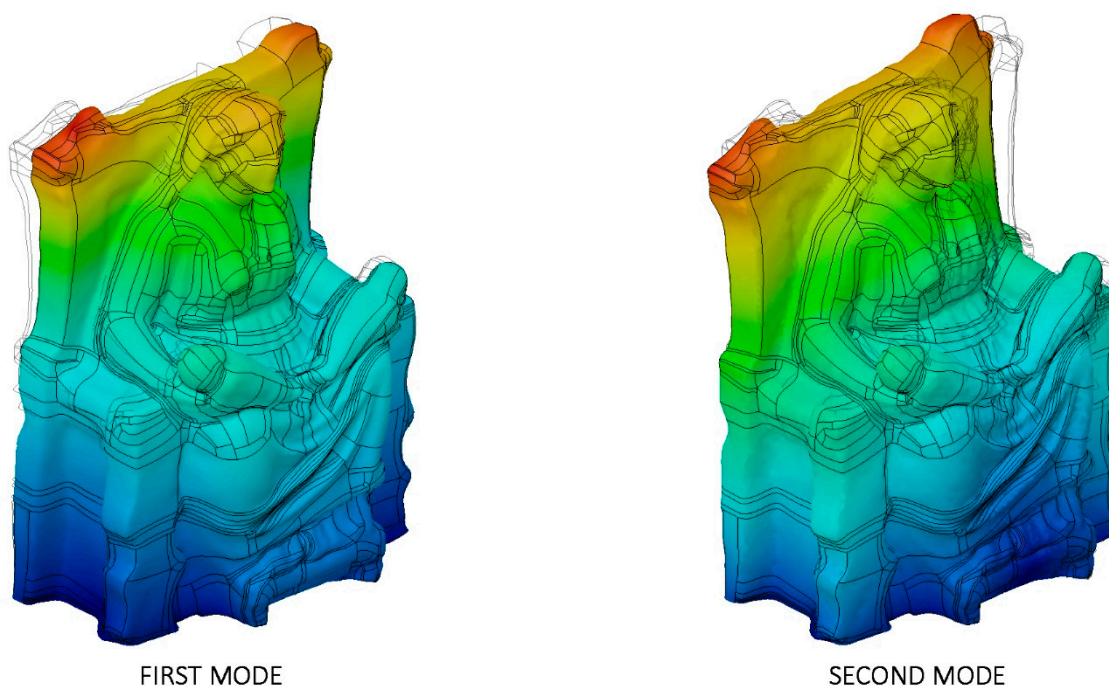
Results from the simulation highlight that the upper parts of the throne are most susceptible to dynamic action due to the shape and characteristics of the sculpture (Figure 11), but the dimensions lead to very high eigenfrequencies that are far higher than the thresholds, 0.06 s–6.67 Hz, suggested by relevant international seismic codes [69]. As a consequence, the geometrical configuration of *Mater Matuta* (Table 4) makes the sculpture comparable to a single rigid block so that a first approach to the design of interventions aimed at the mitigation of the seismic effects can be made according to the theories of rigid block [22,40,70].

Figure 11. Modal analysis of *Mater Matuta*: first (left— $f_1 = 122.2$ Hz) and second (left— $f_2 = 183.6$ Hz) mode; displacement mapping color code ranges between blue (still points) to red (maximum modal displacements).

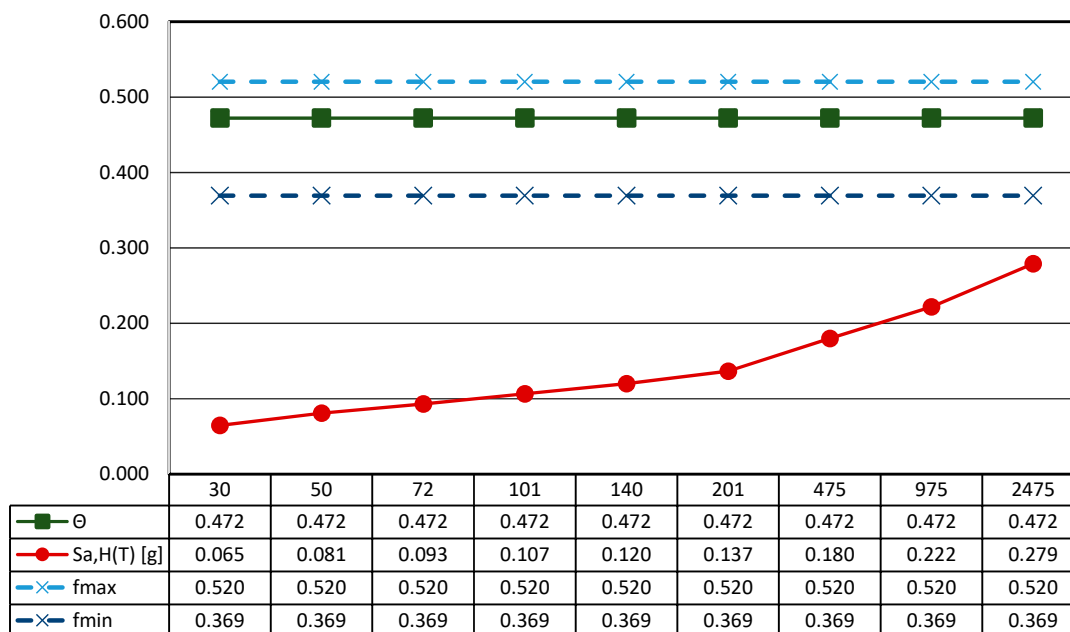
Figure 12 reports the main results of the seismic characterization of the statue assumed to be placed on the ground and subjected to the horizontal ground shaking described by the Italian design code NTC2018 [48] previously illustrated in Section 3.1.

Figure 12. Results of the seismic performance assessment of the *Mater Matuta* under horizontal shaking only.

In more detail, each plot contains four lines: (i) the spectral acceleration at the site for rigid structures ($T = 0$) identified by a red line; (ii) the function Θ , representative of the horizontal acceleration level that triggers rocking motion in green; and the maximum (iii) and the minimum (iv) acceleration [...] thresholds associated to the sliding of the statue—dashed lines—depending on the maximum and the minimum value of the friction coefficient exhibited by tuff stones. The latter, following a consolidated approach in civil engineering, is estimated as $f = 2/3 \tan \varphi$, where φ is the friction angle of the stone [71].

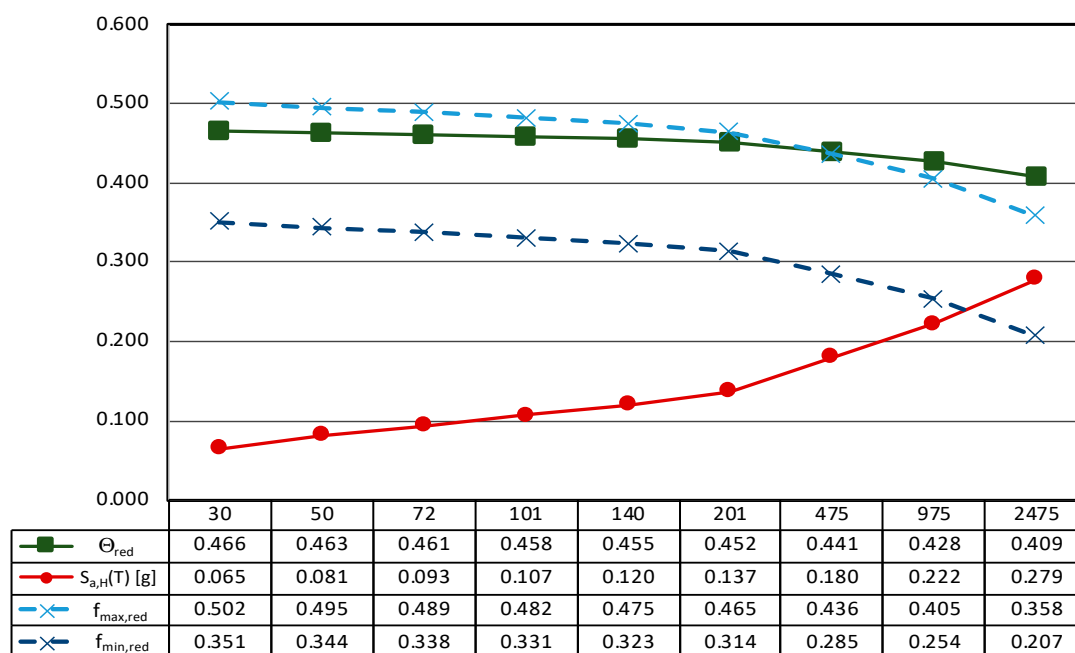
This issue is addressed in Figure 13, where the thresholds of sliding and rocking motion are computed considering the effects of the spectral vertical acceleration provided by Italian seismic design code [48] for rigid components ($T = 0$).

Figure 13. Results of the seismic performance assessment of the *Mater Matuta* under generalized ground shaking.

It is worth noting that, in the case of generalized ground motion, the thresholds decrease as the seismic intensity increases, in other words moving from frequent to rare events. Consequently, the sliding of the statue seems to be likely in the case of very rare events (T_R greater than 975 years) and low values of the friction coefficient. This result shows that, in the case of the *Mater Matuta*, vertical acceleration may play a role in the development of its seismic response, but the return period associated with the generalized ground motion is so high that damage to the asset could come from structural damage to the building (container), whose seismic performance is out of the scope of the work. Conversely, frequent and less rare ground motions should avoid any interference with the asset due to its configuration and geometry.

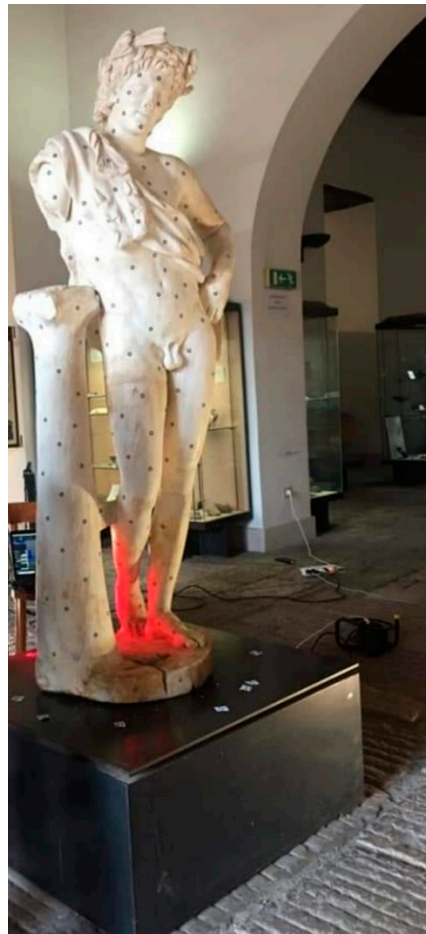
About 350 circular markers were put on the statue (Figure 15) at an average distance of 100–200 mm considering the smoothness of the surface. After the scanner calibration, the software setting in VXelements, mainly the automatic optimization of the shutter (to set the best frequency rate of the acquisition, according to the color and reflectance of the surface) and the resolution value (0.05 mm), was carried out. Due to these markers, a network of reference points can be acquired according to the local and global configuration of the surface. Similarly to the *Mater Matuta*, the editing of the model was carried out, resulting in a three-dimensional model characterized by about 5.8 M of vertices and 11.0 M of triangles (Figure 16).

Figure 15. The preliminary phase of the scanning process.

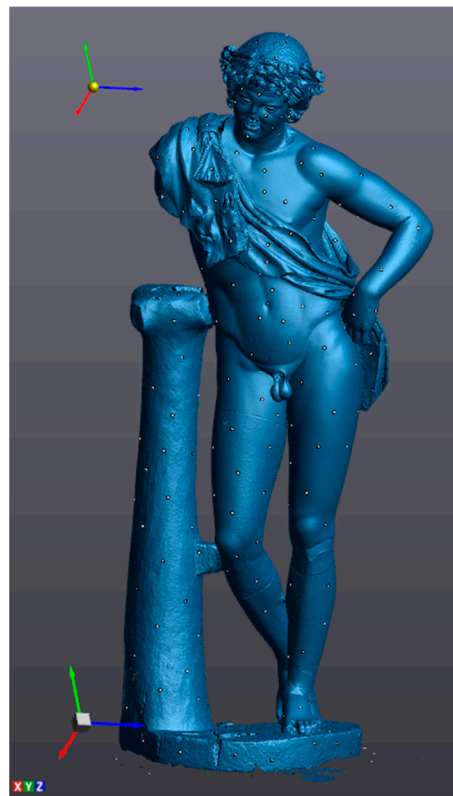
Figure 16. Result of scanning process in VXelements.

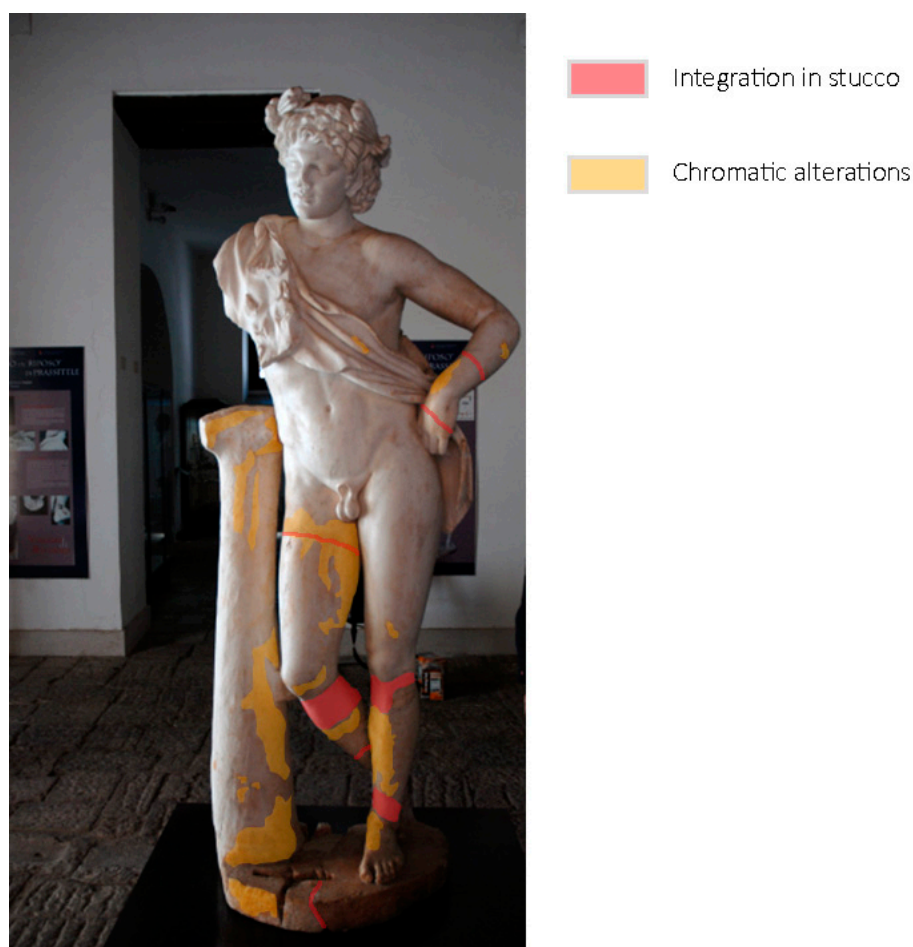
Figure 18. The *Resting Satyr*, current state, and alteration form.

The detected alterations do not affect the statue's preservation; however, the lack of anti-seismic devices and suitable support elements could threaten its safety in case of an earthquake. Indeed, the *Satyr* could oscillate or slide under seismic action. Therefore, a high-intensity seismic event could lead to the statue's overturning and damage in several parts, causing the loss of this valuable artifact.

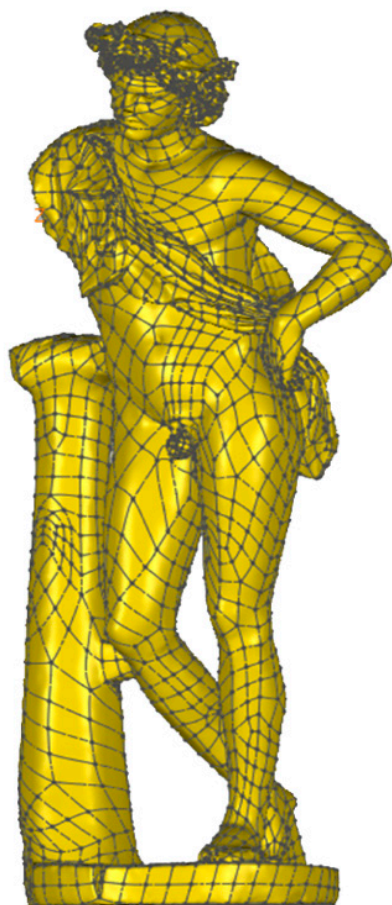
During this scanning process, an input filter was applied to data acquired through laser scanning thanks to the smoothed nature of many parts of the statue. The final result of the mesh editing process is a mesh model characterized by about 400 k triangular polygons, then best fitted by about 4.2 k faces, with higher density where more details occur (Figure 19).

Figure 19. Solid model of the *Resting Satyr*.

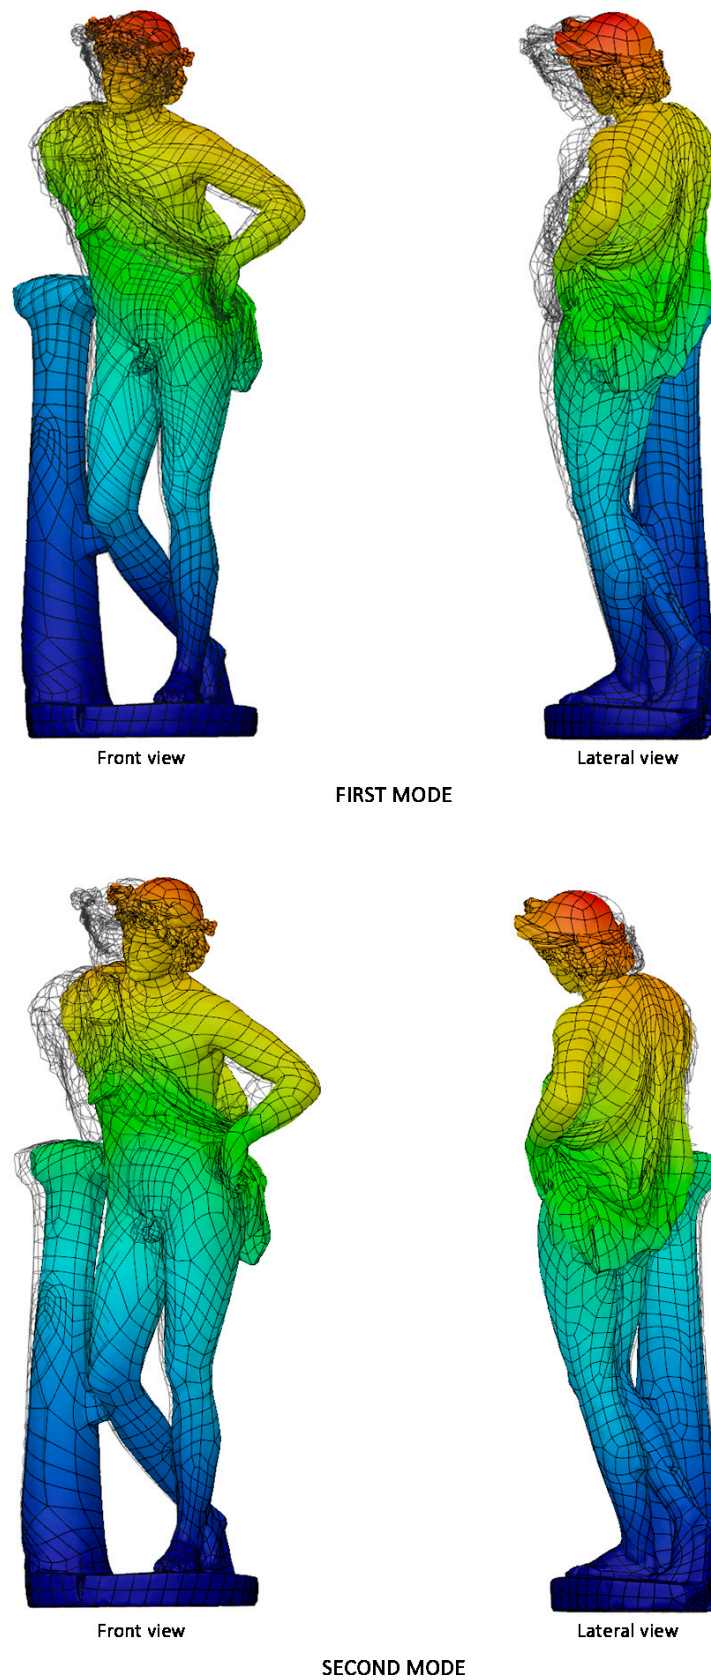
The slender shape of the *Resting Satyr*, compared with the *Mater Matuta*, is demonstrated by the lower value of the first frequency that is just beyond the limit—16.67 Hz—of the rigid non-structural components after ASCE-07 provisions [69], so that again the statue can be classified as a rigid, seismic sensitive structure.

Figure 20. Modal analysis of *Resting Satyr*: first (top— $f_1 = 20.7$ Hz) and second (bottom— $f_2 = 46.5$ Hz) mode; displacement mapping color code ranges between blue (still points) to red (maximum modal displacements).

On this point, it is worth noting that the result is not reliable as the one achieved for the *Mater Matuta*; this is due to the simplified assumptions of the modal analysis, which does not take account of the discontinuities generated by the past fractures of the statue and the effects of the reconstructive restoration performed in recent times. A more detailed analysis of the asset could be carried out using a more refined FE model, but more reliably and efficiently by means of a dynamic identification of the statue carried out through operational modal analyses (OMA), which do not need any excitation, and can be carried out by recording the environmental vibrations of the asset [73].

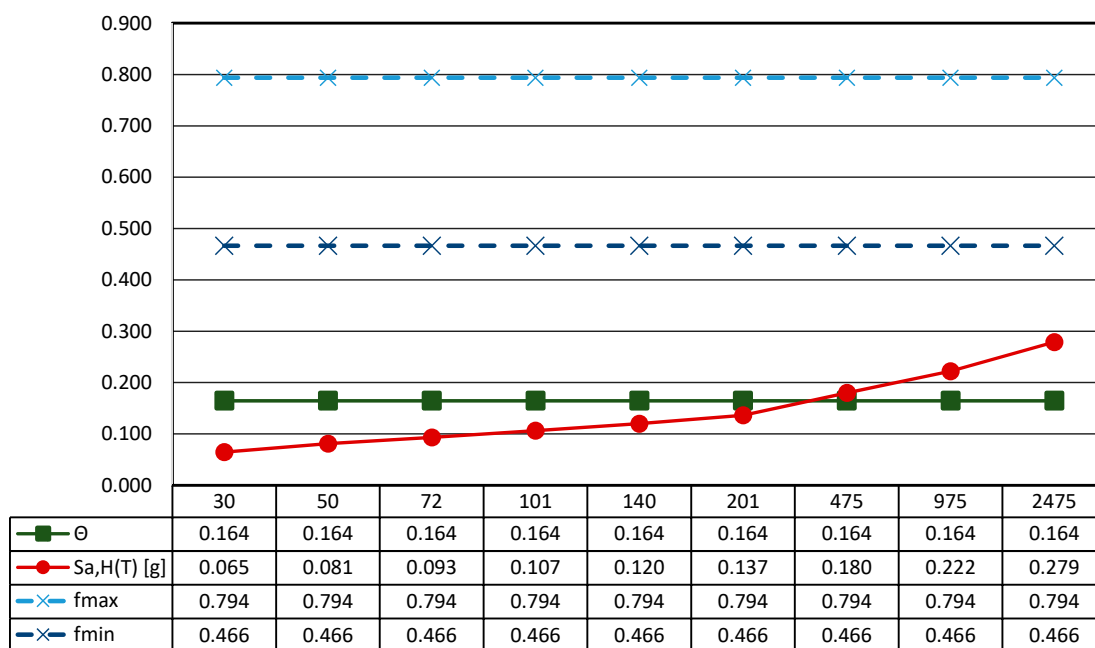
Figure 21. Results of the seismic performance assessment of the *Resting Satyr* under horizontal shaking only.

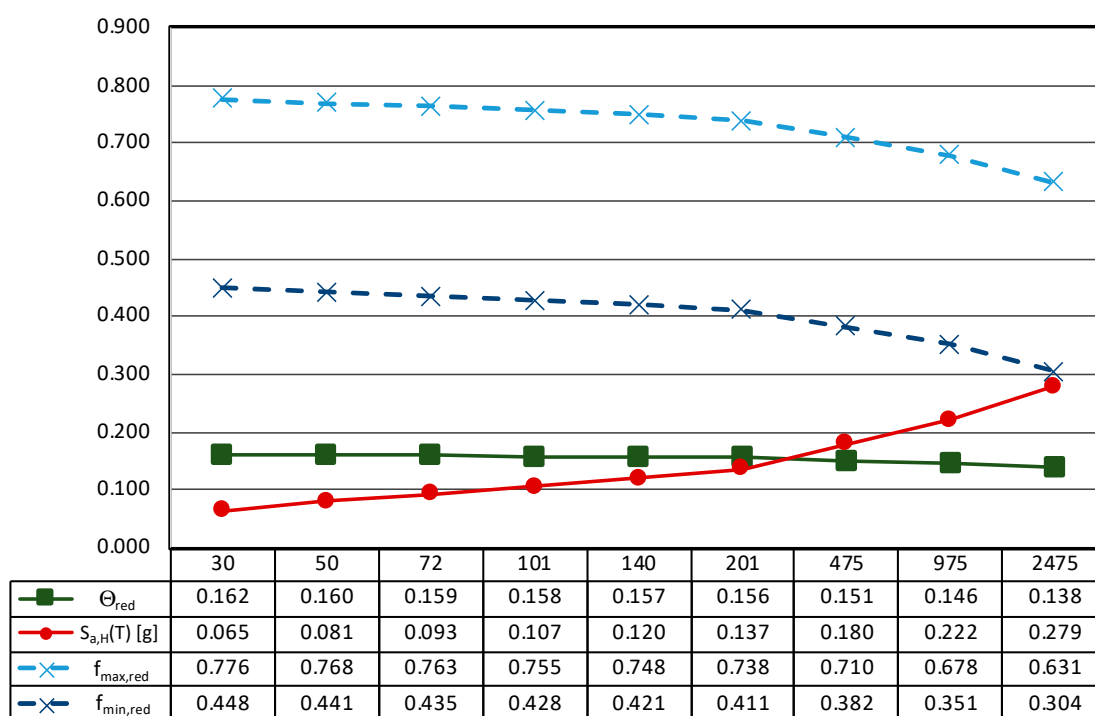
Figure 22. Results of the seismic performance assessment of the *Resting Satyr* under generalized ground shaking.

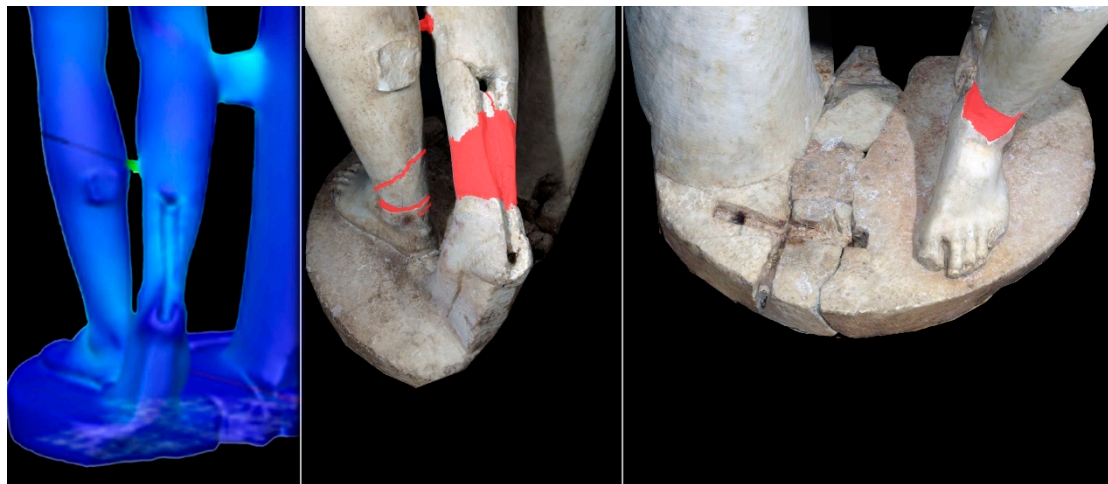
The results highlight that, due to the shape and current configuration of the *Satyr*, stress concentrations are located at the connections of the sculpture to the base and to the tree trunk. In other words, the parts of the sculpture repaired in the past are critical in bearing the loads and need to be further investigated (Figure 23). This is an important outcome of the analysis, as it guides the operators in defining the key zones and details of the assets that need to be investigated in detail. In such a way, all relevant geometrical, material, and interface properties of the installed mechanical devices could be assessed and monitored in time by means of appropriate non-destructive techniques [76–78].

Figure 23. Results of static stress analysis versus previous restoration works.

This additional diagnostic phase, indeed, appears to be propaedeutic for the development of a detailed structural analysis on a model incorporating heterogeneous materials and the steel bars located in the left leg, in the right leg to connect it with the heel, in the connection between the trunk and the right leg, and finally all the relevant interface response of the mechanical anchors installed during the reconstruction process, moving from the connecting element between the two legs [72].
