Seismic Vulnerability Assessment of Existing Italian Hospitals: The Case Study of the National Cancer Institute “G. Pascale Foundation” of Naples

The main aim of the present paper is to share the key findings related to the seismic vulnerability assessment of the National Institute for the Study and Treatment of Cancer (IRCCS) “Giovanni Pascale Foundation” in Naples. In particular, the main evidences could be easily extended to existing hospitals realized in the last century, with the main reference to: construction techniques, quality of constructional material, overt and convert seismic vulnerabilities and possible intervention strategies for risk mitigation.

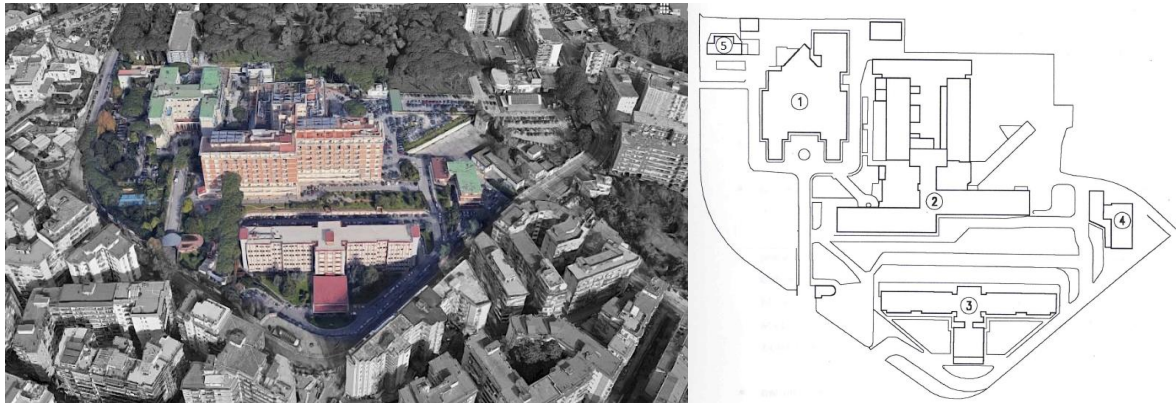
Fig. (1). Satellite view of the Giovanni Pascale Foundation (left) and general plan of the hospital facility (right).

The National Institute for the Study and Treatment of Cancer (IRCCS) "Giovanni Pascale Foundation" in Naples is composed of five independent buildings whose total plan extension, also comprising the access zones and car parks, amounts to about 60000 m². A satellite view of the entire complex and a general plan with the position of the different buildings are provided in Fig. (1), where:

- Edifice 1 is the "Scientific Building" (hereinafter stated as [SB]);
- Edifice 2 is the "Hospitalization Building" (hereinafter stated as [HB]);
- Edifice 3 is the "Day-Hospital Building" (hereinafter stated as [DH]);
- Edifice 4 is the "Administrative Building" (hereinafter stated as [AB]);
- Edifice 5 is the "Nun Building" (hereinafter stated as [NB]).

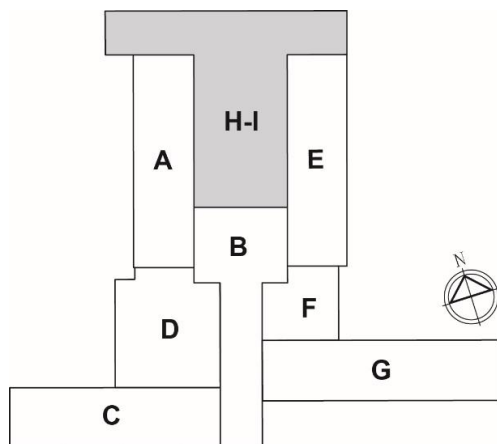
Fig. (6). Plan of [HB] with definition of structural units.

The Hospitalization Building is characterized by a very articulated plan shape: from a central volume (unit B) having a “T” shape and with a North-South orientation, the various units detach, as shown in Fig. (6). It is worth noticing that the portion “H-I” has not been the object of investigation since a seismic retrofitting intervention was already designed when the activities started.

All the investigated structural units of [HB] present an underground floor, while a very heterogeneous in-elevation development characterizes them. In particular, the highest units, *i.e.*, B, C and G, consist of additional ten aboveground floors, while the shortest ones, *i.e.*, F and H-I, are two-story

buildings. Moreover, units E and A present five and four aboveground stories, respectively, while D has two intermediate-level floors in addition to the underground one. Then, two vehicular ramps are present, which permit the connection between the ground floor of C and F units to the external ground level. From a structural point of view, all the units are independent between themselves since they are separated by means of technical joints (*i.e.*, Gerber supports).

Unit A, which is the most complex one, can be in turn considered composed of three independent structural sub-units: A1, A2 and A3. The sub-unit A1 is affected by a strong historical stratification since many interventions aimed at improving existing structures due to change of use or enlargement have been made. From a structural point of view, it consists of mono-directional r.c. frames with transversal beams placed both along the perimeter (having infill-bearing scopes) and in intermediate positions, which support limited inverted-oriented portions of the slab. As far as the horizontal structures are concerned, they are mainly West-East oriented and consist of different typologies in the function of their destination of use. In particular, r.c. with hollow blocks slabs, solid r.c. slabs and concrete slabs with embedded steel beams are present in this sub-unit. On the other hand, the sub-unit A2, which represents the staircase of the sub-unit A1, consists of a r.c. structure with beams and cantilever steps, while the A3 one is a two-story r.c. structure with hollow blocks slabs. The foundation system of all sub-units is of the superficial type.

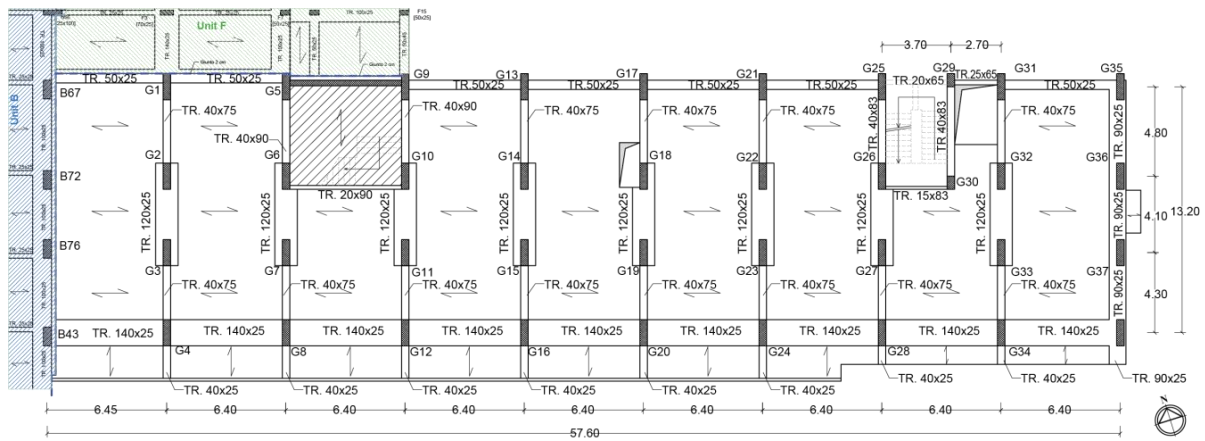
Fig. (13). Carpentry plan (2nd story) of unit G of [HB] buildings.

Then, the last unit of the Hospitalization Building is the G one, whose in-height elevation amounts to eleven stories. The structural system consists of nine mono-directional frames (oriented in the North-South direction) and perimeter beams serving as infill bearing. All slabs are of the r.c. with hollow blocks type, with prefabricated prestressed concrete joists (from first to the fourth story) and cast-*in-situ* ones (from fifth to the eleventh story). Moreover, an articulated staircase is present, which is prevalently composed of three ramps per story (from second to ninth-story), while it consists of two ramps in the first and tenth stories. Plinths on piles support the unit at issue.

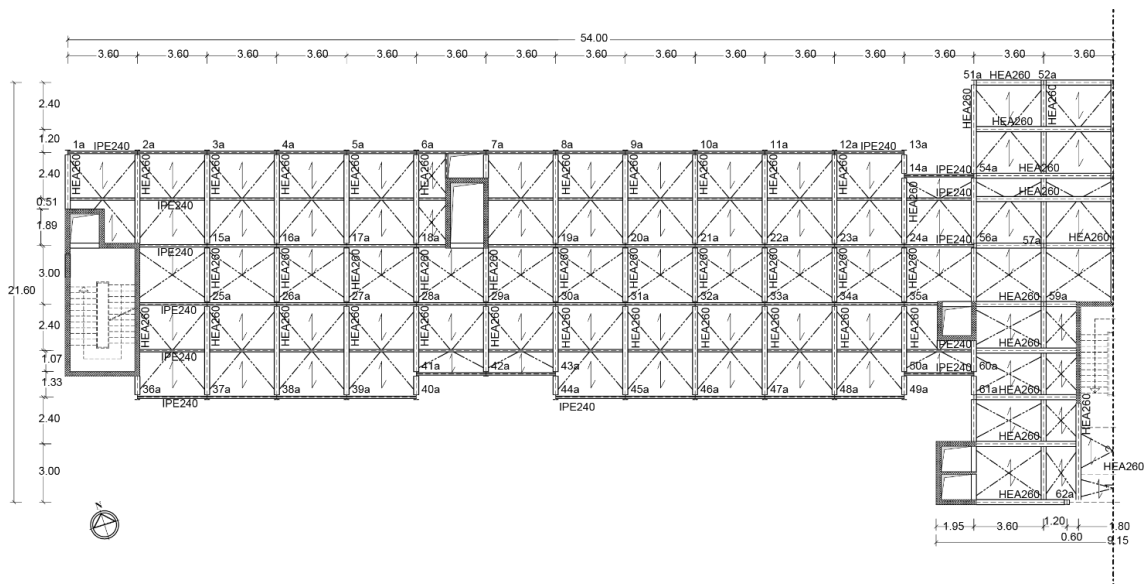
Fig. (14). Left half of the carpentry plan (2nd story) of [DH] buildings.

The [DH] building consists of a singular seven-story steel structure integrated with r.c. cores. Moreover, on the ground floor, a single-level artefact, serving as reception, is present, which is independent of the main steel structure. The steel structure consists of steel frames oriented in both directions and with beams connected to full-height columns by means of hinge nodes. Moreover, for each portion of slab, which is composed of a steel trapezoidal sheet and a concrete upper slab and is oriented in the longitudinal direction (West-East), an intermediate steel beam is present, whose aim is to reduce the total span of the slab itself. The seismic-resistant portion of the structure consists of nine r.c. cores (serving as staircases and elevators) disposed of symmetrically with respect to the barycentric vertical axis (North-South direction). On the contrary, the single-level additional portion of this building presents r.c. frames and a curve-shaped wall. The flat roof is a typical r.c. with hollow blocks slab, which distinguishes two portions having different heights. All the foundation systems are deep

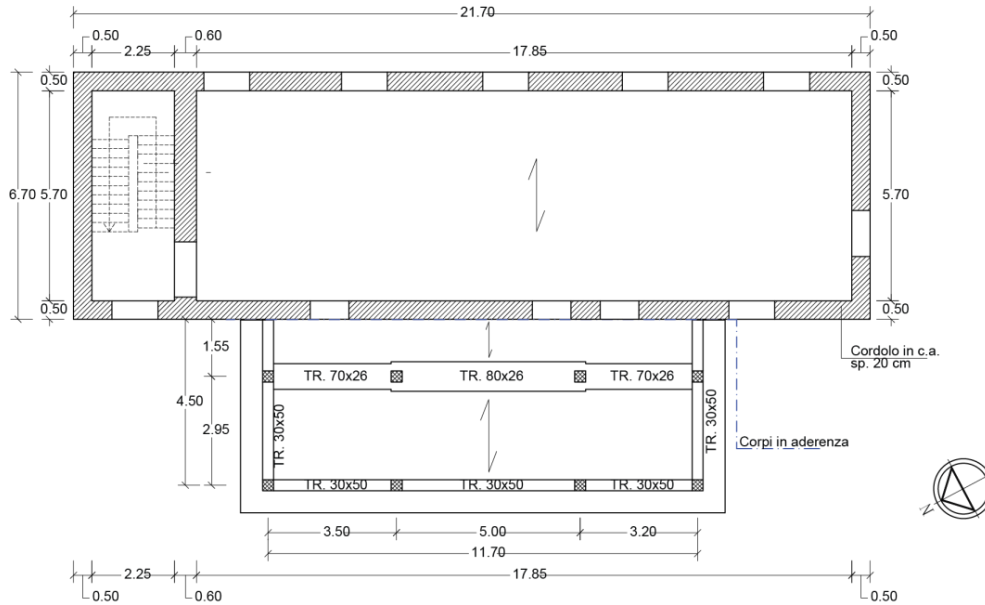
Fig. (16). Carpentry plan (2nd story) of [NB] buildings.

The last building of the medical facility under investigation, *i.e.* [NB], is composed of two structural units: an original tuff masonry building with an adjacent r.c. concrete portion, which is the result of a subsequent enlargement intervention. With reference to the masonry portion, the plan distribution of the structural elements provides the presence of perimeter walls and of a transversal panel delimiting the staircase placed in the East zone. The thickness of the masonry walls is in the range of 50-60 centimetres and two different types of horizontal structures are present: Hollow block combined with r.c. slab (first and second story) and steel slab (third story). On the other hand, r.c. structure presents frames mainly disposed in the West-East direction with r.c. with hollow blocks slabs, which also present a cantilever portion in the proximity of the connection with the masonry unit. As far as the foundation system of the building under investigation is

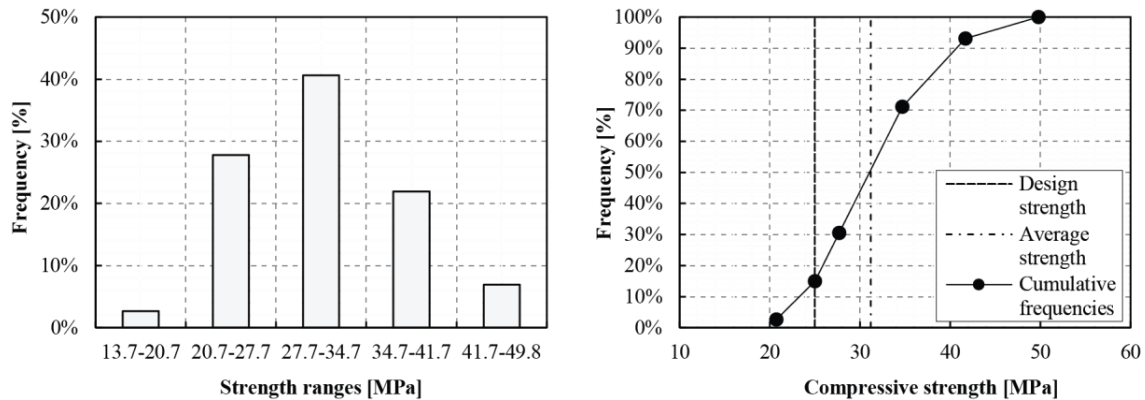
Fig. (17). Distribution analysis of compressive strength of concrete samples extracted from [HB]: Frequency of occurrence of strength range (on the left) and cumulative frequencies compared to design and average strength (on the right).

As far as the concrete is concerned, the homogeneity check has been carried out by analysing the data distribution respect to the declared value in the design phase ($R_{ck}=25\text{MPa}$). Hence, strength ranges have been defined considering the standards provided in the Italian code for new buildings, which considers acceptable a variance of $\pm 3.5\text{MPa}$ for the characteristic value. In particular, starting from the mean value obtained for all units of [HB] ($R_{cm}=31.2\text{MPa}$), the intervals were automatically determined. In Fig. (17) the distribution analysis for all units of [HB] is provided.

In the above graphs, it is clearly shown the Gaussian distribution of the compressive strength obtained with the destructive tests, as well as that the original design cubic strength (*i.e.*, 25 MPa) resulted overcome in about 85% of cases. Moreover, can be asserted that 41%, which is the frequency obtained for the range containing the average value, is surely an acceptable value in order to justify the homogeneity of the material. According to these statements, it has been considered reasonable to adopt a characteristic strength equal to those foreseen in the designing phase, *i.e.* $R_{ck}=25\text{MPa}$. Such an assumption has been even more corroborated by comparing the distributions obtained unit by unit. The additional analyses, which are not reported here for the sake of brevity, always returned values less than 20% of the cumulative frequencies at the original design value.

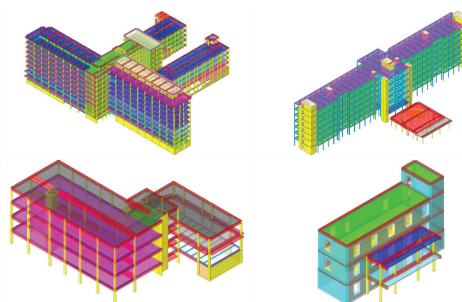
Fig. (18). Views of the numerical models: [HB] (top-left), [DH] (top-right), [AB] (bottom-left) and [NB] (bottom-right).

With reference to r.c. elements, frames have been modelled as mono-dimensional elements (hereinafter stated as *beams*, for both horizontal and vertical elements), while the presence of walls has been introduced in the models by means of 4-node *shell* elements. As far as structural steel elements are concerned, again, *beams* have been adopted, taking care to release the extremity bending moment in the horizontal elements to account for the hinge connections. Finally, for the masonry structure, a typical equivalent frame modelling has been used, with *beam* elements for piers and spandrels and rigid offset simulating their connections. In Fig. (18), the pictures of the implemented numerical models are shown.

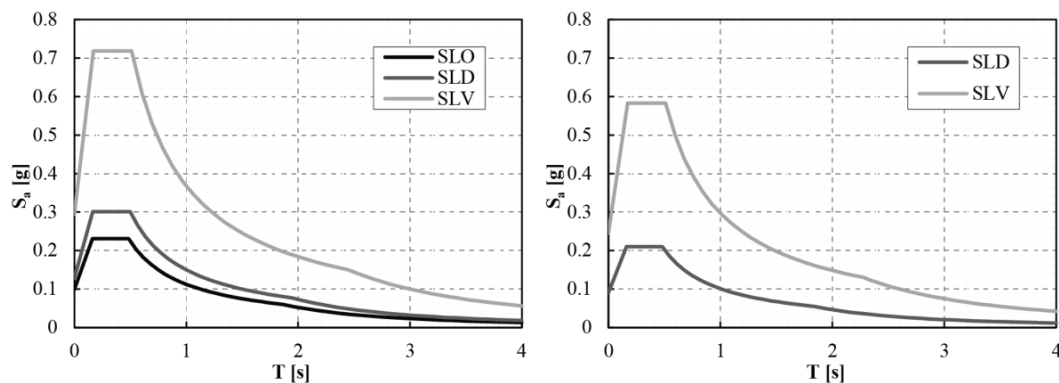
Fig. (19). Response spectra with $C_v=2$ (left) and $C_v=1$ (right).

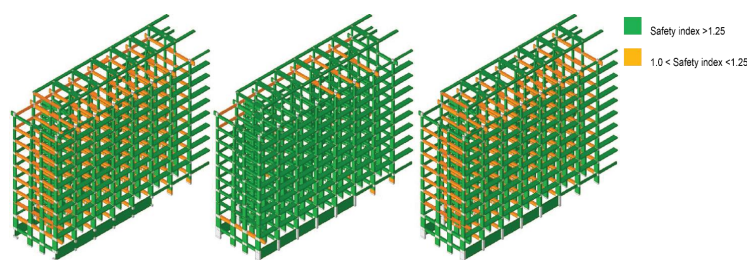
Fig. (20). Work rates of unit C of [HB]: minimum between bending moment and shear (left), bending moment (centre) and shear (right).

It is possible to observe that in almost all beams, the work rates resulted close to the unit due to shear stresses. Nevertheless, these results are surely acceptable in order to guarantee operatively the structures in case of standard load conditions. In addition, the obtained results have been further corroborated by means of six load tests on slabs, which always showed a good structural behaviour.

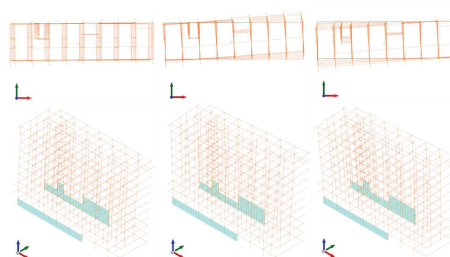
Fig. (21). Main results of the modal analysis: (left) mode 1 (T=2.06s, Mx=62.68%, My=0.18%), (centre) mode 2 (T=1.29s, Mx=0.59%, My=27.88%) and (right) mode 3 (T=0.98s, Mx=0.00%, My=38.21%).

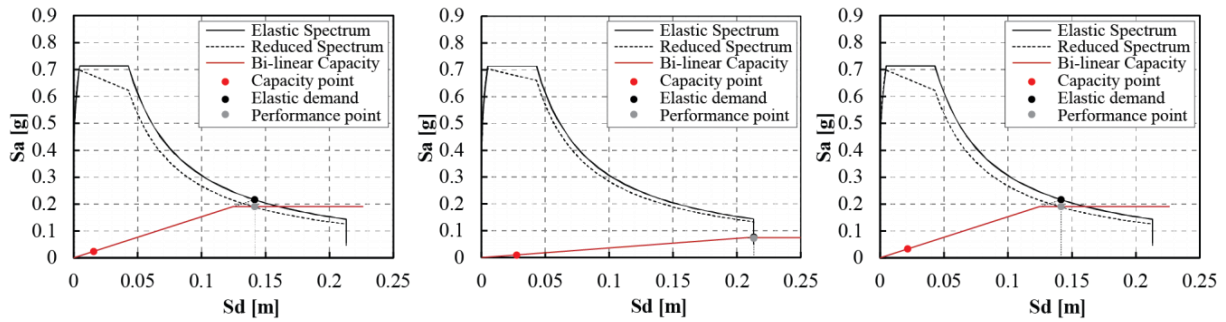
Fig. (22). Check in the ADRS plane for the *SLV* conditions: shear failures (left), node collapse (center) and flexural failure (right).

In Fig.(22), the checks in the ADRS plane related to the *SLV* conditions are plotted, while in Table 8, the obtained seismic risk indexes for each collapse (or damage) mechanism of unit C are summarised.

The results put into clear evidence the high seismic vulnerability of the investigated structure, being the minimum seismic risk index in terms of return periods equal to 0.197. More in detail, as far as the Operatively and Damage limit states are concerned, the structural checks are not satisfied, even if risk indexes quite close to the unit have been obtained. On the contrary, with reference to the structural checks at *SLV* conditions, the structure exhibited significant deficiencies, whatever the collapse mechanism was considered. In order to better understand the evolution of the considered collapse mechanisms, in Fig (23) the seismic risk indexes for each structural element and related to the different collapse criteria at the *SLV* are plotted in a contour view.

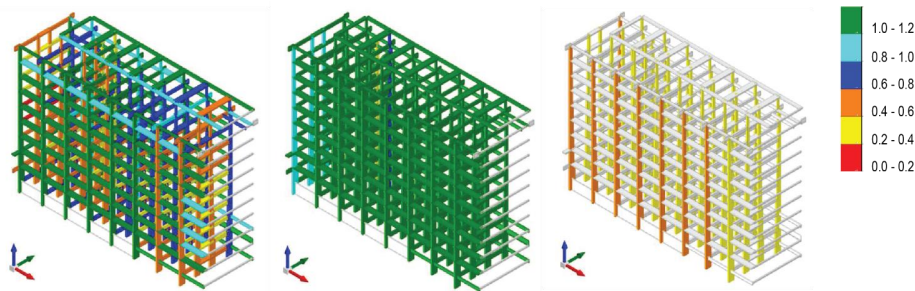
Fig. (23). Seismic risk indexes at the *SLV* for shear failure (left), node collapse (centre) and flexural failure (right).

In particular, among the collapse mechanisms of *SLV*, it is interesting to note that the mechanism corresponding to the lower index is the shear failure of the external beams of 5th and 6th stories. Moreover, columns are also affected by a relevant shear deficiency, especially the ones close to the staircases. Similarly, with reference to node collapse, the main seismic issues have been obtained in the staircase proximity, despite a lack of capacities that have been widely obtained. Finally, with regard to ductile (*i.e.*, flexural) collapses, although some columns present a bad capacity with respect to the demand, the largest portion of elements resulted verified against the design seismic loads.

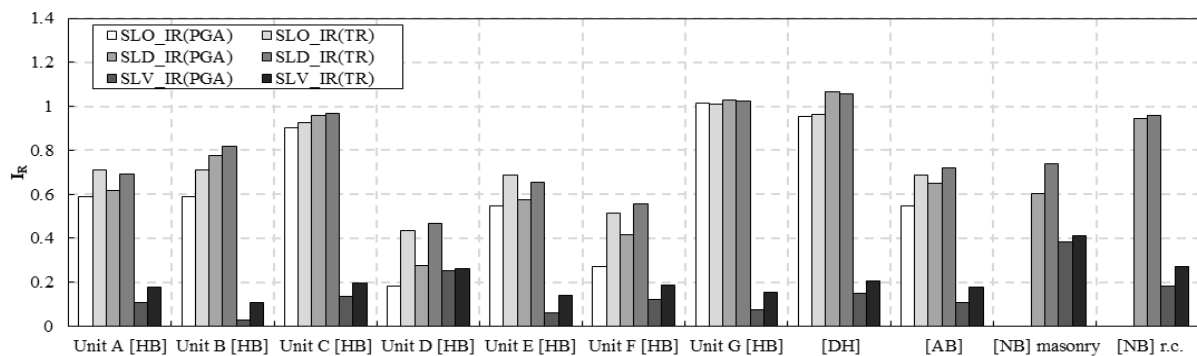
Fig. (24). Seismic risk indexes in terms of both PGA and T_r obtained with the numerical analysis for each unit.

In the whole, the results reveal a lack of seismic capacity with respect to the demand of the investigated structures. More precisely, even in the case of less significant seismic actions (*i.e.*, in *SLO* and *SLD* conditions), the seismic risk indexes resulted in most cases less than 1. As far as the *SLV* conditions are concerned, the so-defined strategic buildings, all returned a seismic risk index less than 0.26, in terms of both PGA and return period. Nevertheless, [NB] also exhibited a significant vulnerability, especially for the r.c. portion, despite less demand due to the ordinary use of the construction.

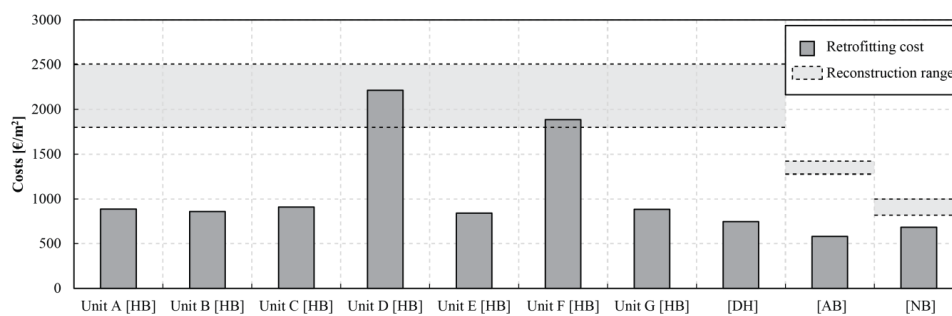
Fig. (26). Comparison between retrofitting and reconstruction costs.

The so-estimated costs include both structural and non-structural interventions, while disregard the labour cost, as well as design and tax amounts. Moreover, a weighted average has been considered for [HB] buildings, which leads to define a total retrofitting cost of 3'1855'000 € and a cost per square meter of story of 932 €/m². It can be stated that, according to this estimation, the Hospitalization Building, due to its structural complexity and strategic functionality, revealed the need of the most expensive interventions.
