Hygrothermal performance of highly insulated external walls subjected to indoor air exfiltration

Journal of Building Physics

DOI: 10.1177/17442591221109956

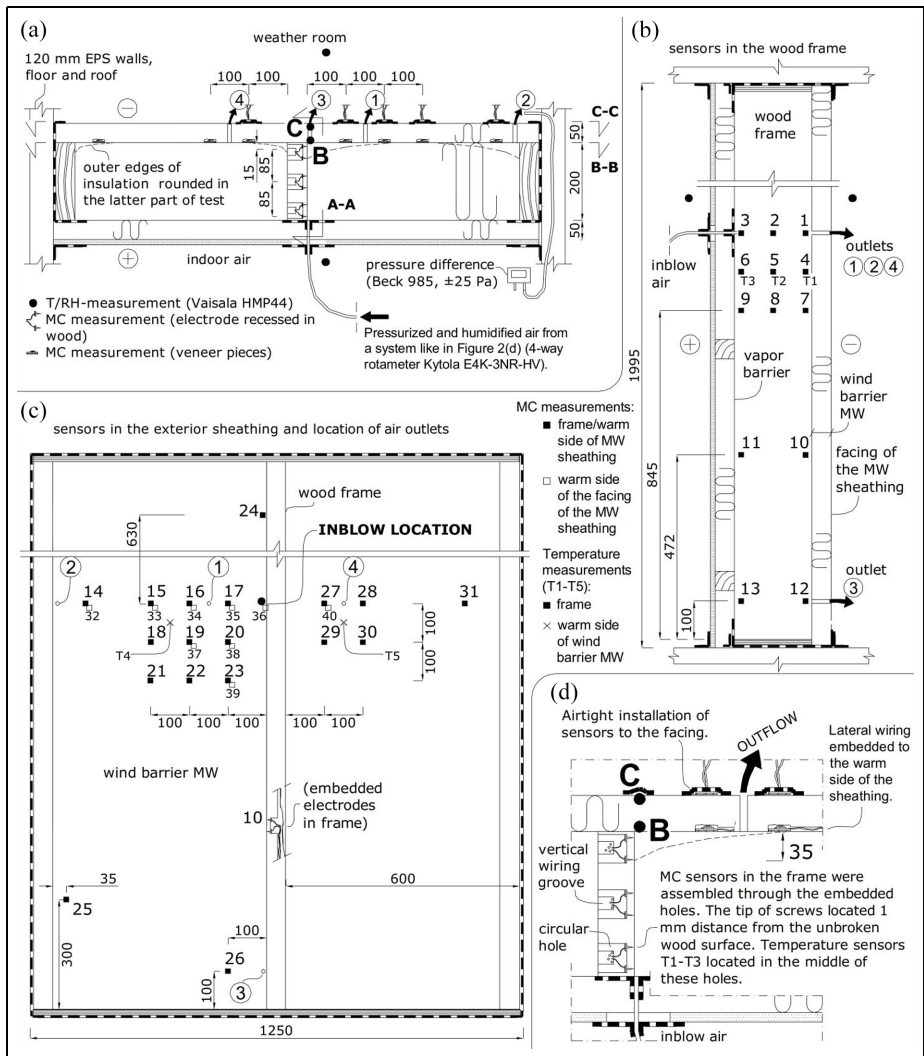
Figure 1. The setup for the MCM test: (a) horizontal section of the test wall, (b) vertical section of the wall seen from the side, (c) vertical sections seen from the outside air, and (d) close-up from the sensor assembly.

In the MCM test, a pipe with an inner diameter of 4 mm penetrated the vapor barrier of the test wall close to its wood frame while maintaining airtightness and represented a point defect in the vapor barrier (Figure 1(a)). Humidified indoor air (approx. 50% RH) was blown through the pipe at average rates of 1 and 2.5 L/min. Each in-blow phase with a different location for the air outflow lasted around 2 days, and the structure dried for the same period between the in-blow phases to minimize its wetting.

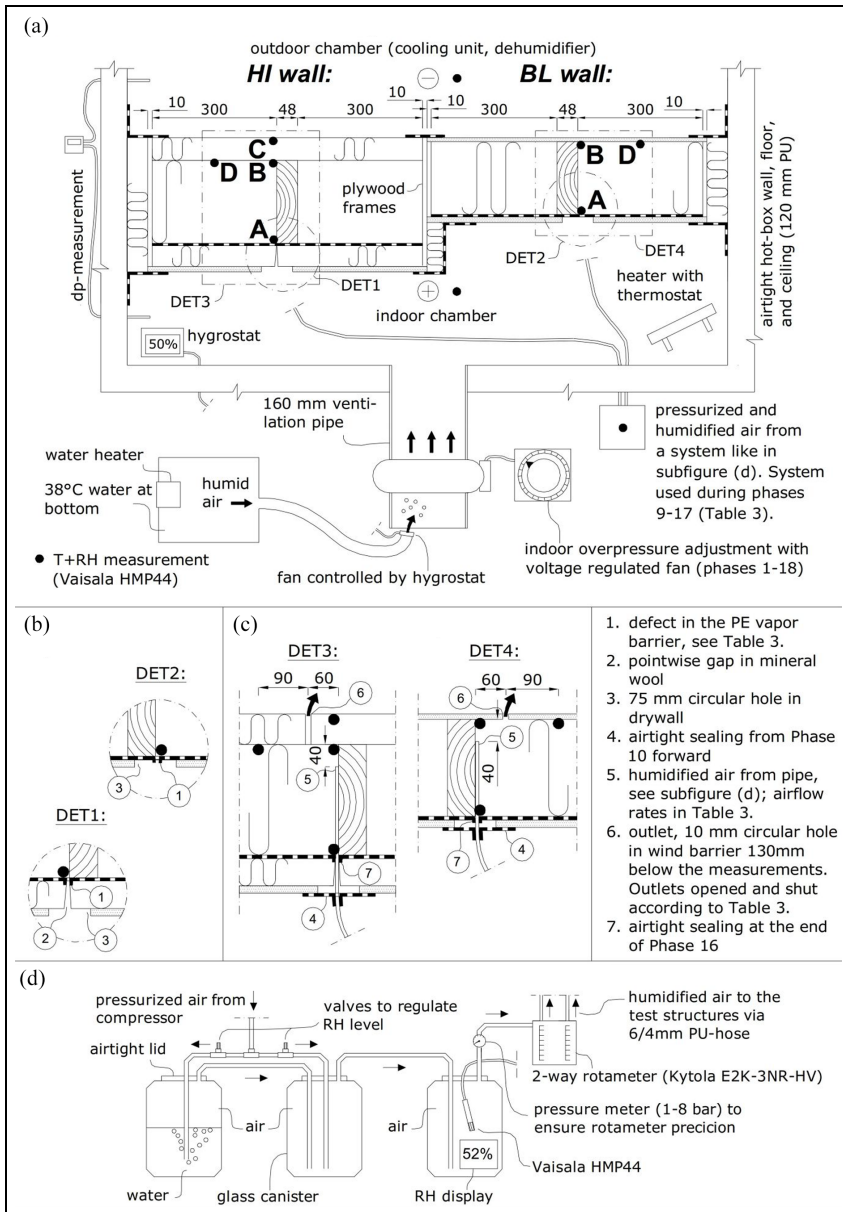
Figure 2. The setup for the MCONI test: (a) the test walls were assembled into a hot-box, (b) DET1–2: defect setup in the interior side of the structures during passive convection, (c) DET3–4: assembly of the in-blow pipes during active convection and the positions of the airflow outlets, and (d) the setup to create humidified air during active convection.

The second method in the MCON1 test, which was similar to the approach used in the MCM test, is called active convection, in which humidified air (Figure 2(d)) was blown directly over the cold side of the walls (Figure 2(c)). This method was used for phases 9–16 and represented a situation in which the thermal insulation does not fill the framing cavity properly or fills it with low hygroscopic materials.

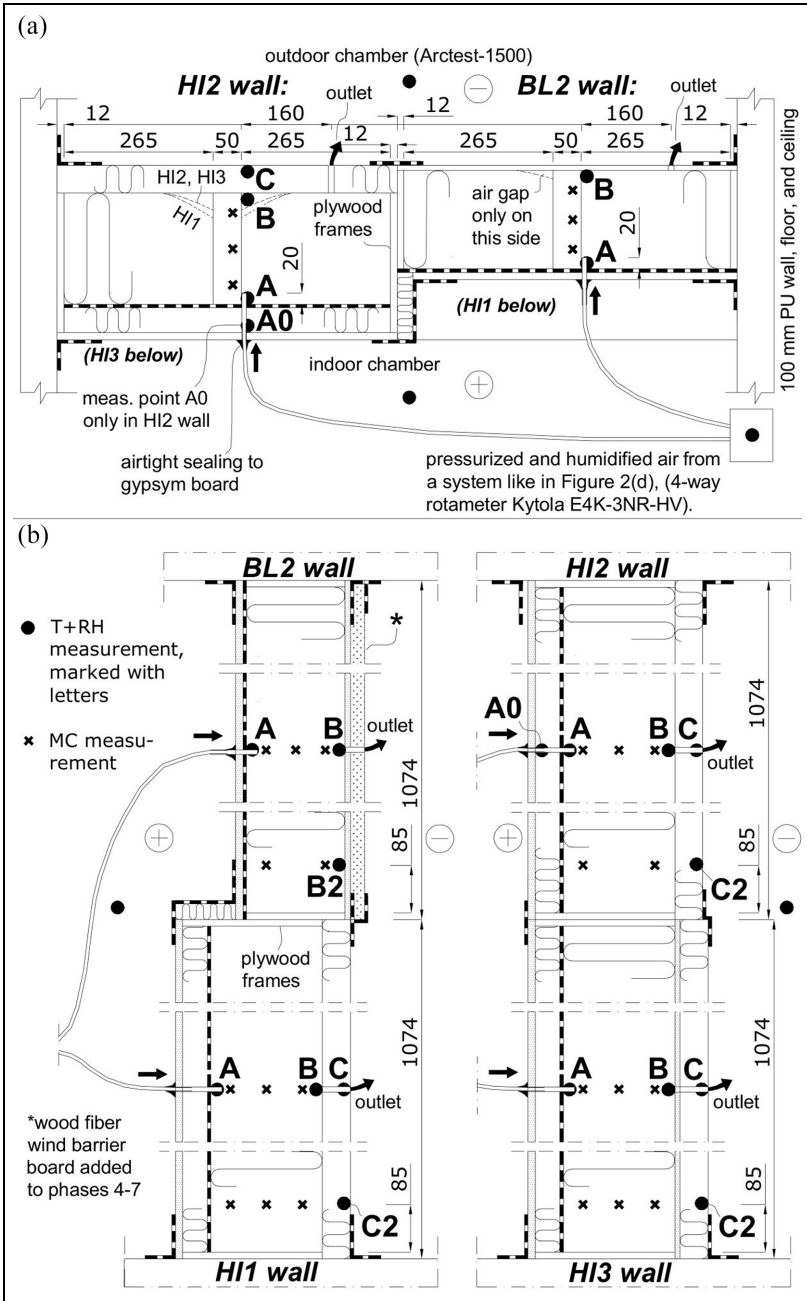
Figure 3. The setup and wall sections in the MCON2 test. All measuring points are located on the same plane: (a) horizontal section at middle height of the upper walls and (b) vertical sections of the four walls.

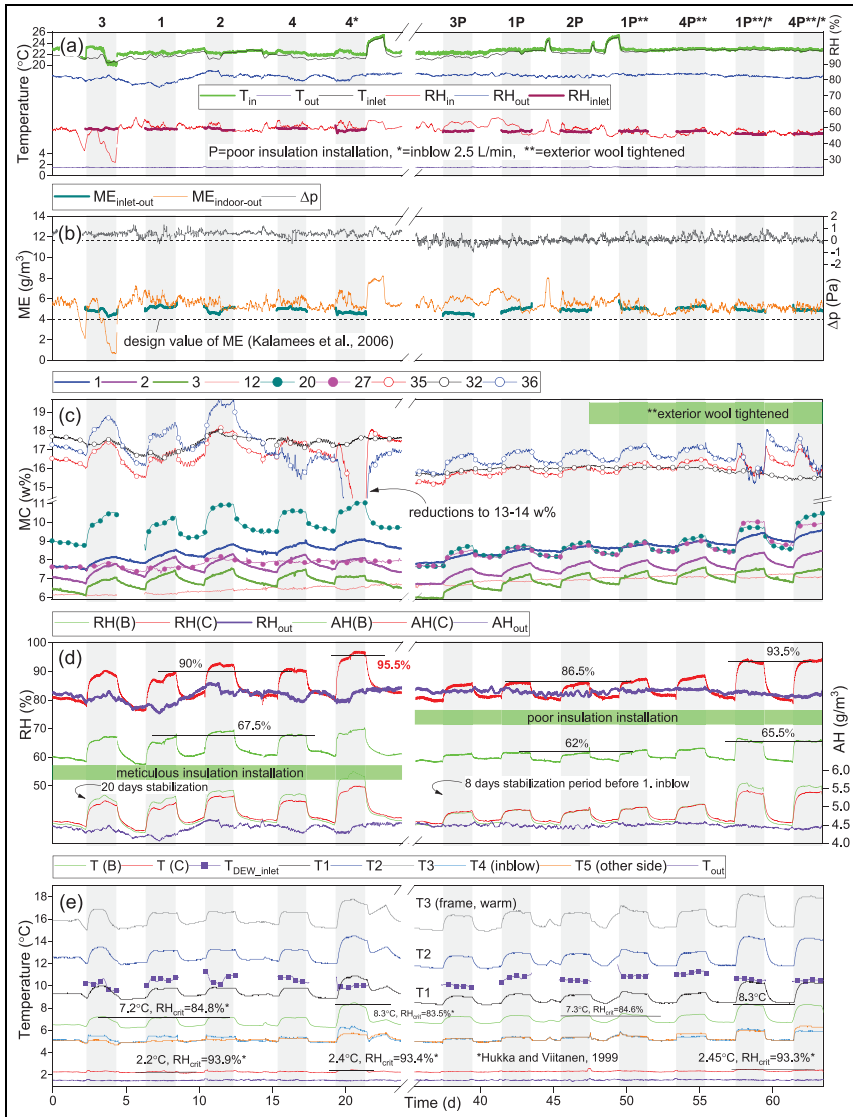
Figure 4. (a, b) The environmental conditions in the indoor and outdoor chambers during the MCM test, (c) the MC in the frame and in the exterior insulation (dotted lines), (d) RH and AH at Point B and C and in the outdoor air, (e) temperature in the frame, at Point B and C, on the warm face of the exterior wool, and in the outdoor air; the air in-blow phases at the top are named with the corresponding outlet number (e.g. Three denotes the air in-blow phase during which Outlet 3 was open).

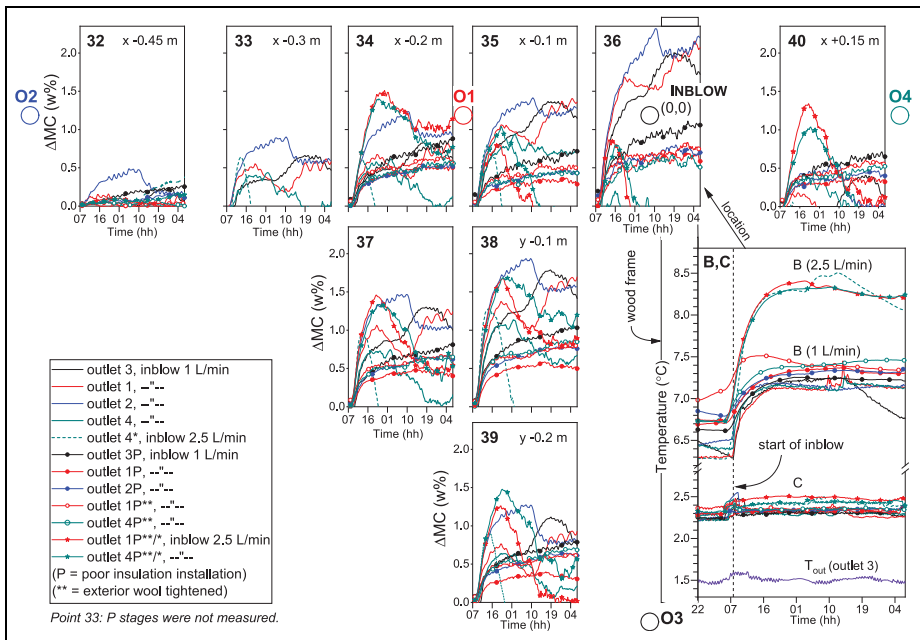
Figure 5. The absolute change in the MCs on the warm side of the facing of the MW sheathing during the in-blow phases of the MCM test. The temperatures at Point B and C also include the period before the in-blow. The numeric values indicate the location of the measurement points relative to the origin located at the in-blow.

The temperature at Point B increased by approximately 0.75 and 2°C for the air-flow rates of 1 and 2.5 L/min, respectively (Figure 5). This increase in temperature compensated for the impact of the higher in-blow rate on the RH at Point B. With an improper insulation installation, the temperature increases were 0.6 and 1.6°C , respectively, which indicates more effective convective heat transfer. At Point C, the temperature changes were of 0.15– 0.2°C , with airflows of 2.5 L/min. The calculated heat flux by conduction from Point B to Point C was equal to the combined convective and radiative heat fluxes on the outer surface of the wall, which indicates that convection was not involved in the heat transfer through the exterior wool, and, thus, the air flowed laterally over the warm face of the exterior wool. With a poor insulation installation, the temperature at Point B during the drying phases was 0.3°C higher than that obtained with proper insulation, which explains a local increase of 6% in the calculated heat flux close to the stud.

The initial MC increase observed during the phases with a 1-L/min in-blow rate decreased rapidly at Point 36 in the phases with an in-blow rate of 2.5 L/min (Figure 5). Further, the timing of this coincided with the temperature increase at points B and T1 (Figures 4(e) and 5). At Point T1, the temperature rose to become close to or more than the dew point of the leakage air, which illustrates the connection between an increase in the exterior temperatures and a reduction in the

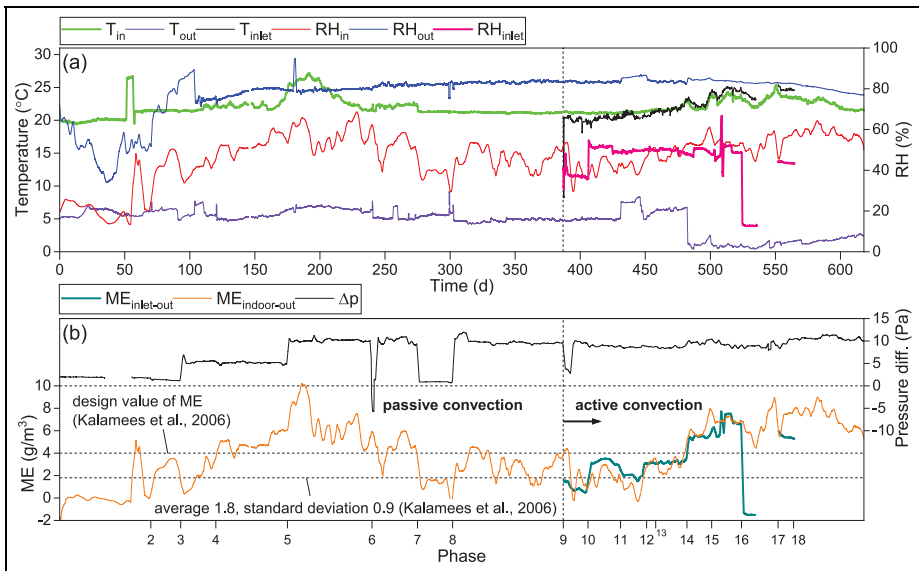
Figure 6. The measured environmental conditions during the MCONI test: (a) temperature and RH and (b) the ME between the inlet and outdoor air and between the indoor and outdoor air in addition to the PD across the walls.

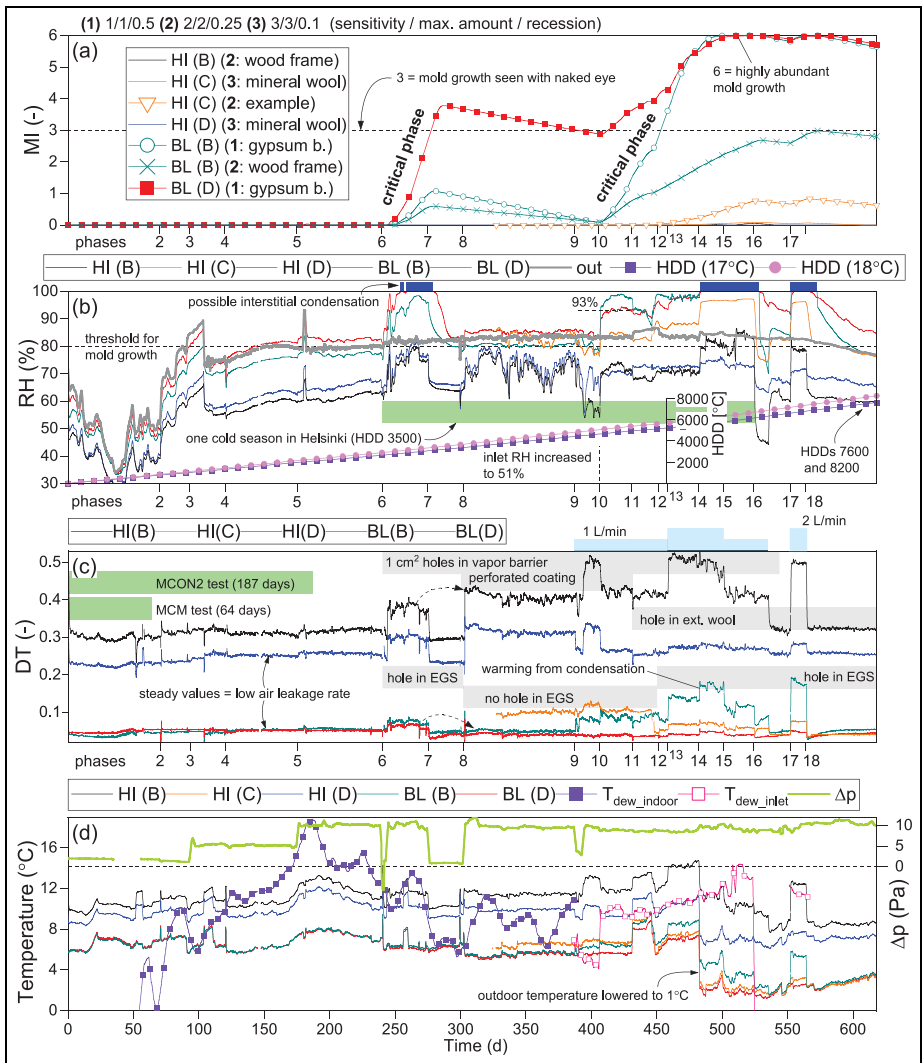
Figure 7. The results from the MCON1 test: calculated (a) MIs, (b) HDDs, (c) DTs, and (d) dew point temperatures of the indoor and in-blow air. Measured (b) RH, (d) temperature and PD. The duration of the MCON2 and MCM tests is illustrated in subfigure (c).

Effect of impaired airtightness on exfiltration. The stable DTs (Figure 7(c)) observed during phases 1–5 suggest that the air leakage through the cuts in the vapor barriers was low. In the middle of Phase 3, the dehumidification of the outdoor air lowered the RH at the exterior side of the walls (Figure 7(b)). In Phase 5, the AHs increased at Point A due to the indoor air being more humid and the PD rising, but they were distinctly below the indoor AH. The RHs for the external sections of the HI and BL walls remained at a safe level of 65%–82%. In Phase 6, the temperatures and AHs rose to become almost equal to the indoor levels at Point A, which implies an increased airflow rate that was enabled by the enlarged defects and the hole in the EGS. The DTs increased in both walls at Point B and D, which supports the previous conclusion. The RH rose to 98%–100% at Point BL(B) and BL(D) during the 19–30-day period, and condensation may have formed at Point BL(D). The rise of the RH was slower than that reported in the numerical study of Ojanen and Kohonen (1989), where 100% RH developed in just a few days. In their study, a low- Γ wall was exposed to an indoor air leakage rate of 7.2 L/min per meter of wall, the indoor RH was 60%, and the outdoor temperature was -22°C , which could explain the faster condensation. The MI value approached three at

Point BL(D) during the 35 days of Phase 6 (Figure 7(a)). The RH values in the HI wall at Point B and D presented a similar trend but remained at a safe level.

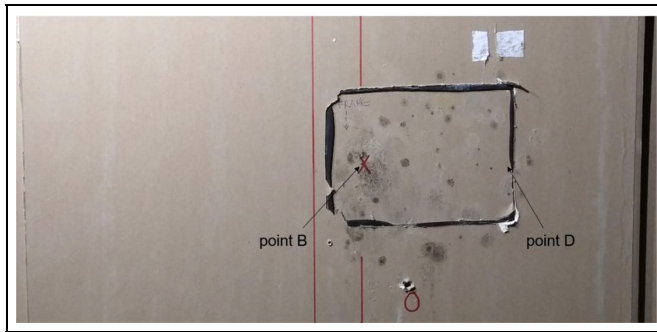
Figure 8. Mold growth was observed on the interior face of the EGS after the MCONI test. The wood frame was located between the vertical lines, the inlet pipe was located opposite the spot marked with the letter “X,” and the outlet hole was located next to the letter “O.” The black ethylene propylene diene monomer (EPDM) sealant is visible at the edges of the EGS piece, whose outer surface was additionally taped. The EGS piece was removed at the end of Phase 3 for probe installations. The board was kept intact before that point.

Risk of mold growth opposite to the air leakage. The moisture accumulation in the exterior part of the BL wall was confirmed via a visual inspection after the test; mold growth was observed on the interior surface of the EGS. The mold covered about 60% of the damaged area, the height and width of which were both 0.2m (Figure 8). This area had an MI value of 5 , and it likely delimited the part of the EGS with

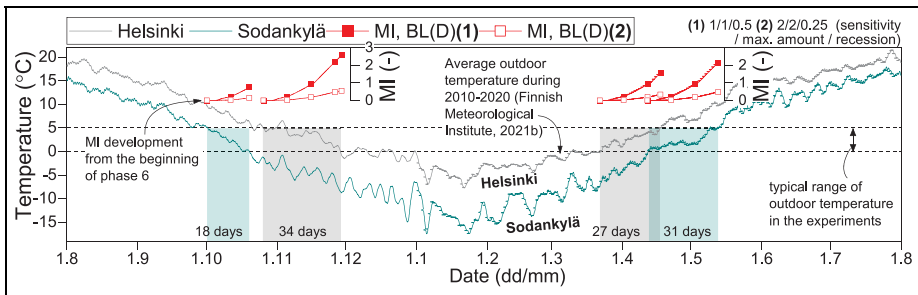
Figure 9. The observed MI development in the BL wall placed in the season whose temperature corresponds to the outdoor temperature used during the MCONI test.

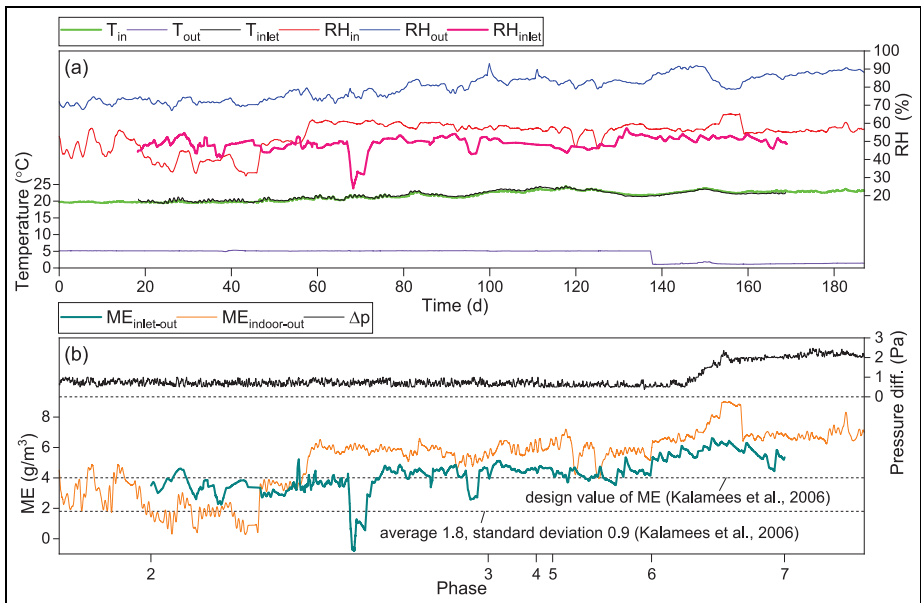
Figure 10. The measured environmental conditions during the MCON2 test: (a) temperature and RH and (b) the ME between the inlet and outdoor air and between the indoor and outdoor air in addition to the PD across the walls.

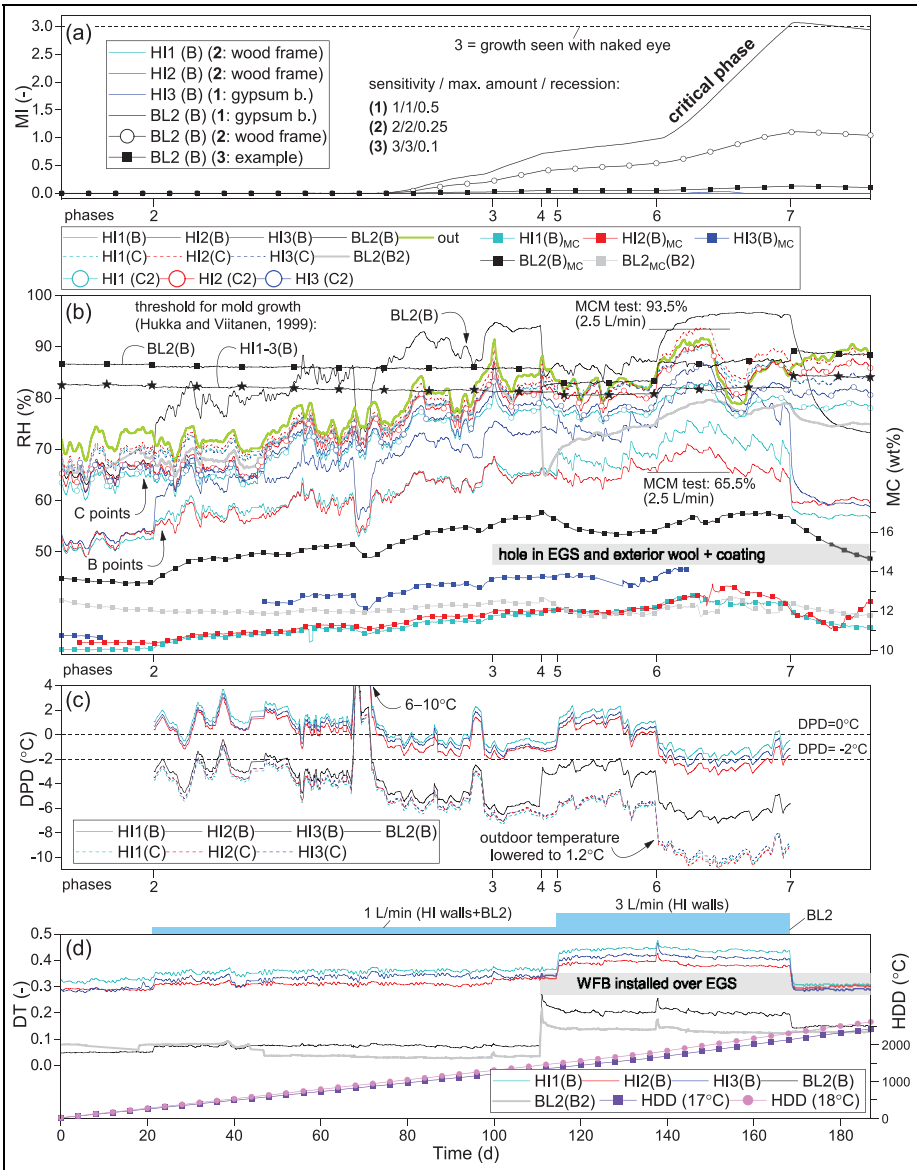
Figure 11. The results from the MCON2 test: the calculated (a) MIs, (c) DPDs, (d) DTs and HDDs with the measured (b) RH and MC at Point B. Additional results are presented from points B2, C, and C2.

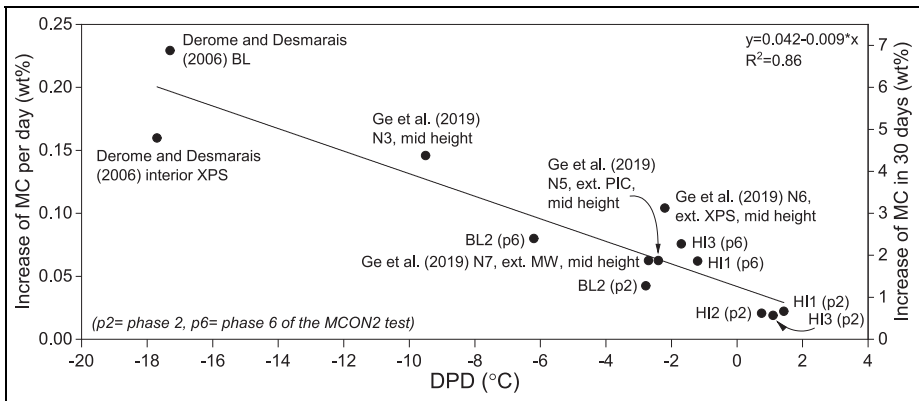
Figure 12. The correlation of the measured MC increase with the DPD value in the studies described in Table 5.

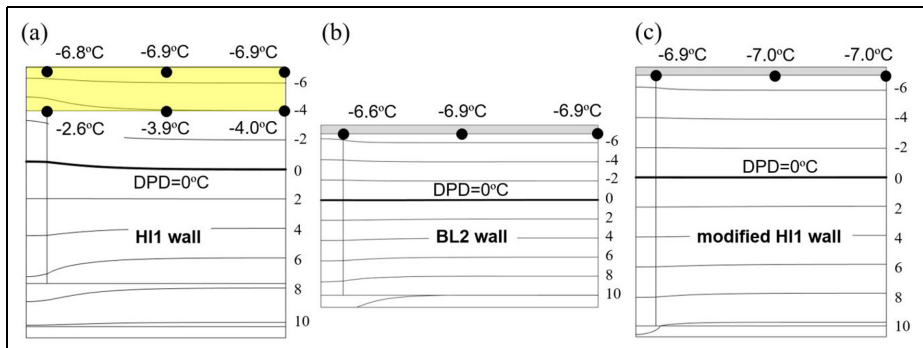
Figure 13. The numerical solution of the two-dimensional DPD distributions in (a) the HI1, (b) BL2, (c) and modified HI1 walls during the third phase of the MCON2 test. The exterior sheathings are highlighted in yellow (MW) and gray (EGS). The calculation was performed with the commercial software Comsol Multiphysics 5.5 using the Heat transfer in solids module to consider the heat transferred only through conduction.

Visualization of exterior thermal conditions through two-dimensional DPD distribution. The average DPD values obtained for the horizontal sections of the HI1 and BL2 walls during Phase 3 of the MCON2 test were visualized by solving the two-dimensional temperature distribution and subtracting the average dew point temperature of the leakage air from the solution. The average values of the temperatures measured for the indoor, outdoor, and leakage air were used with the average RH of the leakage air. The heat transfer coefficients were 7.7 and 25 W/m²K for the internal and external surfaces of the 300-mm-wide domains used in the calculations, respectively. The heat convection from the airflow was not considered. At Point B, the DPD was -6.6 and -2.6 °C for the BL2 and HI1 walls, respectively (Figure 13).

The HI1 wall modified by using gypsum boards on both sides of the 300-mm-thick insulation was also analyzed (Figure 13(c)). The DPD at Point B in the modified HI1 wall was only 0.24°C lower than that in the BL2 wall, indicating that the U value contributes to the moisture accumulation caused by exfiltration less than the Γ value. The measurements support the fact that the hygrothermal behavior of the BL and BL2 walls is extremely similar to the HI walls that are equipped with similar exterior sheathings. Although having a lower temperature at the outer

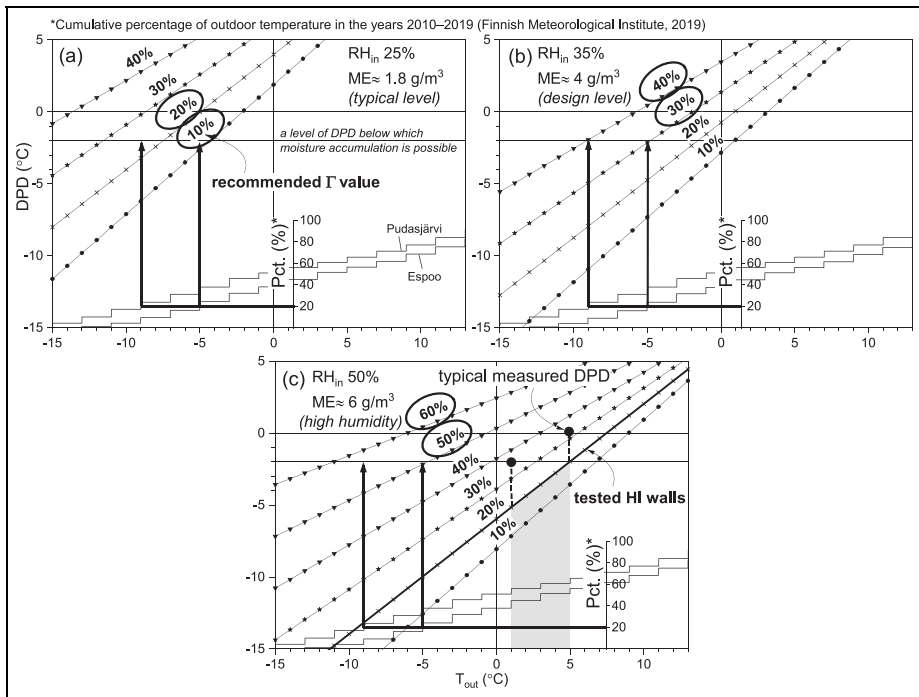
Figure 14. The dimensioning charts to restrict the duration per year (e.g. 20% = 73 days) during which fast moisture accumulation from exfiltration is possible by choosing the Γ value and considering the indoor RH of (a) 25%, (b) 35%, and (c) 50%. The recommended Γ values apply to structures with vapor permeable exterior sheathing (S_d value about 0.1 m). With vapor tight exterior sheathings, the target value of the DPD should be increased to 0 °C.

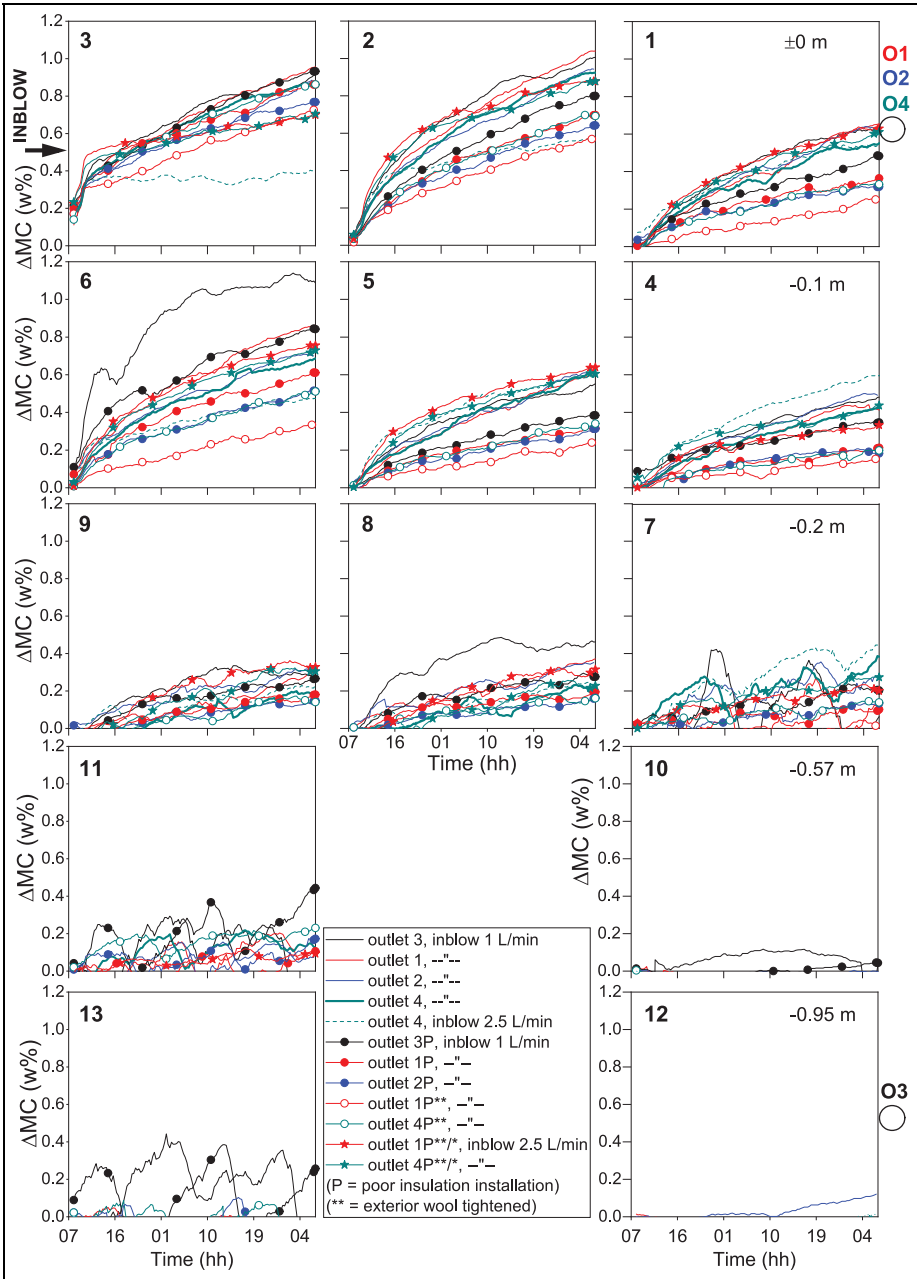
Figure A1. The absolute change in the MCs on the surface of the wood frame during the in-blow phases of the MCM test. The numeric values indicate the height of the measurement points that are relative to the in-blow height.

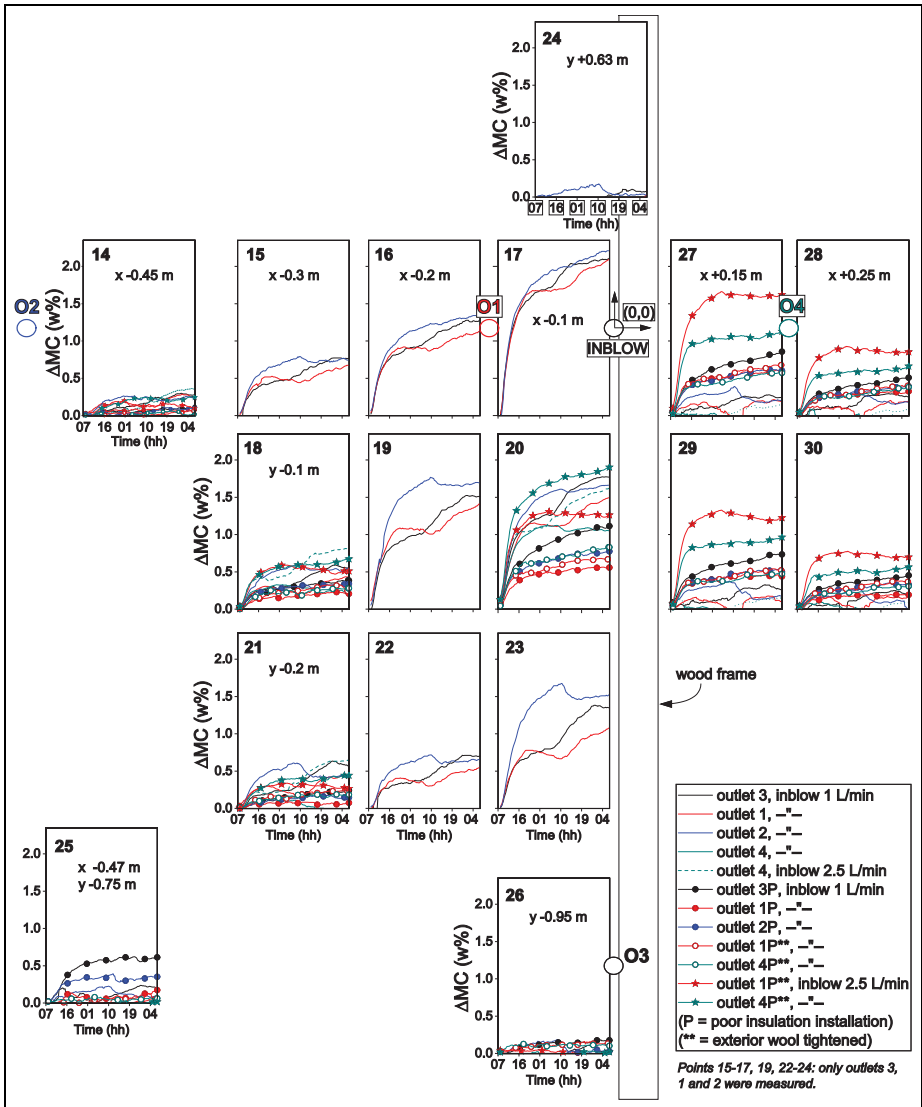
Figure A2. The absolute change in the MCs on the warm side of the exterior MW during the in-blow phases of the MCM test. The numeric values indicate the location of the measurement point relative to the origin located at the inlet.

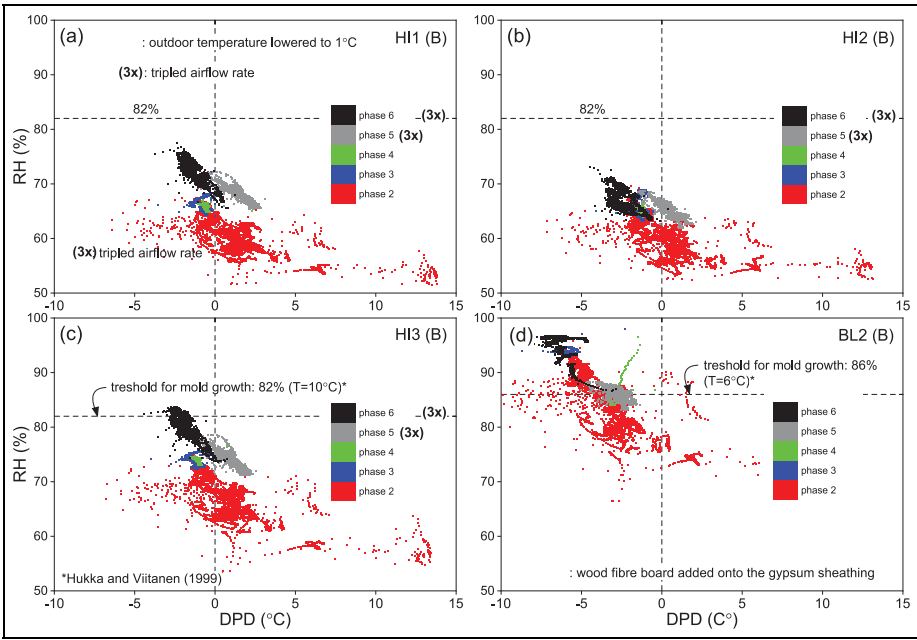
Figure A3. The correlation between the measured RH and DPD at Point B during the MCON2 test.

Figure A3), which, combined with the fact that wood has approximately a linear moisture capacity at high RH levels, explains the significance of the DPD value. The MCM test also showed that the RH at Point B depends little on the outlet location, which may explain the similarity between the current results and the ones by Ge et al. (2019), although in their study, the in-blow air returned to the indoor chamber. The airflow rate, however, restricts the applicability of the method; based on the computer simulations of Ojanen and Kumaran (1995), the heating effect of the airflow, starts to reduce moisture accumulation inside a low- Γ wall when a concentrated air leakage rate is above 12.5 L/min, and with a flow rate of 25 L/min, the accumulation stops completely. Therefore, the DPD method should not be used when the leakage rate is well above 12.5 L/min, as the method ignores the heating effect of airflow. Based on the observations from the MCON2 and MCM tests, with a Γ value of 20%, a flow rate of already 2.5–3 L/min may locally prevent the accumulation of moisture at the cold section of a wall. However, as the MC of the whole wall increases in this situation, such airflow rates are still detrimental to the performance of the wall.

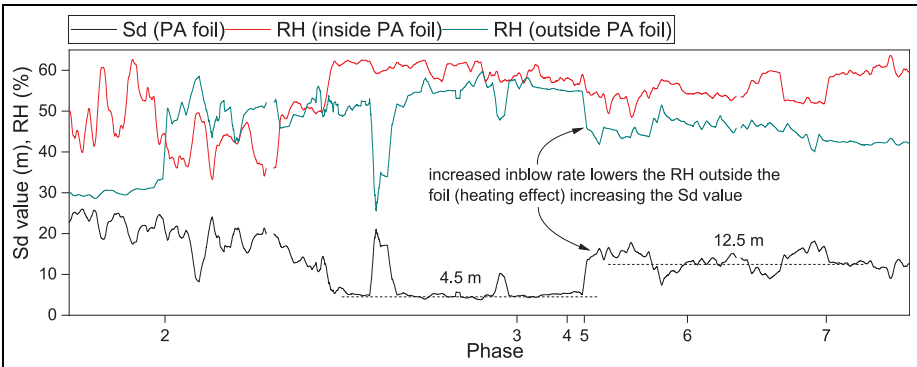
Figure A4. The RH conditions on the different sides of the moisture adaptive vapor retarder (at points A and A0) used in the HI2 wall and the resulting Sd value of this membrane.
