## Development and Experimental Assessment of Friction-Type Shear Connectors for FRP Bridge Girders with Composite Concrete Decks

# Development and Experimental Assessment of Friction-Type Shear Connectors for FRP Bridge Girders with Composite Concrete Decks

**Abstract:** This paper details the development and experimental assessment of a friction-type connector, designed to transfer shear flow between the top flange of a fiber-reinforced polymer (FRP) tub girder and a composite concrete deck for bridge applications. In contrast with previously used bearing-type connectors, this system relies on a deformed FRP surface to transfer shear via direct interlock with the concrete deck. The connector is materially efficient, simple to fabricate, can be used with lower-grade structural or stainless-steel fasteners, and provides a high degree of interface stiffness. Six compression-shear specimens were tested to assess the connector fatigue resistance and ultimate connection strength. Additionally, two short beam specimens were tested in three-point bending, one of which was subjected to fatigue loading. Based on the compression-shear tests and short beam tests, the connection exhibited s

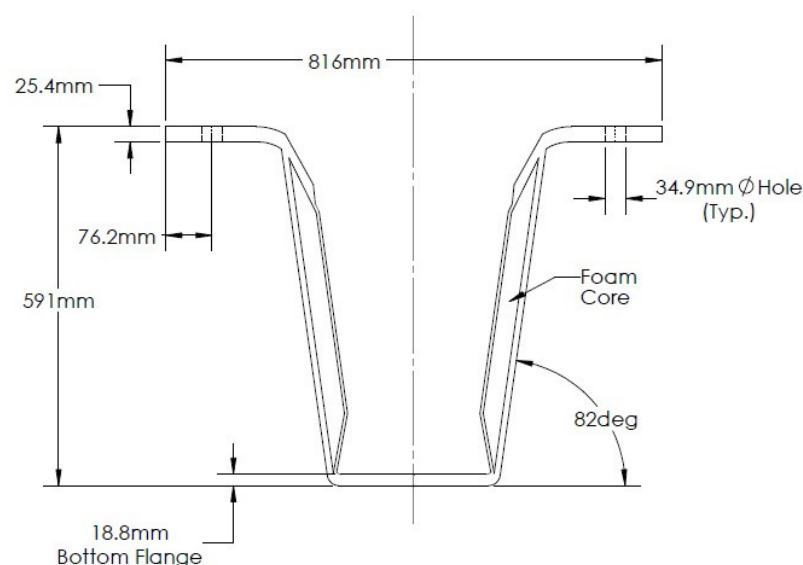
**Figure 2.** FRP Test Girder Cross-Section.

The FRP girder section shown in Figure 2 was used as the basis for the initial connector development and testing detailed in this paper. The important characteristics and properties of the section, along with results of its analysis, are reported here to support the development of the connector testing program. The girder was proportioned to support Strength I loading per current AASHTO *LRFD Bridge Design Specifications* [21], assuming a 12.5 m simple span model structure having a 9.14 m overall width and 4 girders spaced at 2.29 m on the center. The girder's concrete deck consisted of precast panels that were grouted to the shear connectors, using a self-consolidating concrete mix with a 9 mm maximum aggregate size. The design loading consisted of self-weight plus 0.54 lanes of AASHTO HL-93 live load with impact per girder, and 0.51 lanes of AASHTO traffic-induced fatigue loading, including impact per girder. All Strength I HL-93 truck loads were increased by 25%, per Maine Department of Transportation requirements. A 75 mm asphalt wearing surface was assumed to be applied as a minimum superimposed dead load.

The member was fabricated by vacuum infusion using a 3D-printed polymer female mold, and had solid E-glass top flanges, consisting of alternating layers of  $+/-45^\circ$  and

0° E-glass, foam-core webs with balanced +/−45° E-glass face sheets, and a bottom flange, containing uniaxial carbon fabric. Derakane 610c resin produced by Ashland Global of Wilmington, DE, USA—an epoxy-vinylester blend exhibiting excellent durability and toughness that has been successfully used to fabricate hybrid, carbon/glass, concrete-filled FRP tubes used in bridge construction [9,22]—was used for the infusion. The key mechanical properties of the section derived from laminate analysis are summarized in Table 1. It is important to note that the test girder employed first-generation bearing-type shear connectors that were closely spaced at 15.2 cm on the center in each flange. These connectors provided good composite action in the bending test, and the test to failure showed the girder to have a live load bending strength of approximately six times the service live load with impact [18]. However, these connectors exhibited poor fatigue performance in subsequent testing [20]. As a result, the 22.9 m vehicular bridge constructed on the US Route 1A in Hampden, Maine, USA in 2020 (see Figure 3) utilized a second-generation bearing-type connector demonstrated to have sufficient fatigue resistance [20]. An analysis of data from a field live load test of this bridge verified that full composite action was achieved using the second-generation connector [19], although it was reliant on closely spaced high-strength A490 bolts that carried shear transferred through direct bearing on the girder flanges [18,20].

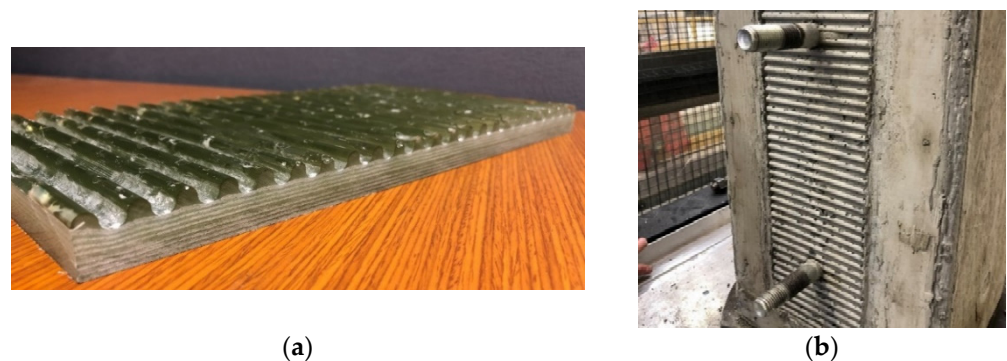
**Figure 4.** Elements of Ridged Shear-Friction Connection: (a) FRP Plate Infused with Ridges Using Caul Plate; (b) Concrete Surface Cast Against Ridged FRP Plate.

A remaining challenge is the creation of the deformed surface on the girder top flange, for which at least three methods exist. The deformations can be formed by machining grooves in the flange after girder infusion, by bonding a deformed plate or other protrusions to the smooth flange top surface after infusion, or creating the deformations during the primary infusion. The third option was selected, since it is the least labor-intensive, uses less material, and does not rely on secondary bonding, which creates an additional failure path that might be subject to environmental or fatigue degradation. The deformations were formed using a high-density polyethylene (HDPE) caul plate, with sinusoidal ridges machined across its width on one surface. The minimum amplitude of the sinusoidal ridges required by ACI [23] for intentionally roughened concrete surfaces in shear-friction connections is 6.3 mm. Before the infusion, the HDPE caul plates were placed above the top flange fabric and under the vacuum infusion bag, with the ridges facing downward. During the infusion process, resin flows between the ridges on the caul plate and produces mirror-image sinusoidal corrugations in excess resin, on the upper surface of the girder top flange. To illustrate, Figure 4a shows a single vacuum-infused FRP plate with the sinusoidal ridges, and Figure 4b shows a cured concrete surface that was cast against a ridged FRP plate. It is important to note that the ridged HDPE caul plates do not bond to the vinylester resin when treated with a bond-release agent, and so can be reused for multiple infusions.

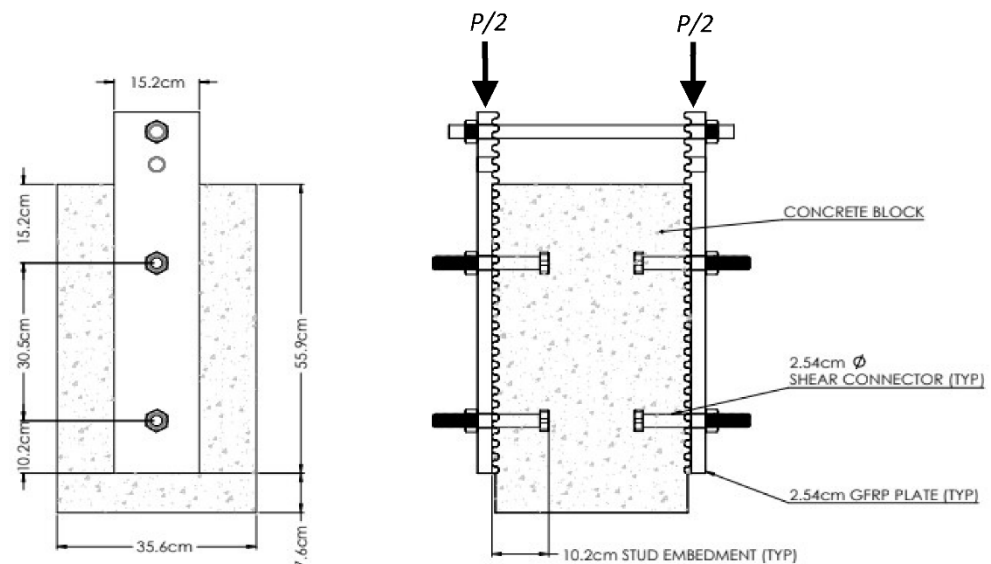
**Figure 5.** Shear Block Test Specimen Details and Geometry.

The dimensions of the compression-shear test specimens and the test configurations are shown in Figure 5. The concrete block was cast against two opposing ridged FRP plates, with a fiber architecture and dimensions matching the girder flanges. The same self-consolidating concrete, with a 9 mm maximum aggregate size that was used for the previously detailed test girder with precast deck panels and tests of bearing-type connections [18,20], was used. The initial tests of all four specimens used A325 bolts spaced at 30.5 cm, less than the 47 cm theoretically needed for strength, but twice the spacing of the bearing connectors used in the original girder test. (Later in this paper, the use of a stainless steel threaded rod in lieu of A325 bolts is assessed with additional tests.) The FRP plates were coated with form oil, prior to the concrete casting, to eliminate the chemical bond between the ridged FRP and concrete surfaces, and the plates were removed after the block was cured, prior to reinstalling for each test, to verify there was no chemical bond. The fasteners were torqued to 305 N-m and independent tests of instrumented bolts by Guzzi [20] demonstrated to produce a bolt pre-tension of 227 kN, the value required by AASHTO [21] for a slip-critical connection. To produce identical shears of P/2 on each side of the connection as shown in Figure 5, the specimens were loaded by a hydraulic actuator reacting on the center of a single steel plate, supported by the protruding portions of both FRP connection plates. The instrumentation consisted of a calibrated load cell, as well as four linear variable differential transformers (LVDTs) that measured relative slip during the fatigue test, one at each fastener. For the strength tests, PONTOS digital image correlation was used to measure the relative slip between the FRP plate and the concrete block near each bolt. These and all the tests detailed later in this paper were conducted indoors, at a temperature of approximately 20 degrees C. The humidity was not controlled, and did vary seasonally and, to a lesser extent, daily, depending on the time of year. However, the material properties of the concrete and FRP are not expected to vary significantly with normal changes in temperatures and humidity experienced by a typical bridge.

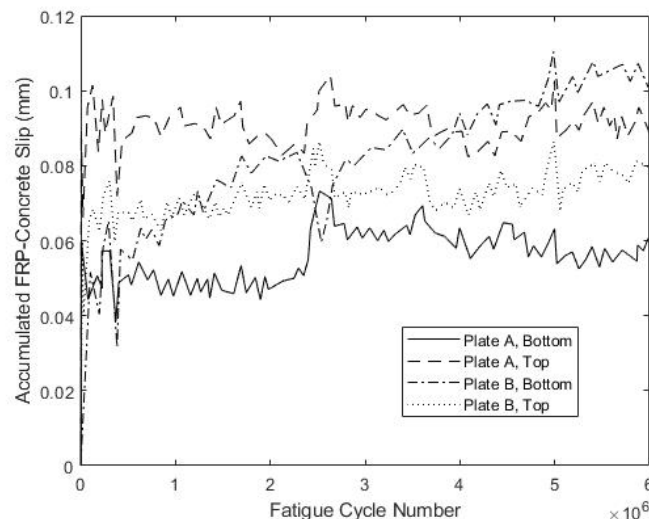
**Figure 6.** Fatigue-Induced Slip at FRP-Concrete Interface for S1.

Both specimens S1 and S2 withstood the full  $6 \times 10^6$  cycles of fatigue loading, while exhibiting little stiffness degradation or apparent damage. To illustrate, Figure 6 shows the total measured slip near each fastener, corresponding the maximum load of 212 kN measured over the course of  $6 \times 10^6$  load cycles for specimen S1. These data indicate that the maximum slips were very small, on the order of 0.1 mm, and tended to stabilize near their peak value early in the fatigue regime. This is consistent with very little damage accumulation and good shear transfer between the concrete and FRP. The slips observed for specimen S2 had greater variability at different fasteners, but were similarly small, ranging from 0.02 to 0.13 mm, and also stabilized early in the fatigue regime.

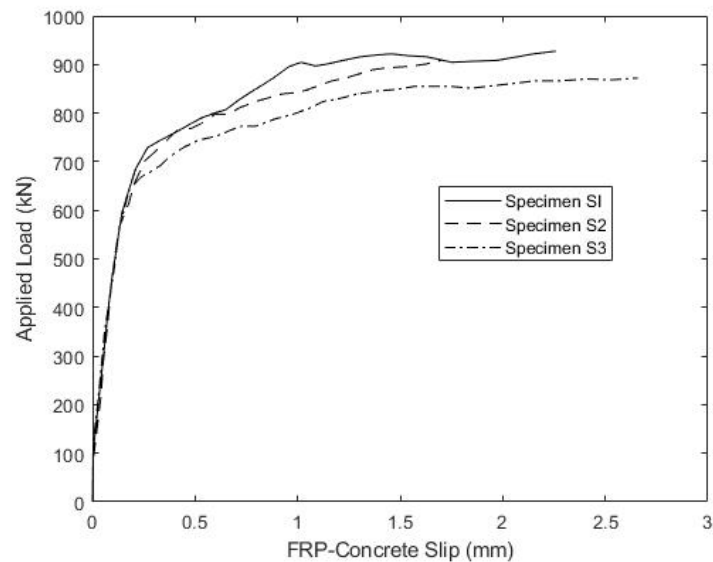
Figure 7. Shear Connection Load-Slip Response under Monotonic Loading to Failure.

that the FRP ridges were able to withstand the expected ultimate shear flows and that the connection design was controlled by concrete shear strength. To illustrate, Figure 8 shows the failed concrete ridges on a compression-shear specimen post-failure, following the removal of the FRP plates. The bolts were not bent or otherwise deformed, and although there is a vertical crack in the concrete block, there was no evidence of a bearing failure of the concrete or the FRP plate near the bolts.

It is also valuable to assess connection stiffness, as it helps to better understand the degree of composite action the connection can provide. For the linear range of load-slip data up to ~600 kN, as shown in Figure 7, the average stiffness of specimens S1–S3 is 4250 kN/mm. In contrast, similar tests of bearing-type connectors with four, A490 fasteners exhibited an average stiffness of 625 kN/mm [18], which is 85% less than the 4250 kN/mm observed here. The greater stiffness of the ridged friction-type connection will result in a higher degree of composite action in an FRP beam with a concrete deck.

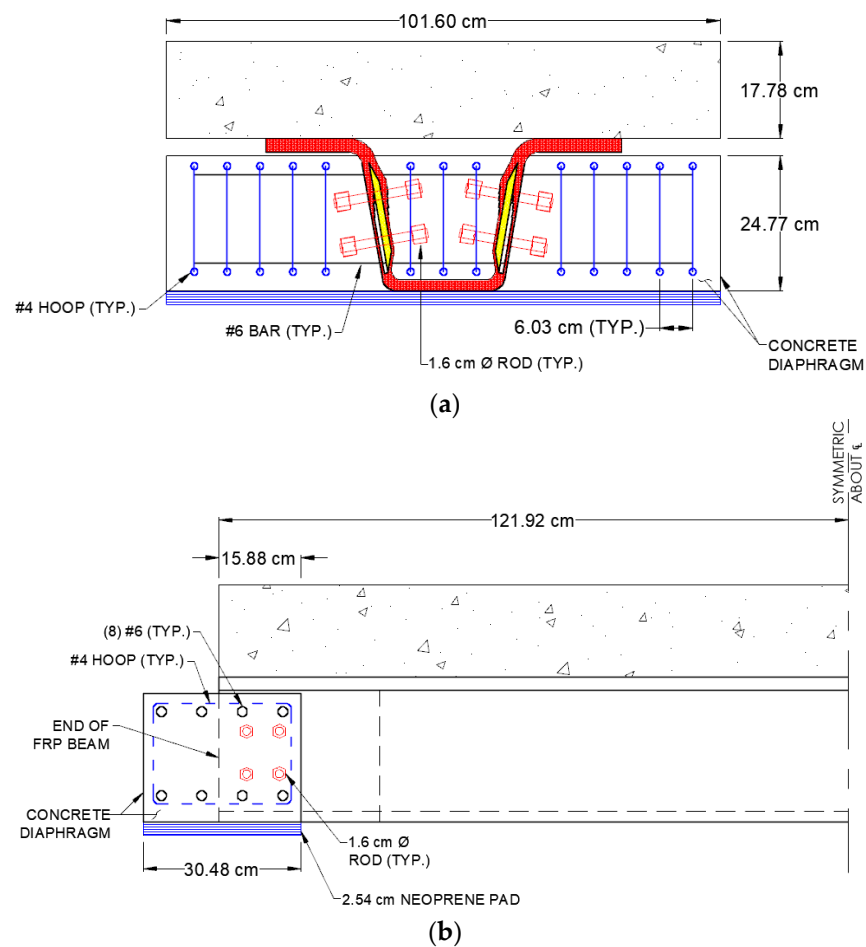
**Figure 9.** Details of Short Beam Specimens: (a) End Elevation; (b) Details of Short Beam Specimens.

Table 3 summarizes the dimensions of the beams; the same E-glass and carbon fabric architecture and foam core webs used for the model beam detailed in Section 2 were used here. Figure 9 is a dimensioned drawing of a specimen, showing the 17.8 cm thick concrete deck and details of the beam connection to the end concrete diaphragm. The concrete deck had longitudinal and transverse steel reinforcing, typical of that found in a bridge deck, and was cast from the same self-consolidating mix used for the shear block specimens. The deck concrete compressive strength,  $f'_c$ , on the day of beam strength testing was 77.4 MPa, based on standard cylinder tests. The critical computed cross-sectional properties needed to compute shear flows at the deck-girder interface using Equation (5) are the first moment of the concrete deck taken about the neutral axis of the section  $Q = 4503$  cm<sup>3</sup> and the transformed section moment of inertia  $I = 162.2 \times 10^4$  cm<sup>4</sup>, as reported by Guzzi [20].

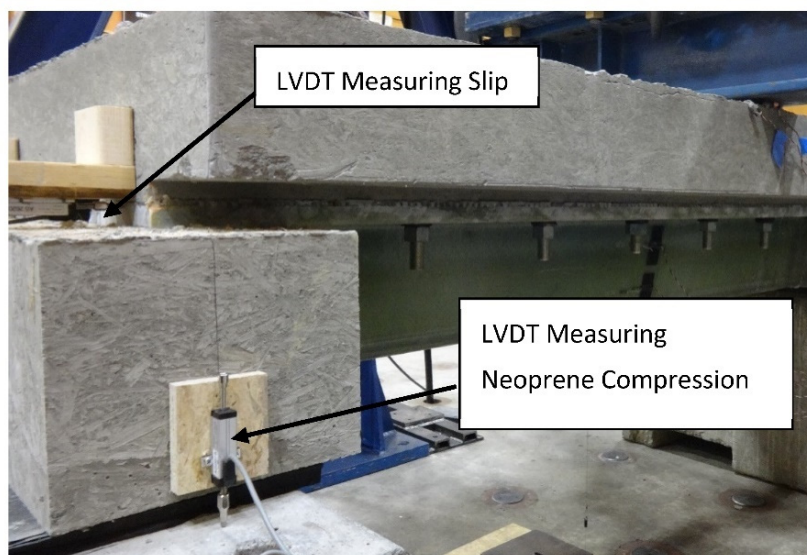
Figure 10. Short Beam Specimen Instrumentation at Support.

cycling, beam B1 was loaded in displacement control at a constant rate to failure. Beam B2 was a control specimen loaded to failure identically to beam B1, but was not initially fatigued. All load was applied via a 1330 kN hydraulic actuator and load was recorded with a calibrated load cell. As shown in Figure 10, additional instrumentation included two LVDTs at each girder end to measure slip between the concrete deck and girder flanges, and two LVDTs at each support to measure the vertical compression of the neoprene bearing pad. An LVDT was also installed at midspan to measure gross beam vertical displacement.

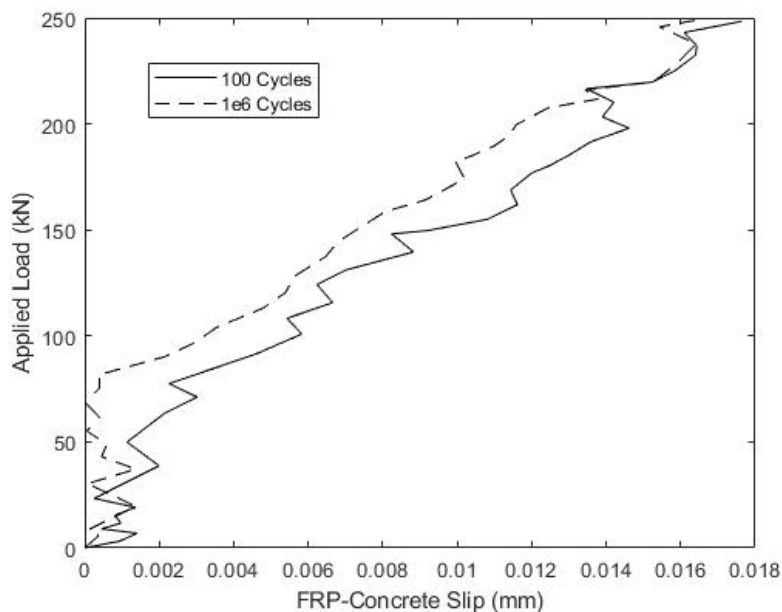
Figure 11. Beam B1 Service Load-Slip Behavior during Fatigue Cycling.

Specimen B1 withstood the full  $1 \times 10^6$  fatigue cycles, and Figure 11 illustrates the relationship between the applied load and slip up to the full fatigue load of 249.3 kN after 100 and  $1 \times 10^6$  fatigue cycles. The small recorded slips and similar slip magnitudes during both tests indicate no significant damage or loss of composite action due to load cycling. Consistent with this, Figure 12 shows nearly identical, linear load versus mid-span displacement for beam B1 after 100 and  $1 \times 10^6$  fatigue cycles.

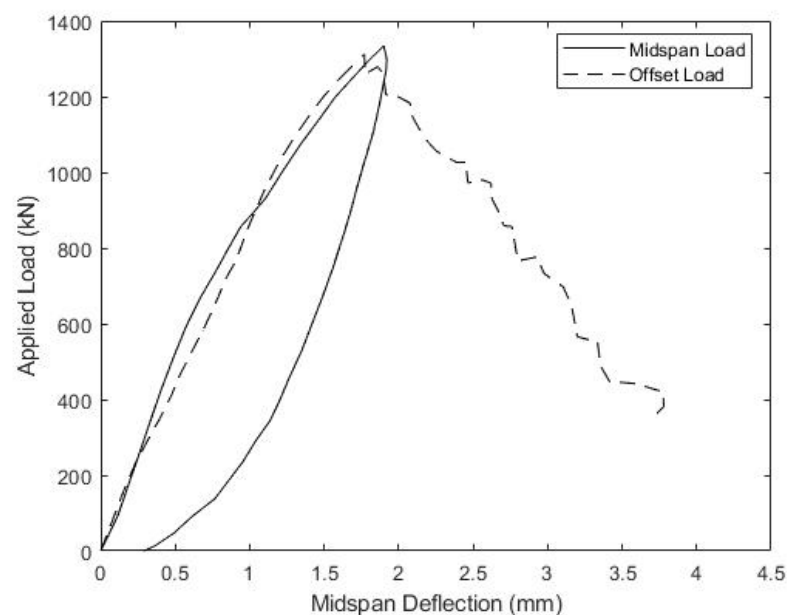
**Figure 13.** Beam B1 Ultimate Load-Displacement Response.

The load versus mid-span displacement results, gathered during the strength testing of beams B1 and B2, are given in Figures 13 and 14, respectively. Beam B1 was initially loaded with the actuator positioned at mid-span, as represented by the solid curve in Figure 13, but the maximum actuator capacity was reached before catastrophic failure, and the beam was then unloaded. In order to increase internal shear between the load point and one support to induce failure, the actuator was subsequently shifted 30.5 cm closer to one support. This increased the maximum shear in the beam by 25%, from  $P/2$  to  $0.625P$ , for a given actuator load  $P$ . The results of the offset load test are given in Figure 13 by the dotted curve, and shifting the actuator was successful at producing failure. For consistency, the same protocol of initially loading at mid-span, followed by offsetting the actuator 30.5 cm closer to one support, was also used to test beam B2, and its load-displacement response is shown in Figure 14. Figure 15 includes a photo of B1 after failure highlighting the diagonal cracking of the deck that coincided with the failure of the concrete ridges.

The load-displacement response of beams B1 and B2 are similar, with both specimens sustaining the full actuator load under mid-span loading, followed by failure under offset loading. Beam B1 carried a peak load of 1315 kN during the offset load test, which corresponded to a maximum shear force of 822 kN, whereas beam B2 carried a peak force of 1248 kN, producing a maximum shear force of 780 kN. These shear forces at failure can be used to estimate the maximum shear flow,  $f_v^u$ , at the girder-deck interface with Equation (5), which gives  $f_v^u = 0.898$  kN/mm for beam B1 and 0.853 kN/mm for beam B1. These values are both higher than the shear flows at failure taken directly from the compression-shear specimens S1–S3 (Table 2), despite specimens S1–S3 having a slightly higher concrete compressive strength. Consistent with this, the normalized shear flows at failure,  $f_v^u / \sqrt{f_c'}$ , are 102 and 97 for B1 and B2, respectively, both higher than observed for compression-shear specimens S1–S4. One possible reason for these higher, directly observed and normalized

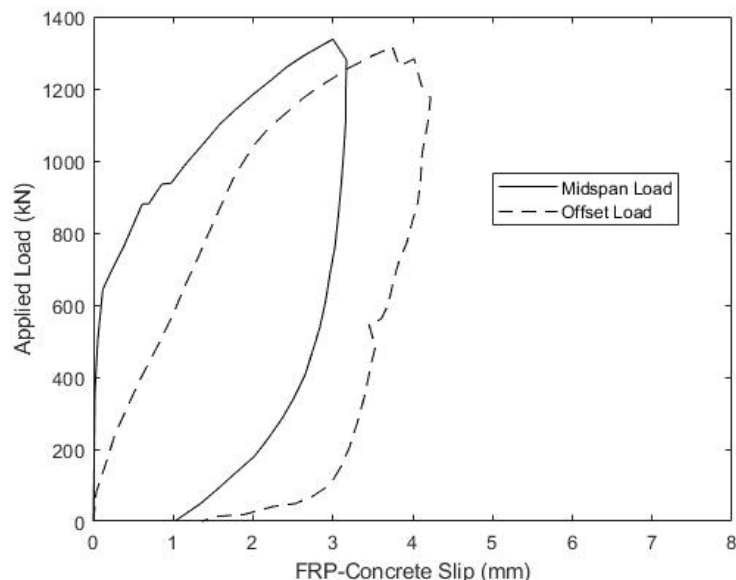
Figure 16. Beam B1 Ultimate Load-Slip Response.

The relationship between the applied load and slip between the concrete deck and girder top flange is also of significant interest. Figures 16 and 17 show the measured load versus the average slip for both the midspan and offset load scenarios for beams B1 and B2, respectively. Both specimens showed consistently small slips and relatively linear responses, until the midspan loads of about 650 kN, which corresponds to a shear of 325 kN and an interface shear flow,  $f_v^u$ , of 0.355 kN/mm. At larger loads, slips increased more quickly to a maximum average value of 3–3.5 mm. During subsequent offset loading, both B1 and B2 exhibited nearly linear load-slip responses until about 950 kN of the applied load, which corresponded to a slip of ~2 mm. The softer interface response, measured during the offset loading, does indicate that loads larger than 650 kN in the midspan load test might have caused some damage to the girder-deck interface.

While girder-deck interface slips measured during the offset loading test are larger than those recorded during the compression-shear tests, they cannot be directly compared, due to the different specimen scales and lengths of the deck-flange interface in the two tests. It is also important to emphasize that the AASHTO LRFD Strength I factored interface shear is 0.404 kN/mm, which is only 14% above the value of  $f_v^u = 0.355$  kN/mm, corresponding to the apparent onset of damage, and is less than half of the average  $f_v^u$  at beam failure.

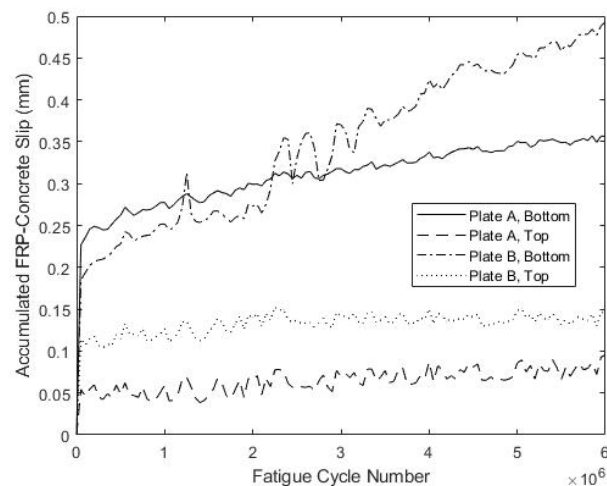
Figure 18. Fatigue-Induced Slip at FRP-Concrete Interface for S5.

The development of the connector slips during fatigue testing is shown in Figures 18 and 19 for specimens S5 and S6, respectively. For S5, three of the four measured slip values stabilized after about  $1 \times 10^6$  cycles and increased little thereafter, whereas for S6, this was the case for two out of four measured slip values. The maximum measured slip at the bottom of plate B for specimen S5 was 0.49 mm, which is larger than the maximum observed slip for specimens S1–S4. However, the large oscillations in measured slip at this location over  $2.5 \times 10^6$ – $3.5 \times 10^6$  cycles might reflect poor anchoring of the LVDT at that location. Specimen S6 exhibited smaller slips that never exceeded 0.2 mm, which is more consistent with the results from specimens S1–S4. Overall, these results indicate performance during load cycling similar to that observed for specimens S1–S4.

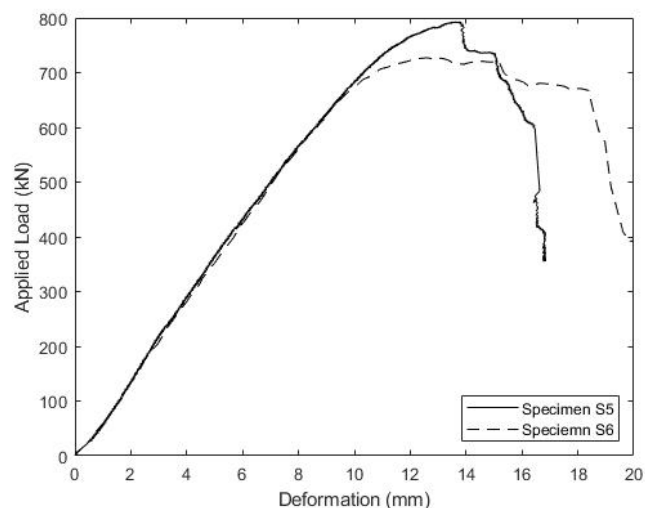
**Figure 20.** Stainless Steel Connector Load-Deformation Response under Monotonic Loading to Failure.

Figure 20 includes the load vs load head displacement relationship during the post-fatigue failure tests. Specimen S5 had an ultimate strength of 791 kN, while S6 failed at 729 kN, although S6 exhibited more ductility with a longer load plateau. As with previous specimens, the peak load was characterized by the shear failure of the concrete ridges, and the lower concrete compressive strength of specimen S6 could explain its somewhat lower capacity and greater ductility. The shear flows at failure are given in Table 4, and are less than the shear flows at failure observed for specimens S1–S3, but greater than those for S4. However, specimens S1–S3 all had higher concrete strengths than specimens S5 and S6, whereas specimens S5 and S6 both had higher concrete strengths than specimen S4. The normalized capacity,  $f_v^u / \sqrt{f_c^l}$ , given in the last column of Table 4 indicates values somewhat lower than those observed for specimens S1–S4. However, this could be due to the fact that, unlike specimens S5 and S6, the connectors in specimens S1–S4 were consistently pre-tensioned to a high level. This pre-tension will induce compressive stress on the shear plane, tending to increase the concrete strength. Relative to the AASHTO LRFD Strength I factored demand for the model bridge girder of 0.404 kN/mm, specimen S5 exhibited 75% excess capacity and specimen S6 exhibited 61% excess capacity. Furthermore, given a yield stress of 215 MPa for the stainless steel rod, Equation (2) predicts a capacity of 0.321 kN/mm for both specimens, assuming a connector spacing of 30.5 cm, which is less than half the measured capacity of both specimens. These low predicted strengths are due to the low yield stress of the 304 stainless steel, and the discrepancy with the observed values could indicate that the connector yield strength does not play a significant role in

strength, as implied by Equation (2). This is consistent with the post-mortem observations of concrete ridge shear failure. The connection stiffness (load vs. slip) cannot be determined, since slips were not measured during the strength tests.
